Asset #05397(Routine, Underwater type 2)

SH 183 Log 5.35 over HURRICANE CREEK

Location: 3.3 MI S OF I-30

Team Lead: Shane Byrd Inspection Date: 03/13/2024

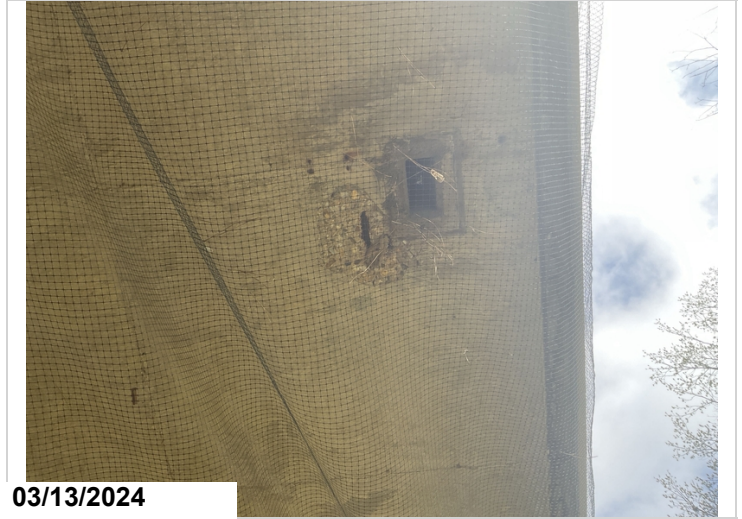
Span 5 spall with exposed rebar at right scupper drain.

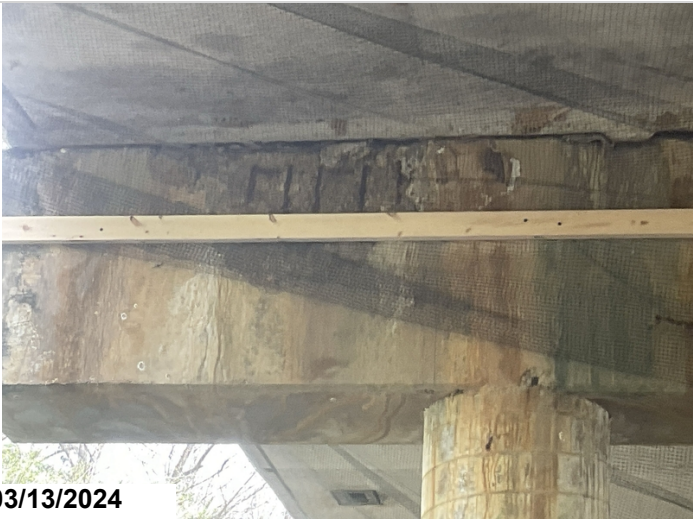
Bent 6 cap back left of column 1 spall with rebar.

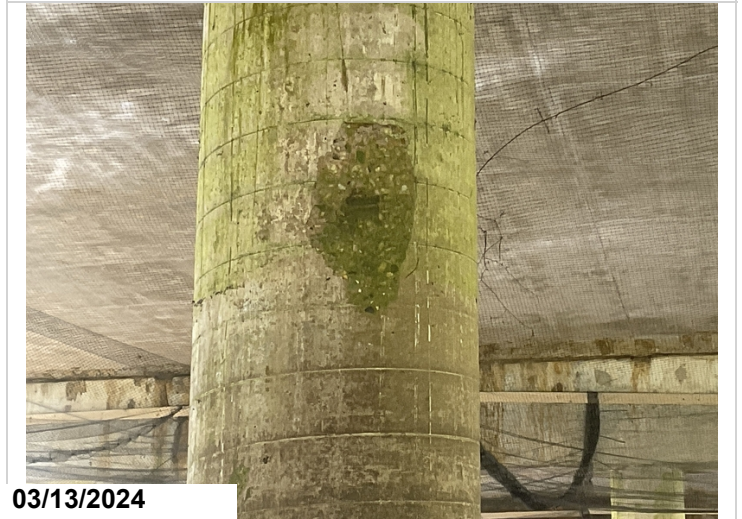
Bent 2 column 5 ahead spall with rebar.

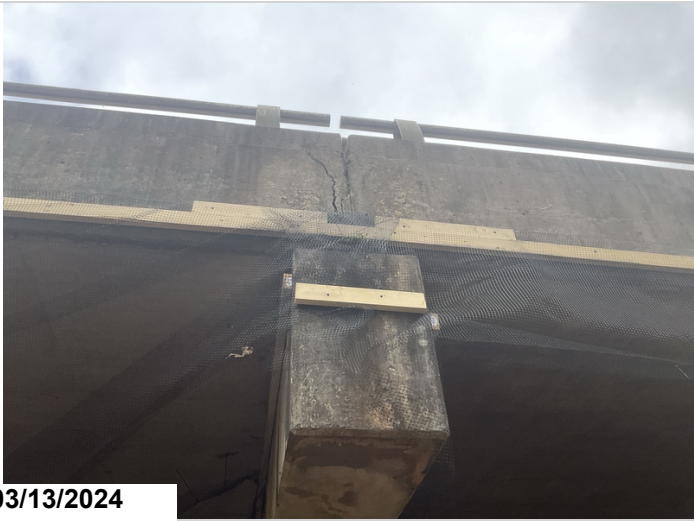
Span 3 right side of slab at bent 3 delamination.

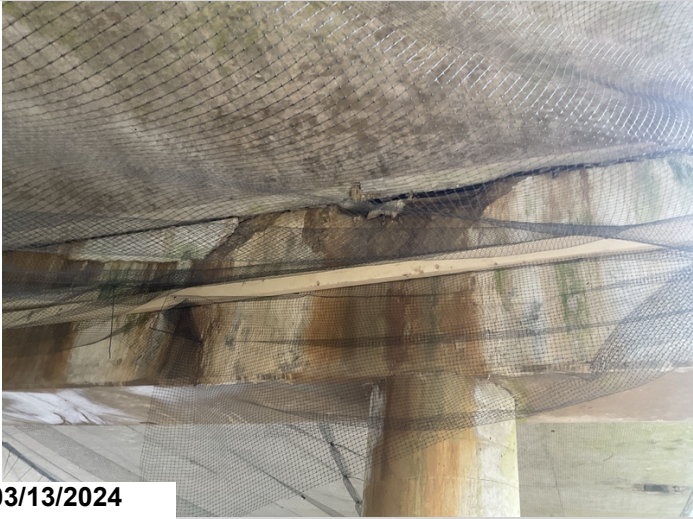
Bent 2 cap back at column 3 spall and delam.

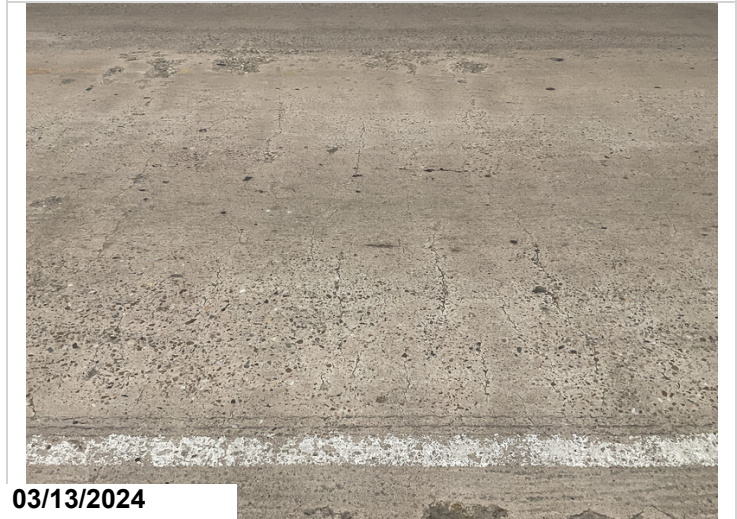
Deck span 2 transverse cracks on two foot centers.

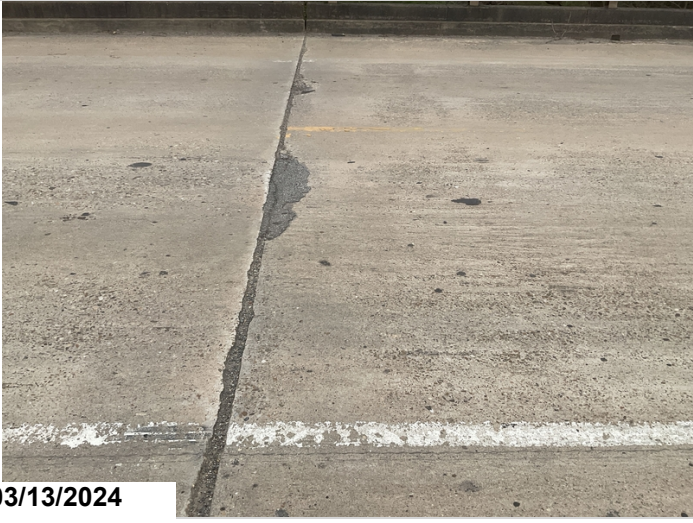
Span 3 at bent 3 spall and spall filled with asphalt.

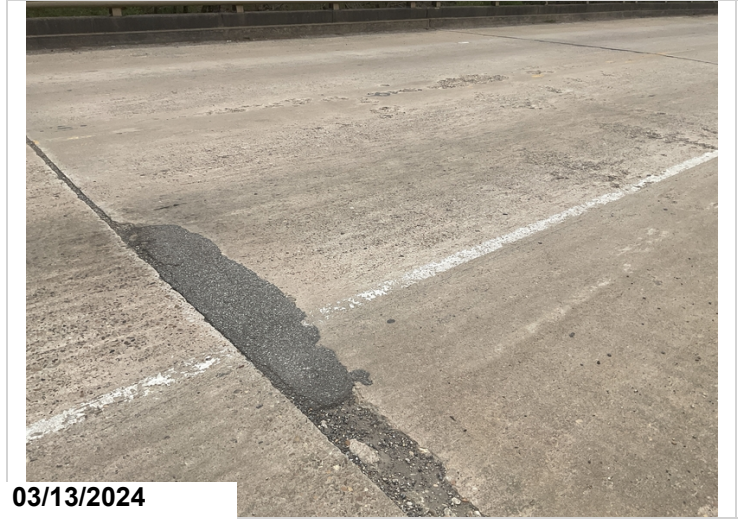
Span 5 spalls and spalls filled with asphalt.

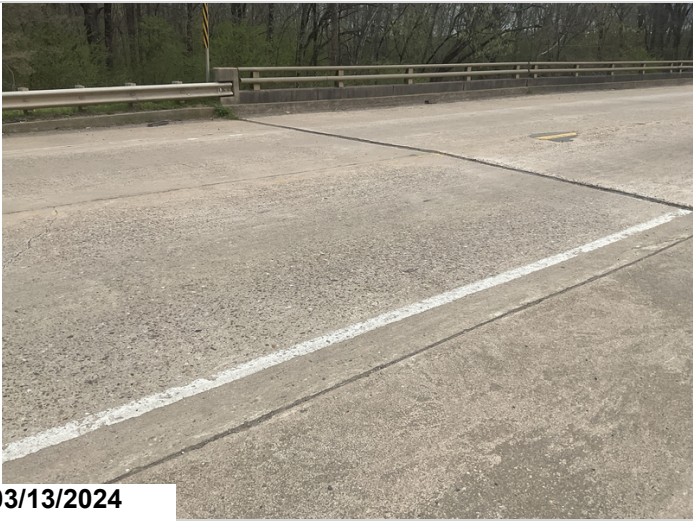
North approach slab has settled up to 2"

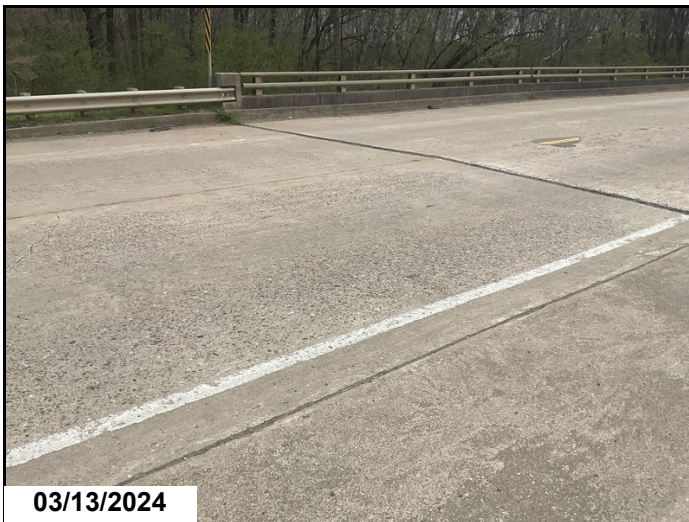
Both approach slab has settled Approx. 2 inches causing traffic to impact the bridge.

North approach slab has settled up to 2"

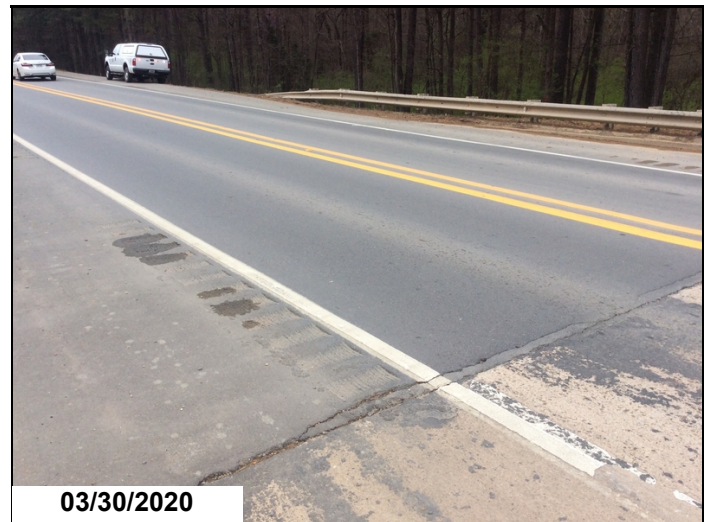
The south approach slab that has been overlaid.

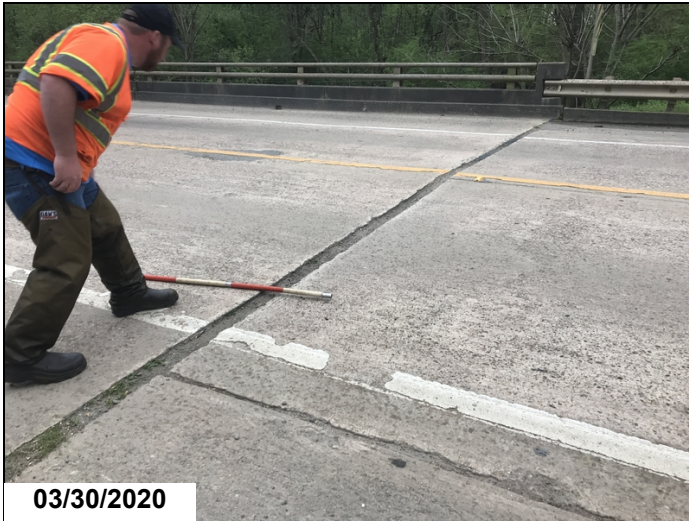
Approach at north end of bridge has setteled.

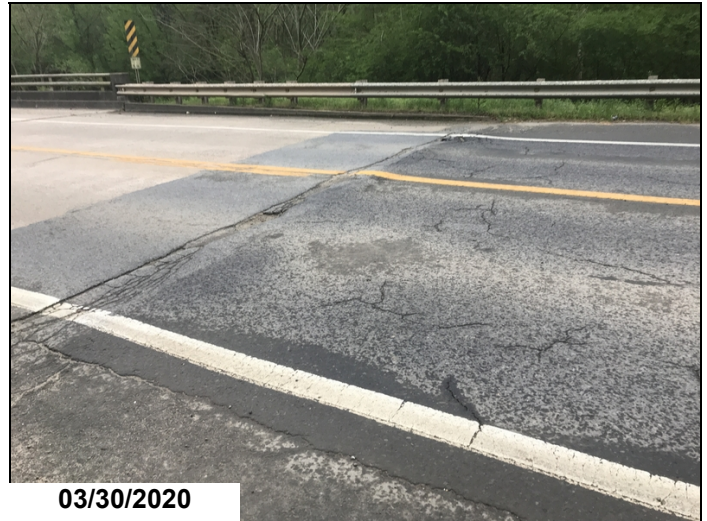
2018  
The south approach slab has been overlaid and no settlement can be detected. At the north approach slab the asphalt has heaved making a hump where vehicles impact it making a small ramp.  
The north approach slab adjacent to span 6 has settled.

Asphalt has heaved up causing traffic to impact load the approach slab at the north end of the bridge.

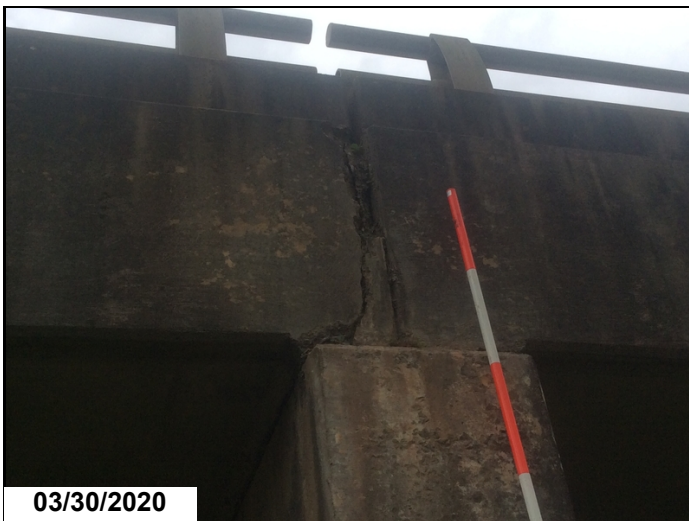
Span 5 at Bt. 6, right side, delam.

Span 5 at bent 6 delamination on the right side of slab.

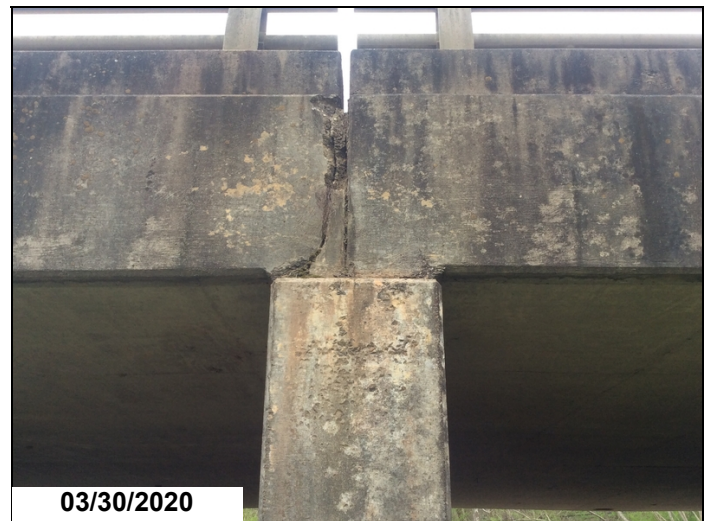
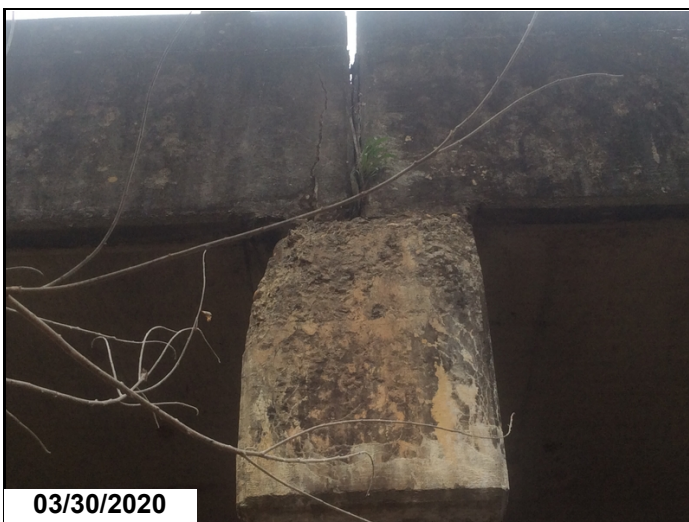
Span 2 right side at bent 3 delam on slab and spall on end of cap.

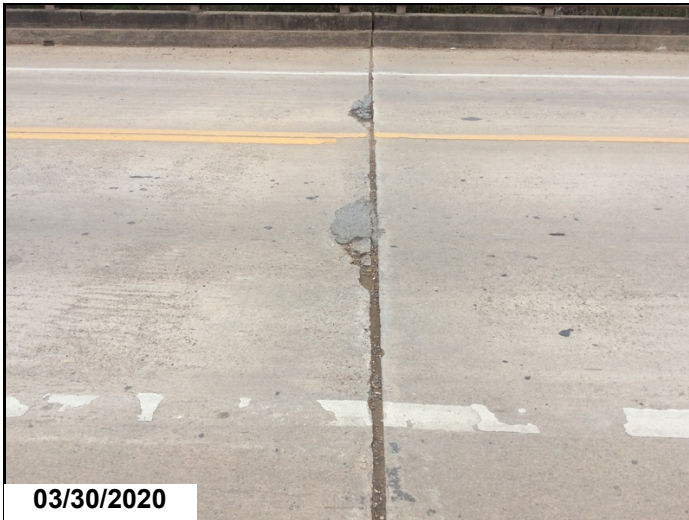
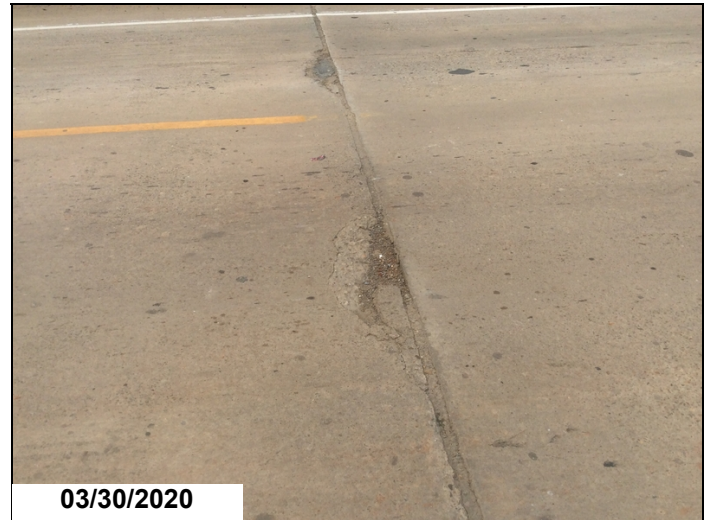
Spalls in the deck at span 3 bent 4.

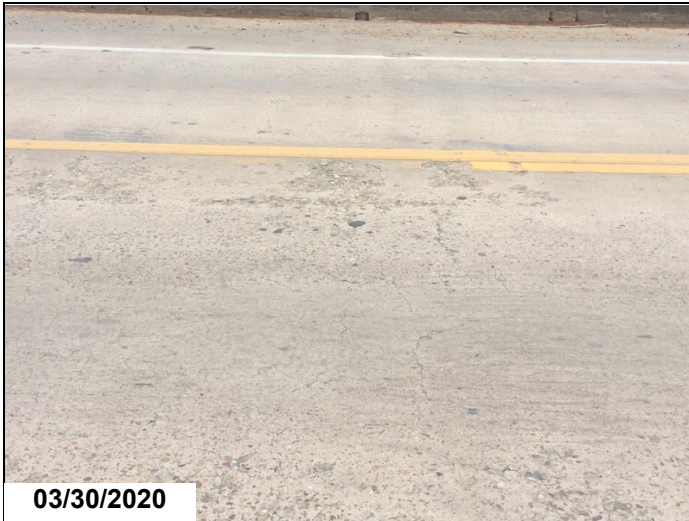
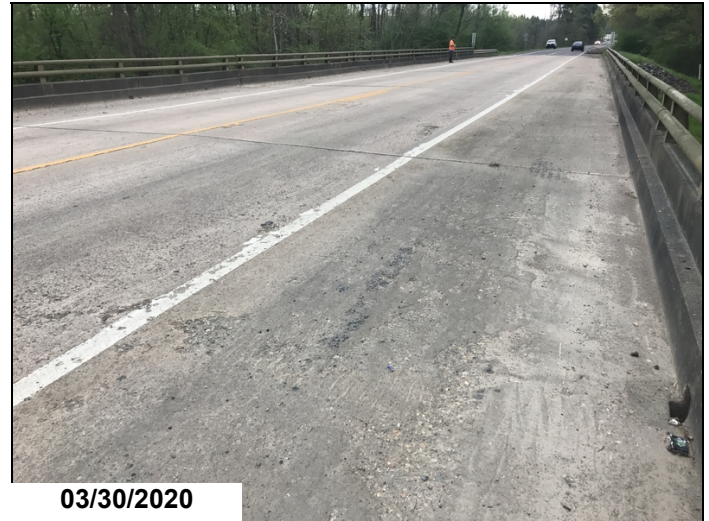
Spans 1 & 2, heavy scaling.

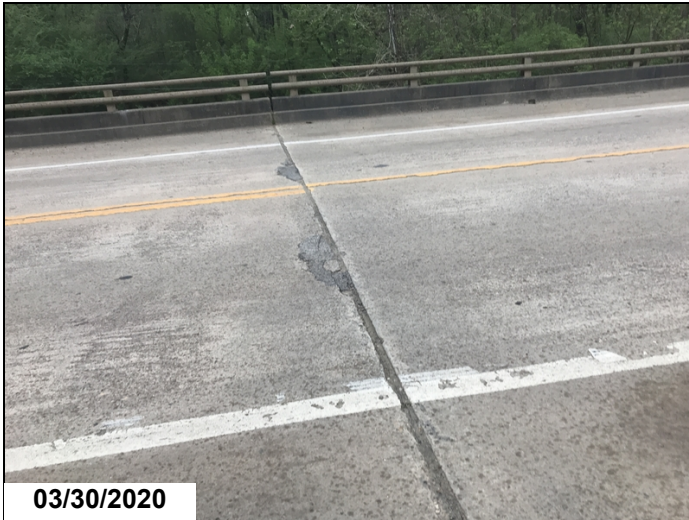
Span 3 spalls filled with asphalt.

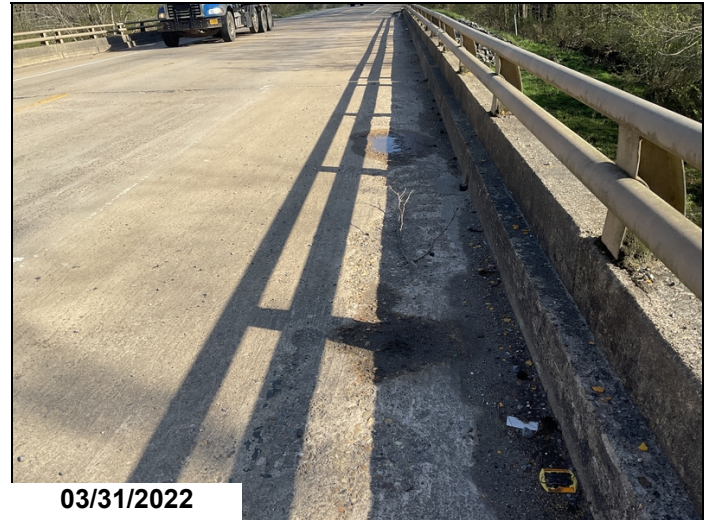
Span 3, right shoulder: couple open spalls

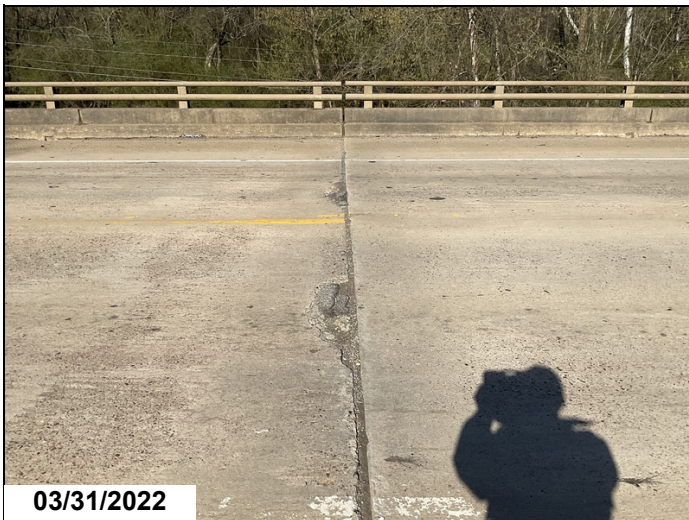
Bent 4: couple open spalls at the joint.

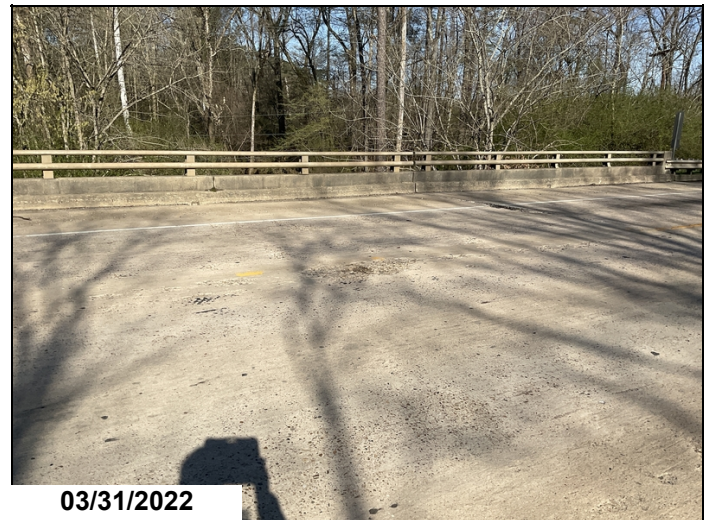
Span 5: Spall at centerline.

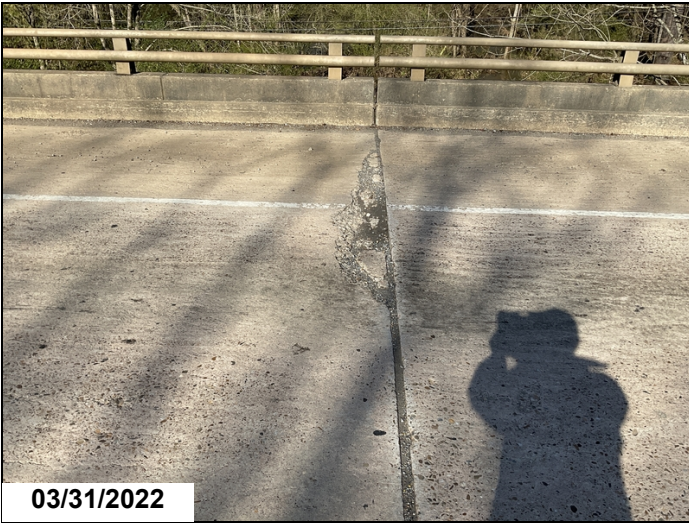
Bent 6: Spall in the left lane

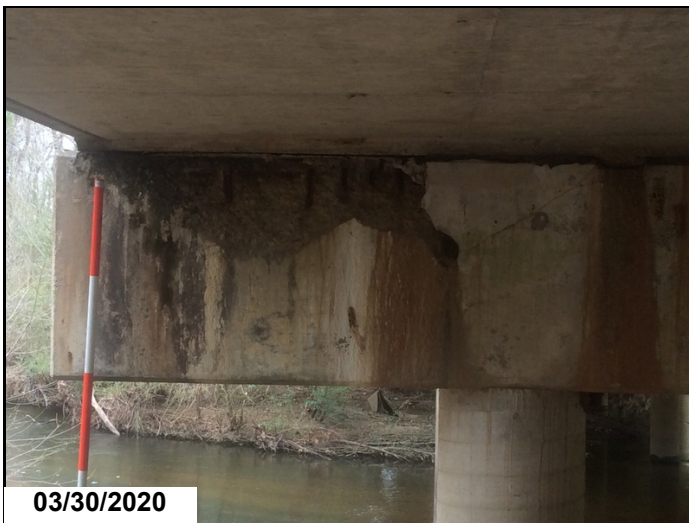
Bent 2 cap back left of column 1 spall with exposed rebar.

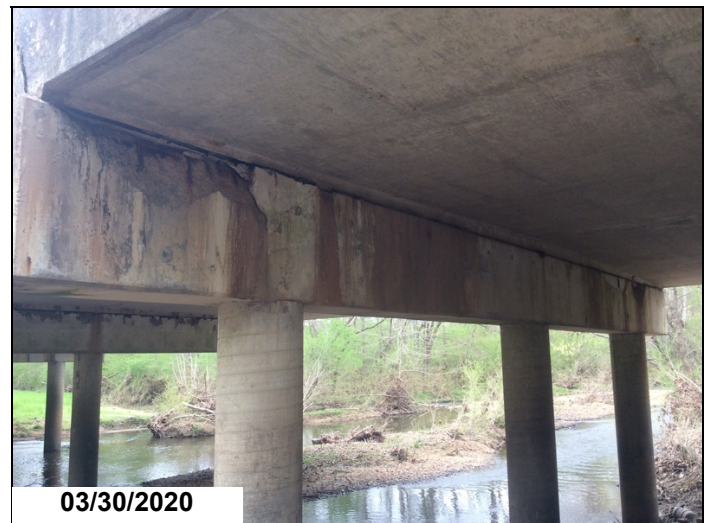
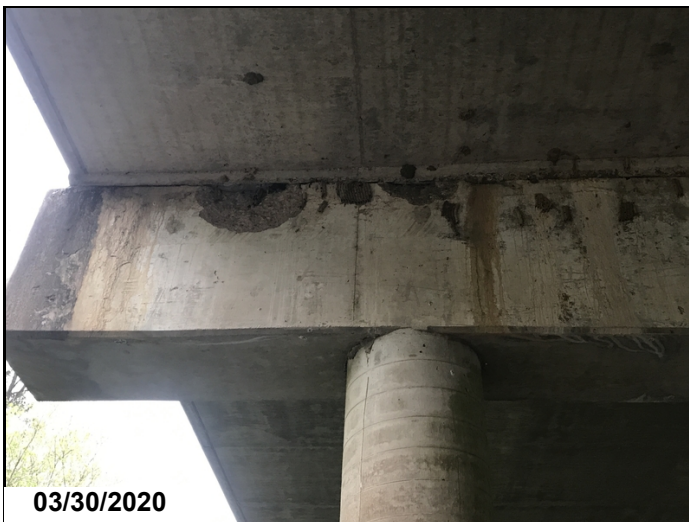
Cap at Bt. 4, back left side, spall.

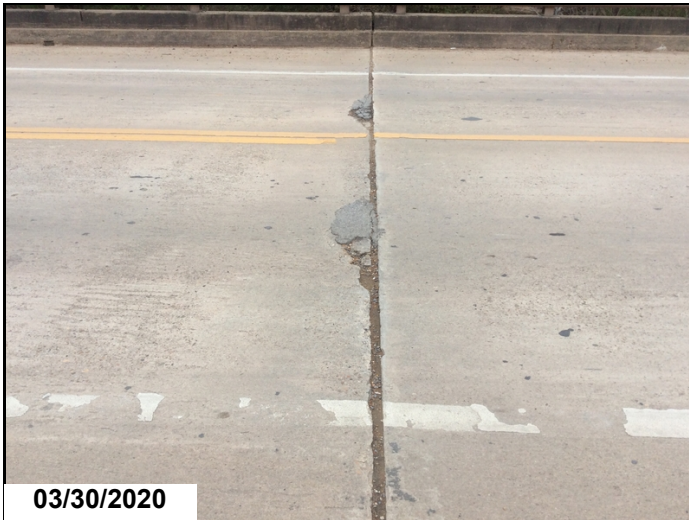
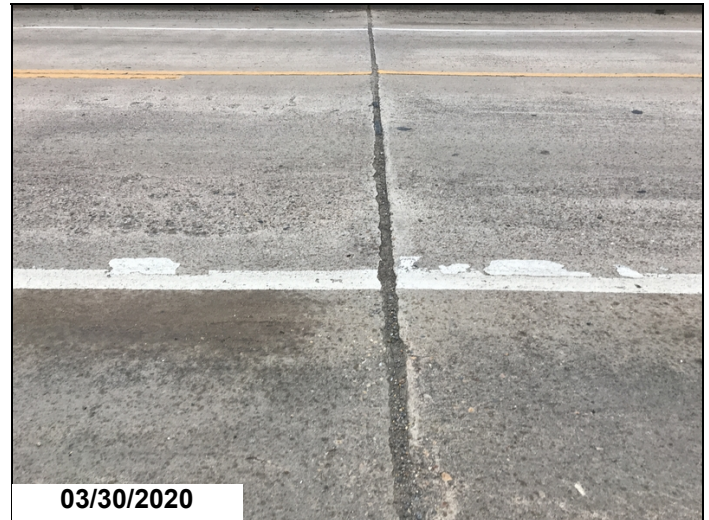
Pourable joint seals are leaking and are completely filled with debris.

Bt. 3, joint seal missing & full of debris.
