Asset #06464(Routine)  
SH 183 SEC 1 over N.W.1ST S.E. 1ST UPRR

Location: 1.8 Mi S. Jct I-30

Team Lead: Shane Byrd Inspection Date: 09/13/2023

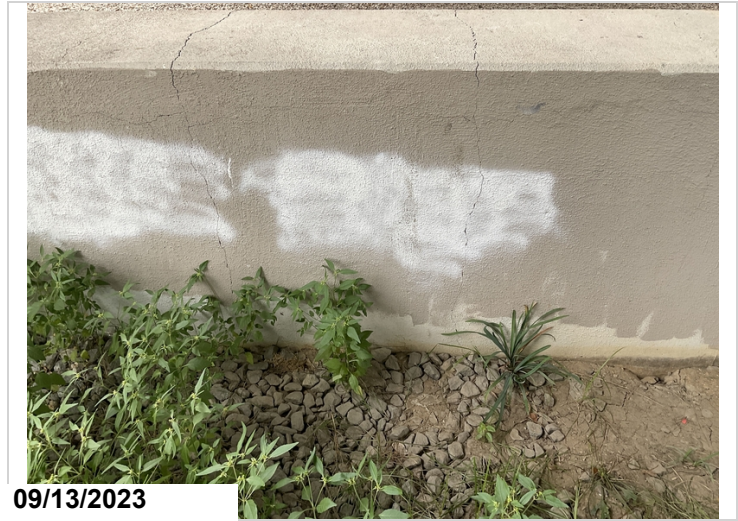
Bent 2 pier wall between columns 1 & 2 cracks.

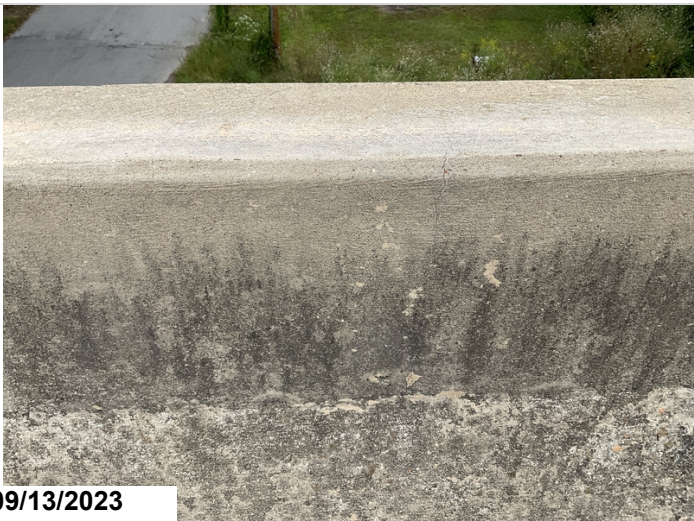
Span 1 bridge rail left side small vertical crack.

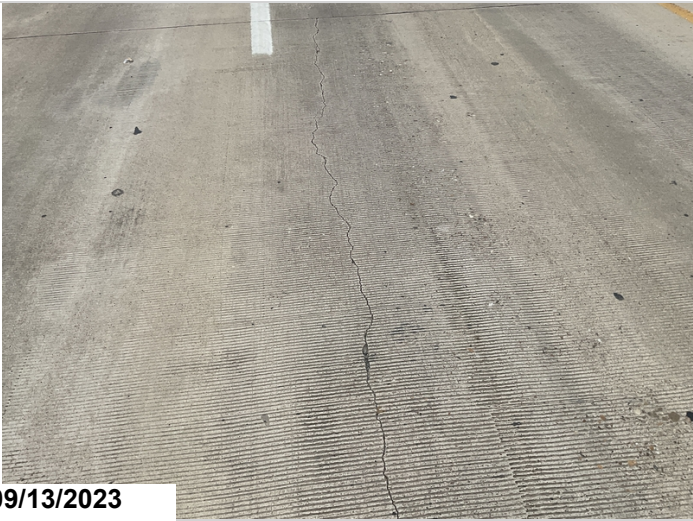
South approach slab longitudinal crack. Up to 0.60" wide.

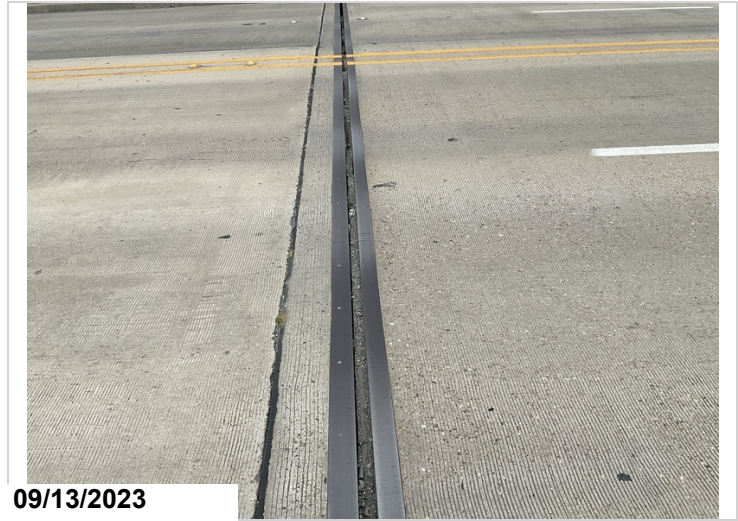
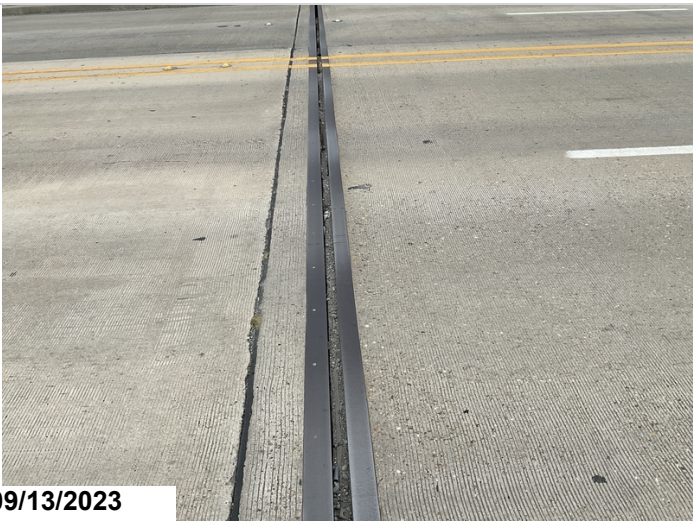
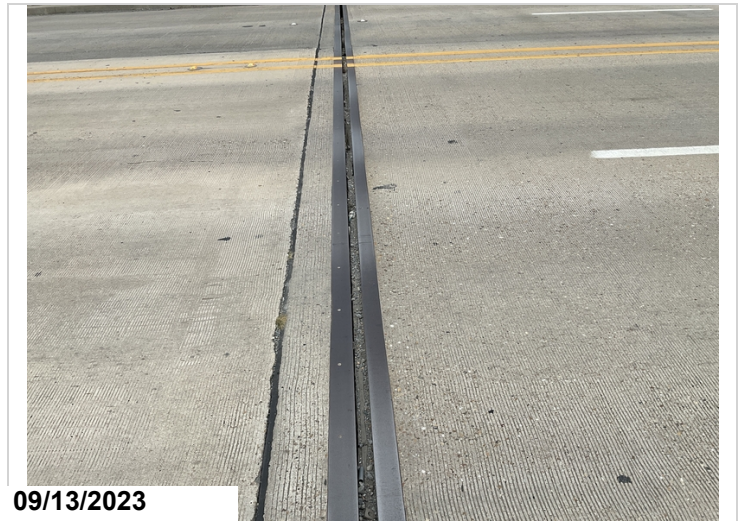
Abutment 1 and bent 6 Abutment.  
10 feet of joint seal has falling out on abutment 1 and the rest of joint seals have lost bond and allow debris on bearings and beam ends.

Bent 1 pourable joint seal has lost bond.

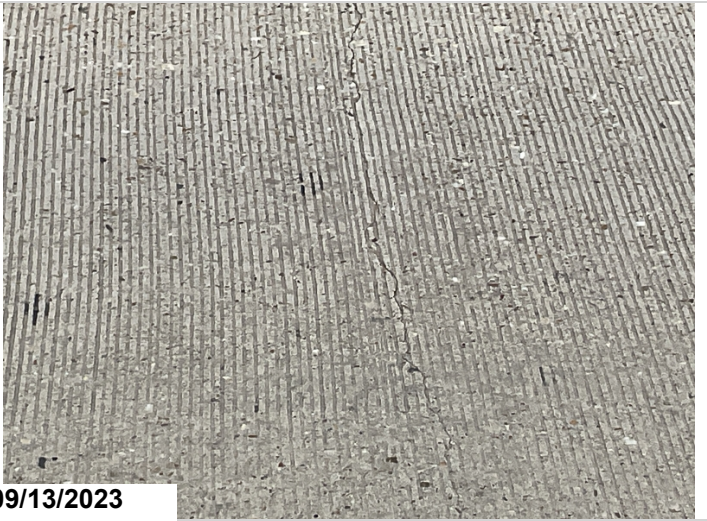
Deck span 1 transverse crack up to 0.30" wide.

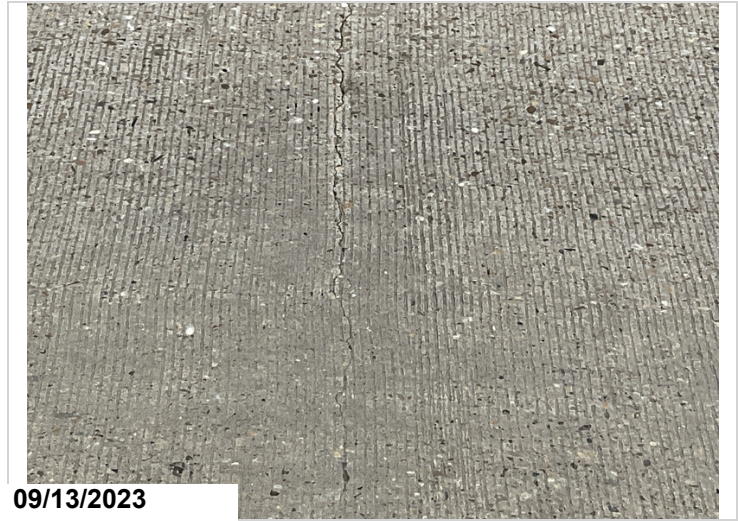
Deck span 6 transverse crack up to .040" wide.

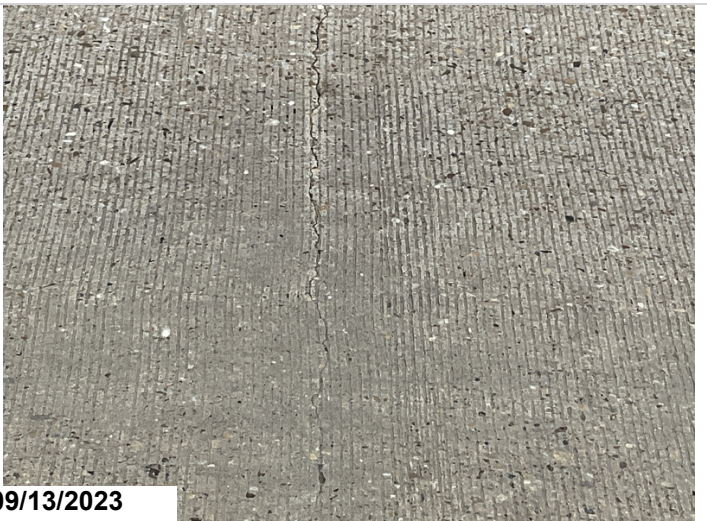
Span 6 transverse crack up to .040" wide.

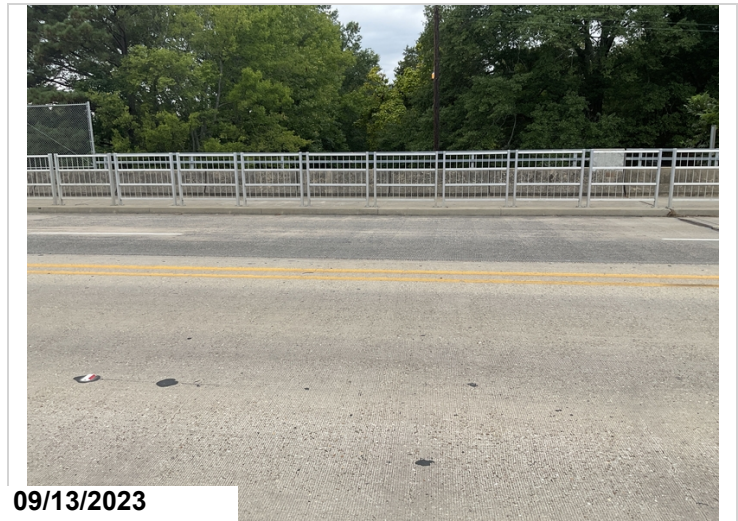
Span 6 south bound lanes have light abrasion.

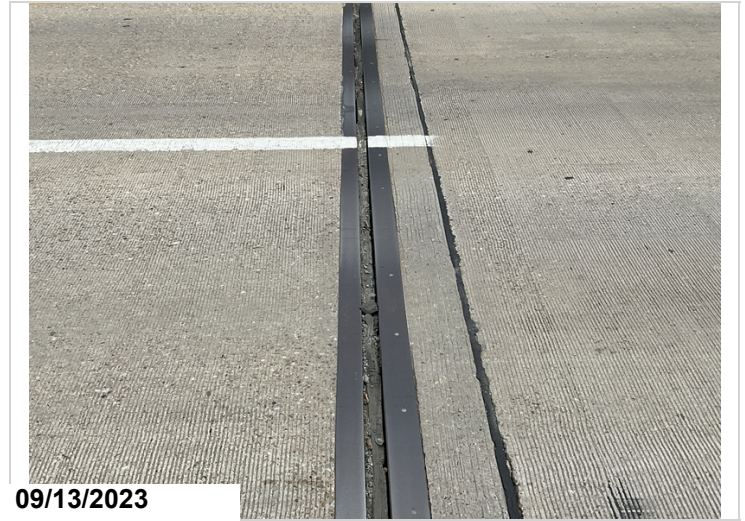
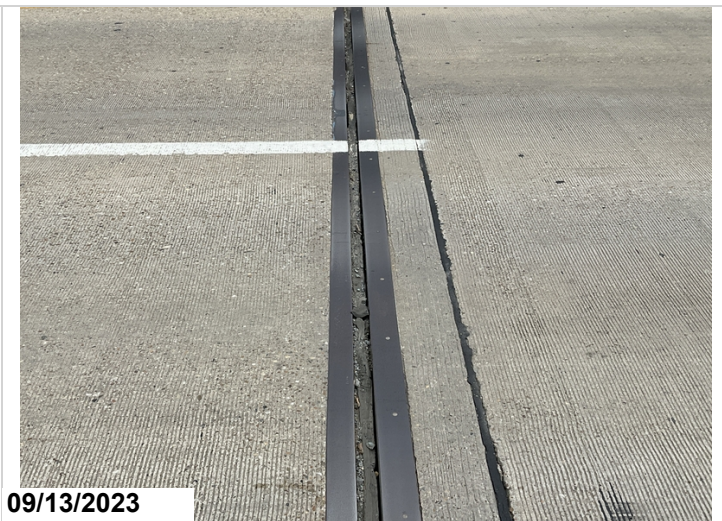
Bent 6 pourable joint seal has lost bond.

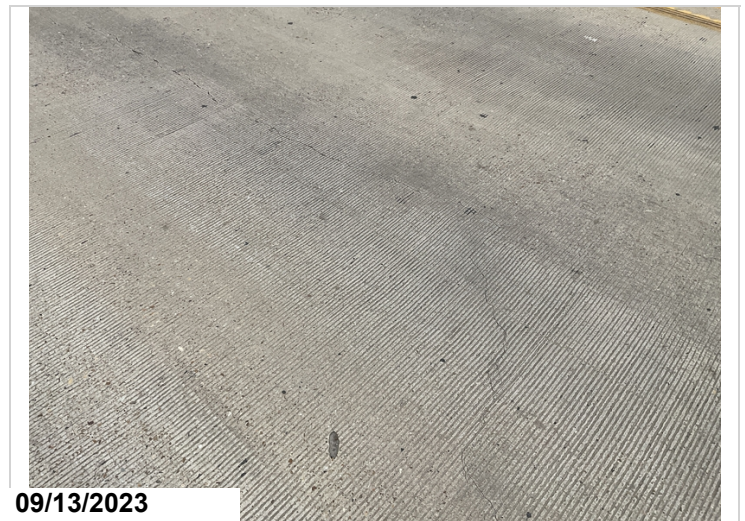
North approach slabs has small cracks.

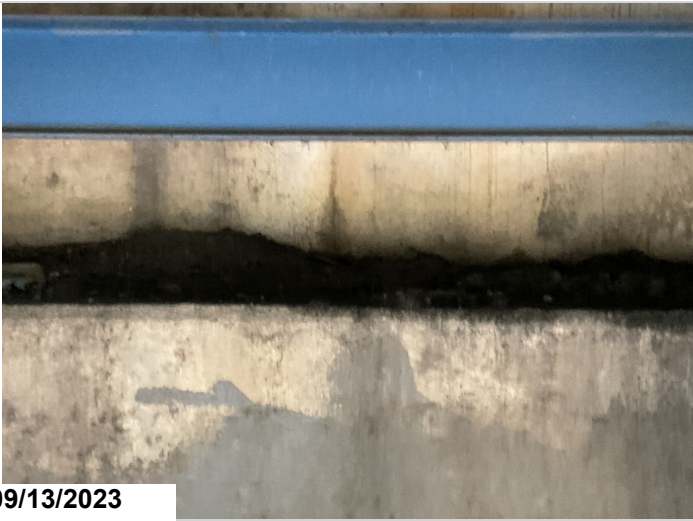
Bent 6 small vertical cracks in the back wall.

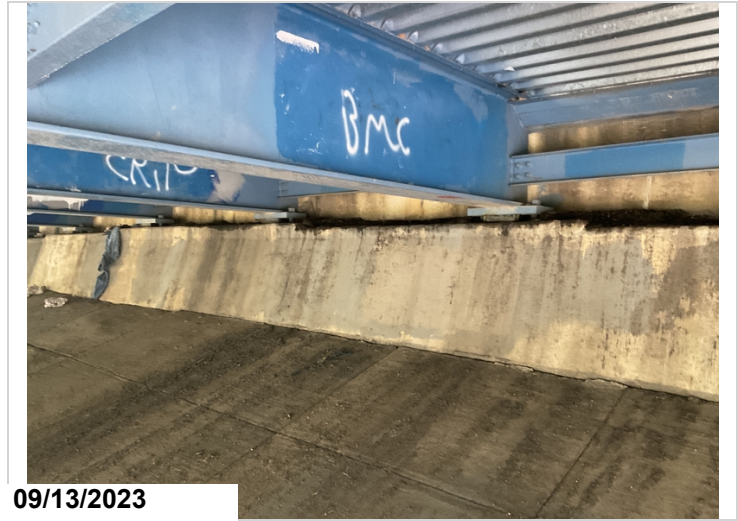
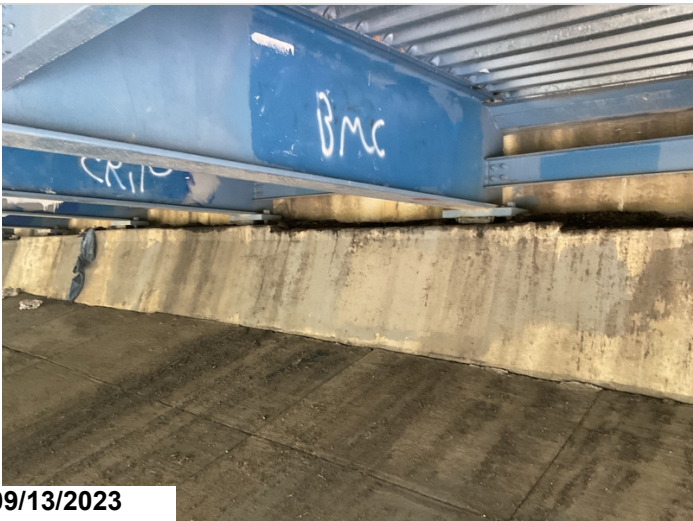
Bent 6 dirt and debris built up on abutment due to leaking joint seals.

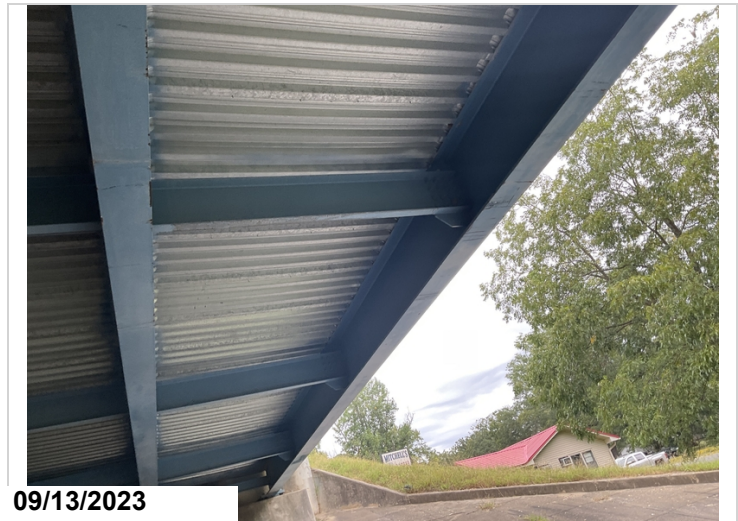
Beam 7 & 8 minor scrapes to bottom flanges due to traffic impact.

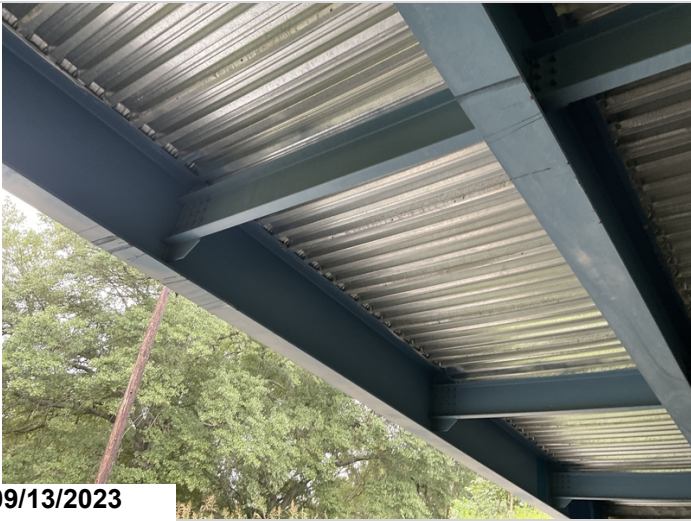
Beam 1 & 2 minor scrapes to bottom flanges due to traffic impact.

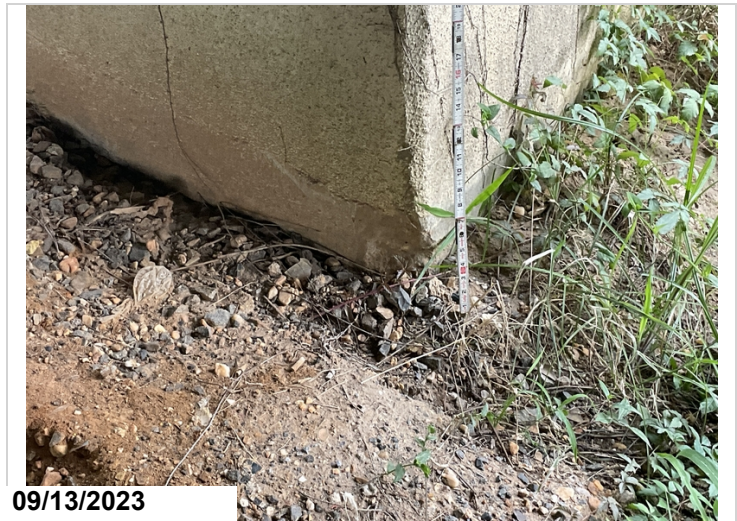
Bent 5 column 4 back left side at ground line minor spall.

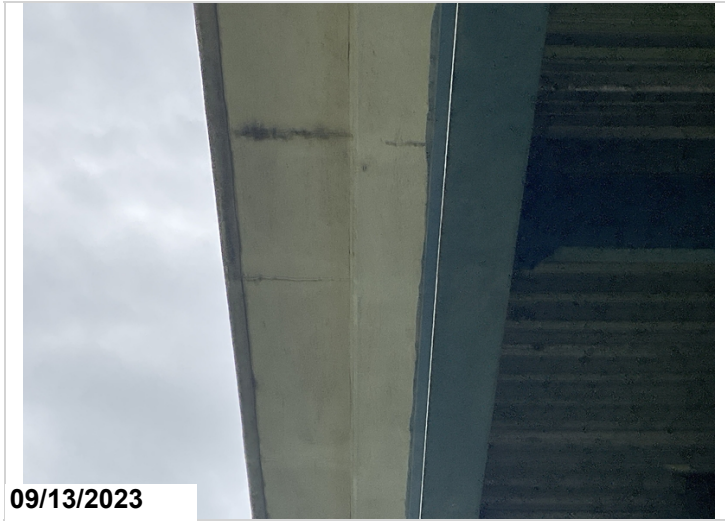
Span 4 soffit overhang cracks with light efflorescence.

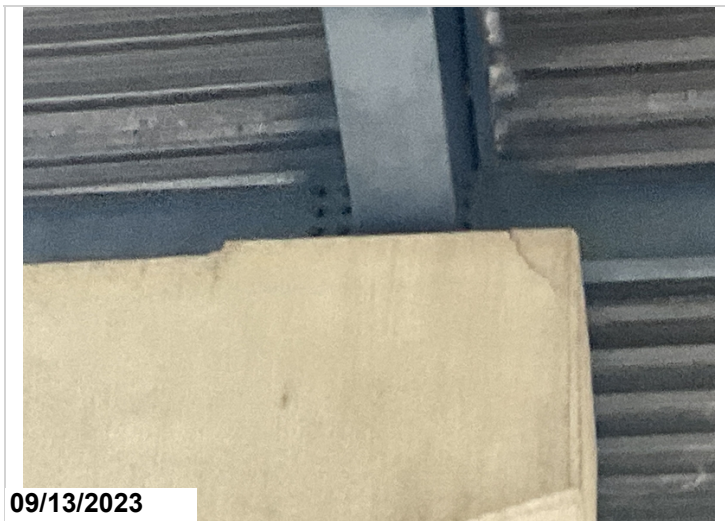
Bent 3 cap ahead left of column 3 crack.

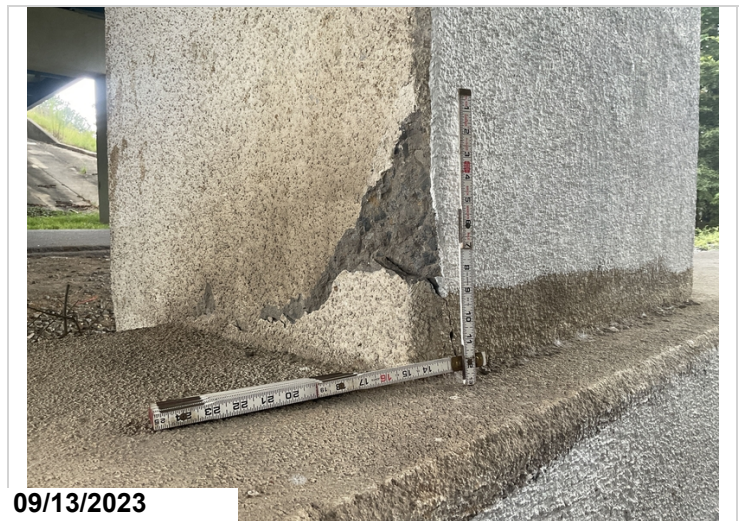
Bent 2 column 2 right side above pier wall spall.

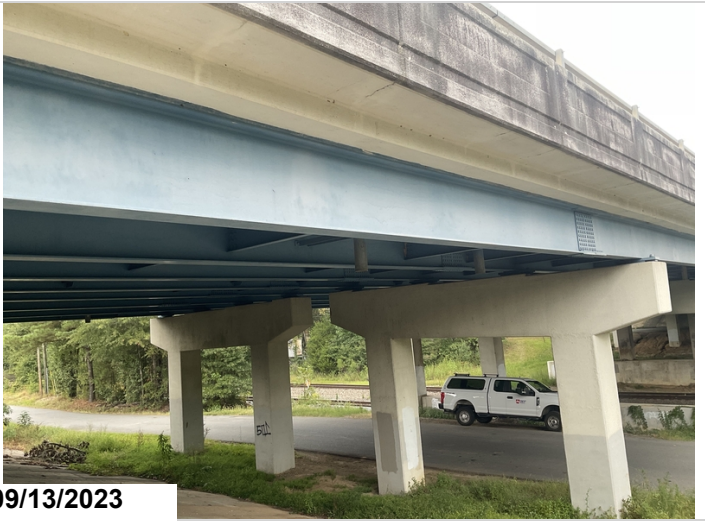
Span 1 beam 8 paint system is chalky.

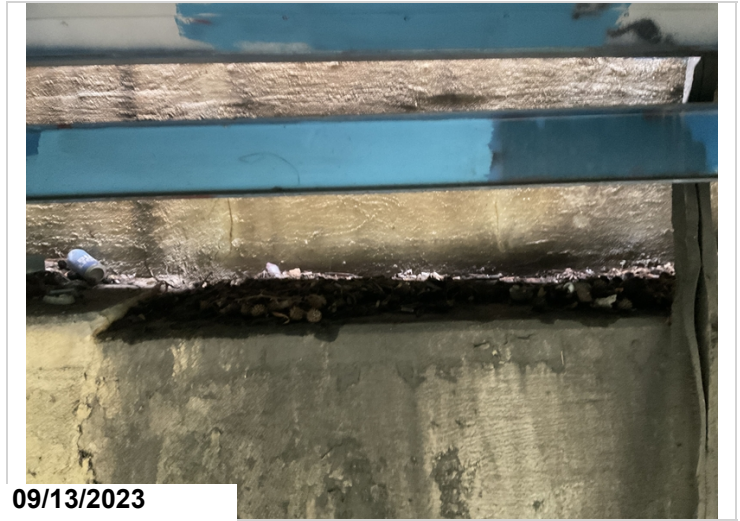
Bent 1 small vertical cracks in the back wall.

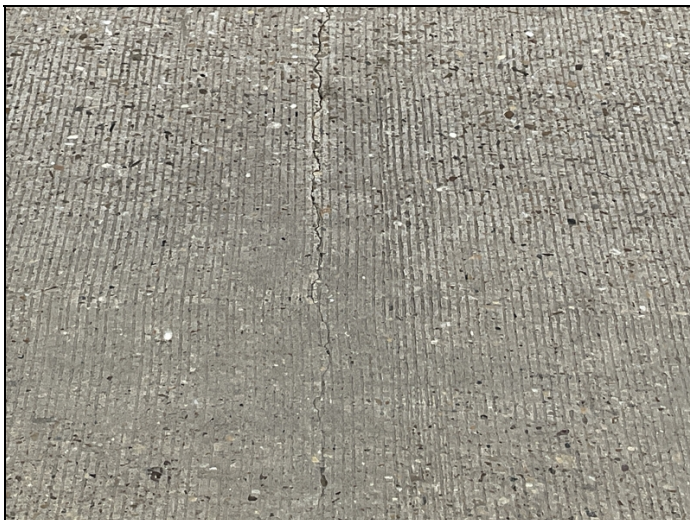
Scattered longitude and transverse cracks in all spans up to 0.040 wide.

Span 6 transverse crack up to .040" wide.

#### A-54 - Sealable Deck Cracks (Yes)

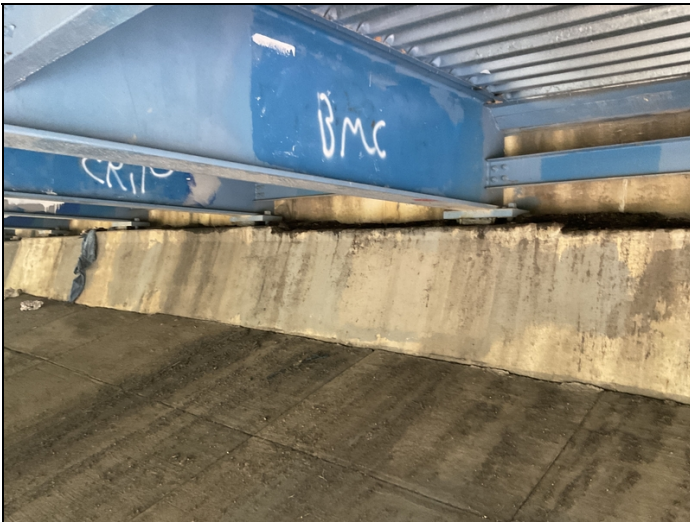
Bent 1 & 6 have dirt and debris on top of abutments due to leaking joint seals.

Bent 6 dirt and debris built up on abutment due to leaking joint seals.

**A-58 - Cap Cleaning/Flushing Needed (Yes)**

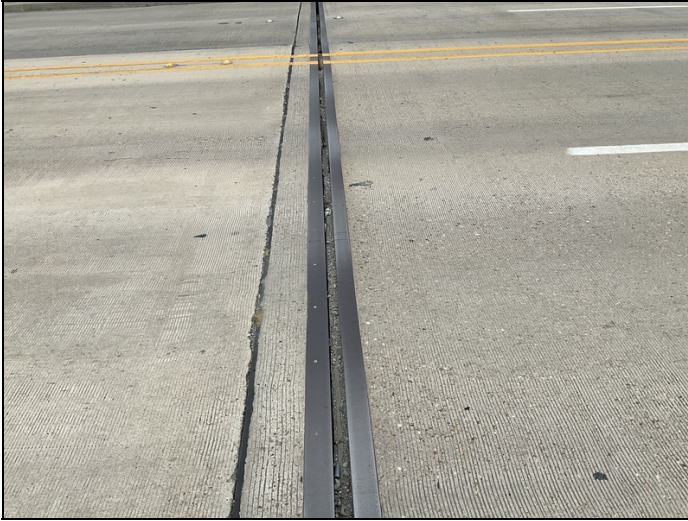
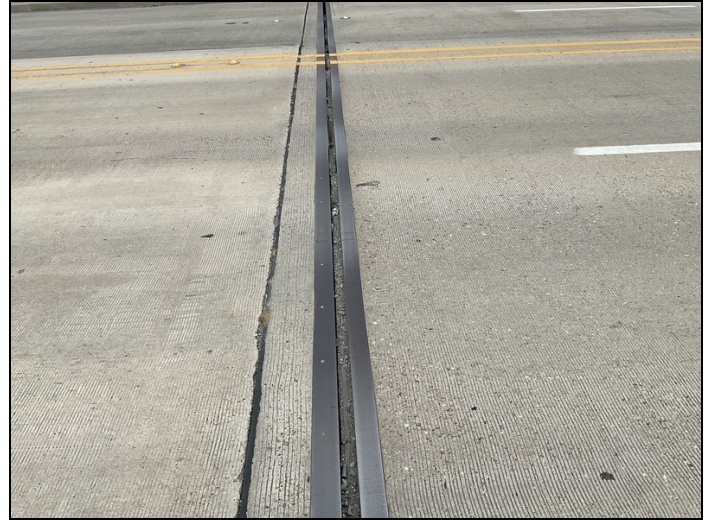
10 feet of joint seal has falling out on abutment 1 and the rest of joint seals have lost bond and allow debris on bearings and beam ends.

Bent 1 pourable joint seal has lost bond.

**A-59 - Joint Repair Needed (Yes)**

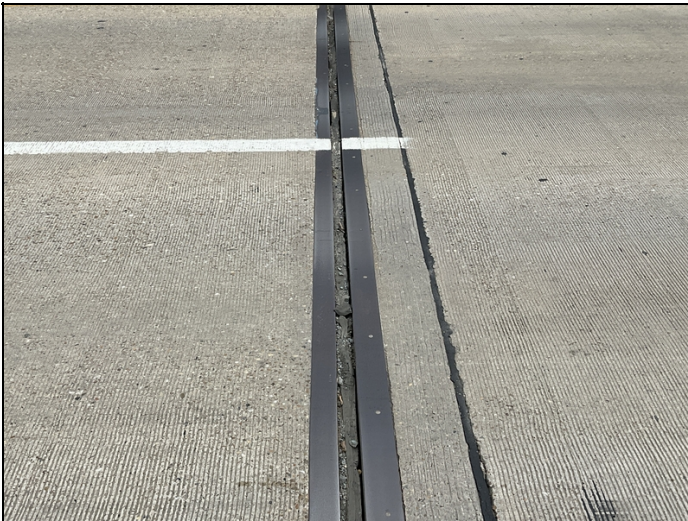
Bent 6 pourable joint seal has lost bond.
