Asset #06910(Routine)
SH 183 Log 8.40 over I-30 Sec 22/0 Log 122.96

Location: 0.34 MI S SH 5 JCT

Team Lead: Keith Harris Inspection Date: 03/29/2023

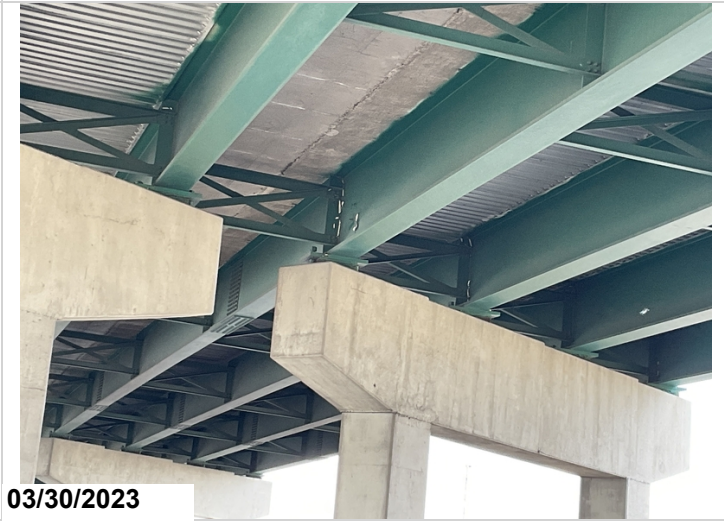
(107) Abutment 1 and abutment 5 bay 4, girders 4 and 5, loose bolts. (515-107) Abutment 1 girders 1 and 3 have paint peeling. Outside of girders 1& 9 are chalky. Span 4 girders 1,3&4 at bent 4 have peeling paint							
205	Reinforced Concrete Column	EA	12	10	2	0	0
1080	Delamination/Spall/Patched Area	EA	2	0	2	0	0

Span 4 girders 1,3&4 at bent 4 have peeling paint

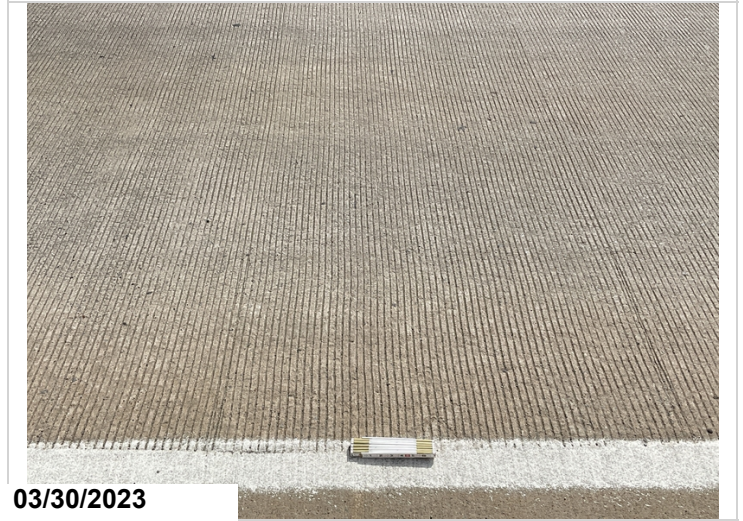
(12) All spans unsealed cracks in the deck up to .020" Spans 1 and 4 map cracking. Soffit overhangs and stage construction(no deck pans) transverse cracks with efflorescence.							
107	Steel Open Girder/Beam	LF	3600	3592	8	0	0
1020	Connection	LF	8	0	8	0	0
515	Steel Protective Coating	SF	40800	36251	4549	0	0
3410	Chalking (Steel Protective Coatings)	LF	4533	0	4533	0	0
3420	Peeling/Bubbling/Cracking	LF	16	0	16	0	0

Span 2 transverse cracks in deck up to 0.020"

A-54 - Sealable Deck Cracks (Yes)

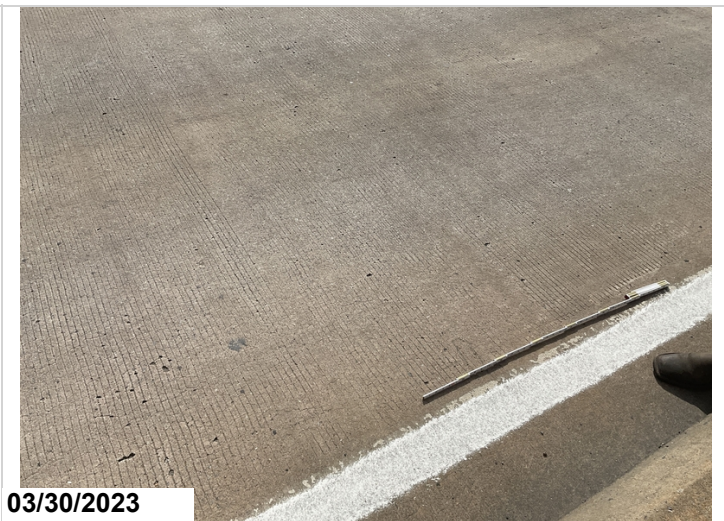
Span 1 map cracking

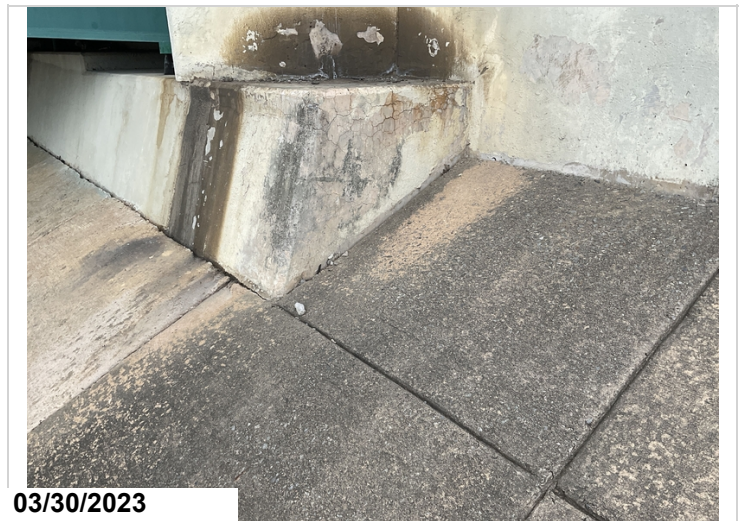
Map cracking on left end of bent 1

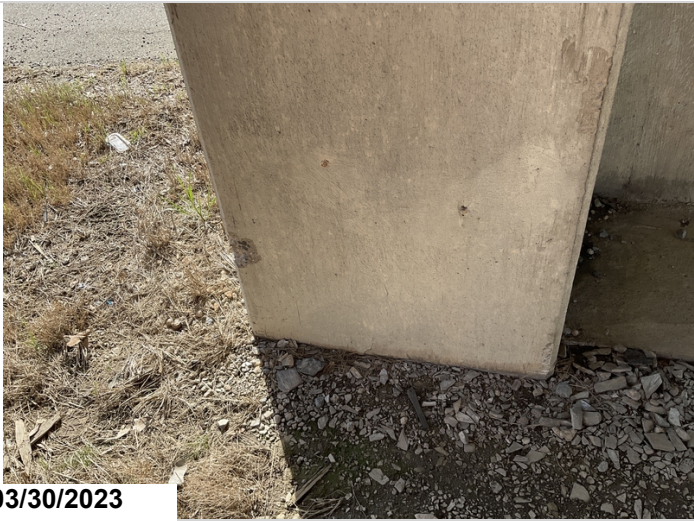
(205) Bent 2 columns 3&4 have small spalls							
215	Reinforced Concrete Abutment	LF	186	99	87	0	0
1120	Efflorescence/Rust Staining	LF	8	0	8	0	0
1130	Cracking (RC and Other)	LF	79	0	79	0	0

Small spall column 4 at bent 2

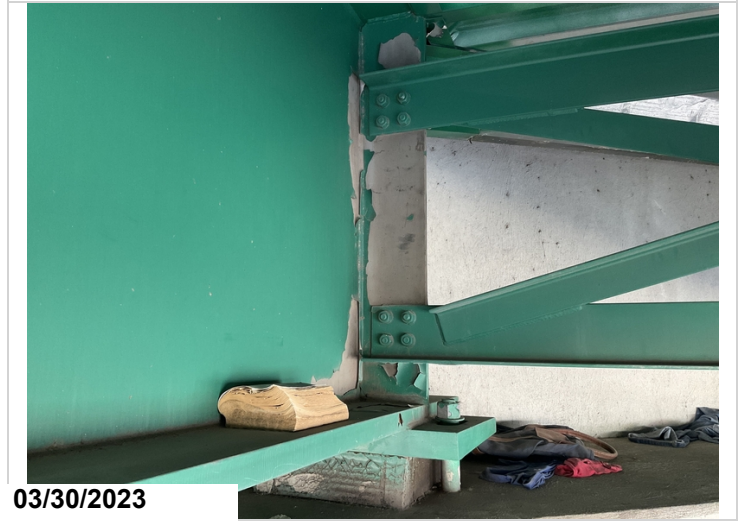
Bent 1 girder 3 peeling paint

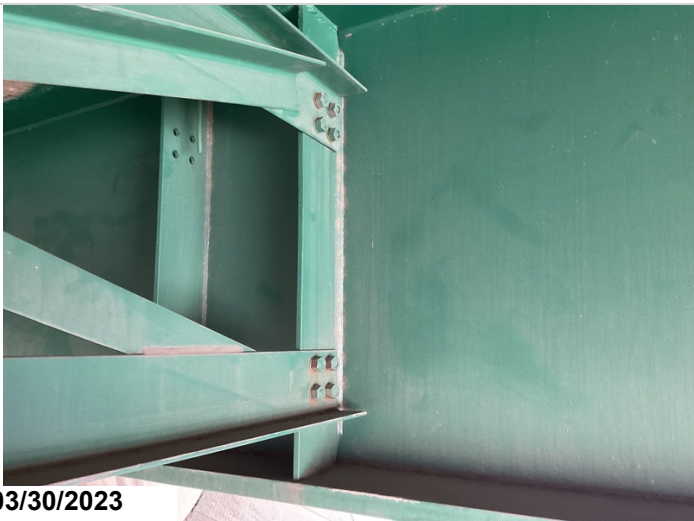
Bent 1 girder 4, loose diaphragm bolts on right side
Common left side of girder 5

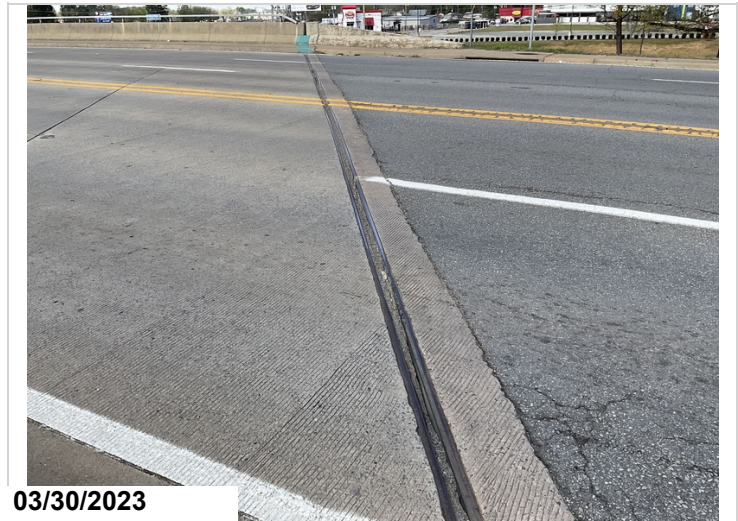
Joint seals are full of debris

Joint seal at bent 5 is full of debris

A-56 - Joint Cleaning/Flushing Needed (Y)

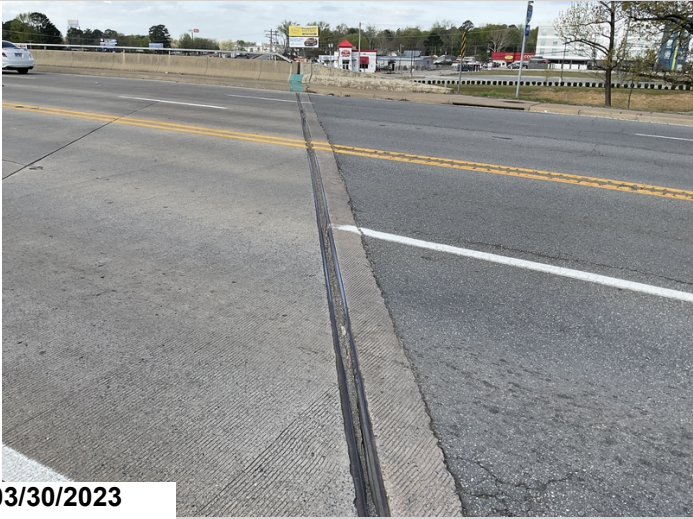
Bent 5 joint seal is torn and leaking

(300) Joint seal at bent 5 is leaking 12' left of centerline. bent 1 joint is partially full of debris Bent 5 is full of debris							
305	Assembly Joint without Seal	LF	12	12	0	0	0

A-59 - Joint Repair Needed (Y)

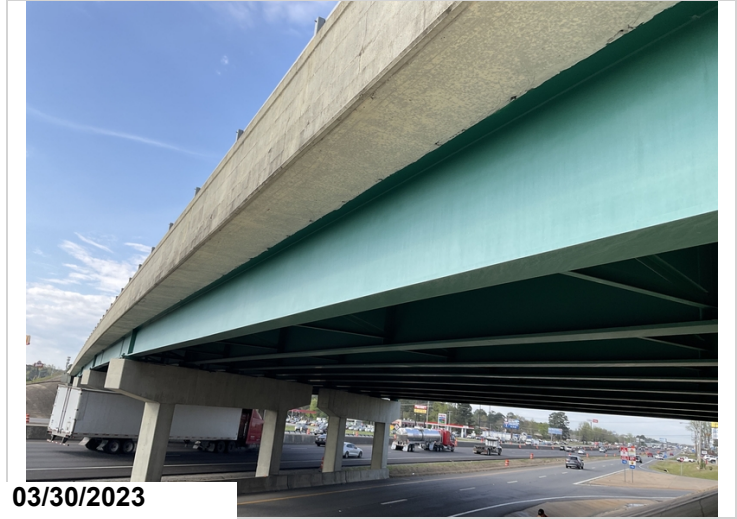
Paint is chalky on outside of girder 9

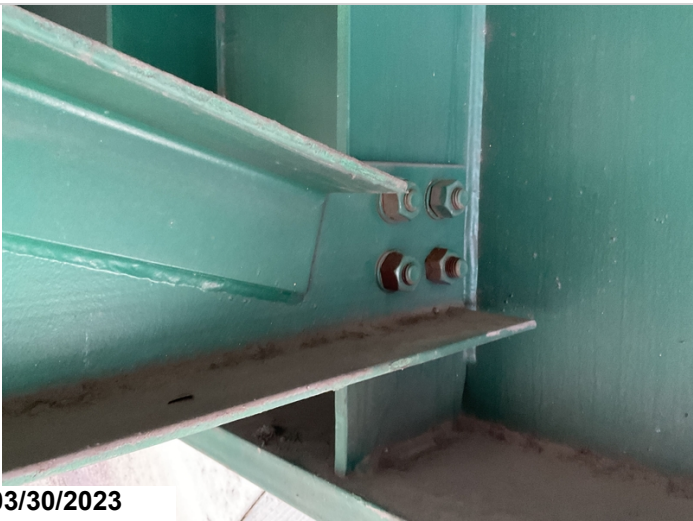
Bent 5 girder 5 left side 3 loose diaphragm bolts

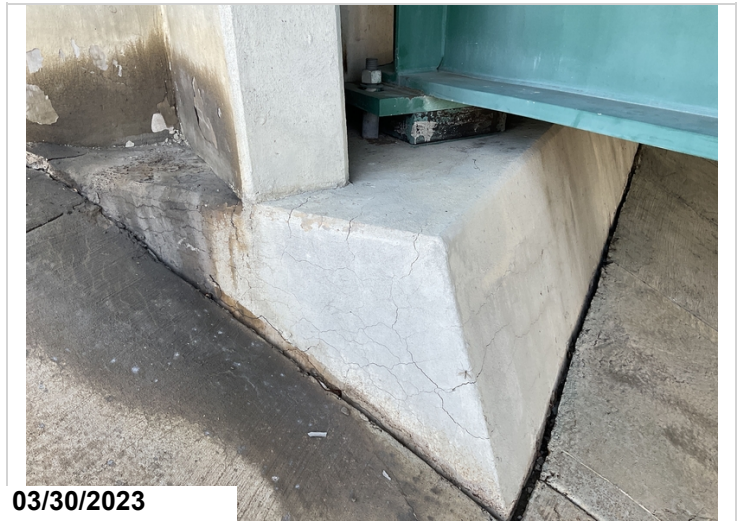
(215) Small cracks in both back walls. Bent 5 abutment has map cracking on both ends							
234	Reinforced Concrete Pier Cap	LF	245	222	23	0	0
1080	Delamination/Spall/Patched Area	LF	1	0	1	0	0
1130	Cracking (RC and Other)	LF	22	0	22	0	0

Bent 5 cracks on left end. Common right end

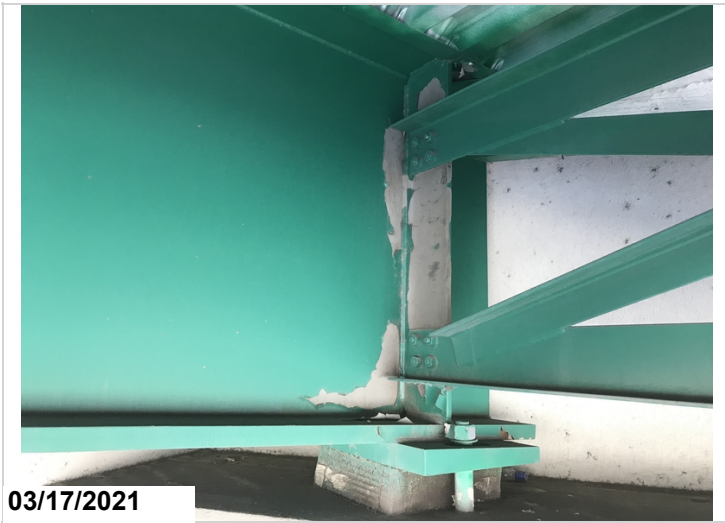
Bent 1, girder 3: paint is peeling. This is the only area observed where the paint is in this condition.

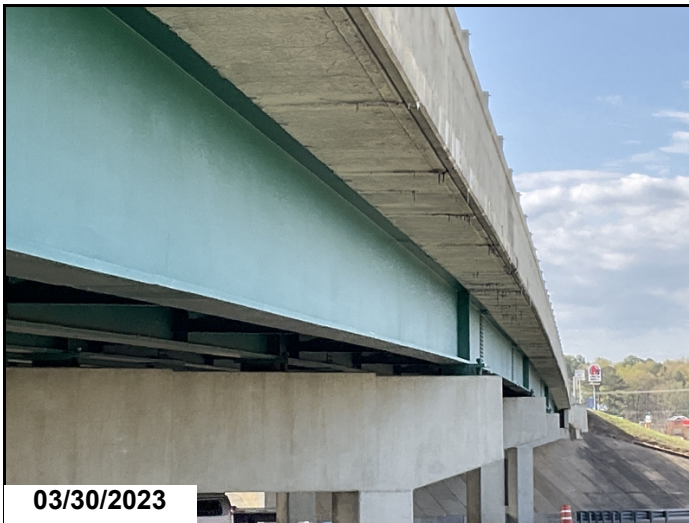
Stalactites on overhang on left side of bridge over traffic.

Spans 3&4 left side soffit overhang has cracks with efflorescence and stalactites.

Type of Work: Repair (General)

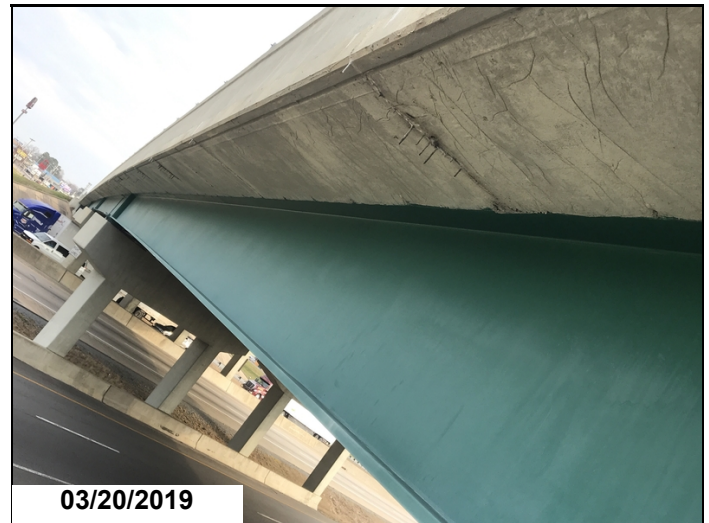
Span 1 left side soffit overhang has cracks with efflorescence and stalactites.

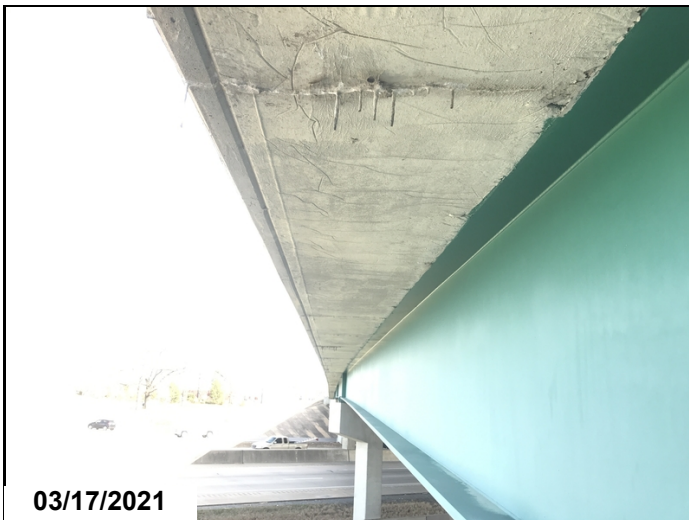
Span 1: left overhang has transvers cracking with heavy efflorescence build up.

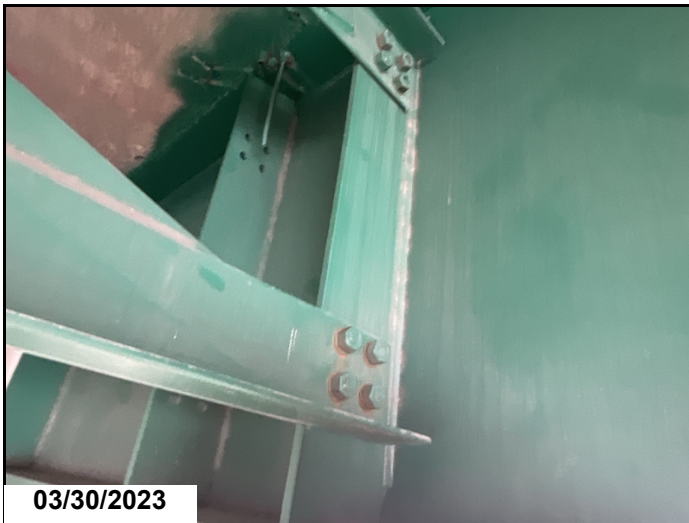
Span 1 loose bolts on all 5 diaphragms between girders 4 & 5

Span 1 loose bolts on 1st diaphragm between girders 4 & 5. Common all diaphragms between girders 4&5 in span

Type of Work: Superstructure Repair

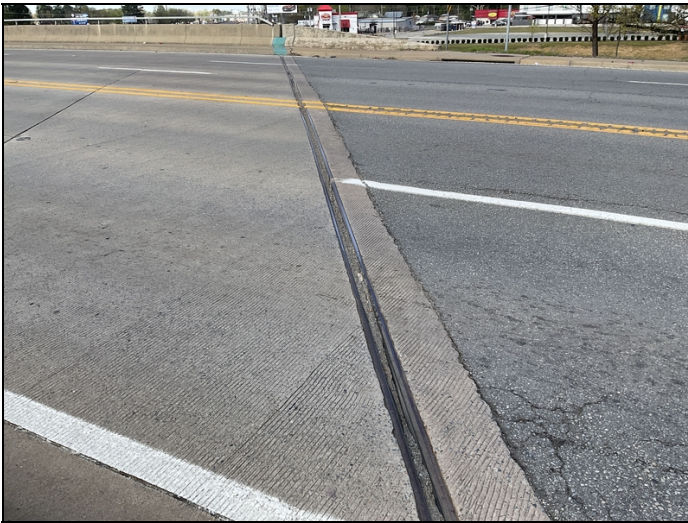
Joint seals are full of debris

Joint seal at bent 5 is full of debris

A-56 - Joint Cleaning/Flushing Needed (Yes)

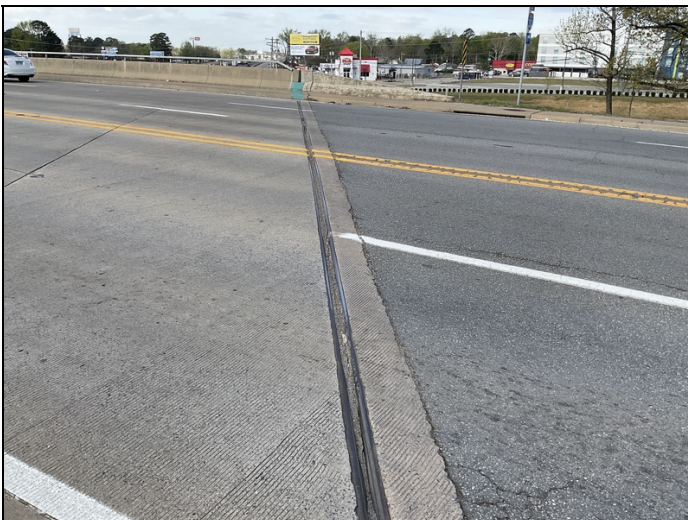
Bent 5 joint seal is torn and leaking

A-59 - Joint Repair Needed (Yes)
