Asset #07088(Routine, Underwater type 2)

HWY 183 over Depot Creek

Location: .028 MI E JCT SH 35 &amp; 183

Team Lead: Keith Harris Inspection Date: 04/03/2024

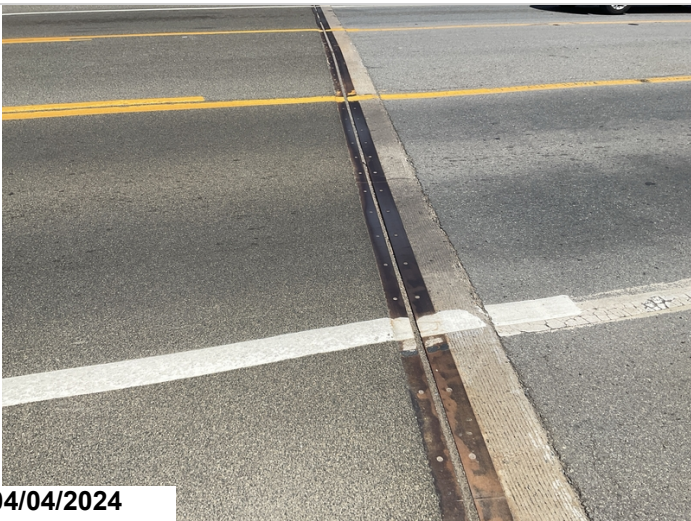
Joints are particularly filled with debris

Bent 4 Joint seal is particularly filled with debris

#### **A-56 - Joint Cleaning/Flushing Needed** (Y)

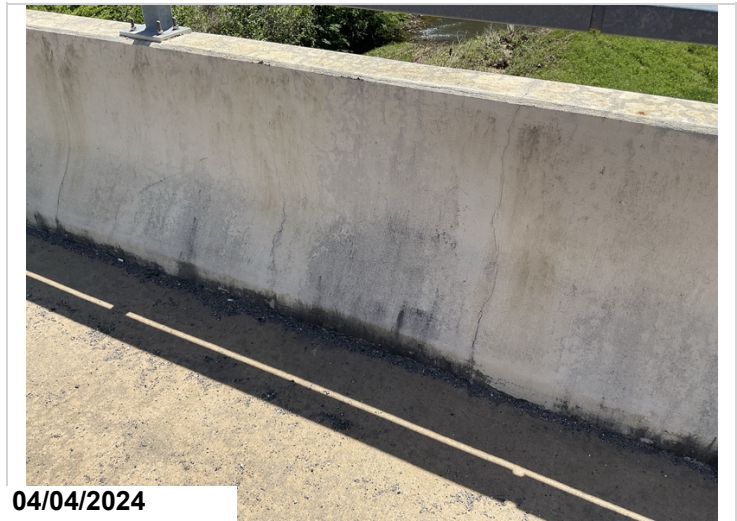
Span 1 right bridge rail. Typical cracks up to 0.020". CS2

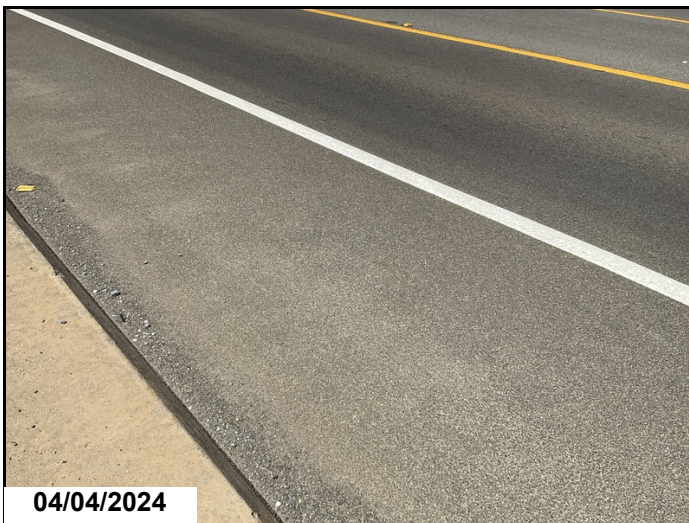
New polymer overlay in 2023

New polymer overlay in 2023

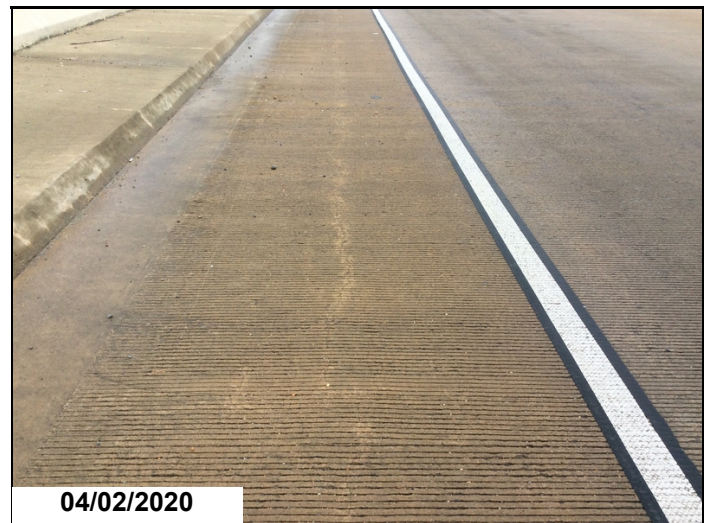
Deck has sealable longitude cracks in all spans.

Span 1 longitude cracks.

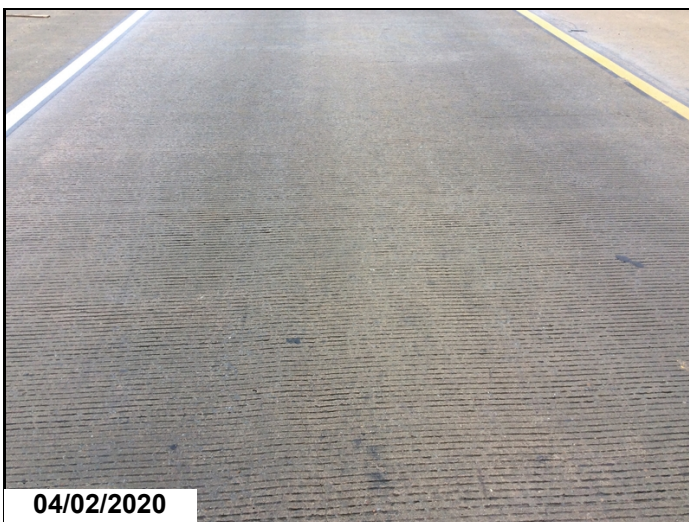
Span 3 longitude cracks.

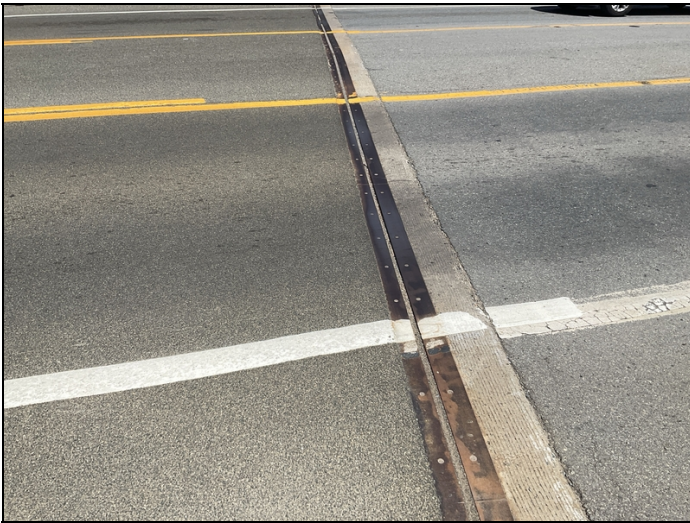
Joints are particularly filled with debris

Bent 4 Joint seal is particularly filled with debris

**A-56 - Joint Cleaning/Flushing Needed (Yes)**
