Route:183 Section:01 Log:4.88

IDENTIFICATION	
(1) State Names	5 - Arkansas
(8) Structure Number	07297
(5) Inventory Route	1
(2) Highway Agency District	06 - District 06
(3) County Code	125 - Saline County

Asset #07297 (Routine)
SH 183 over UPRR Spur
Location: 2.5 MI S Bryant

Team Lead: Chris Doggett Inspection Date: 08/06/2024

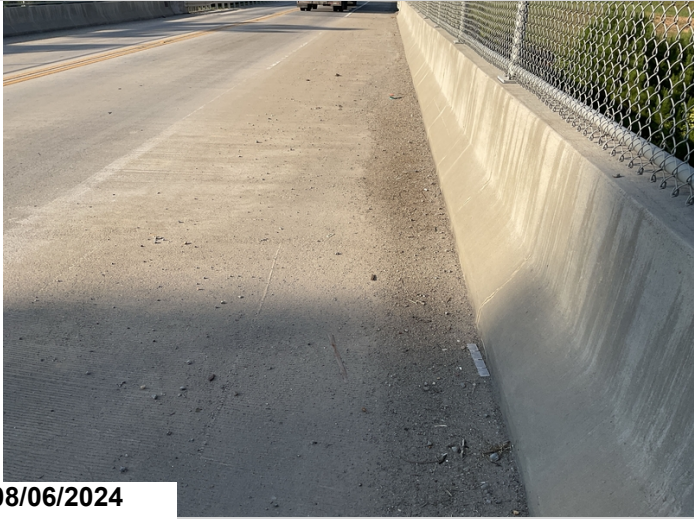
Gutter line is full of debris.

A-55 - Deck Washing Needed (Yes)

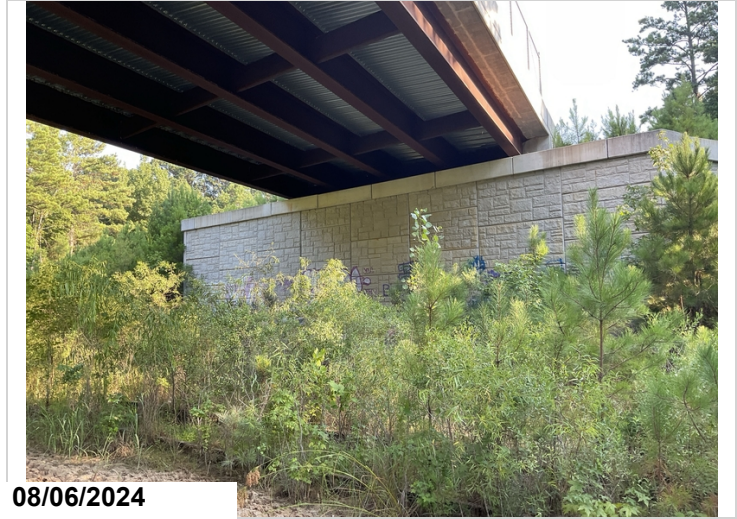
Heavy growth of vegetation

A-64 - Vegetation Removal Requested (Yes)

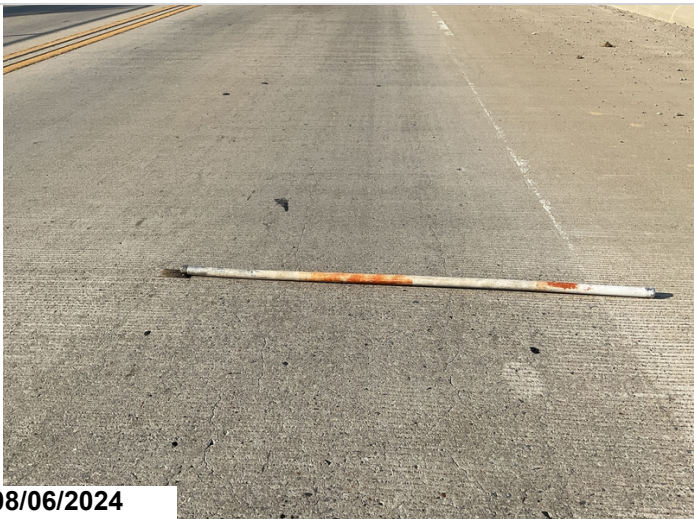
Multiple unsealed longitudinal cracks running the entire length of the bridge.

Multiple unsealed longitudinal cracks that span the entire length of the deck.

A-54 - Sealable Deck Cracks (Yes)

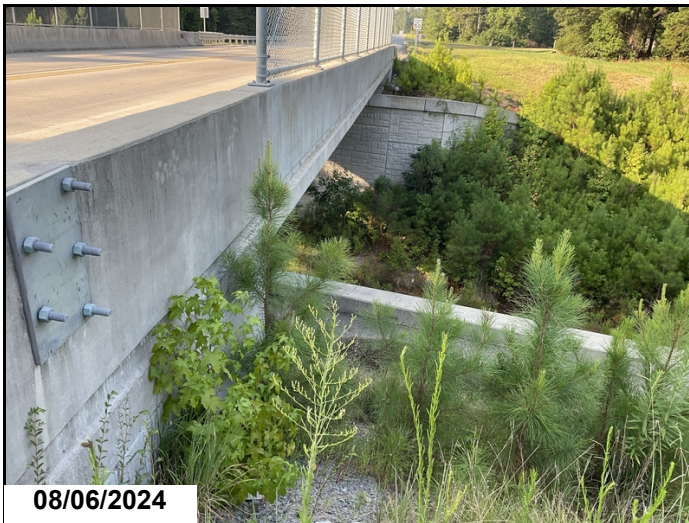
Trees growing against MSE wall at all 4 corners of bridge.

Small trees are growing up against the bridge on all four corners and MSE wall.

Type of Work: (Inactive) (Inactive) 1 - Clean

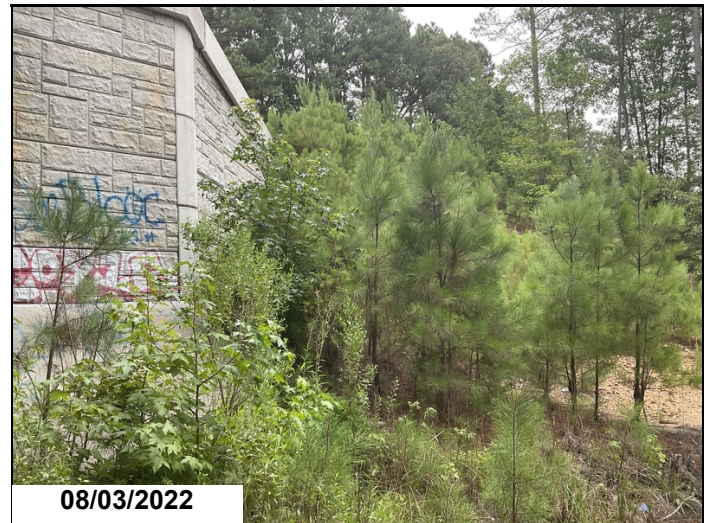
Trees growing at MSE wall at northeast corner.

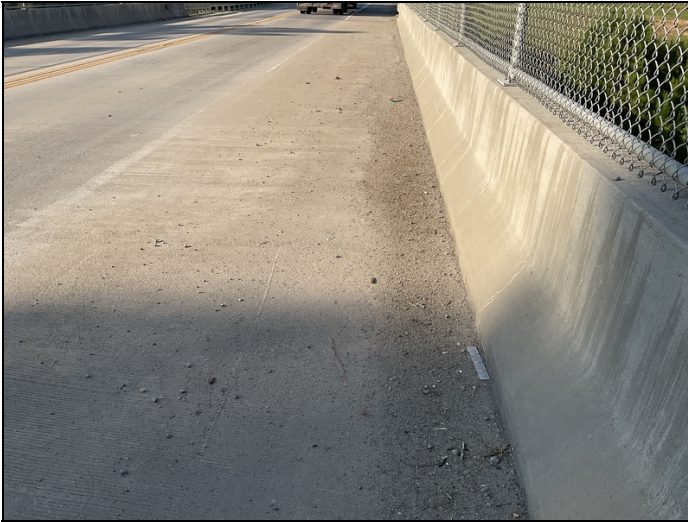
Gutter line is full of debris.

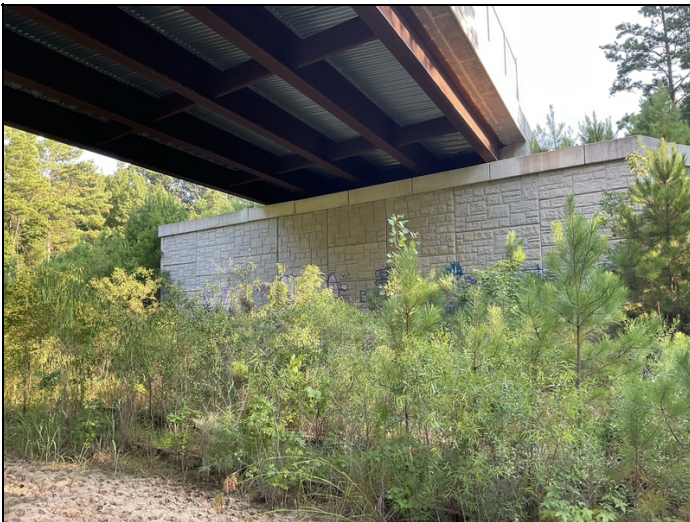
Heavy growth of vegetation
