Asset #M2246(Routine)

SH 183 Log 2.93 over ALCOA PLANT PVT. RD.

Location: 3 MI E JCT SH 35 & 183

Team Lead: Keith Harris Inspection Date: 01/04/2024

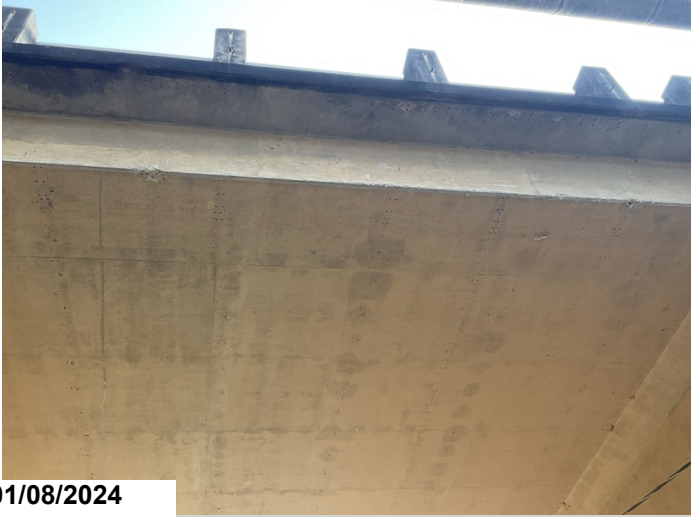
Under side of slab has 3 small spalls on left side.

Small spalls on left side of slab

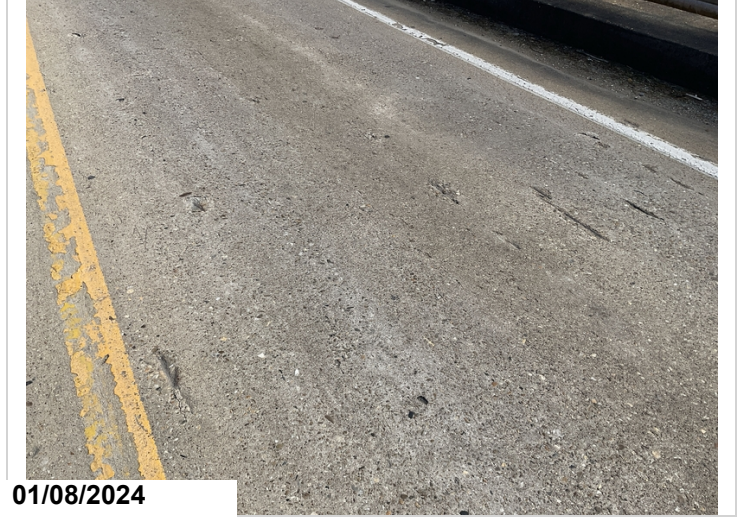
Deck has exposed reinforcing steel on right side at beginning of bridge and scattered cracks throughout structure.

Deck, spalls with exposed rebar in right lane

A-54 - Sealable Deck Cracks (Yes)

A-61 - Polymer Overlay Advised (Yes)

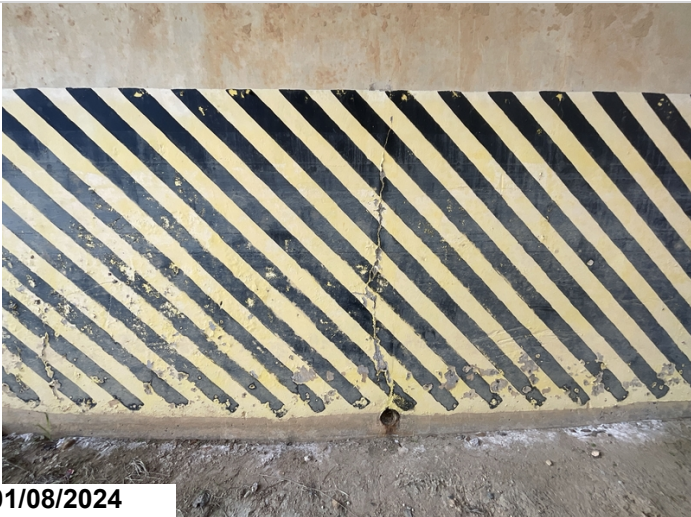
Small spalls and cracks in both abutments.

Bent 1 vertical crack up to 0.030"

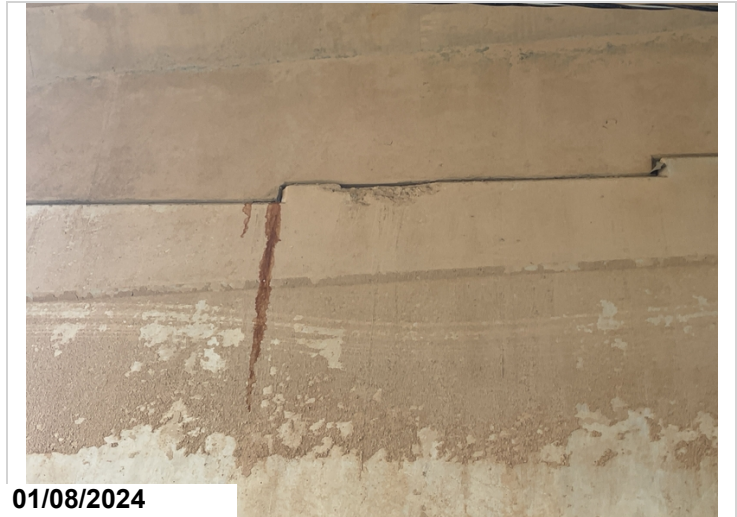
Bent 1 small spall

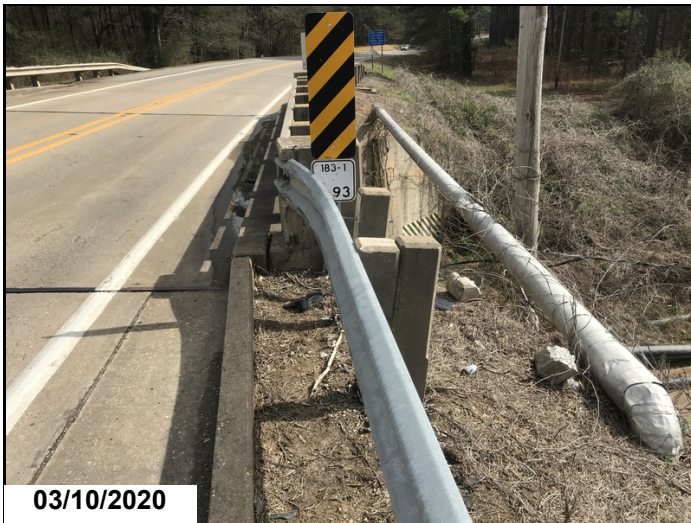
Northbound right side

The northbound approach guardrail on both sides have been damaged.
