Asset #03170(Record Change)

SH 38 Log 10.16 over PIGEON ROOST CR.

Location: 1.0 M E OF SH 31 TNT

Team Lead: Anahi Mendez, Inspection Date: 10/18/2023

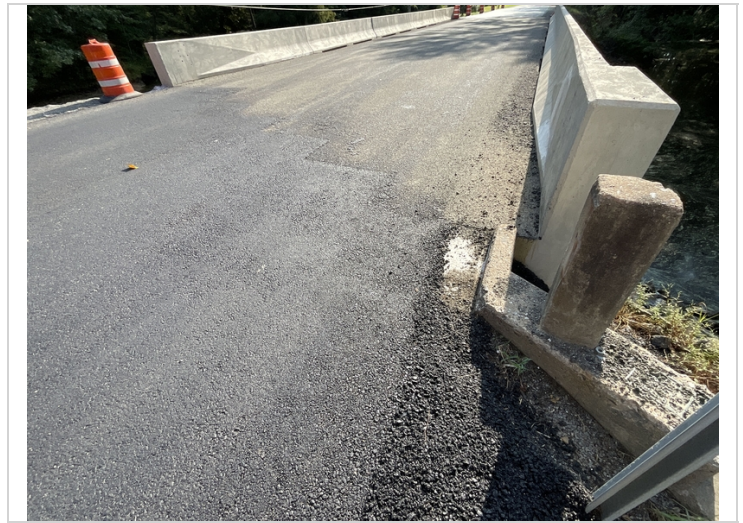
backwall at bent 1

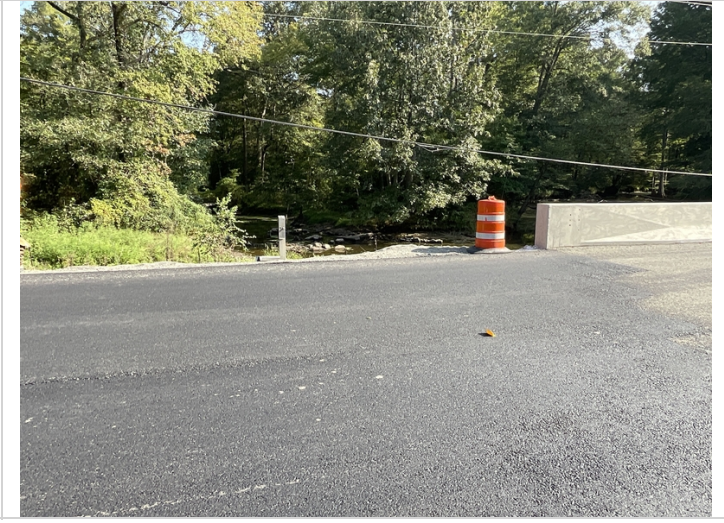
Guardrail not in place

approach guardrail needs installed after superstructure replacement

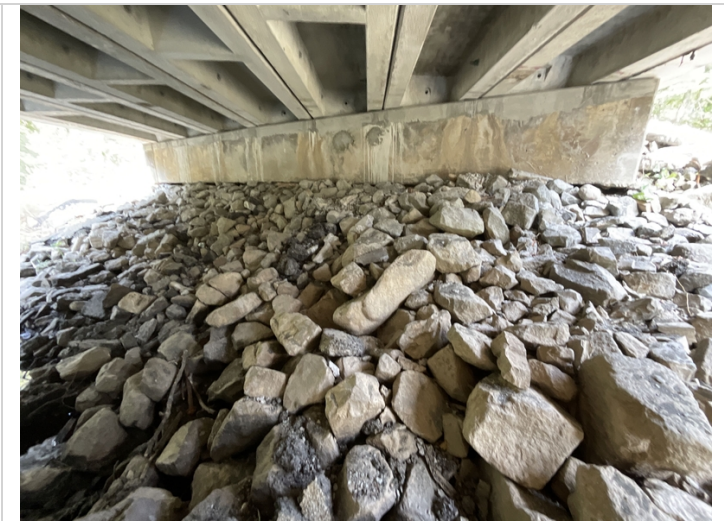
(215) Bent 1 small patch under unit 3 right leg. Bent 6 has some cracking under unit 6 and a spall under the left leg of unit 5.							
227	Reinforced Concrete Pile	EA	16	0	16	0	0
1190	Abrasion/Wear (PSC/RC)	EA	16	0	16	0	0

Bent 1 abutment

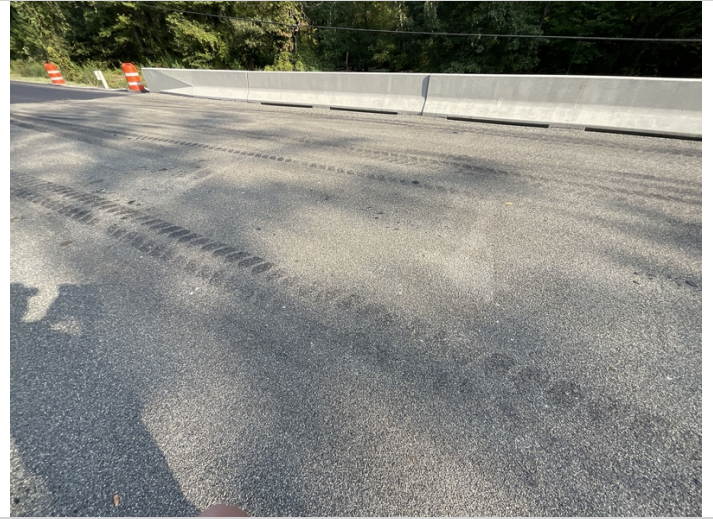
Polymer overlay added 9/2023

Polymer overlay added

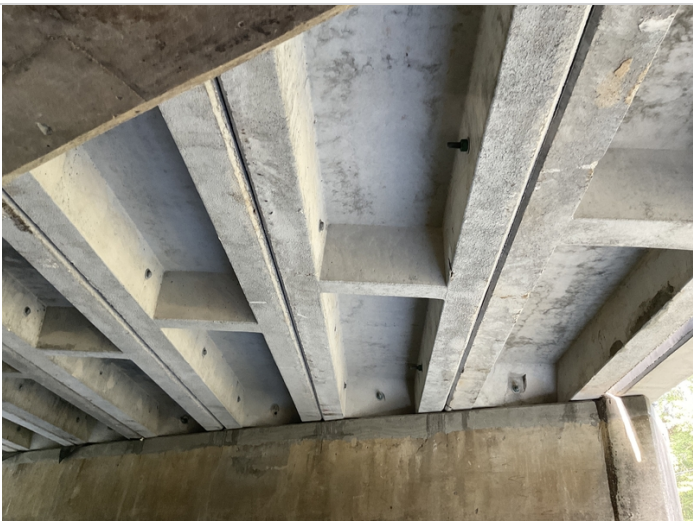
Units are bolted and grouted

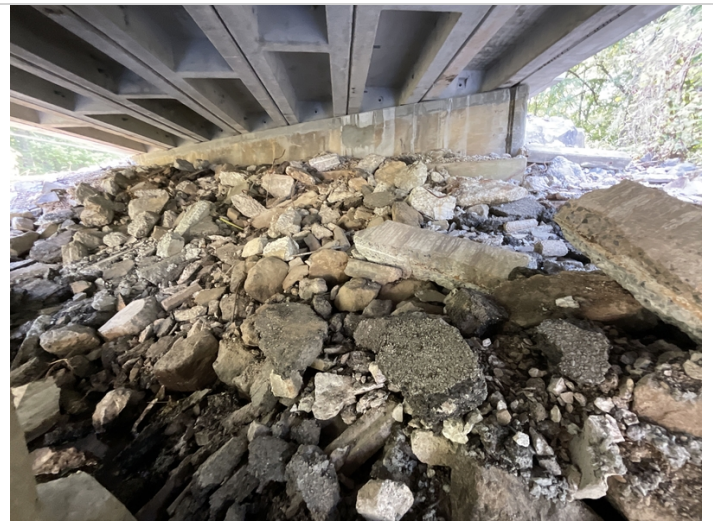
Bent 6 abutment

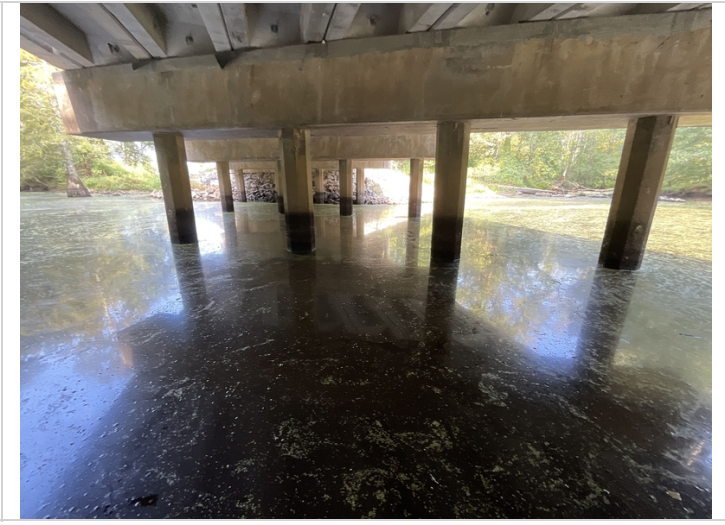
(227) All piles have abrasion to the lower section							
234	Reinforced Concrete Pier Cap	LF	124	60	52	12	0
1080	Delamination/Spall/Patched Area	LF	13	0	9	4	0
1120	Efflorescence/Rust Staining	LF	6	0	6	0	0
1130	Cracking (RC and Other)	LF	45	0	37	8	0

Abrasion to piles

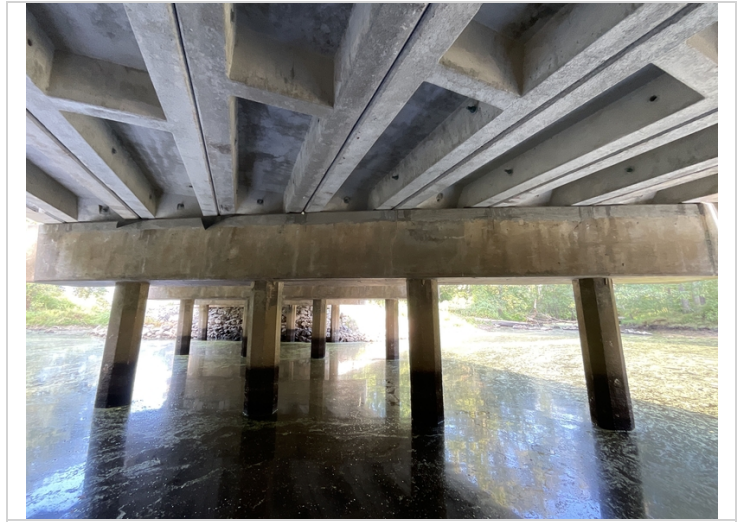
(234) caps have had a 1" concrete crown added 2023 caps have had 5" added to the height Bent 2, both ends of the cap have cracking with efflorescence and some scattered cracks in previous repairs. Bent 3 back side has a crack on the right end, on the ahead side, the face is cracked at pile 4 Bent 5 has a horizontal crack on the ahead face, six inches down from the top under units 1,2,3 and 4.

Caps have crown added
5" at ends 6" in the middle

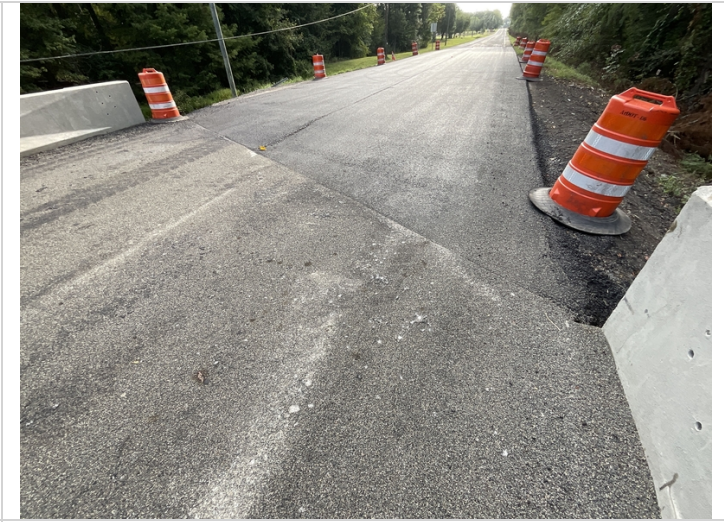
East approach has settled

approach roadway at East end of the bridge has settled up to 1 1/2"

Type of Work: Approach Leveling/Maintenance

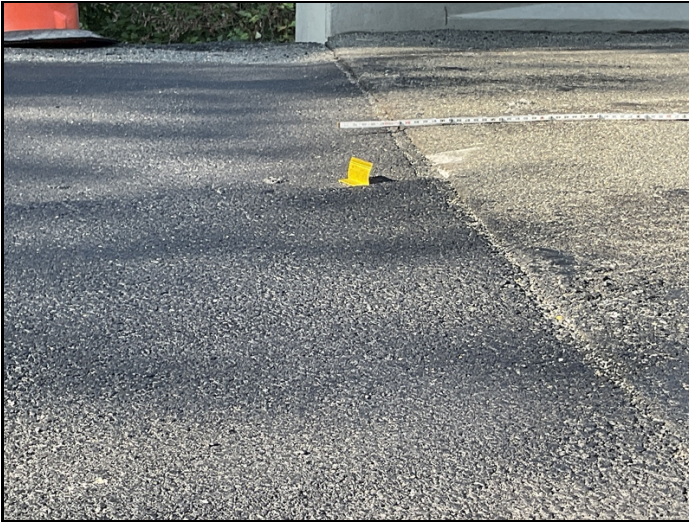
Approach roadway has settled at the east end of the bridge
