Asset #04845(Routine)

SH 38 over U.P.R.R.

Location: 0.2 M E SH 367

Team Lead: Bryan Saunders, Inspection Date: 07/05/2023

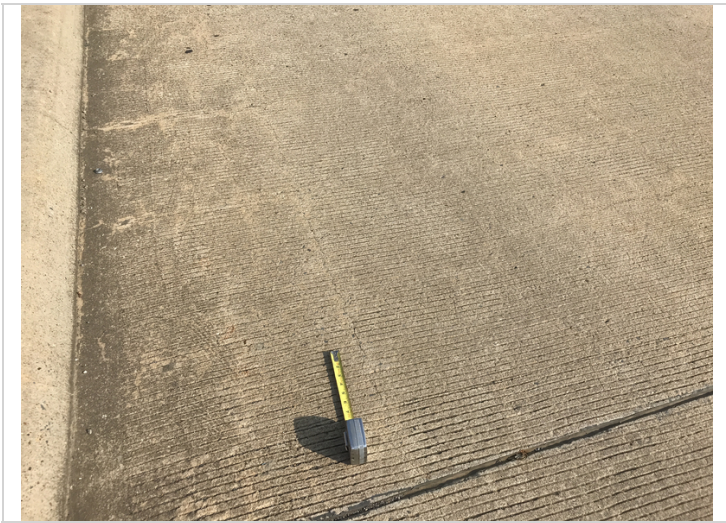
Span 3 longitudinal crack up to 0.015"

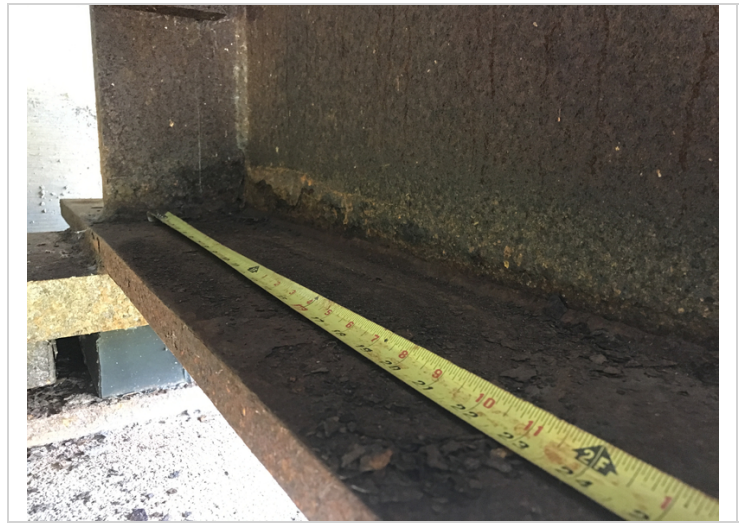
(107) Bent 4 beam 8 laminating rust on inside beam end (515-107) Bent 4 beam 8 laminating rust on inside beam end							
205	Reinforced Concrete Column	EA	8	8	0	0	0
215	Reinforced Concrete Abutment	LF	217	183	34	0	0
1080	Delamination/Spall/Patched Area	LF	1	0	1	0	0
1130	Cracking (RC and Other)	LF	33	0	33	0	0

Bent 4 beam 8 laminating rust on inside of beam end
