Asset #04845(Routine)

SH 38 over U.P.R.R.

Location: 0.2 M E SH 367

Team Lead: Bryan Saunders, Inspection Date: 07/05/2023

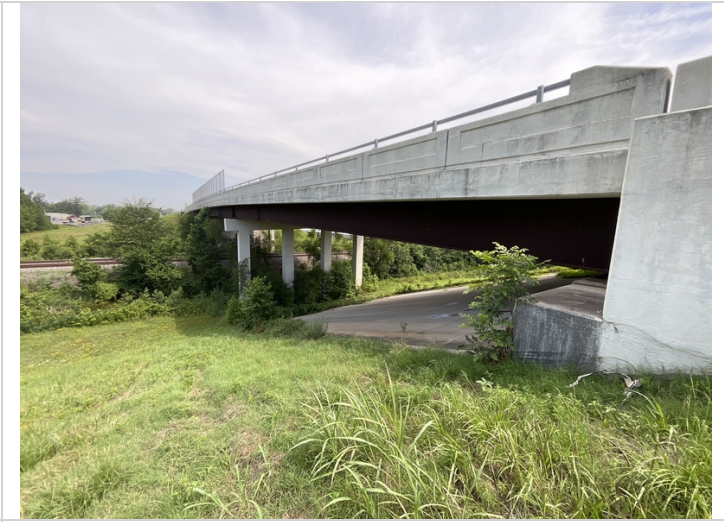
Elevation

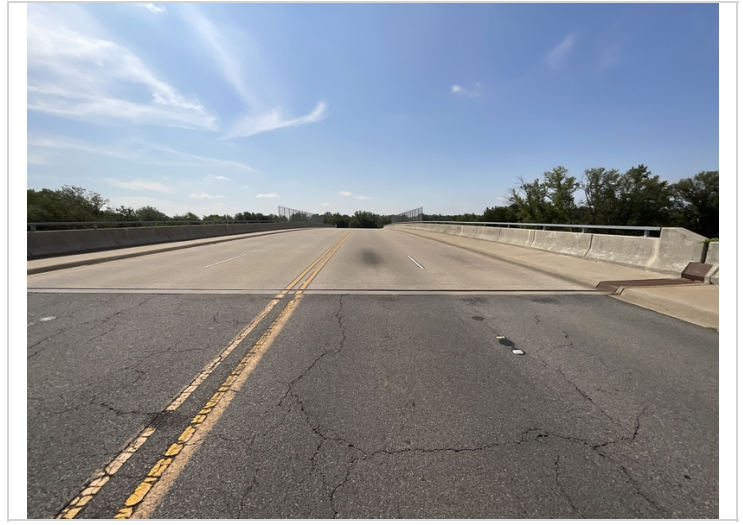
Approach looking east

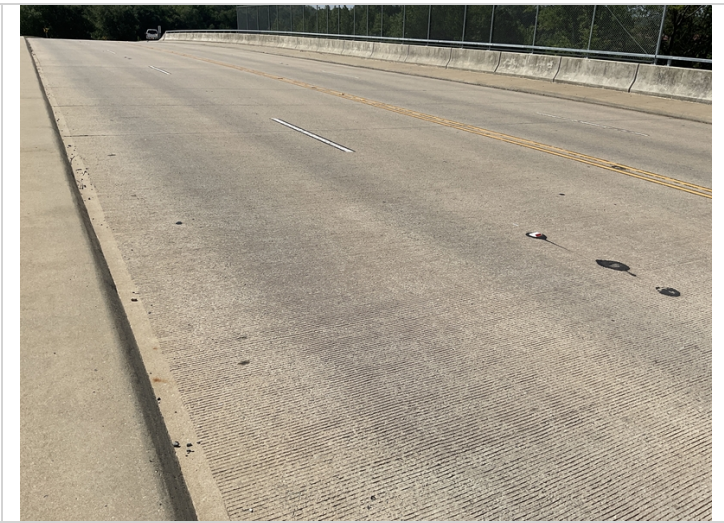
Deck view

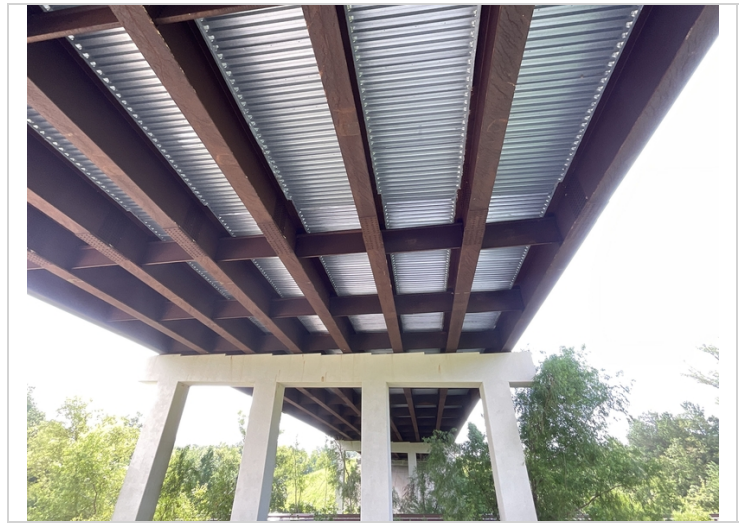
Soffit view

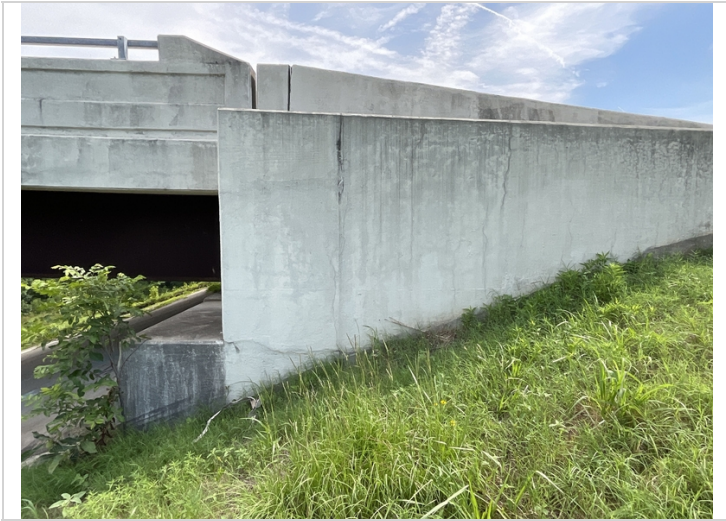
ELEMENTS	DESCRIPTION	UNITS	TOTAL	CS1	CS2	CS3	CS4
205	Reinforced Concrete Column	EA	8	8	0	0	0
215	Reinforced Concrete Abutment	LF	217	183	34	0	0
1080	Delamination/Spall/Patched Area	LF	1	0	1	0	0
1130	Cracking (RC and Other)	LF	33	0	33	0	0
(215) Scattered cracks in both back walls Bent 4 small spalls in top of backwall							
234	Reinforced Concrete Pier Cap	LF	122	122	0	0	0

Cracking at bent 4 abutment

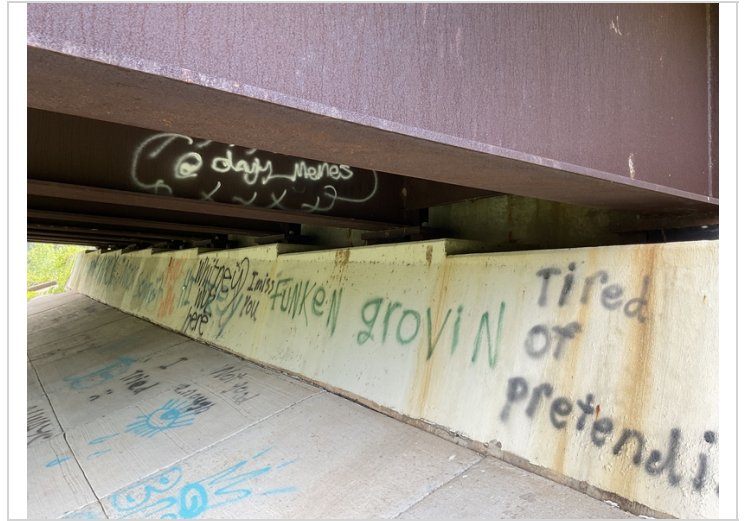
Bent 4 typical condition

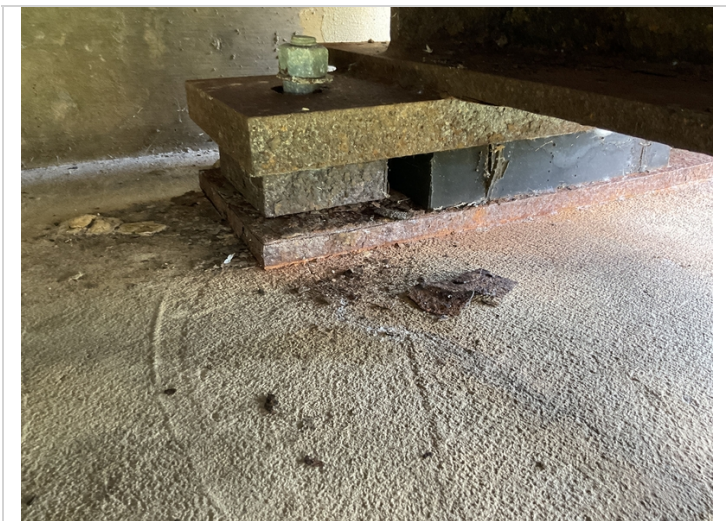
Comment: overall in good condition except bent 4 masonry plate under beam 8  
graffiti under bridge but not in public view

Masonry plate at bent 4 beam 8

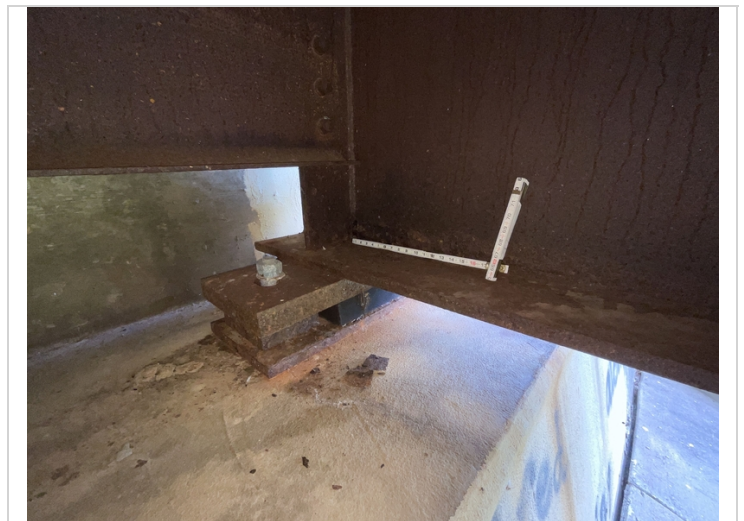
Comment: super in in good condition with the exception of girder 8 at bent 4 has corrosion to lower flange up to 1' from beam end

Corrosion/laminated rust at bent 4 beam 8

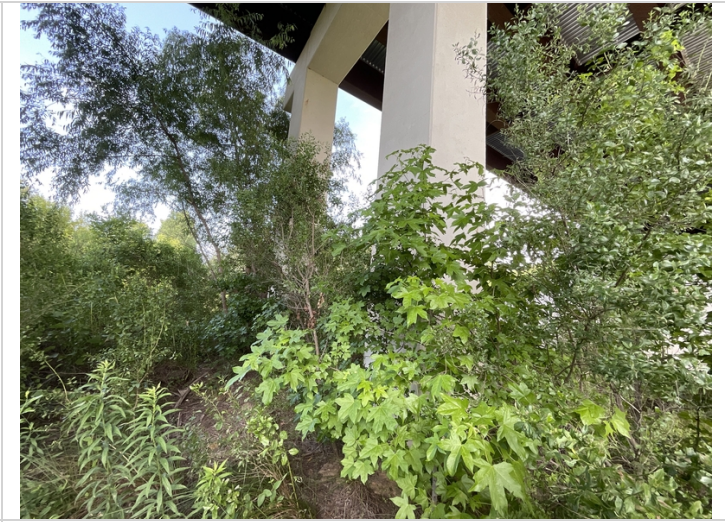
Trees and vines growing at bent 2 and 3

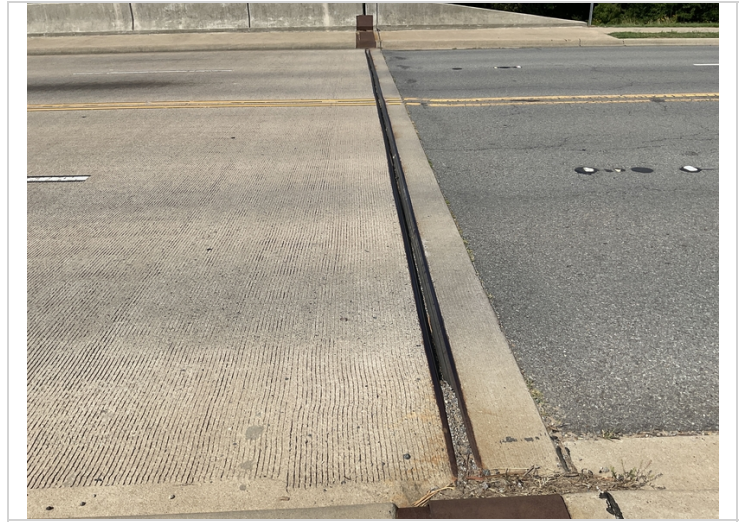
debris are starting to accumulate

Joint at bent 1 has debris impaction

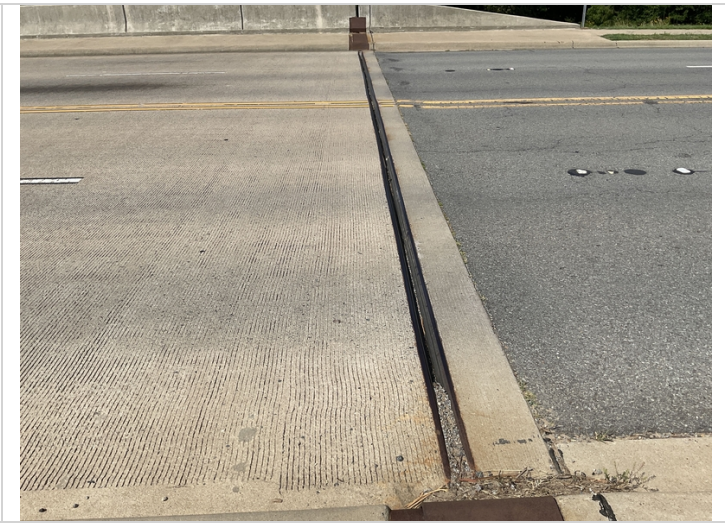
Joint at bent 1 needs cleaning

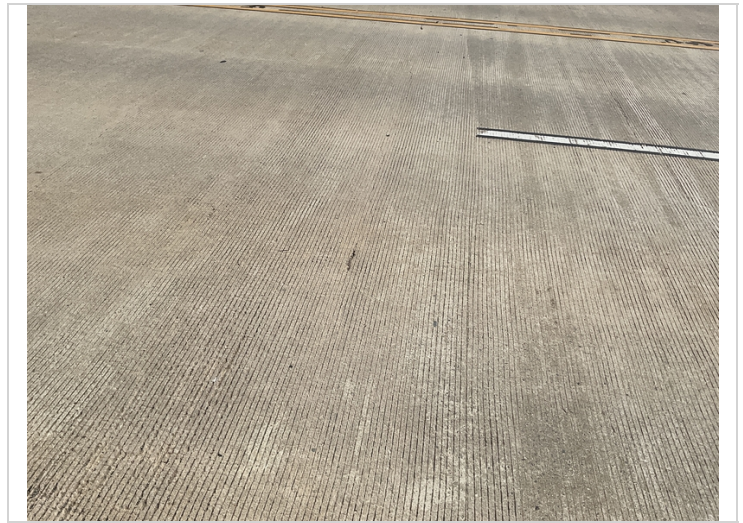
ELEMENTS	DESCRIPTION	UNITS	TOTAL	CS1	CS2	CS3	CS4
12	Reinforced Concrete Deck	SF	21386	17840	3546	0	0
1120	Efflorescence/Rust Staining	SF	146	0	146	0	0
1130	Cracking (RC and Other)	SF	3400	0	3400	0	0
(12) Scattered transverse cracks on 6 foot centers that have been sealed in the past but the seal is deteriorating in all three spans. (0.030 inch avg.) Cracks with efflorescence in overhang

Deck has sealable transverse cracks

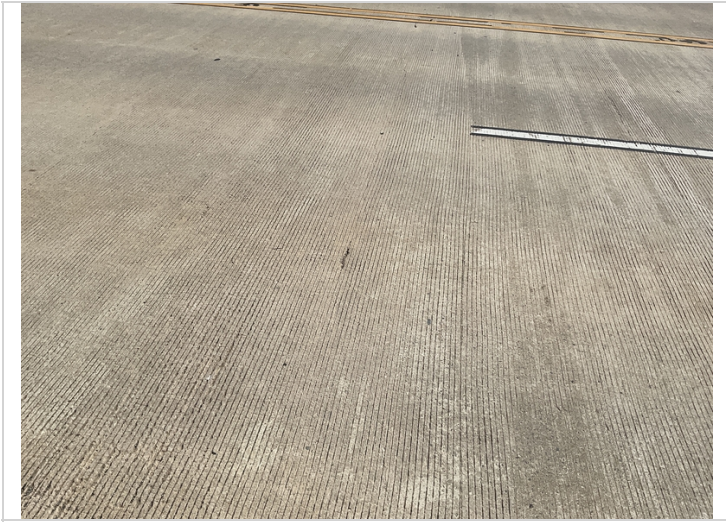
Transverse cracks in deck

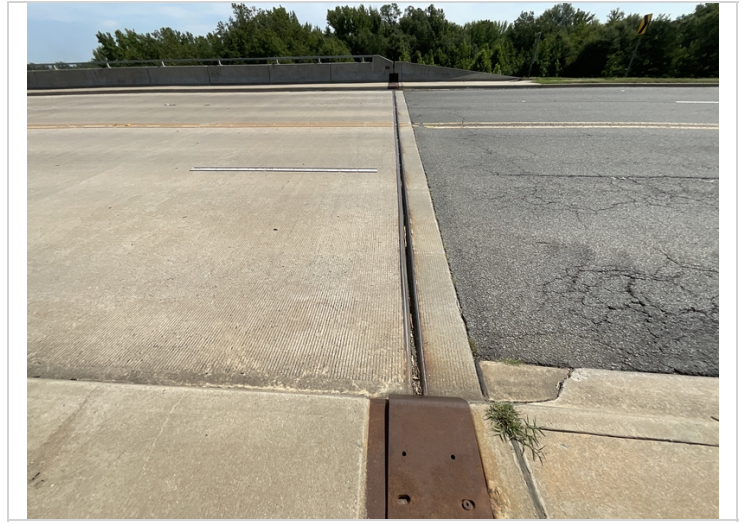
Joint at bent 4 typical for all joints

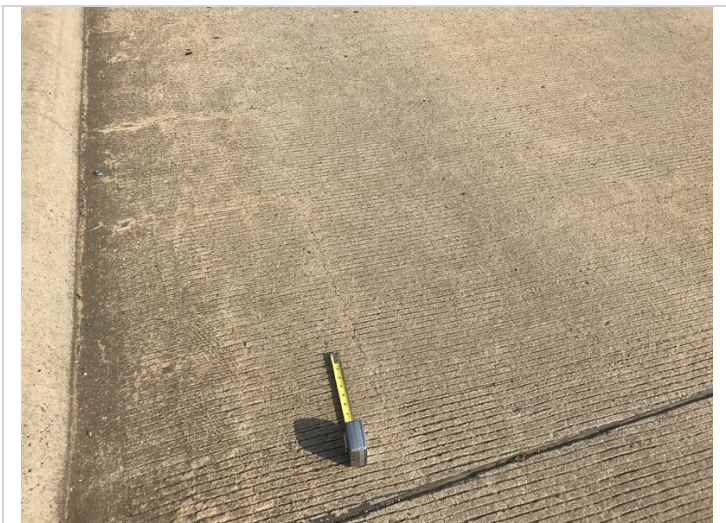
Span 3 longitudinal crack up to 0.015"

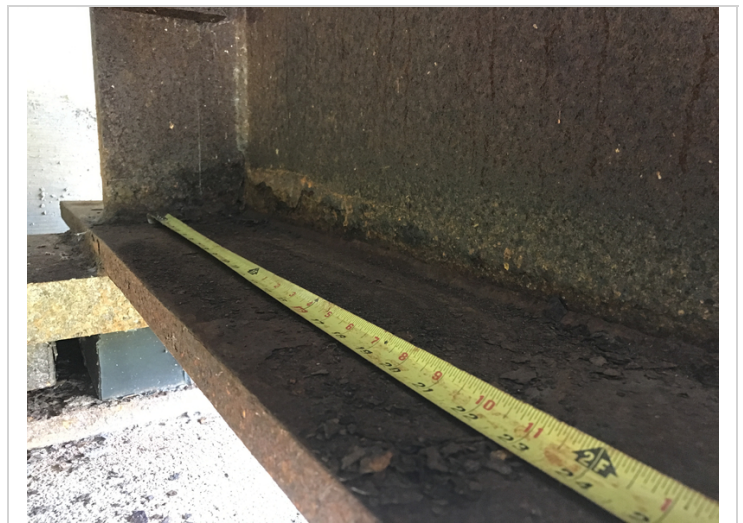
ELEMENTS	DESCRIPTION	UNITS	TOTAL	CS1	CS2	CS3	CS4
107	Steel Open Girder/Beam	LF	2720	2718	2	0	0
1000	Corrosion	LF	2	0	2	0	0
515	Steel Protective Coating	SF	32741	0	32739	2	0
3430	Oxide Film Degradation Color/Texture Adherence(Steel Protective Coatings)	LF	32741	0	32739	2	0
(107) Bent 4 beam 8 laminating rust on inside beam end							
(515-107) Bent 4 beam 8 laminating rust on inside beam end

Bent 4 beam 8 laminating rust on inside of beam end

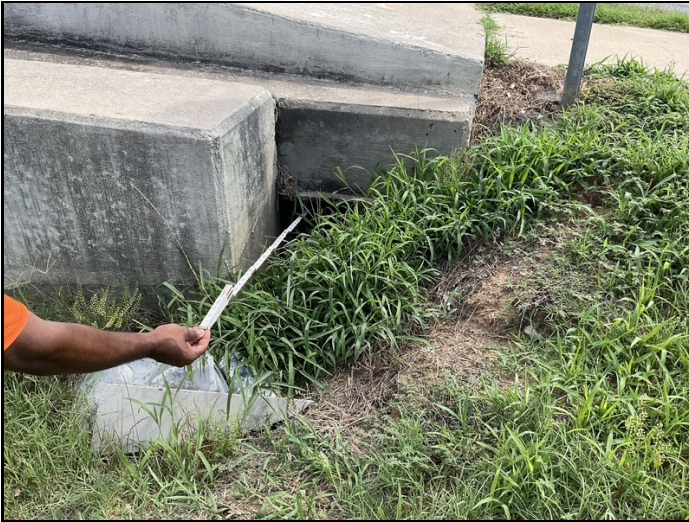
Erosion at bent 4 sidewalk on southeast end

Erosion at bent 4 ride side

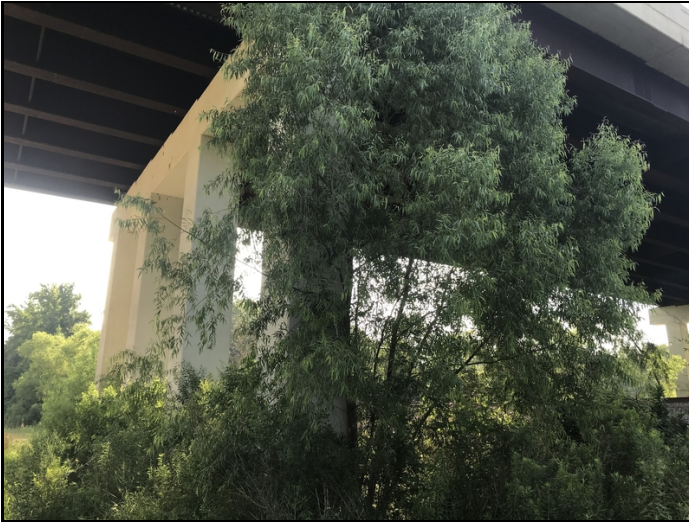
Trees growing against columns at bents 2&3.

Trees and vines growing against columns at Bent 2

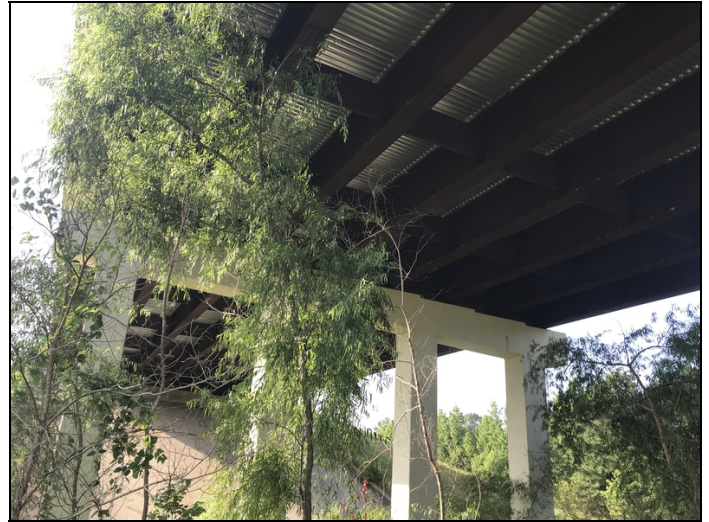
Bent 3 trees growing under bridge
