Asset #06813(Routine)

SH 11 Log 2.38 over Bayou Des Arc

Team Lead: Bryan Saunders, Inspection Date: 06/28/2023

General Observation

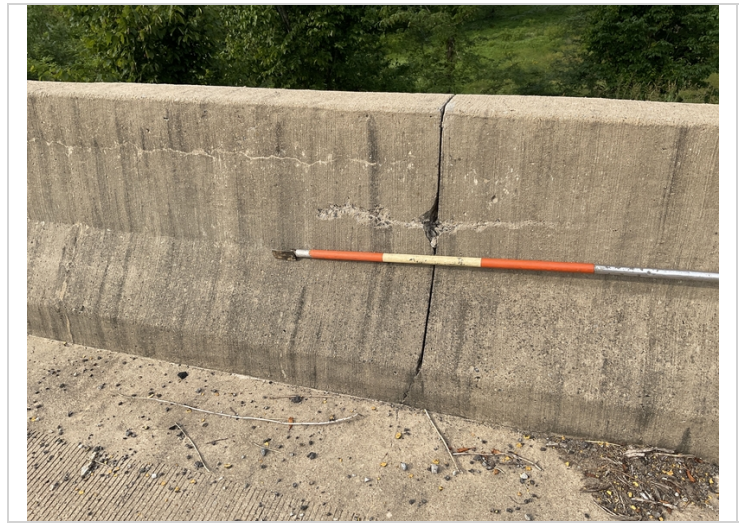
(331) small vertical cracks Contact spall in the bridge rail at bent 6 left side

Contact spall in the bridge rail at bent 6 abutment

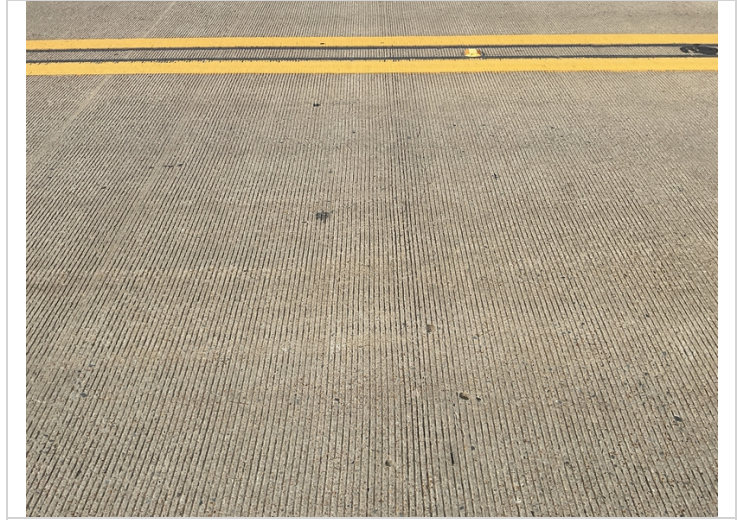
ELEMENTS	DESCRIPTION	UNITS	TOTAL	CS1	CS2	CS3	CS4
12	Reinforced Concrete Deck	SF	21795	19780	2015	0	0
1120	Efflorescence/Rust Staining	SF	240	0	240	0	0
1130	Cracking (RC and Other)	SF	1775	0	1775	0	0
(12) Small longitudinal and transverse cracks in all spans Cracks with efflorescence in overhang .

Transverse cracks in the deck up to .020"

Type of Maintenance	Is recommended?
A-54 - Sealable Deck Cracks	Yes
A-55 - Deck Washing Needed	No
A-56 - Joint Cleaning/Flushing Needed	No
A-57 - Beam End and Bearing Paint Needed	No
A-58 - Cap Cleaning/Flushing Needed	No
A-59 - Joint Repair Needed	No
A-60 - Full Beam Painting Needed	No
A-61 - Polymer Overlay Advised	Yes
A-62 - Hydro and LMC Advised	No
A-63 Missing/Incorrect Log Mile Signage	No
A-64 - Vegetation Removal Requested	Yes

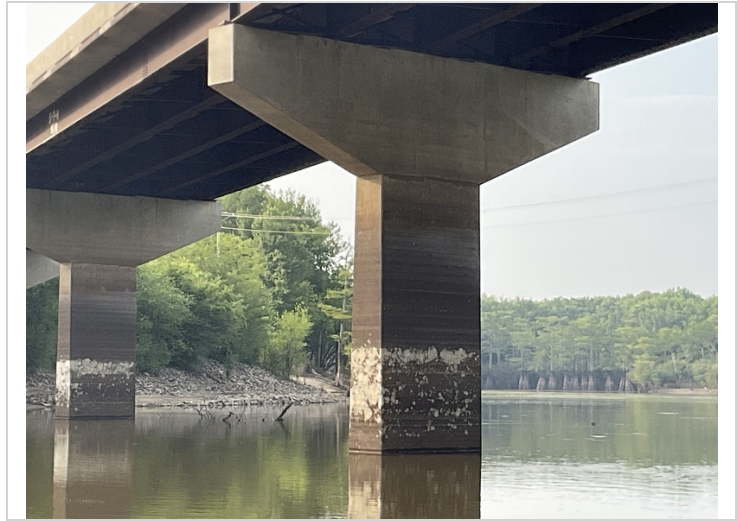
Bent 4

(215) small cracks in the abutment							
234	Reinforced Concrete Pier Cap	LF	162	151	11	0	0
1130	Cracking (RC and Other)	LF	11	0	11	0	0
(234) Vertical cracks in the cap of Bent 2, 3, 4 and 5 at the edges of the pier wall . (0.012 to 0.015 inch).							
303	Assembly Joint with Seal	LF	85	85	0	0	0
310	Elastomeric Bearing	EA	30	30	0	0	0
331	Reinforced Concrete Bridge Railing	LF	1015	722	293	0	0
1120	Efflorescence/Rust Staining	LF	6	0	6	0	0
1130	Cracking (RC and Other)	LF	283	0	283	0	0
7000	Damage	LF	4	0	4	0	0

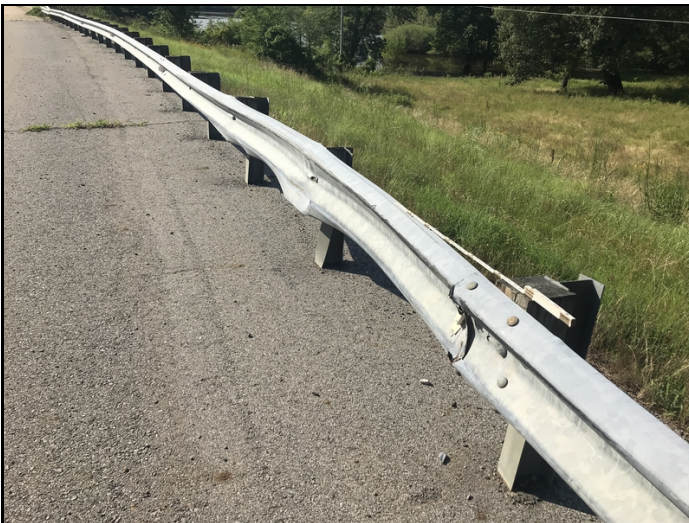
Northwest guardrail has traffic damage

Type of Work: Repair (General)
