Asset #M1319(Routine, Underwater type 2)

SH 7 Spur Log 0.25 over GULPHA CREEK

Location: 1.37 MI S OF SH 7 HOT SPR

Team Lead: Shane Byrd, Inspection Date: 04/26/2022

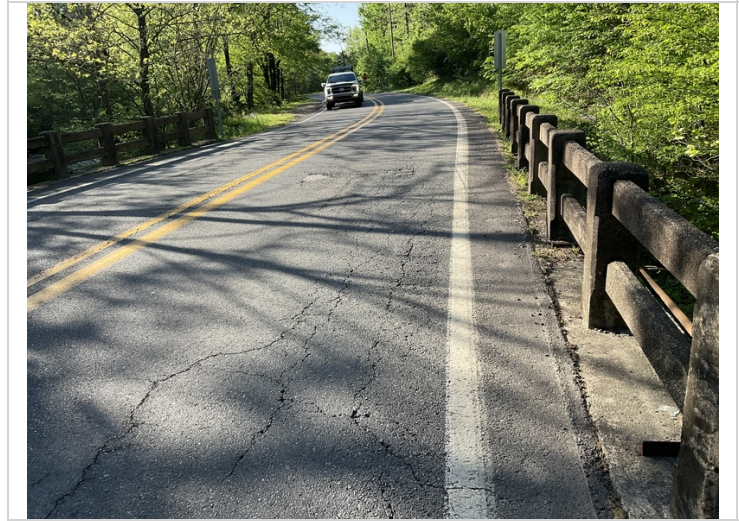
ELEMENTS	DESCRIPTION	UNITS	TOTAL	CS1	CS2	CS3	CS4
38	RC Slab	SF	1380	1380	0	0	0
1130	Cracking (RC and Other)	SF	0	0	0	0	0
510	Wearing Surfaces	SF	1219	1033	186	0	0
3210	Delam/Spall/Patched Area/Pothole	SF	4	0	4	0	0
3220	Crack (Wearing Surface)	SF	182	0	182	0	0
(38) Potholes in southbound lanes							
(510-38) Cracks and patches in wearing surface.

Potholes in southbound lane.

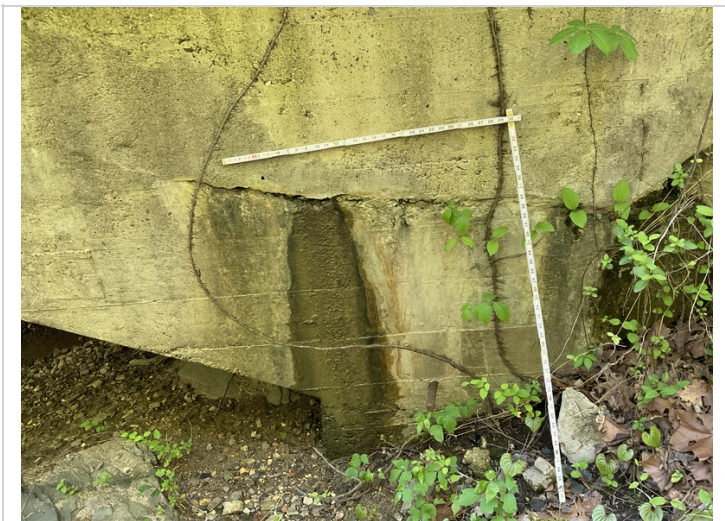
ELEMENTS	DESCRIPTION	UNITS	TOTAL	CS1	CS2	CS3	CS4
144	Reinforced Concrete Arch	LF	46	33	13	0	0
1080	Delamination/Spall/Patched Area	LF	2	0	2	0	0
1130	Cracking (RC and Other)	LF	11	0	11	0	0
(144) Cracks and small spalls in the arch.

Crack in left side of arch.

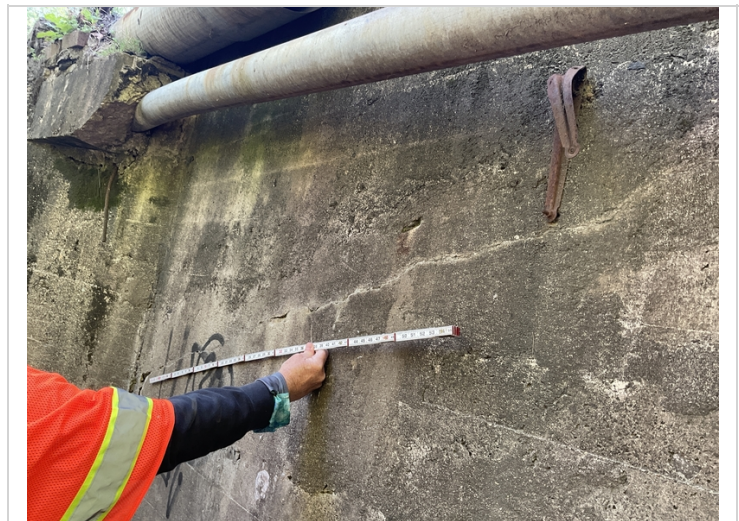
Bent 2 left side of arch crack.

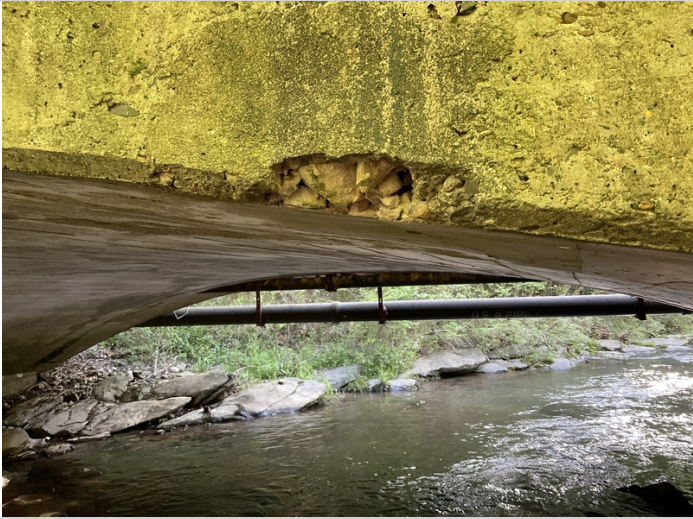
Spall on left side of arch.

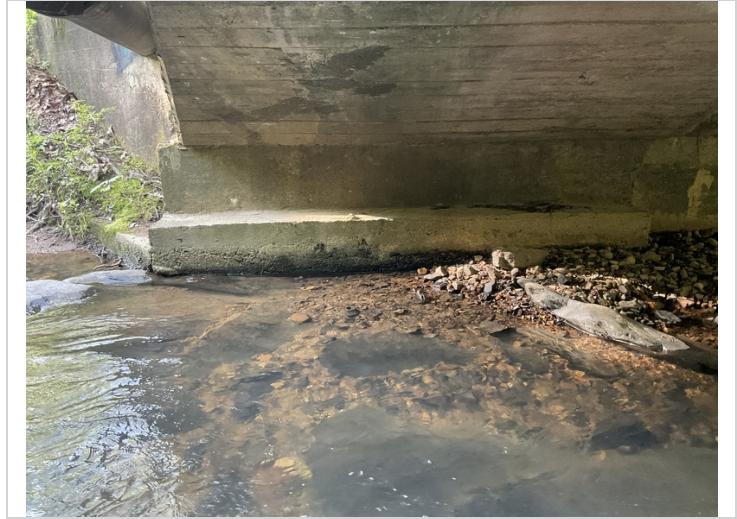
ELEMENTS	DESCRIPTION	UNITS	TOTAL	CS1	CS2	CS3	CS4
215	Reinforced Concrete Abutment	LF	62	62	0	0	0
220	Reinforced Concrete Pile Cap/Footing	LF	20	8	12	0	0
1190	Abrasion/Wear (PSC/RC)	LF	6	0	6	0	0
6000	Scour	LF	6	0	6	0	0
(220) Bt. 1 has 4" of abrasion. Bt. 2 has been undermined 6" but supported by solid rock formation.

Bent 1 has 6' of abrasion on right end.

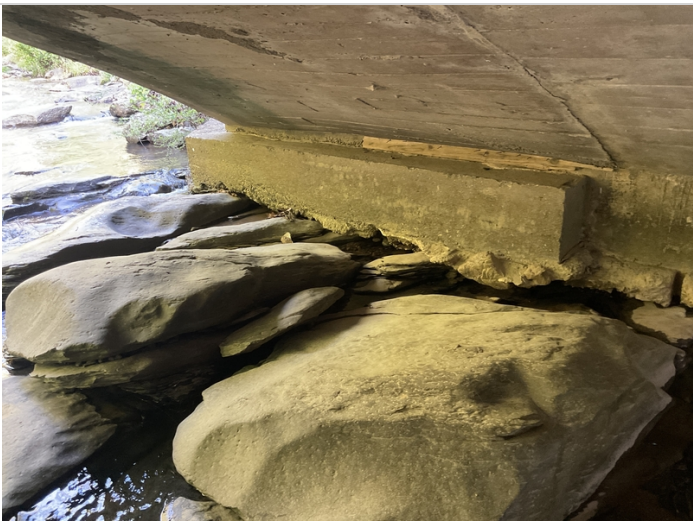
Bt. 2 has been undermined 6" but supported by solid rock formation.

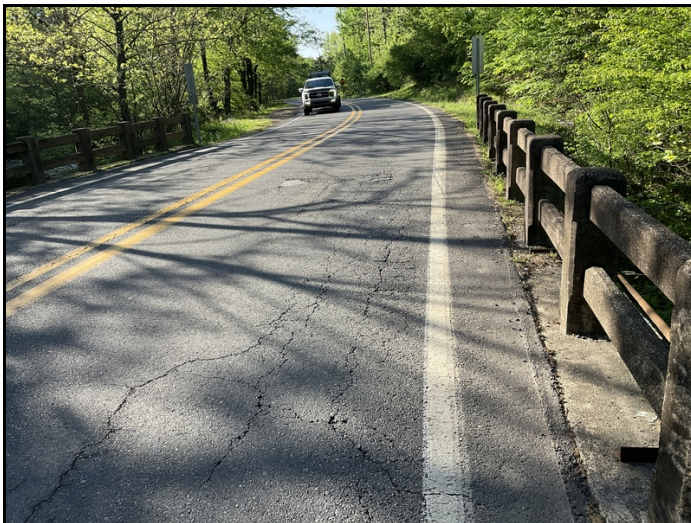
South bound lane has potholes in the asphalt wearing surface.

Potholes in southbound lane.

Type of Work: Repair (General)
