**Asset #M1320**(Routine, Underwater type 2)

**SH 7 Spur Log 0.83 over GULPHA CREEK**

**Location: 1.0 MI S OF SH 7 AT HOT S**

**Team Lead: Shane Byrd, Inspection Date: 04/26/2022**

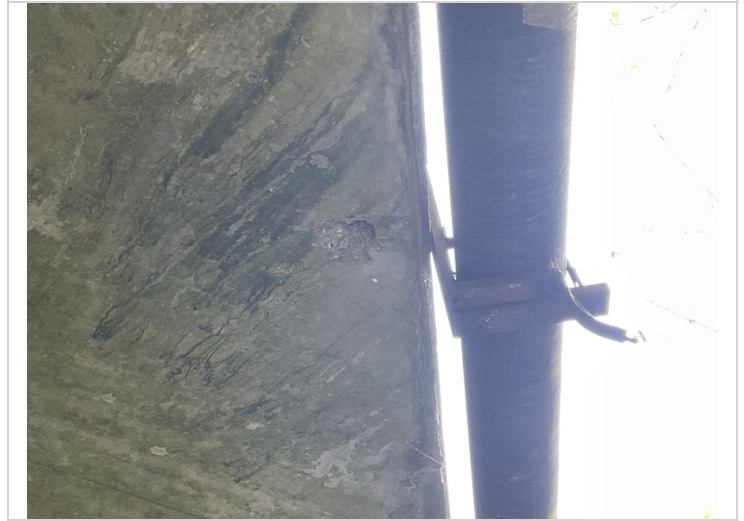
ELEMENTS	DESCRIPTION	UNITS	TOTAL	CS1	CS2	CS3	CS4
144	Reinforced Concrete Arch	LF	40	8	28	4	0
1090	Exposed Rebar	LF	2	0	2	0	0
1120	Efflorescence/Rust Staining	LF	22	0	18	4	0
1130	Cracking (RC and Other)	LF	8	0	8	0	0
(144) Cracks with efflorescence, some with buildup.

Spall with exposed rebar on right side on arch.

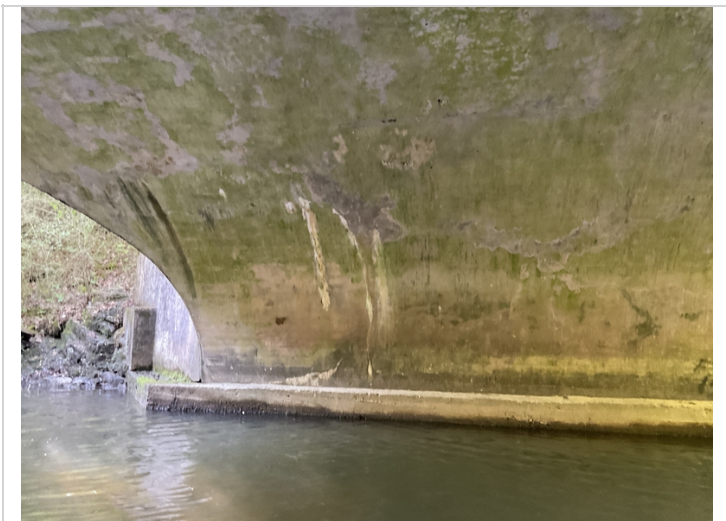
Cracks with efflorescence in the arch at abutment 1.

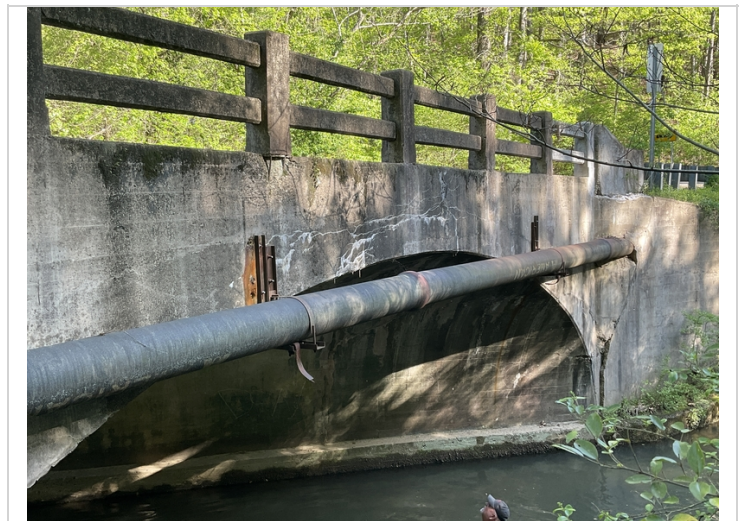
Cracks with efflorescence on right side of arch.

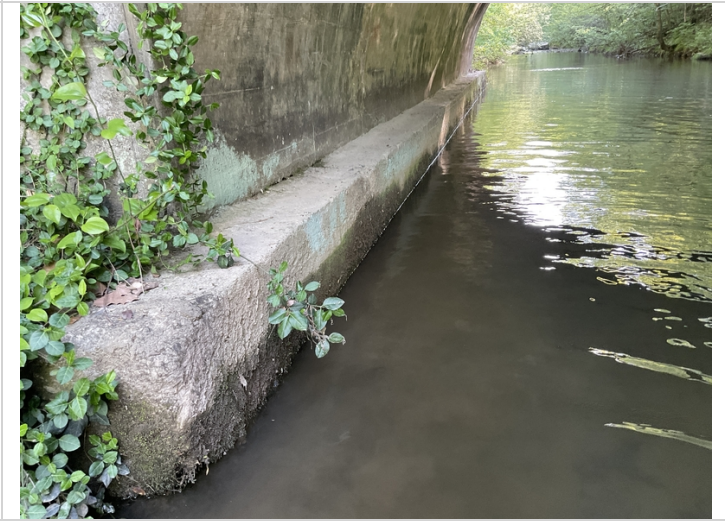
ELEMENTS	DESCRIPTION	UNITS	TOTAL				
				CS1	CS2	CS3	CS4
215	Reinforced Concrete Abutment	LF	85	85	0	0	0
(215) Both footings exposed and have abrasion.							
220	Reinforced Concrete Pile Cap/Footing	LF	89	0	89	0	0
1190	Abrasion/Wear (PSC/RC)	LF	89	0	89	0	0

Exposed footing at abutment 2 with abrasion.

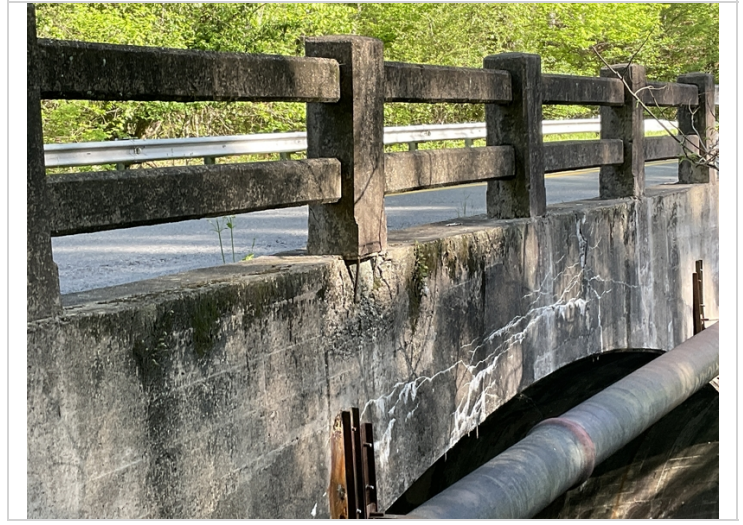
Right rail has exposed rebar.
