**Asset #M1321** (Routine, Underwater type 2)

**SH 7 Spur Log 0.85 over GULPHA CREEK**

**Location: .8 MI S OF SH 7 HOT SPRNG**

**Team Lead: Shane Byrd, Inspection Date: 04/26/2022**

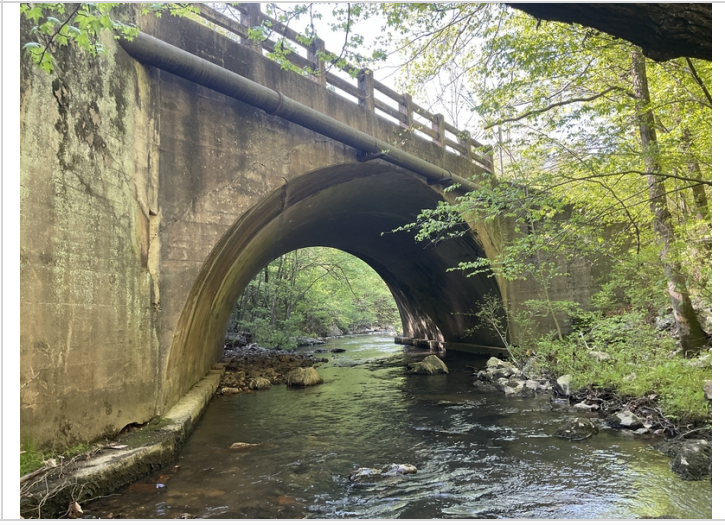
Elevation.

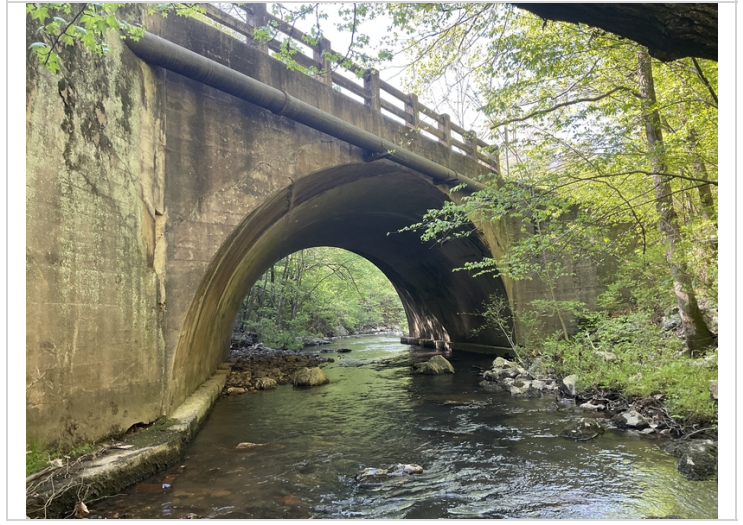
Elevation.

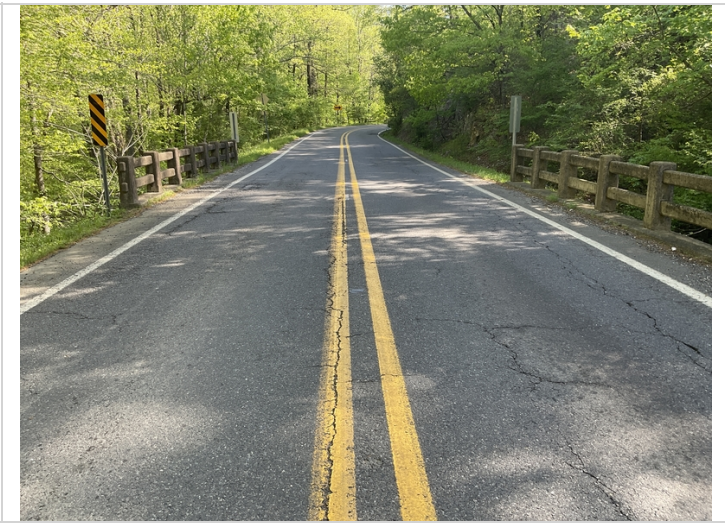
Deck overview.

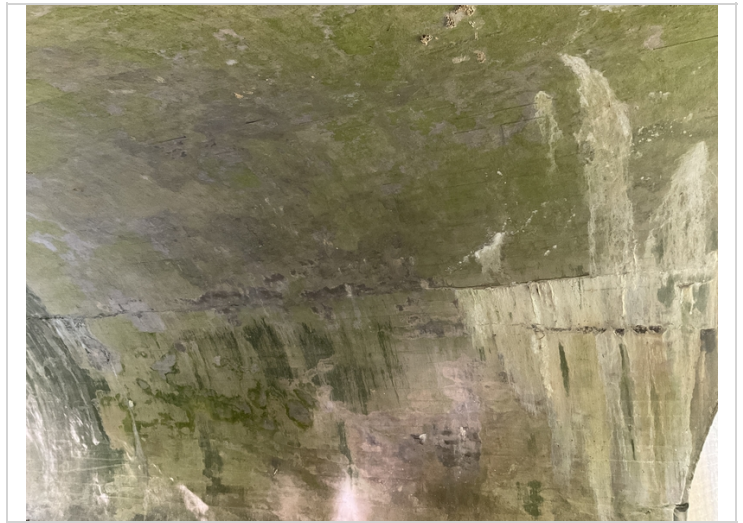
Soffit.

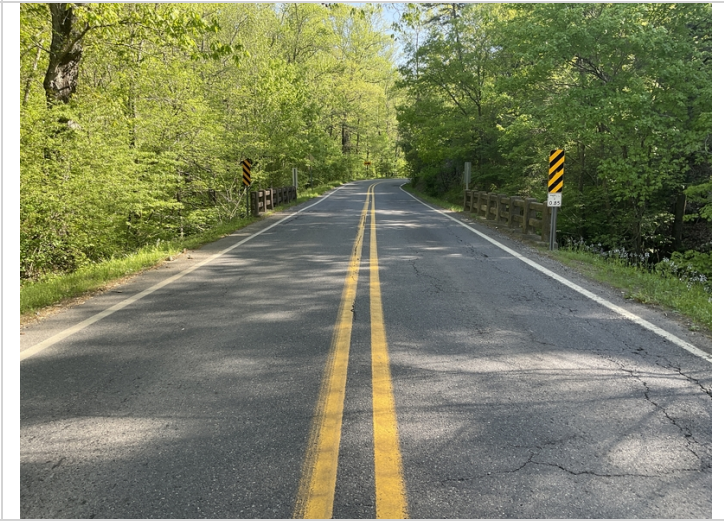
Approach Northbound.

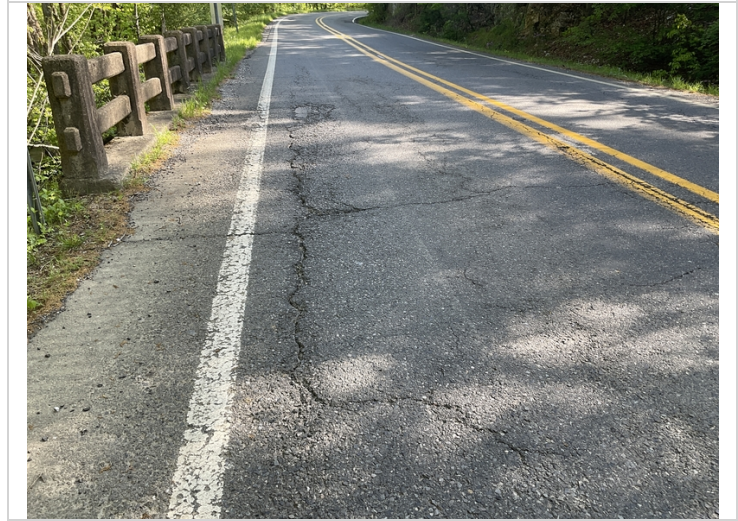
ELEMENTS	DESCRIPTION	UNITS	TOTAL	CS1	CS2	CS3	CS4
38	RC Slab	SF	1230	1230	0	0	0
510	Wearing Surfaces	SF	1066	906	120	40	0
3220	Crack (Wearing Surface)	SF	160	0	120	40	0
(38) Cracks in asphalt overlay							
(510-38) Cracks in the wearing surface.

Large cracks in asphalt wearing surface.

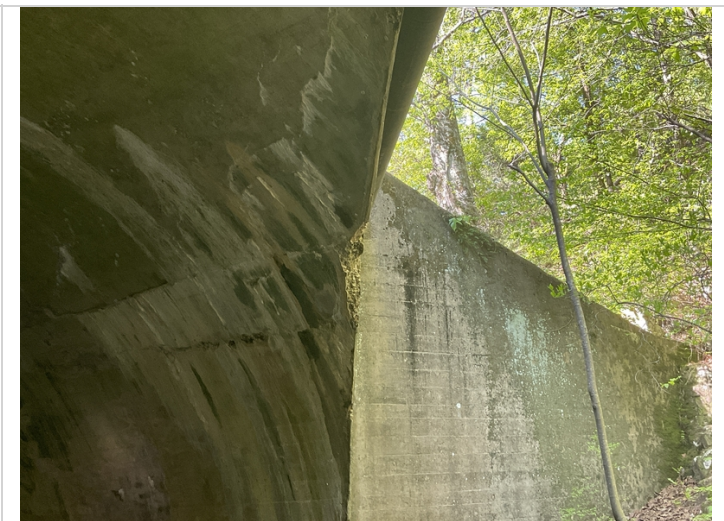
ELEMENTS	DESCRIPTION	UNITS	TOTAL	CS1	CS2	CS3	CS4
144	Reinforced Concrete Arch	LF	39	13	17	9	0
1080	Delamination/Spall/Patched Area	LF	6	0	2	4	0
1120	Efflorescence/Rust Staining	LF	20	0	15	5	0
(144) Scattered spalls and cracks with efflorescence.

Spall on left side of arch.

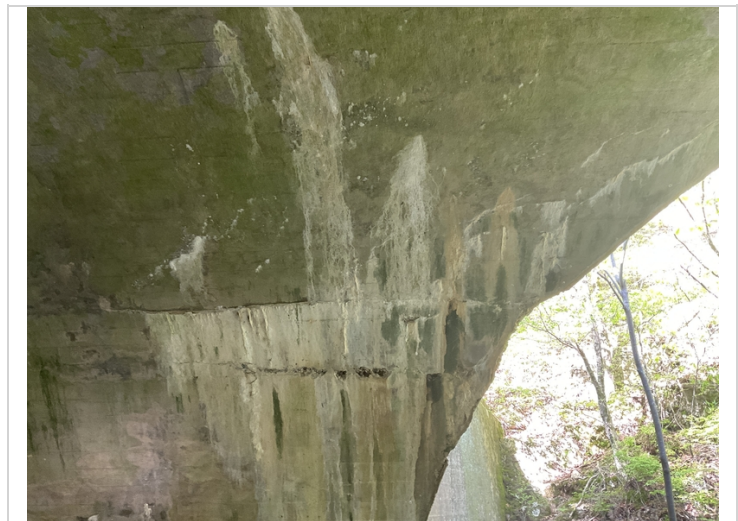
Cracks with efflorescence in the soffit of arch.

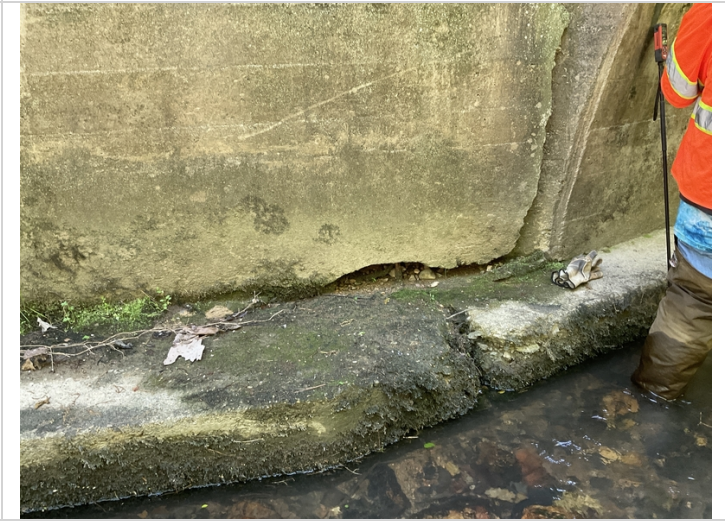
ELEMENTS		DESCRIPTION	UNITS	TOTAL	CS1	CS2	CS3	CS4
215	Reinforced Concrete Abutment		LF	85	85	0	0	0
(215) Abrasion along abutment								
220	Reinforced Concrete Pile Cap/Footing		LF	89	70	16	3	0
1190	Abrasion/Wear (PSC/RC)		LF	19	0	16	3	0
(220) Abrasion on bent 1.								
(1190-220) Severe abrasion on the left side of bent 1.

Abrasion left side abutment 2 wing wall

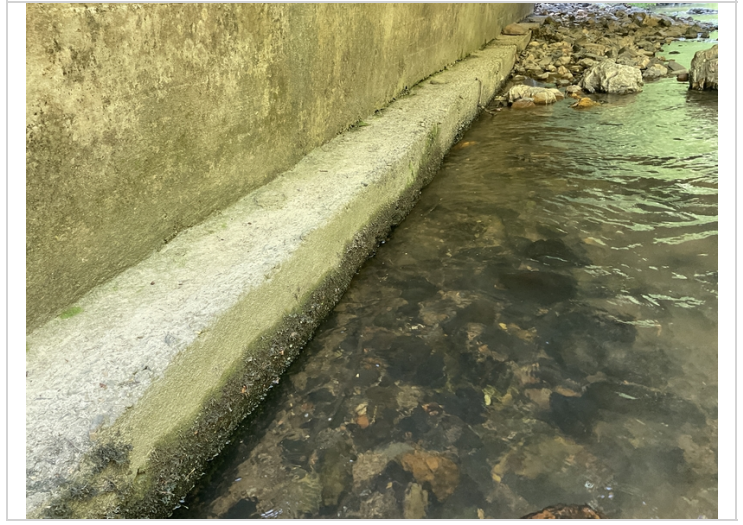
Abrasion bent 2 footing.
