**Asset #M1322**(Routine, Underwater type 2)

**SH 7 Spur Log 1.47 over GULPHA CREEK**

**Location: 0.5 MI SO OF JCT SH 7**

**Team Lead: Shane Byrd, Inspection Date: 04/26/2022**

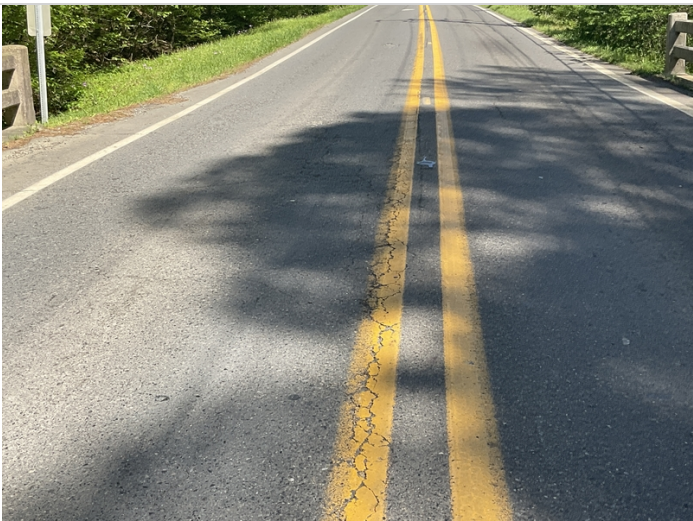
ELEMENTS	DESCRIPTION	UNITS	TOTAL				
				CS1	CS2	CS3	CS4
38	RC Slab	SF	660	660	0	0	0
510	Wearing Surfaces	SF	604	492	112	0	0
3210	Delam/Spall/Patched Area/Pothole	SF	2	0	2	0	0
3220	Crack (Wearing Surface)	SF	110	0	110	0	0

Cracks in the wearing surface.

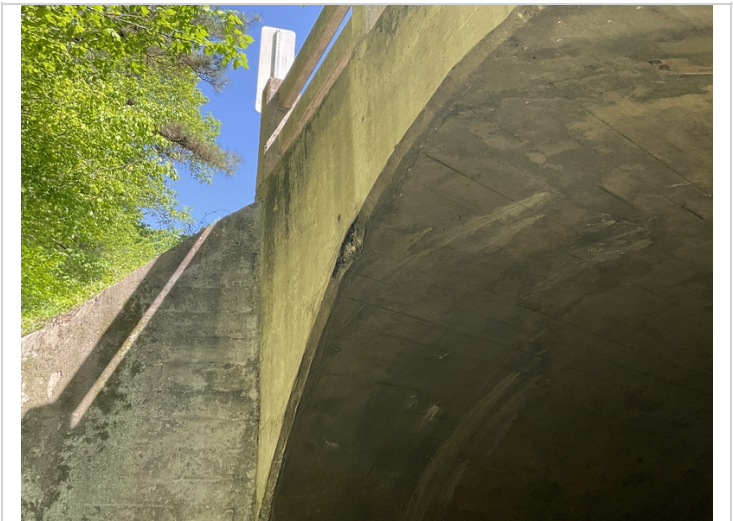
ELEMENTS		DESCRIPTION	UNITS	TOTAL	CS1	CS2	CS3	CS4
144		Reinforced Concrete Arch	LF	20	5	6	9	0
1080		Delamination/Spall/Patched Area	LF	5	0	0	5	0
1120		Efflorescence/Rust Staining	LF	10	0	6	4	0
(144) Both edges of arch have spalls, cracks with efflorescence scattered throughout.

Spall on left side of arch.

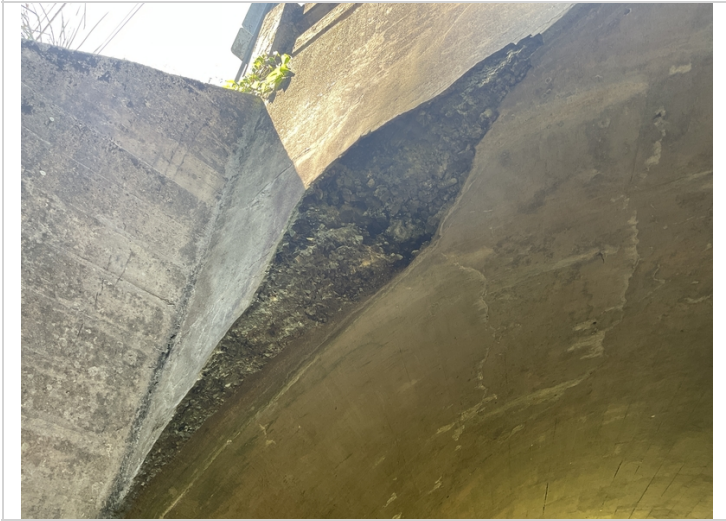
Spall on right side of arch.

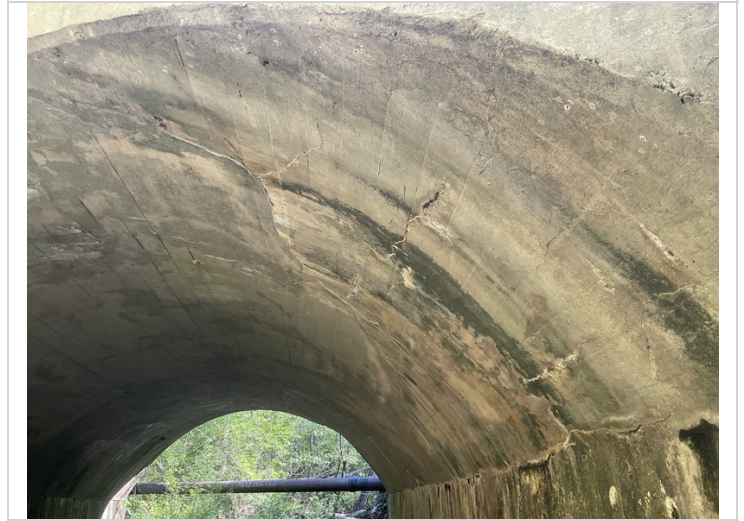
Cracks with efflorescence in the arch.

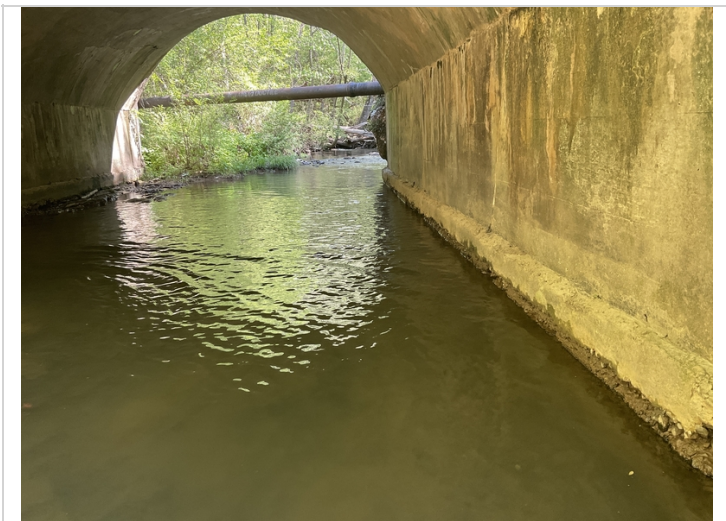
ELEMENTS	DESCRIPTION	UNITS	TOTAL	CS1	CS2	CS3	CS4
215	Reinforced Concrete Abutment	LF	68	64	4	0	0
1130	Cracking (RC and Other)	LF	4	0	4	0	0
220	Reinforced Concrete Pile Cap/Footing	LF	68	0	0	68	0
1190	Abrasion/Wear (PSC/RC)	LF	68	0	0	68	0
(220) All of the footings have abrasion.

Bent 1 footing has severe abrasion common bent 2.

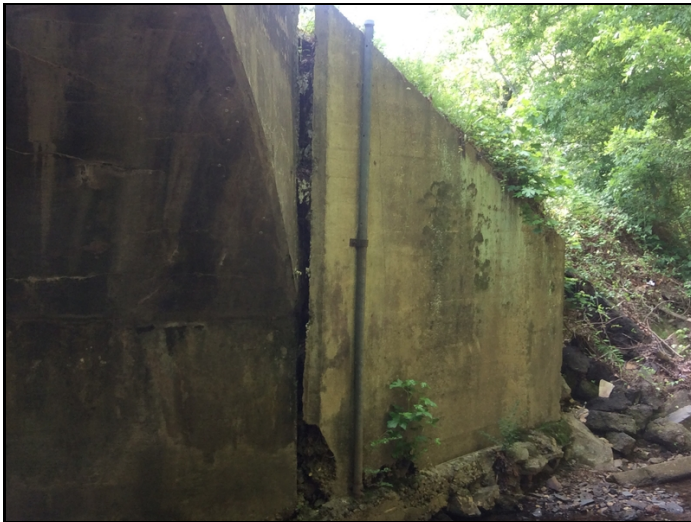
South end of bridge left wing wall has settled and separated from bridge.

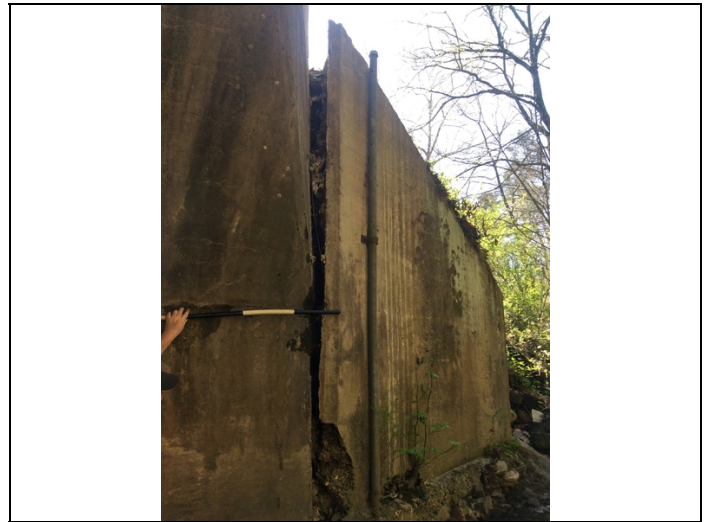
Southwest wing wall leaning on at top six inches. The gap is up to 6 3/4" as of 2020.

Southwest wing wall leaning on at top six inches.

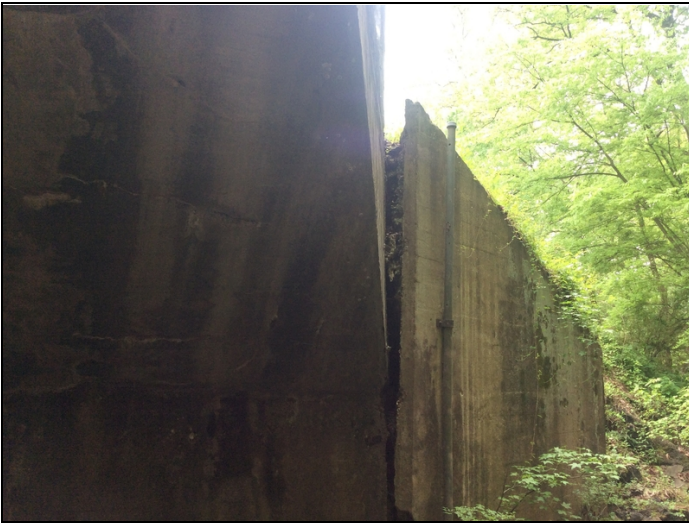
South west wing wall is leaning.

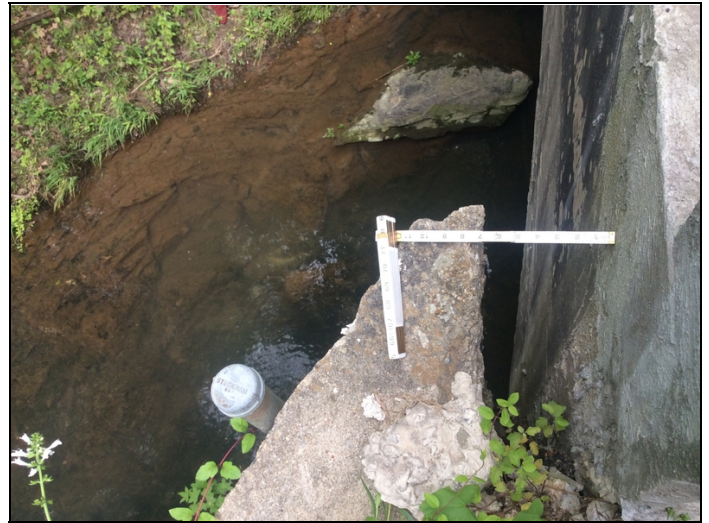
The southwest wing wall has a 6 3/4" gap, leaning away from the bridge at the top.

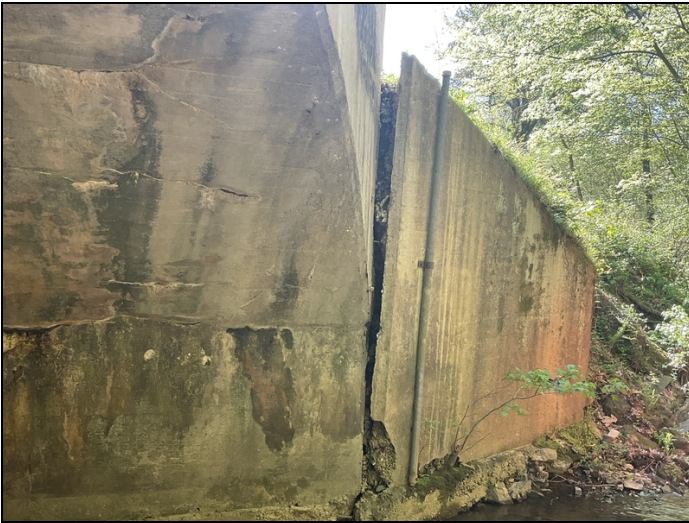
Southwest wing wall leaning on at top six inches. The gap is up to 6 3/4" as of 2022 no change.

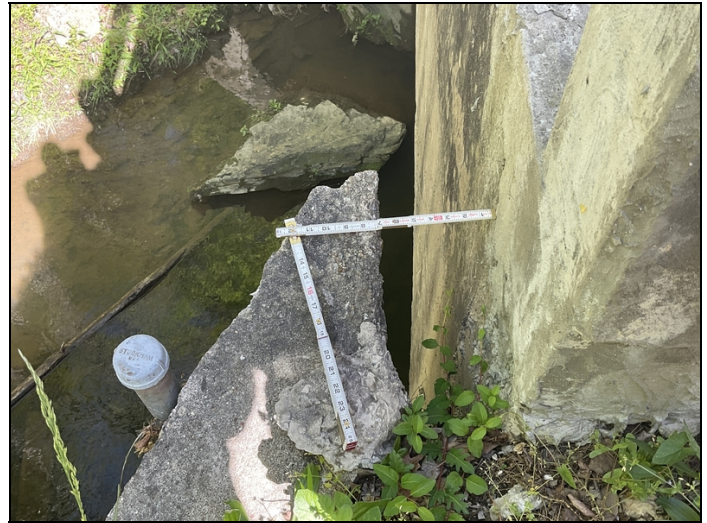
Southwest wing wall leaning on at top six inches. The gap is up to 6 3/4" as of 2022 no change.
