Asset #01538(Routine, Underwater type 2)

SH 10-SEC 8 EB over GILL ST, RR, ROSE CREEK

Location: 1.18 M W US 70

Team Lead: Keith Harris Inspection Date: 06/27/2023

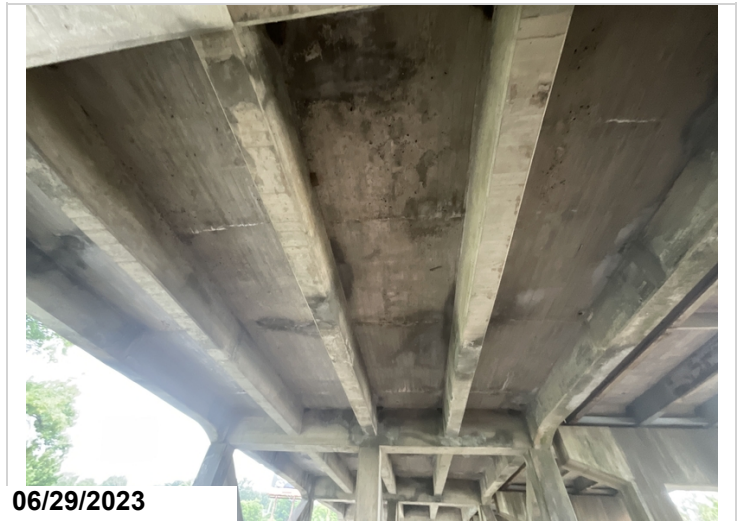
(16) The soffit of all spans have spalls with exposed rebar and patched areas. All of the soffit between beams have cracks with rust stains and light to moderate efflorescence. The concrete curb on the left side of bridge has spalls. Span 27, bays 2 and 3 have fire damage from transients.							
(510-16) Asphalt is deteriorating causing pot holes at multiple joints Cracks in asphalt overlay							
110	Reinforced Concrete Open Girder/Beam	LF	4110	3014	1032	64	0
1080	Delamination/Spall/Patched Area	LF	166	0	166	0	0
1090	Exposed Rebar	LF	108	0	44	64	0
1130	Cracking (RC and Other)	LF	822	0	822	0	0

Span 4 soffit view

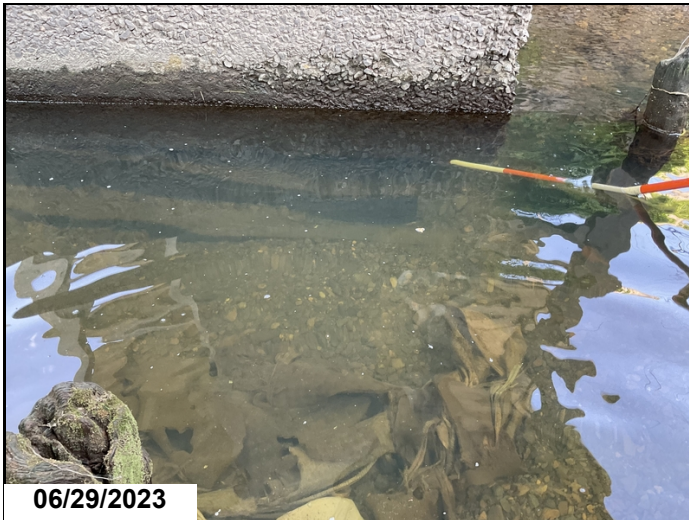
Bent 16 bottom of footing exposed and undermined 2' on downstream end due to scour.

Bent 16 footing is undermined 2' on downstream end

Type of Work: Substructure Repair

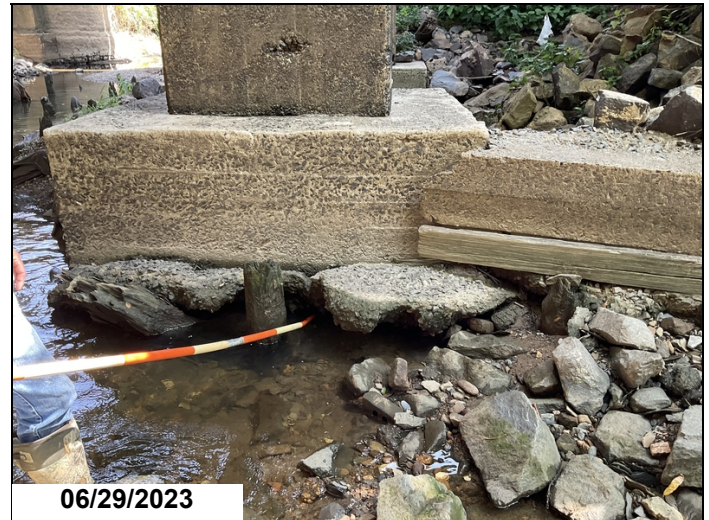
Bent 15 footings are exposed on columns 1&2. Column 1 is undermined 1' on upstream end

Bent 15 footing is undermined 1' on upstream end

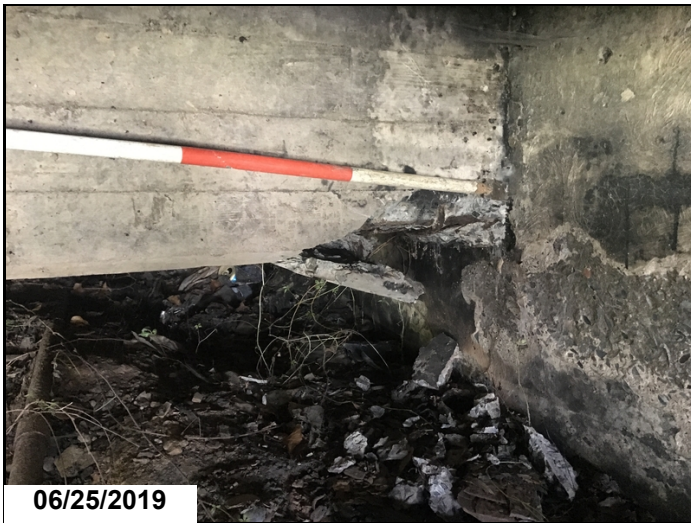
Span 27 girder 2 has spall with exposed rebar on bottom near abutment 2.

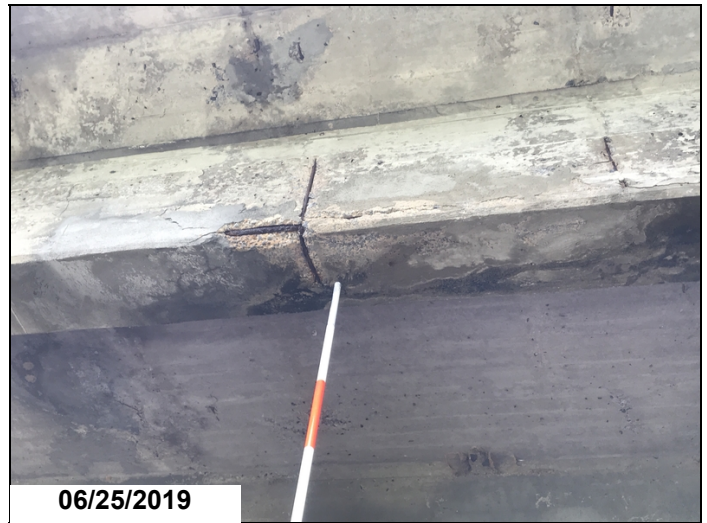
Span 5 girder 1 left side has spall with exposed rebar.

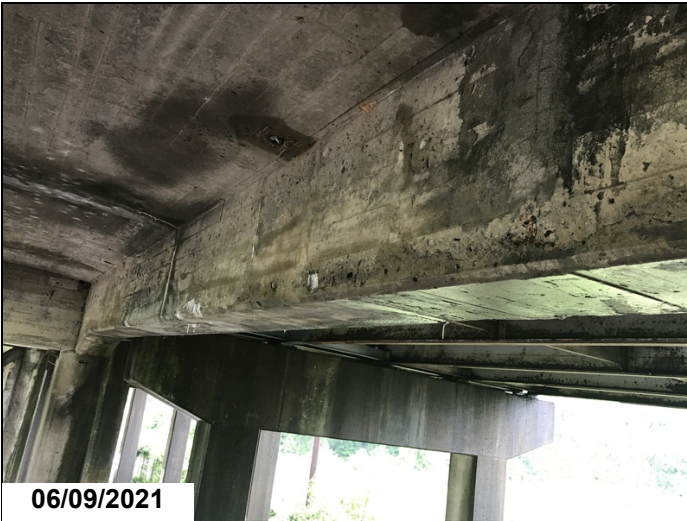
Span 6, girder 5: multiple cracks with efflorescence build up and small spalls.

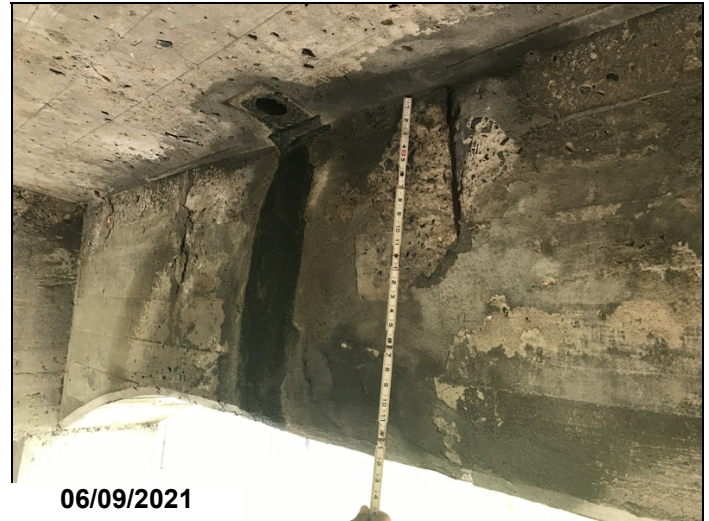
Span 7, girder 1 with multiple spalls with exposed rebar.

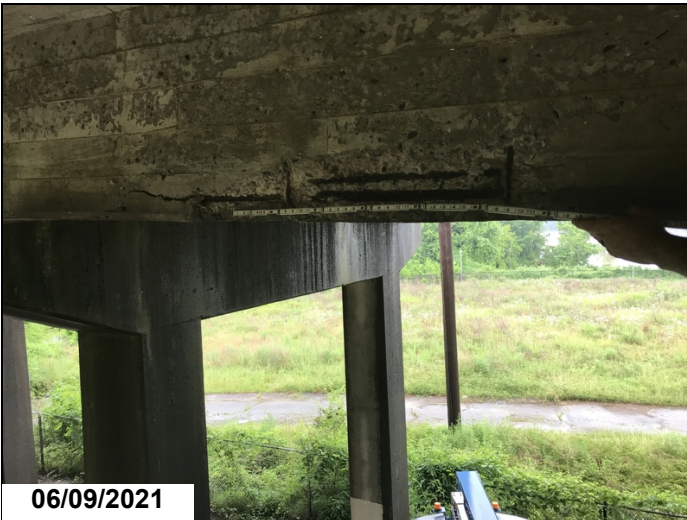
Span 8, girder 3: large spall with exposed rebar. There are 10' of delam on this girder also.

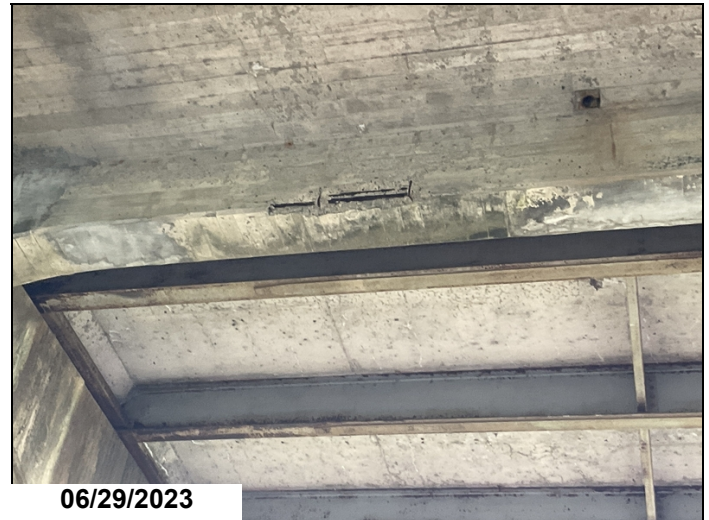
Span 8 girder 4 spall with exposed rebar on left side

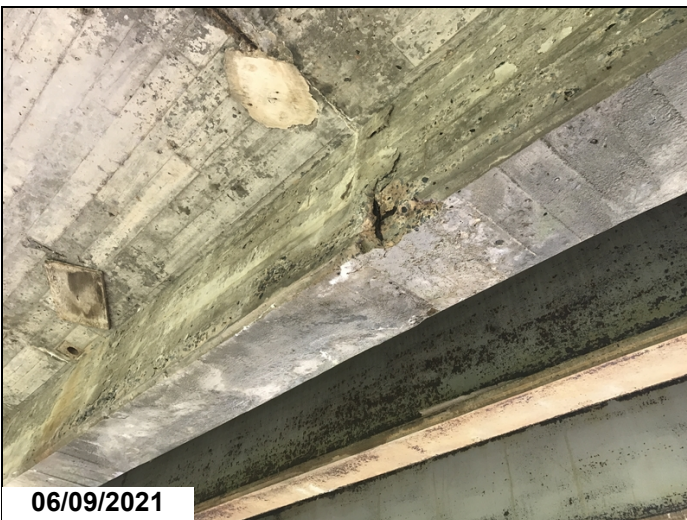
Span 13, girder 5: spall with exposed rebar.

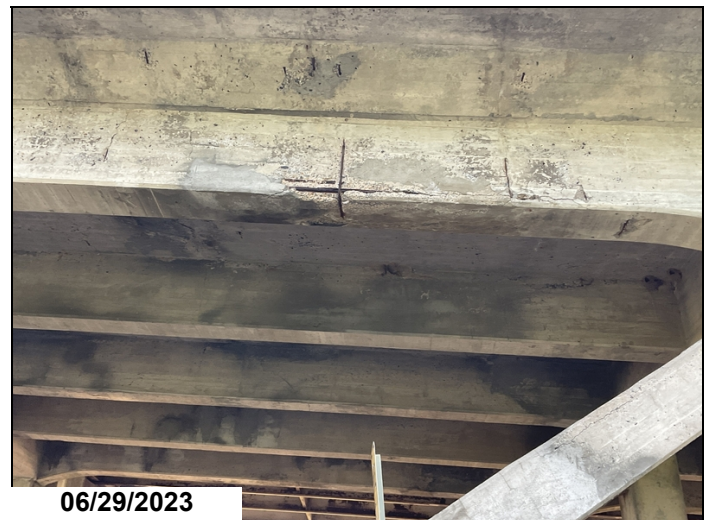
Span 5 girder 1 left side has spall with exposed rebar.

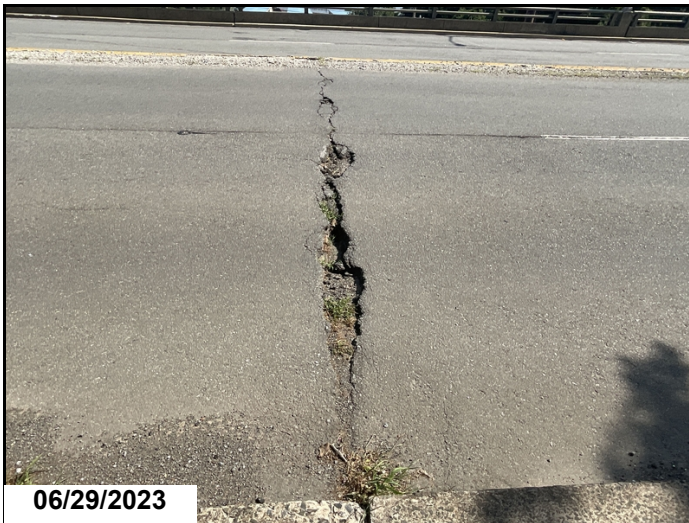
Abutment 2

Bent 2: asphalt is deteriorating at joint creating a bump in the roadway. Multiple joints are in a similar condition.

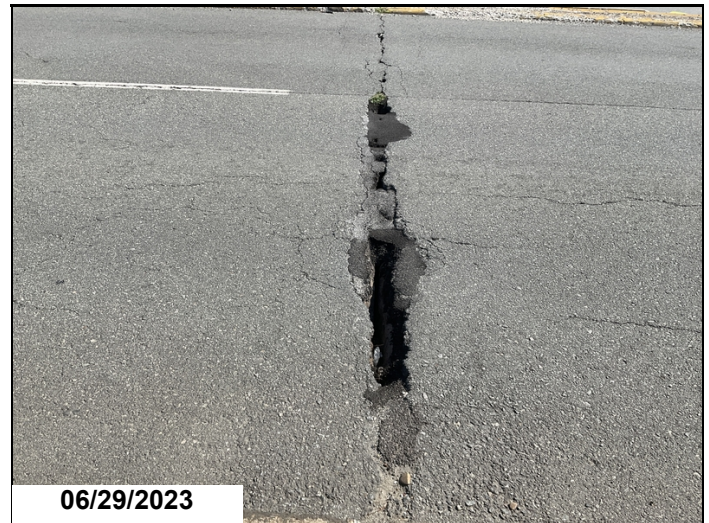
Bent 13 spalls in asphalt overlay at joint

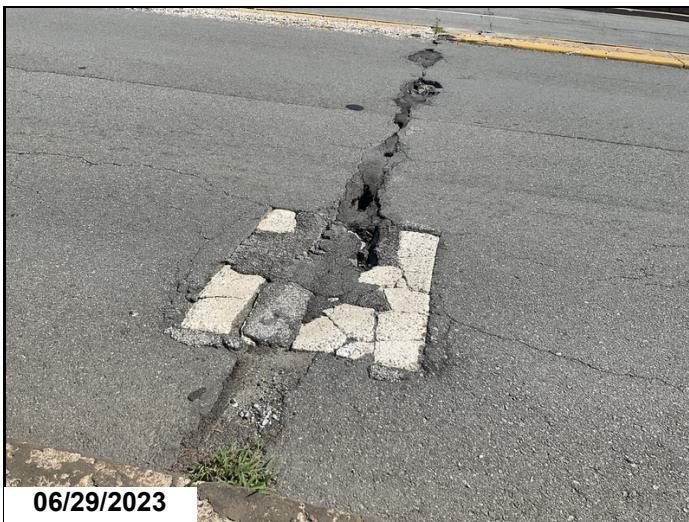
Bent 6 spalls in asphalt overlay at joint

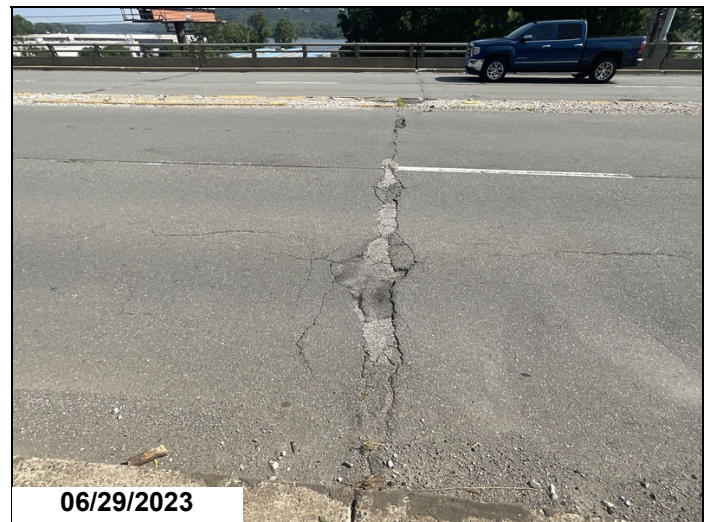
Bent 19 spalls in asphalt overlay at joint

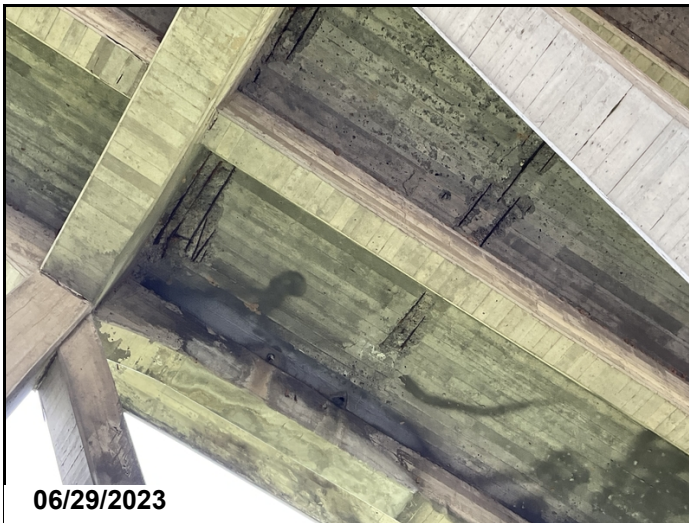
Span 13 exposed rebar on soffit

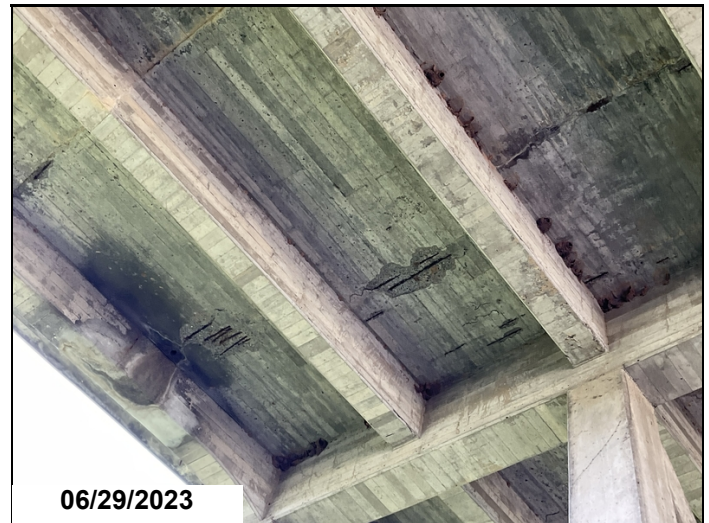
Span 14 exposed rebar on soffit

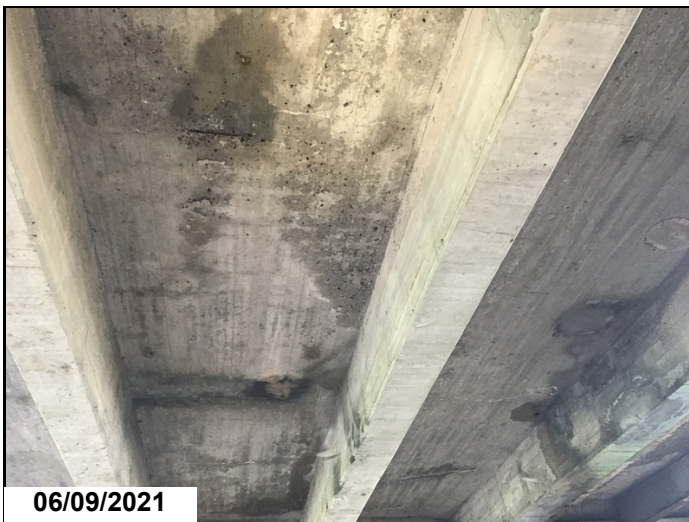
Span 3 has spalls with exposed rebar and multiple cracks with efflorescence staining.

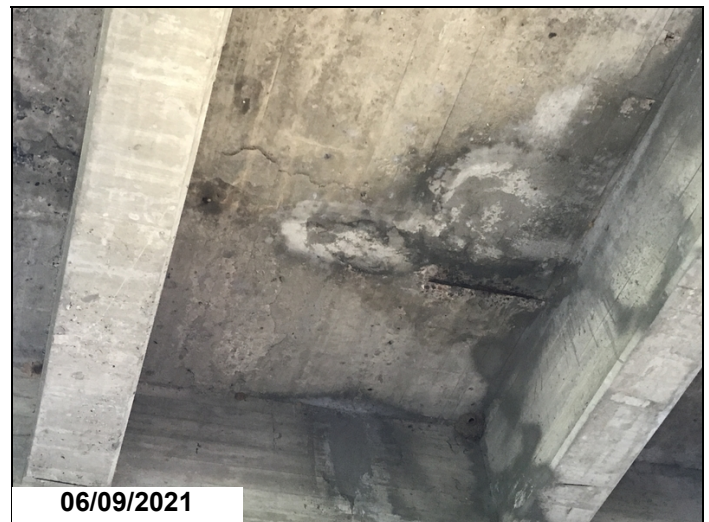
Span 5, between girders 2 and 3: large delam and spall with exposed rebar.

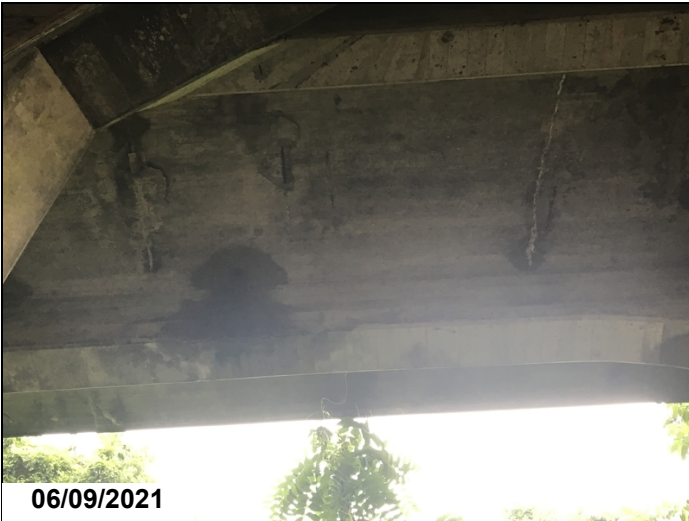
Span 24: soffit has multiple spalls with exposed rebar and large delams.

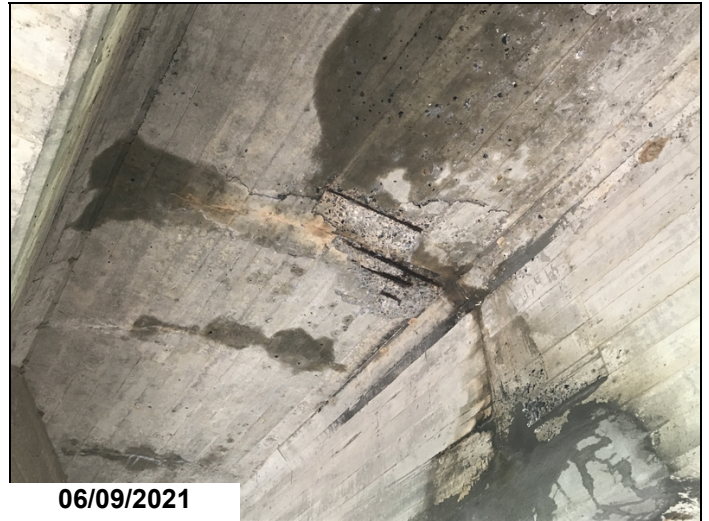
Span 22: between girders 2 and 3 has large spall with exposed rebar.

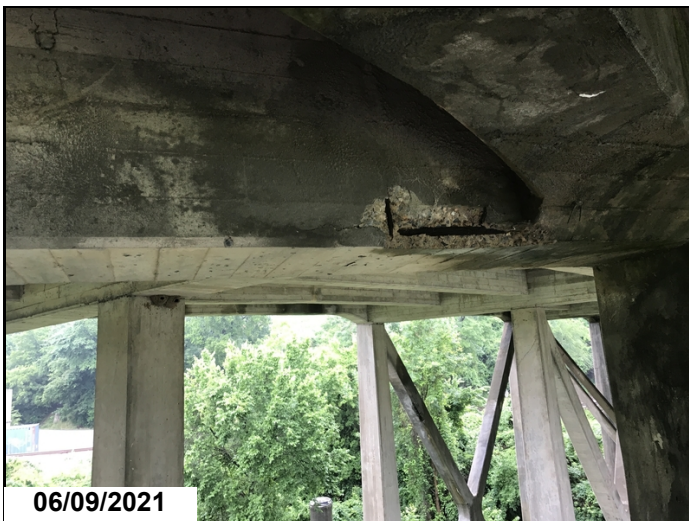
Bent 10 right end of cap has spall with exposed rebar.

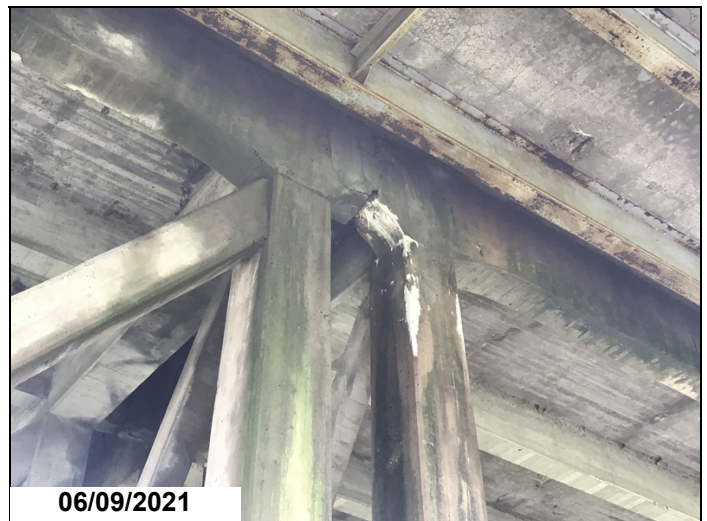
Bent 14 cap, at the joint: a previous patch is now a delam and there is a spall with exposed rebar above that. Also, heavy amount of efflorescence build up at this location.

Bent 14 at the joint: a previous patch is now a delam and there is a spall with exposed rebar above that. Also, heavy amount of efflorescence build up at this location.

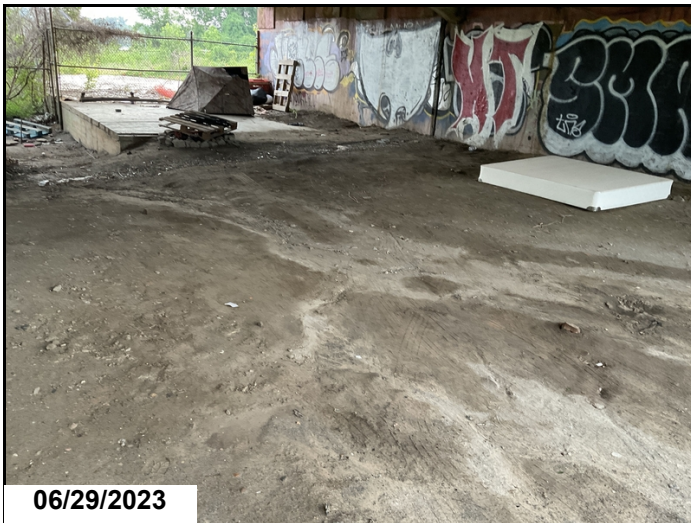
Abutment 1 under this structure homeless have made a camp and have fire pits built under bridges

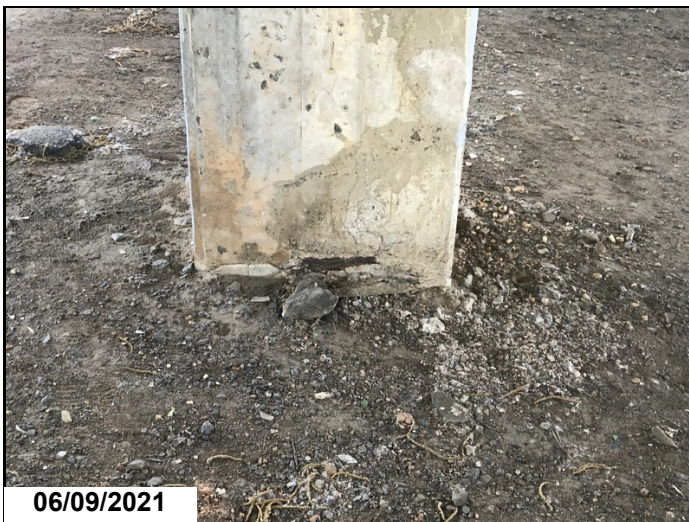
Bent 4, column 2: spall with exposed rebar.

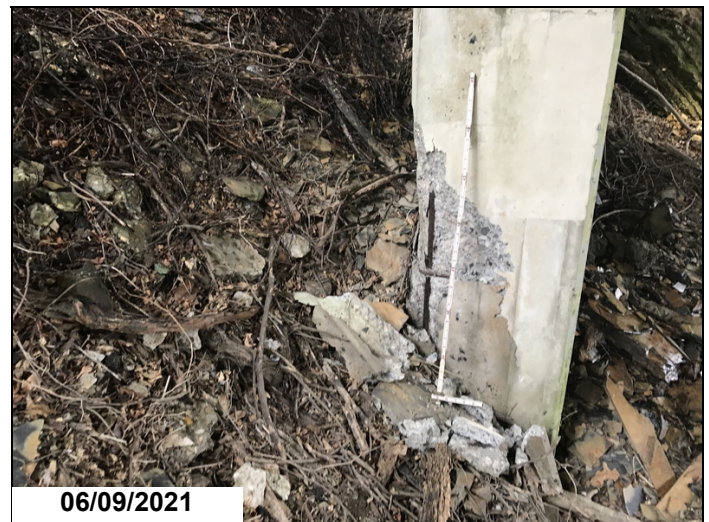
Bent 25, column 1: large spall with exposed rebar that has section loss.

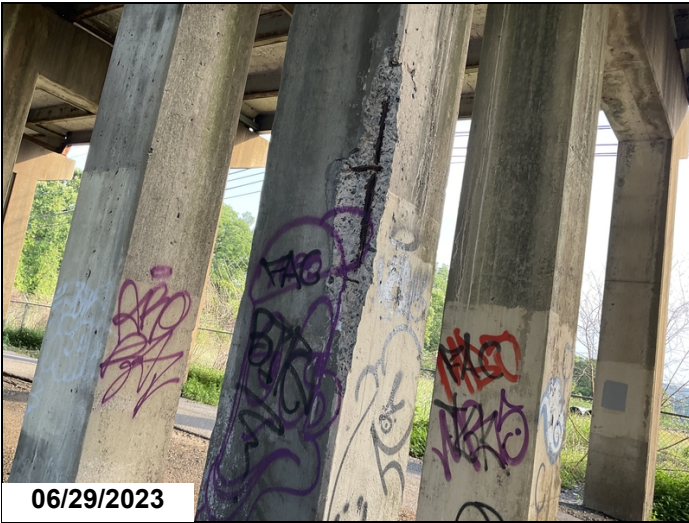
Bent 7 column 3 large spall with exposed rebar
