Asset #A1538(Routine, Underwater type 2)

SH 10-SEC 8, WB LN over Gill St/RR/Rose Bayou

Location: 1.21 MI W & US 70

Team Lead: Keith Harris Inspection Date: 06/27/2023

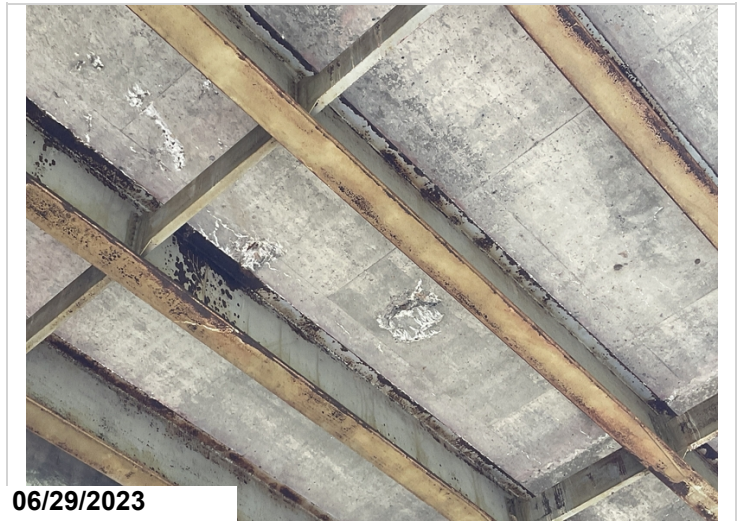
Span 10 exposed rebar on soffit

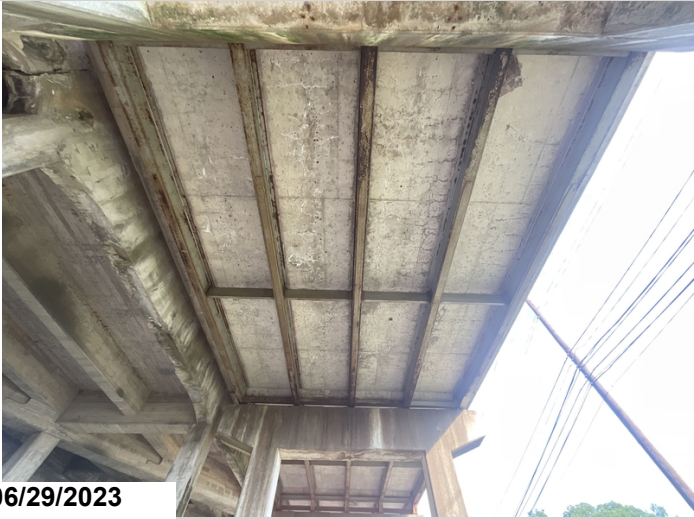
Span 8 soffit view

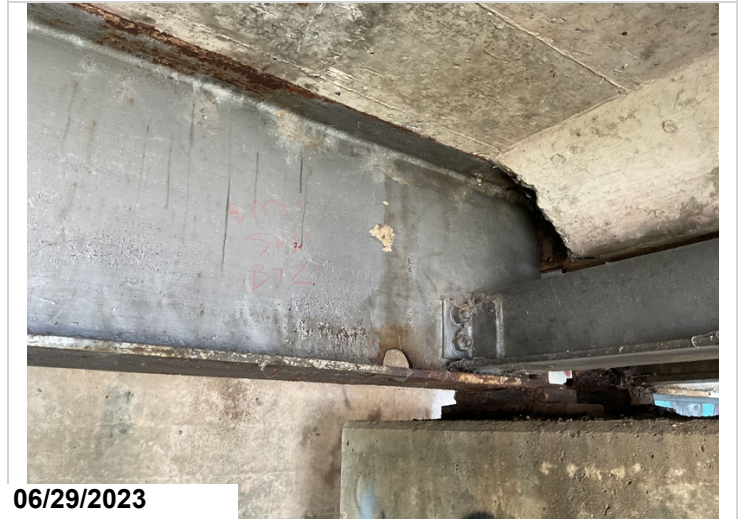
Span 21 beam 1 at bent 21 t-splice repair

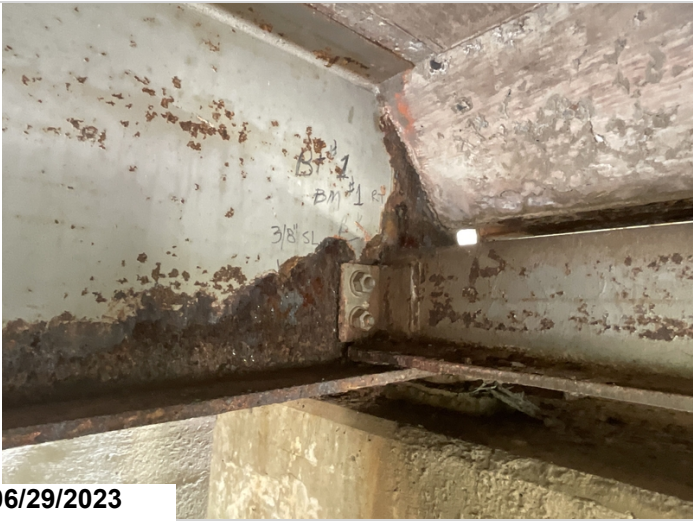
Bent 1, beam 1 right side: section loss up to 3/8" to the end of web and haunch area. Bottom flange with 1/16" section loss

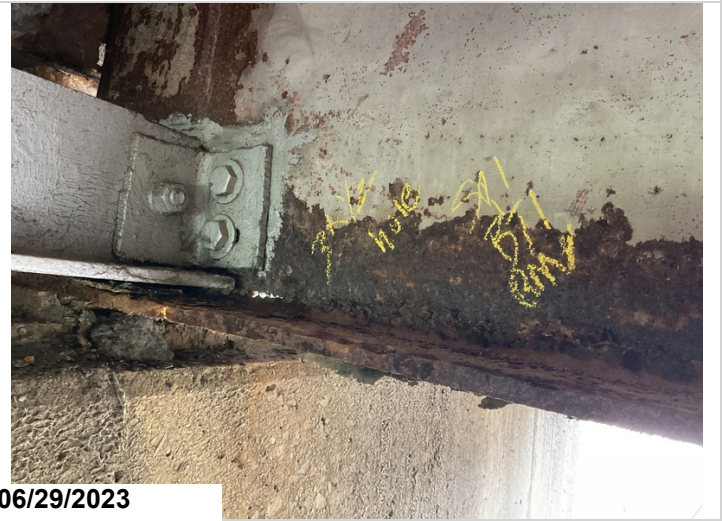
Bent 1 span 1 beam 4, 3"x1/2" hole in lower web 13" from beam end.

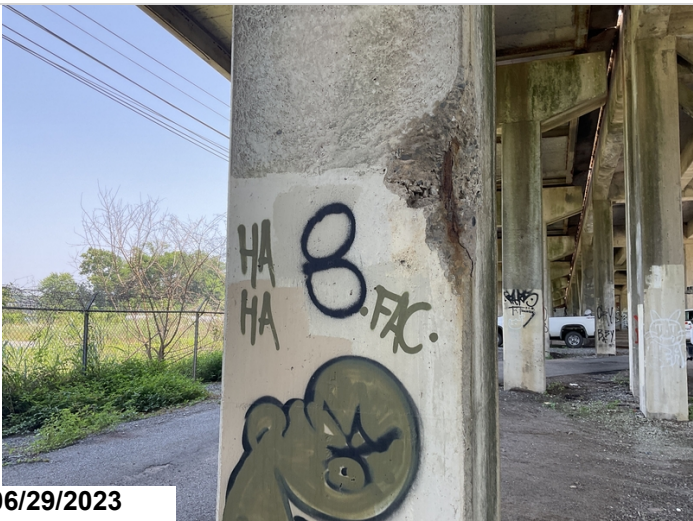
bent 8 column 1 spall with exposed rebar 3 spalls with exposed rebar.

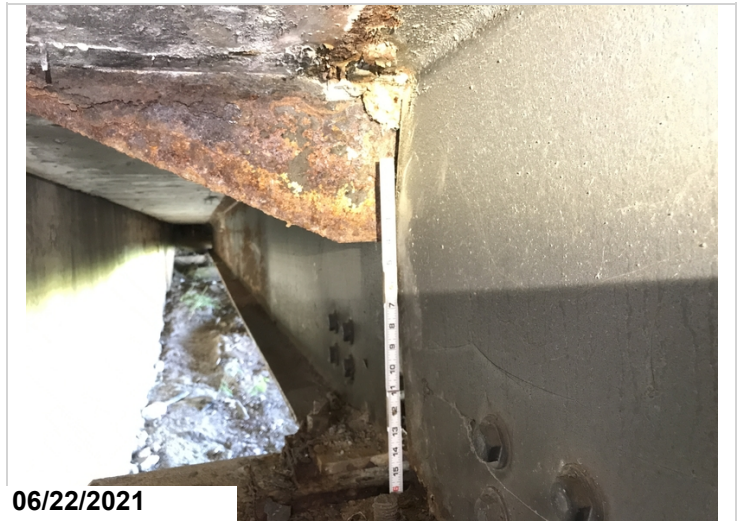
Back of Bent 22, span 22, beam 1 left side: web has some out of plane bending due to pack rust at the haunch on the opposite side

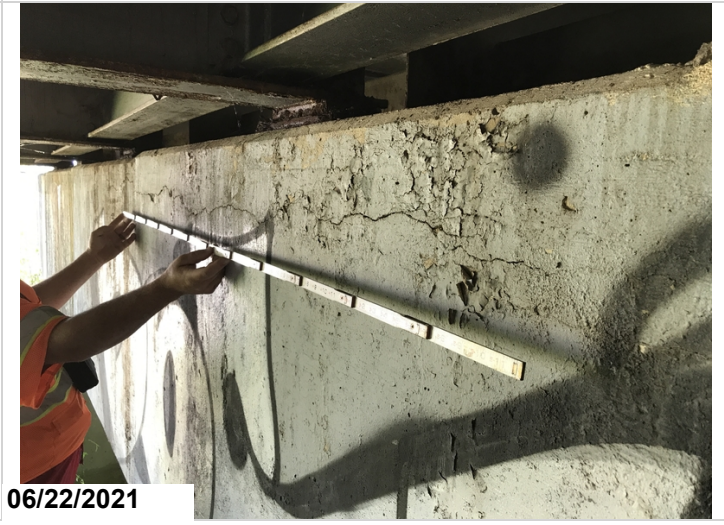
(234)	Bent 1 ahead, bent 8 ahead, bent 9 bottom, bent 10 back and ahead, bent 12 bottom, bent 13 ahead, bent 18 bottom all have spalls with exposed rebar. Spalls at bent 15 have been repaired by state forces. Bent 21 large crack across the face						
311	Movable Bearing	EA	115	0	0	115	0
1000	Corrosion	EA	115	0	0	115	0

Ahead side of bent 21: large horizontal crack runs along the entire face. (Approximately up to 1/8" in width.)

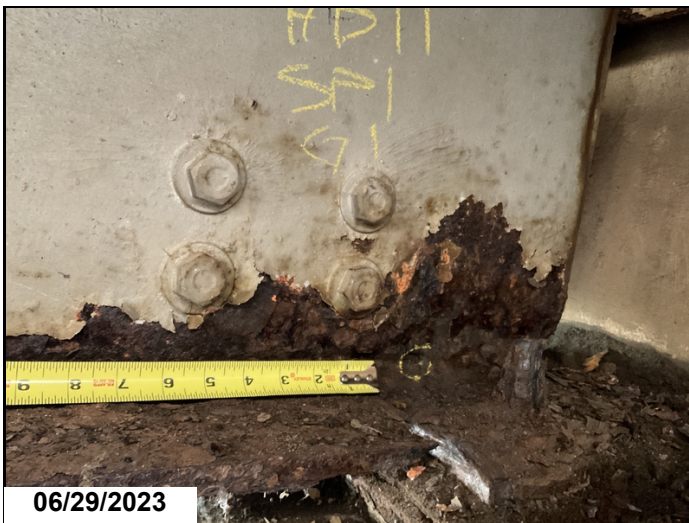
2023: Abutment 1 span 1 beam 1, 8" of left side of bottom flange has 100%. 1/2" hole in lower web 6" from beam end. Right bottom flange has 75% section loss over bearing  
Bent 6, span 6, beam 3: 10"x1" holes in the web at the haunch where it nearly goes to the end of the girder and lower web just back from the diaphragm. 4"x4" hole in lower web in front of diaphragm. 1" hole behind diaphragm. 1/2" section loss to left side of bottom flange 1" in front of bearing.  
span 15, bent 15, beam 2: 4"x1" hole in lower web. Bottom on left side only has 1/8" remaining and is distorted from pack rust under diaphragm  
Bent 16, span 16 beam 1. Right bottom flange is down to a knives edge. 3/8" section loss to lower web and haunch area.  
Span 17 bent 17 beam 5, left bottom flange is down to a knives edge 5' in length. 14"x5" hole in lower web. 5/16" section loss in haunch area.

Abutment 1 span 1 beam 1, 8" of left side of bottom flange has 100%. 1/2" hole in lower web 6" from beam end. Right bottom flange has 75% section loss over bearing

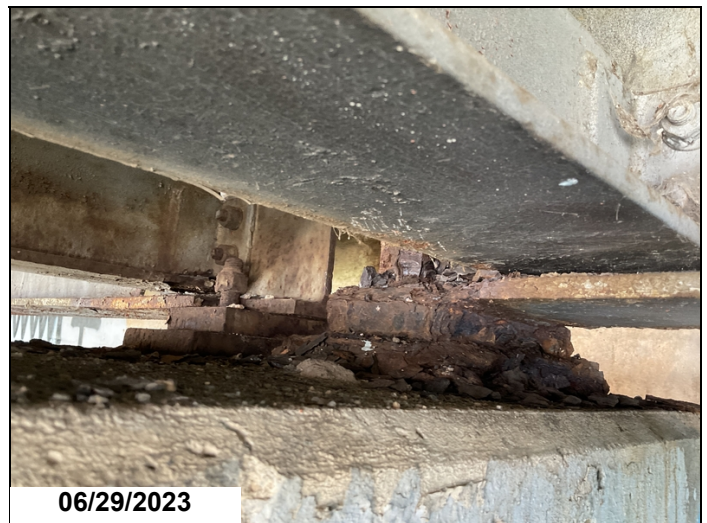
2022: Ahead bent 21, span 22, beam 1: beam has severe section loss to the bottom flange at the bearing.  
Bent 22, span 22, beam 1, right side: bottom flange with severe section loss at its bearing area. The beam doesn't have much section left.

Ahead bent 21, span 22, beam 1: beam has severe section loss to the right bottom flange at the bearing.

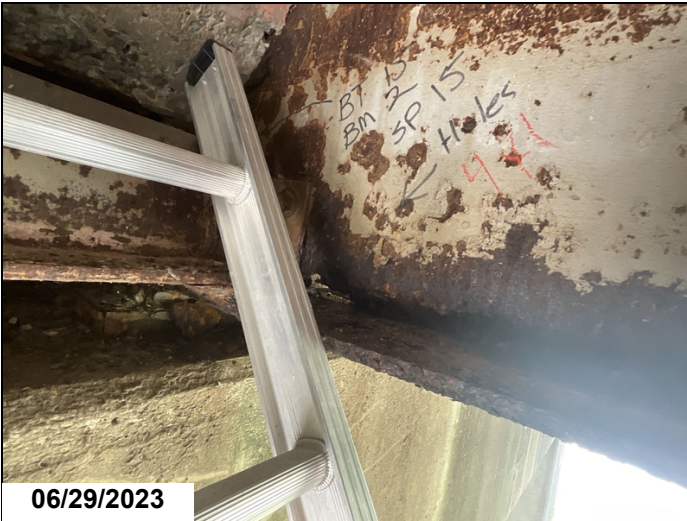
span 15, bent 15, beam 2: 4"x1" hole in lower web. Bottom on left side only has 1/8" remaining and distorted from pack rust under diaphragm

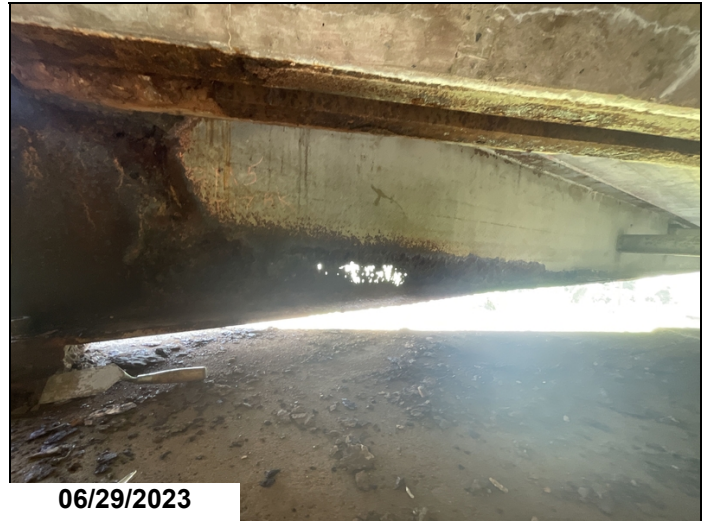
Span 17 bent 17 beam 5, left bottom flange is down to a knives edge 5' in length. 14"x5" hole in lower web. 5/16" section loss in haunch area.

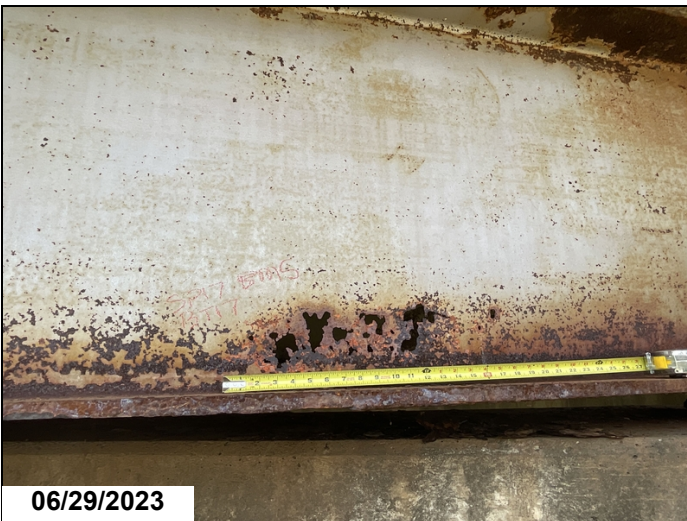
Span 17 bent 17 beam 5, left bottom flange is down to a knives edge 5' in length. 14"x5" hole in lower web. 5/16" section loss in haunch area.

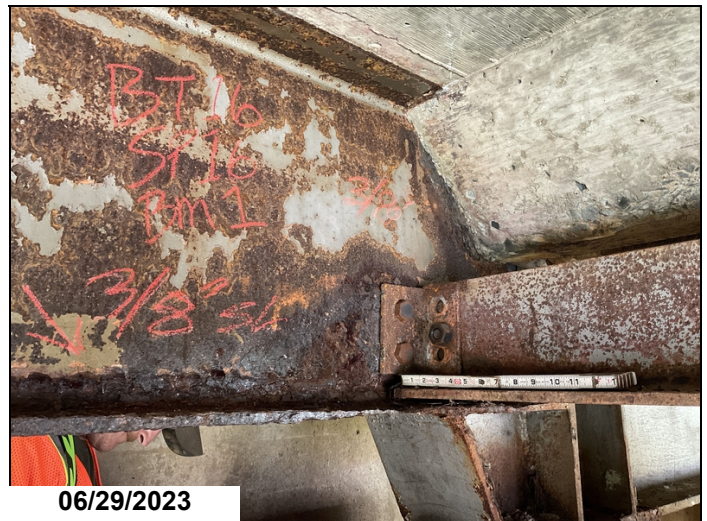
Bent 16, span 16 beam 1. Right bottom flange is down to a knives edge. 3/8" section loss to lower web and haunch area.

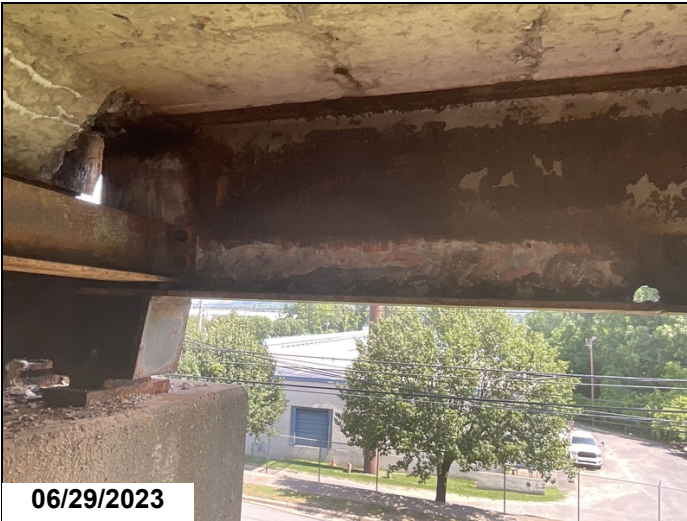
Bent 16 span 16 beam 5 t-splice repair 2023

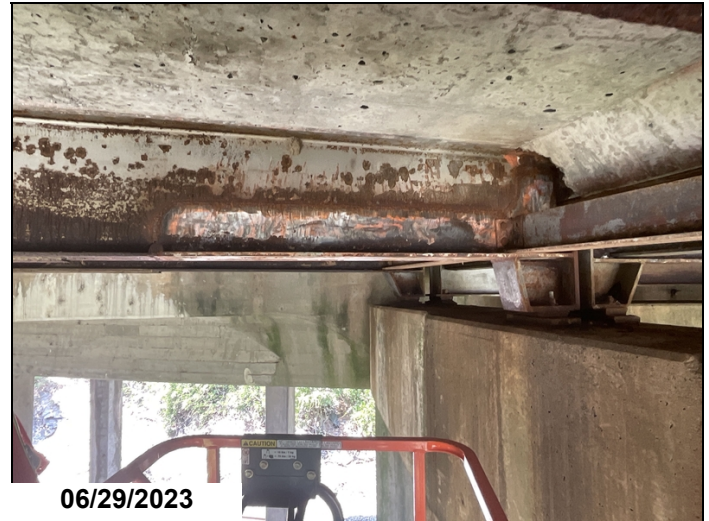
Bent 16 span 16 beam 2, t-splice repair 2023

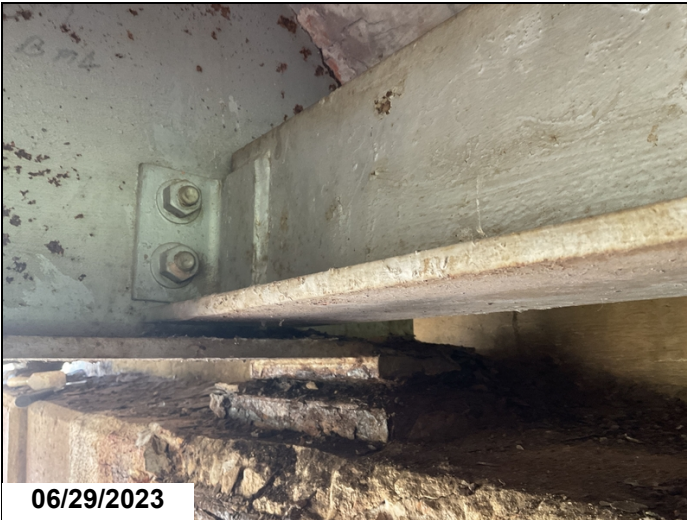
Abutment 1 span 1 beam 4, left bottom flange is down to a knives edge over bearing. 6" from beam end.

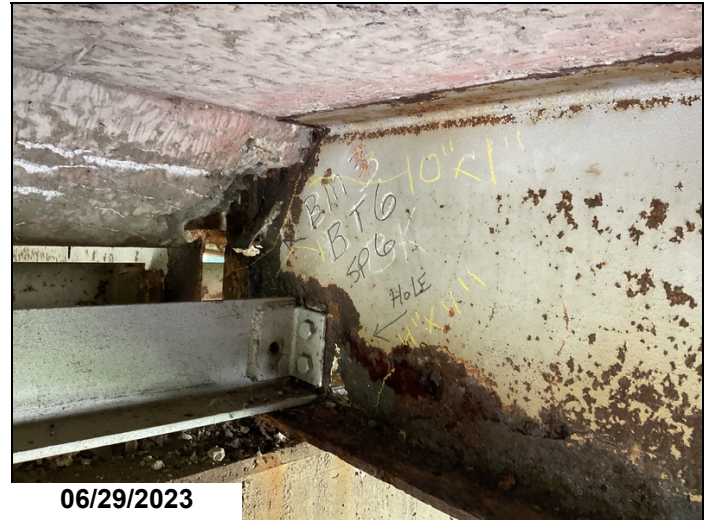
Bent 6, span 6, beam 3: 10"x1" holes in the web at the haunch where it nearly goes to the end of the girder and lower web just back from the diaphragm. 4"x4" hole in lower web in front of diaphragm. 1" hole behind diaphragm. 1/2" section loss to left side of bottom flange 1" in front of bearing.

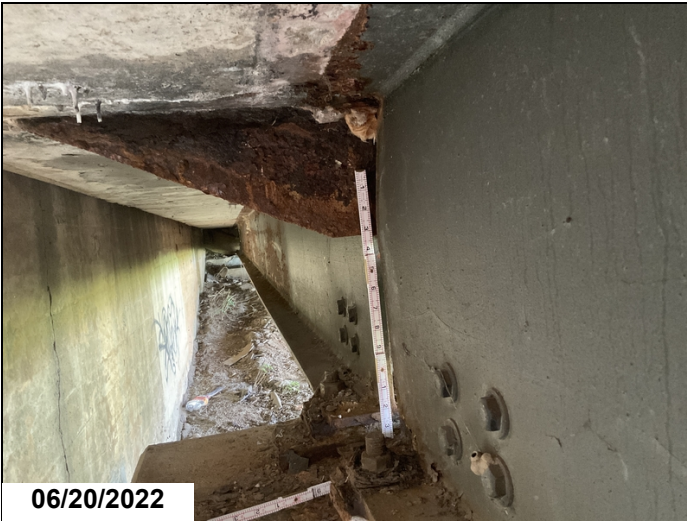
Bent 22, span 22, beam 1: web has some out of plane bending due to severe section loss. 2022

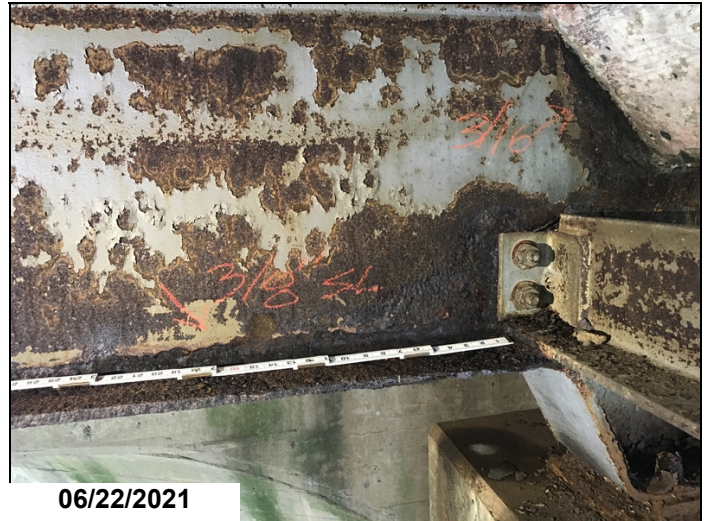
Bent 16, beam 1, span 15: section loss to both upper and lower web and bottom flange edge down to knives edge 8 inches in length back from diaphragm

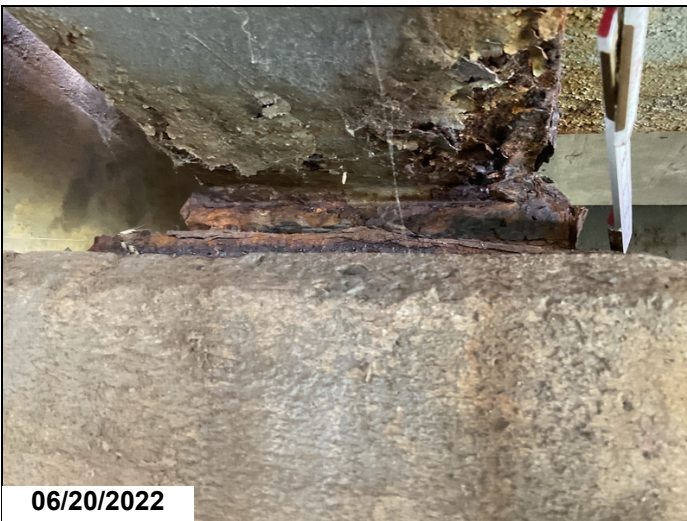
Bent 22, span 22, beam 1: bottom flange with severe section loss at it's bearing area.

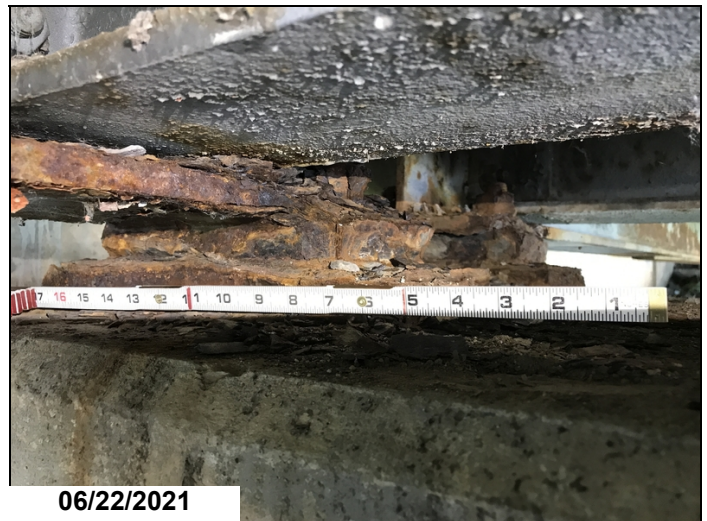
Bent 22, span 22, beam 1, right side: bottom flange with severe section loss at its bearing area. The beam doesn't have much section left.

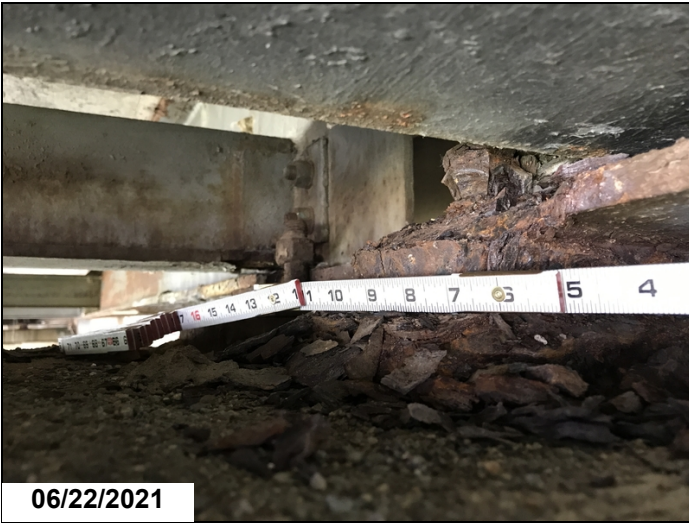
Ahead bent 21, span 22, beam 1: beam has severe section loss to the bottom flange at the bearing.

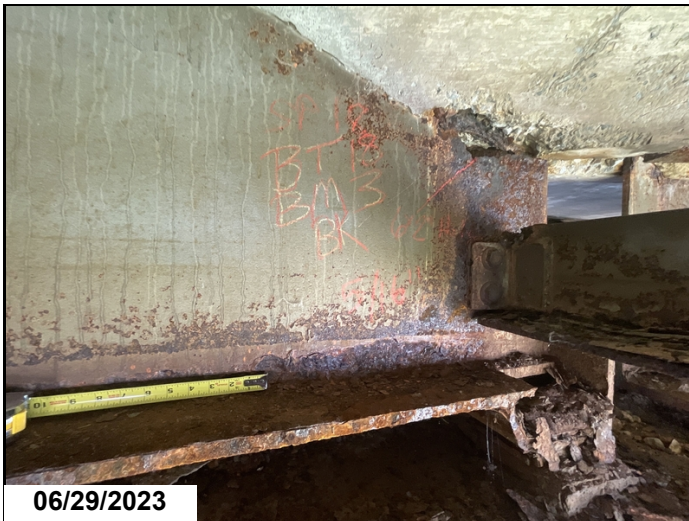
Span 18, bent 18, beam 3: 6"x2" hole in haunch area.  
5/16" section loss in lower web.

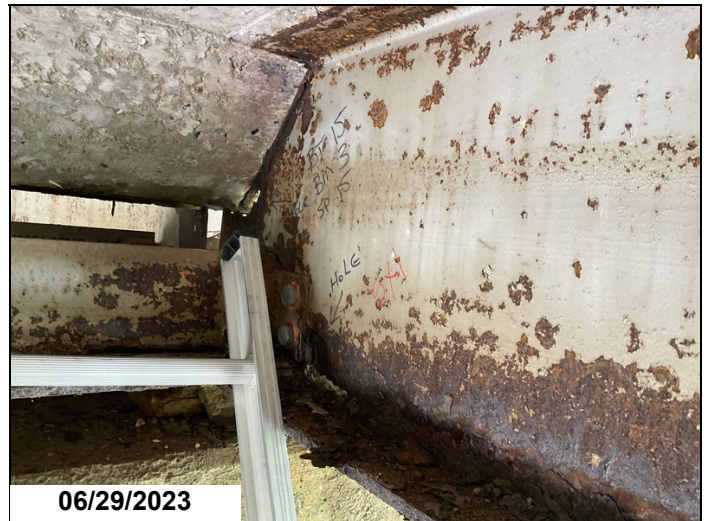
Span 15, bent 15, beam 3: 5"x1" hole in haunch and  
lower web.

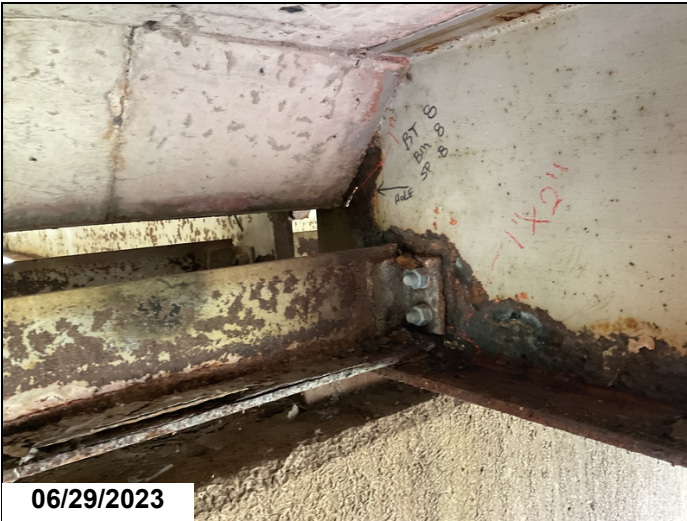
Bent 8, span 8, beam 4: section loss at the beam end with 1"x 2" hole in lower Web 10" from beam end 1" hole in haunch

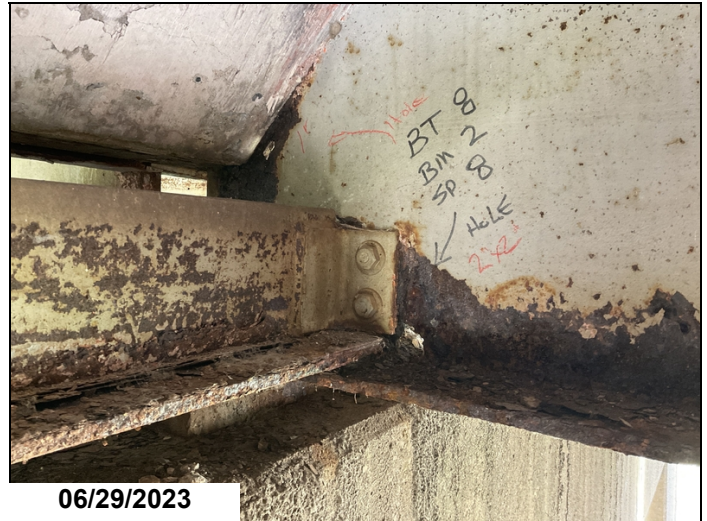
Bent 8, span 8, beam 2: section loss at the beam end with 2"x 2" hole in lower Web 10" from beam end 1" hole in haunch

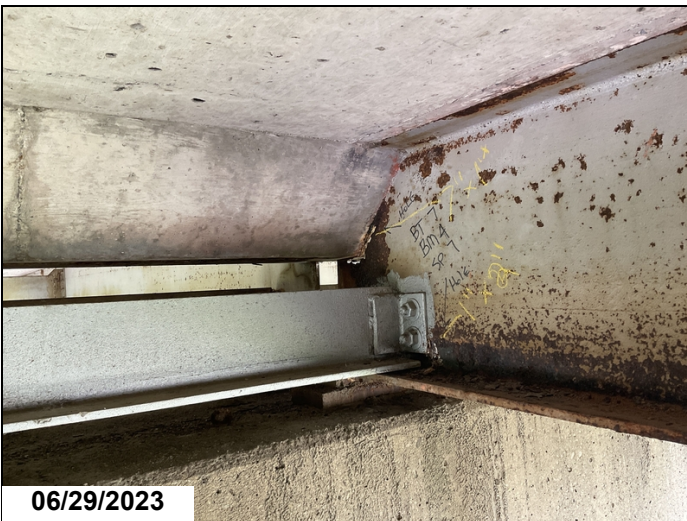
Bent 7, span 7, beam 4: section loss at the beam end with 2"x 1" hole in lower Web 10" from beam end and 7" x 1" hole in haunch

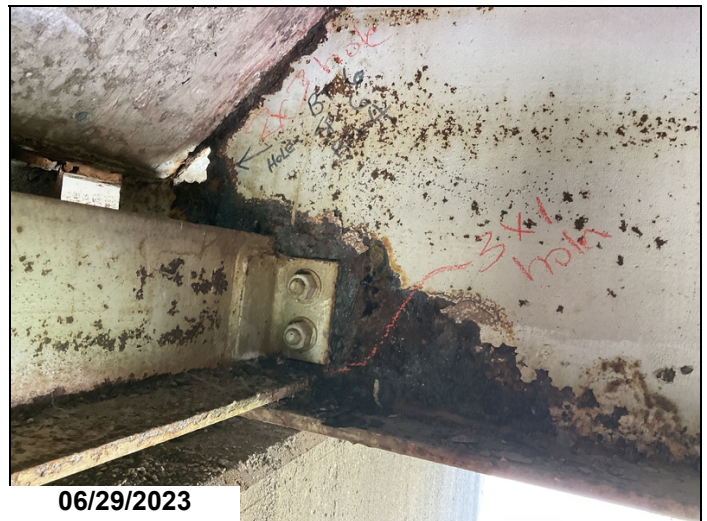
Bent 6, span 6, beam 4: section loss at the beam end with 3"x1" hole in lower Web 10" from beam end and 3"x2" hole in haunch

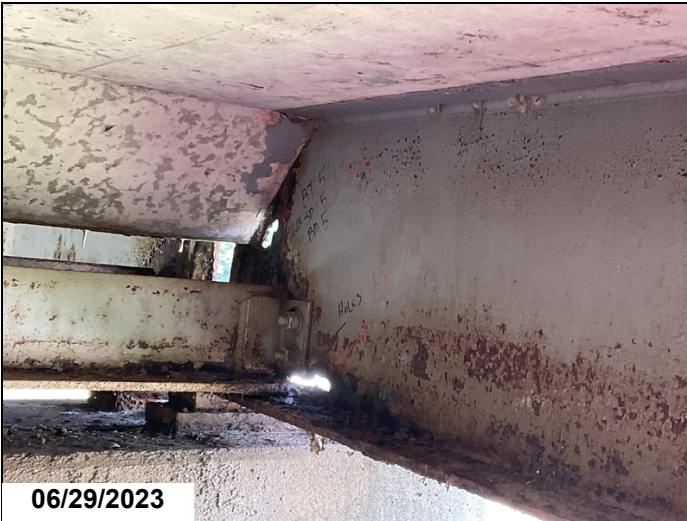
Bent 5, span 5, beam 5: section loss at the beam end with 6"x2" hole in lower web 12" from beam end and 3"x2" hole in haunch

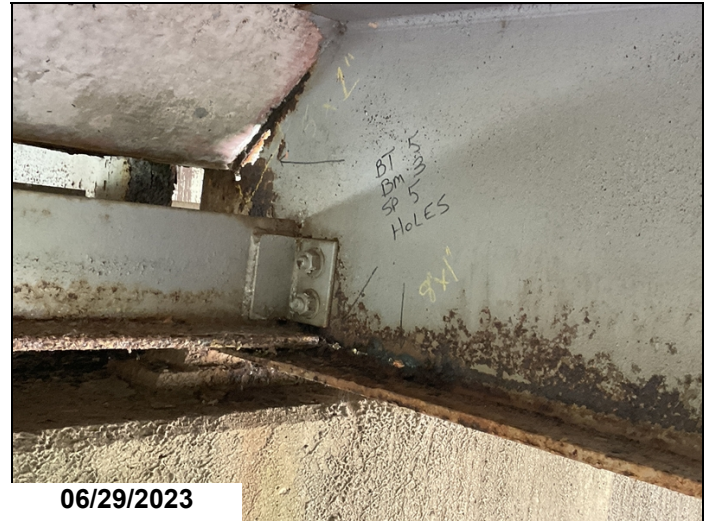
Bent 5, span 5, beam 3: section loss at the beam end with 8"x1" hole in lower web 12" from beam end and 5"x1" hole in haunch

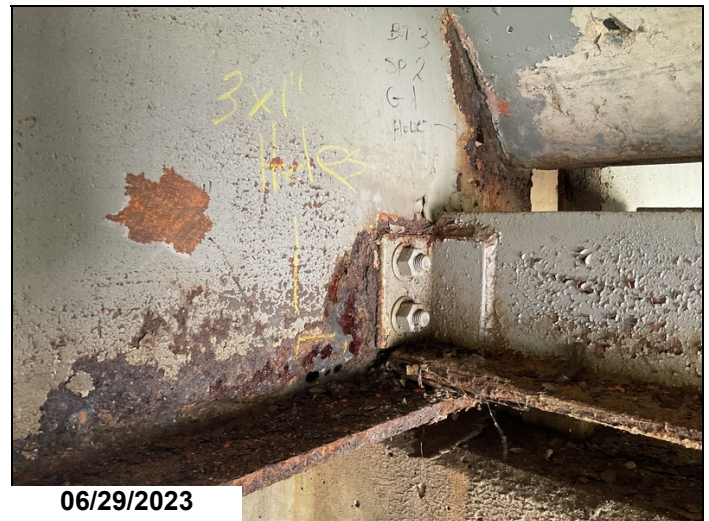
Bent 3, span 2, beam 1: 1-1/2" hole in the web at the haunch. 3"x1" hole in lower web

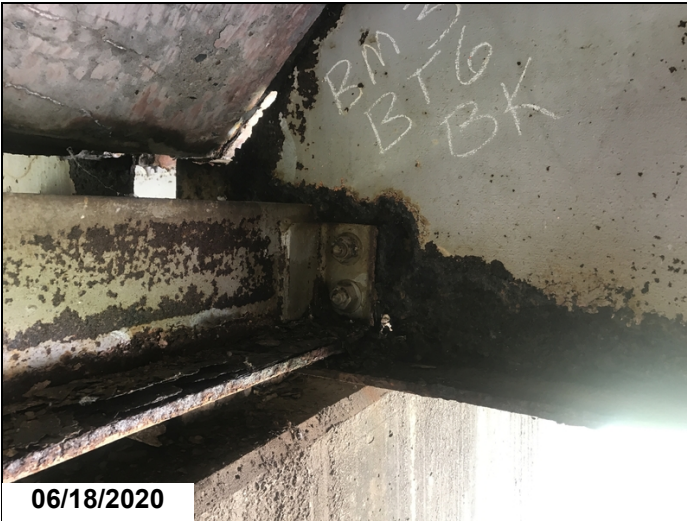
Bent 6 beam 3 holes in the upper and lower web

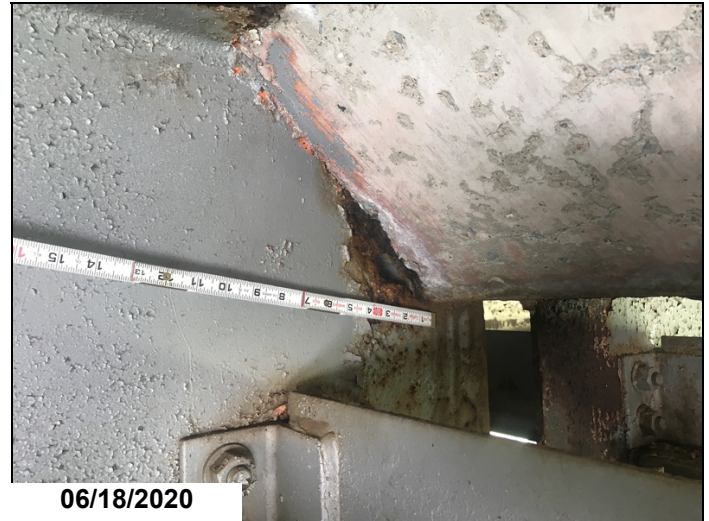
Bent 5 beam 2 back hole in the web.

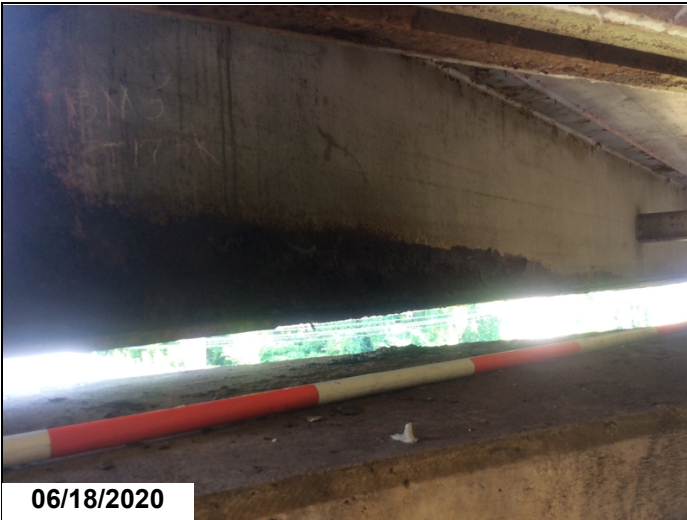
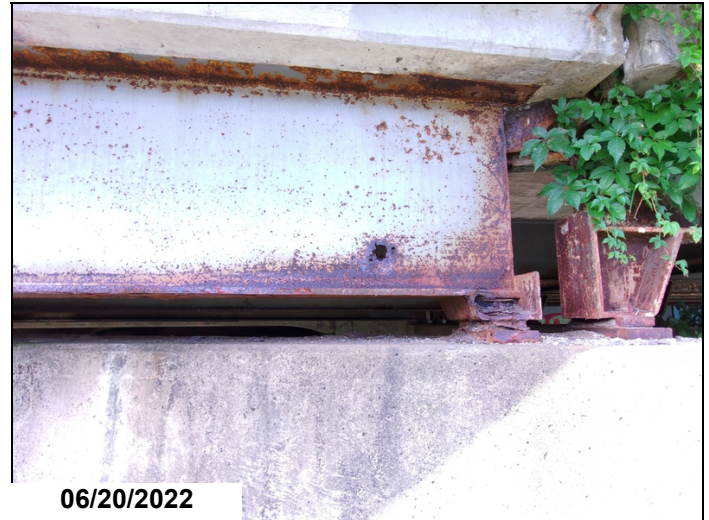
Bent 19, span 19, beam 5: large hole in web.2022

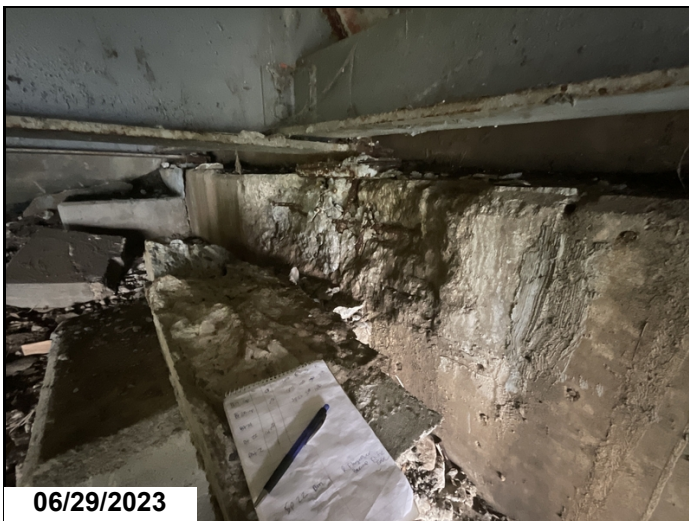
Abutment 2 has a spall under beam 2 with 50% section loss to bearing area.  
Previous repairs under beams 1&3 have delams.

Abutment 2, spall 50% bearing loss area

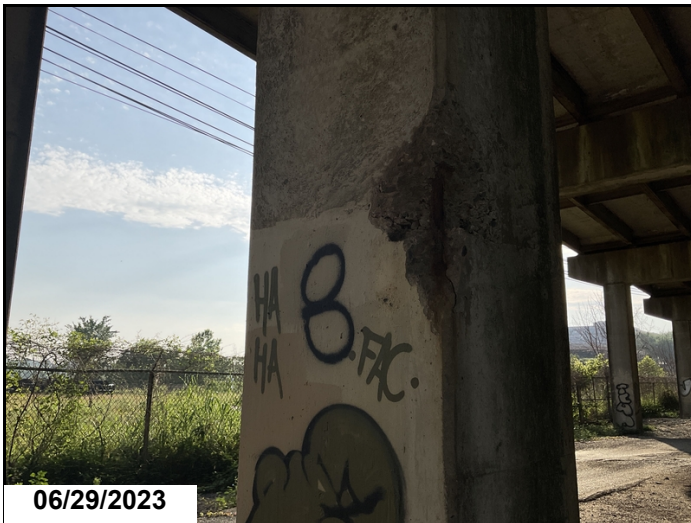
Bent 8 column 1 spall with exposed rebar

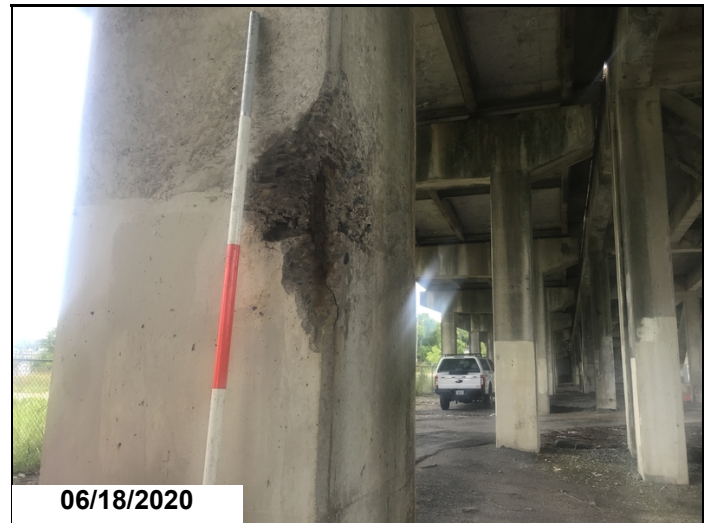
Bent 8 column 2 spall with exposed rebar.

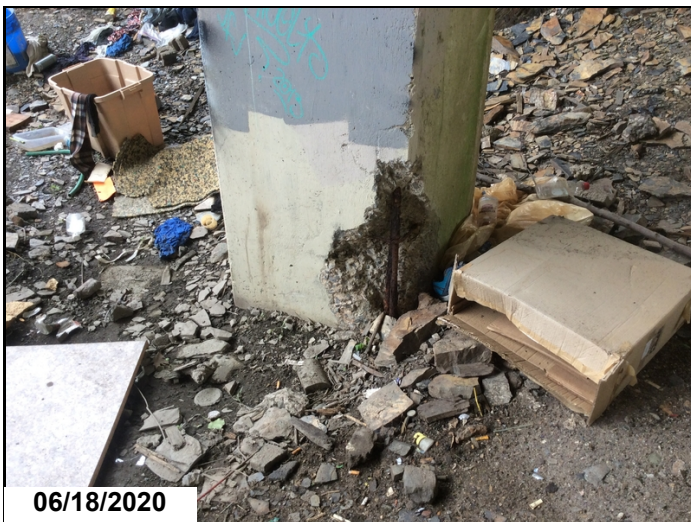
Bent 16 column 1 spall with exposed rebar.

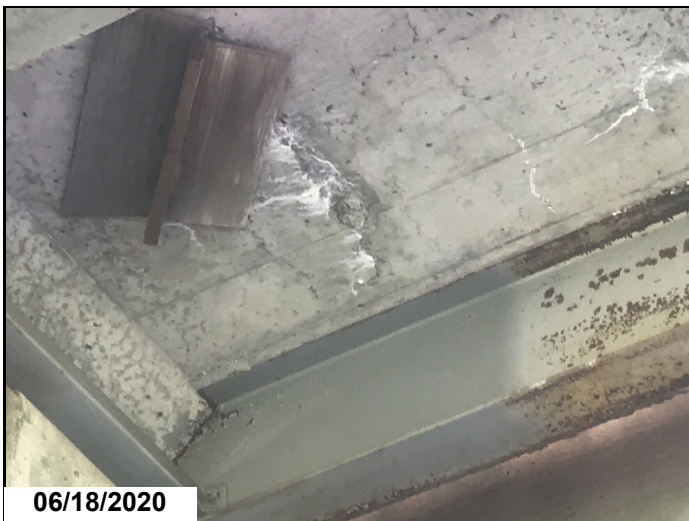
Span 6 soffit between beams 1 & 2 delam.

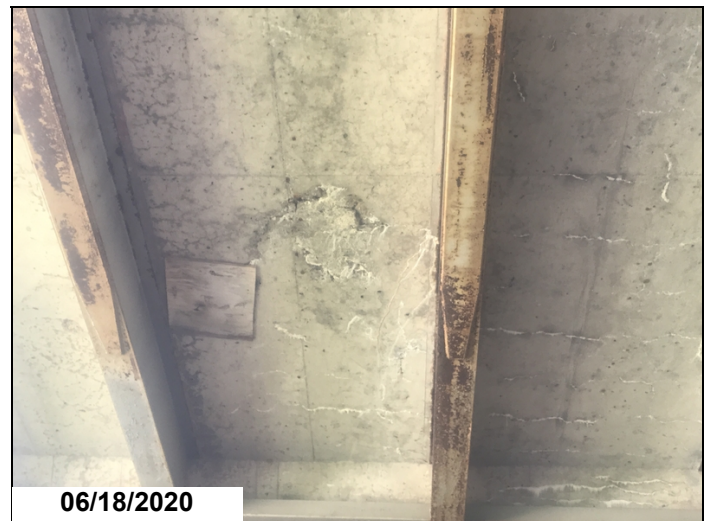
Span 3 soffit between beams 3 & 4 delam.

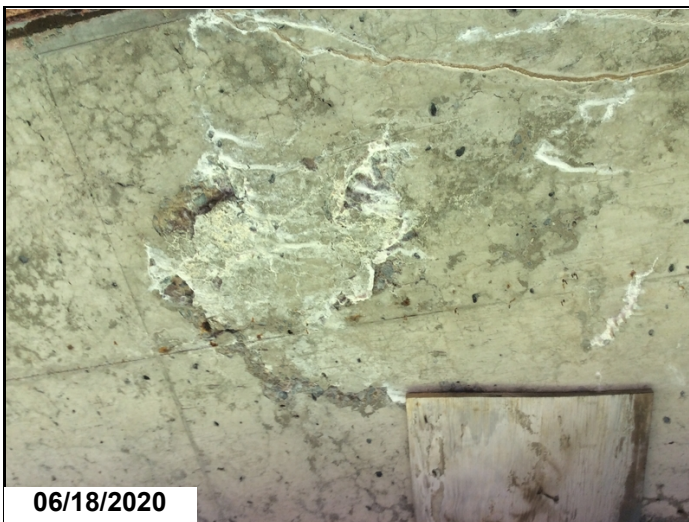
Span 3 soffit between beams 3 & 4 large delamination.

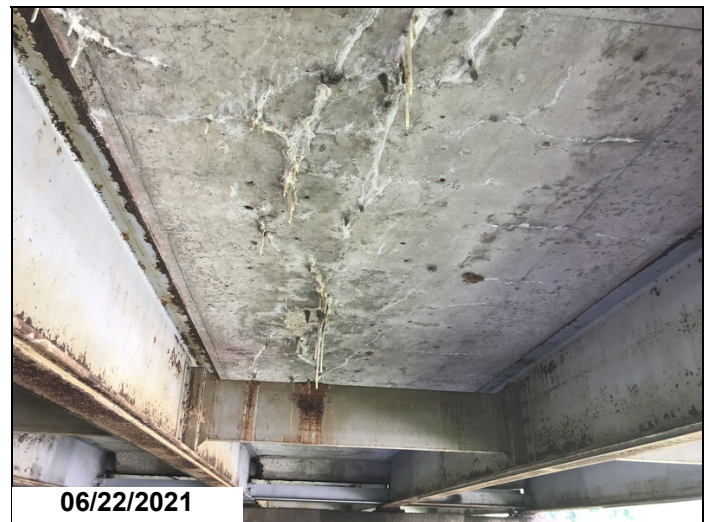
Span 3 soffit between beams 3 & 4 large delamination. Span 6 between beams 1 & 2 delamination.  
Span 4 soffit between beams 3 & 4: heavy amount of cracking and efflorescence build up.

Span 4 soffit between beams 3 & 4.

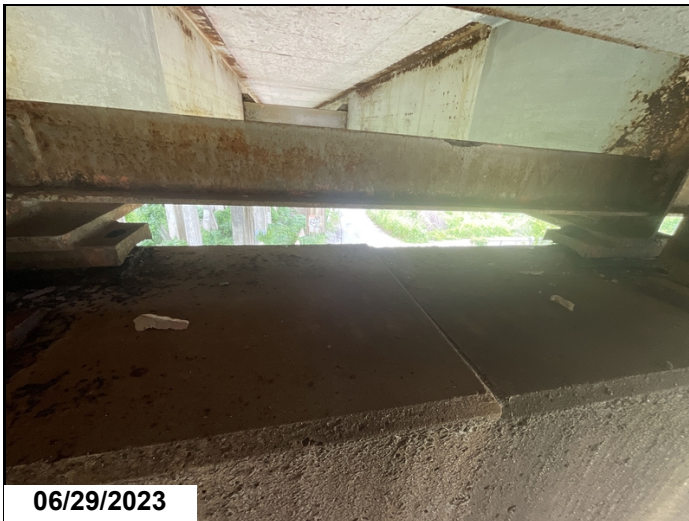
Span 10 at bent 9 anchor bolts missing

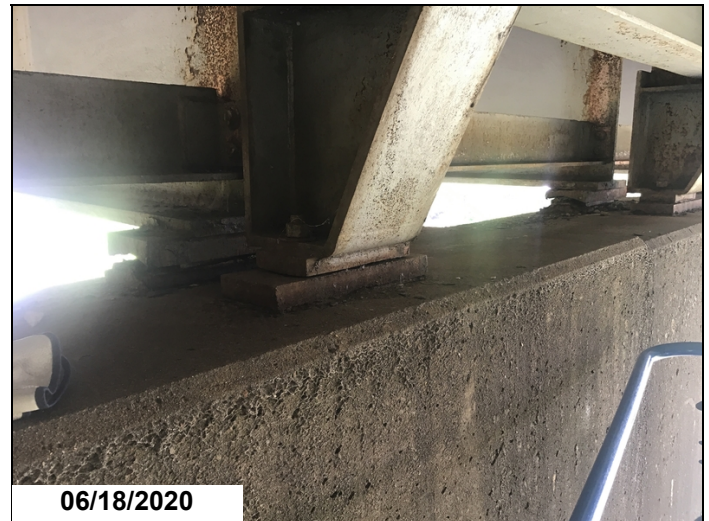
Bent 9 bearing at beams 2 & 3 ahead missing anchor bolts.

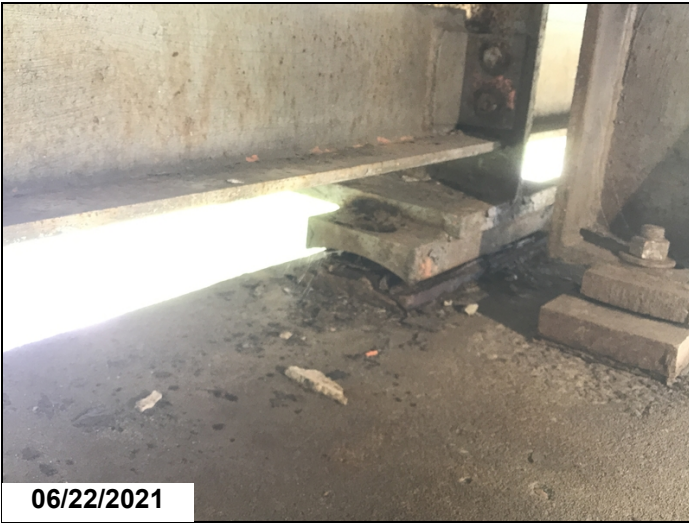
Bent 9, span 10, beam 2: bearing is missing anchor bolts.  
Common to all moveable bearings at this bent

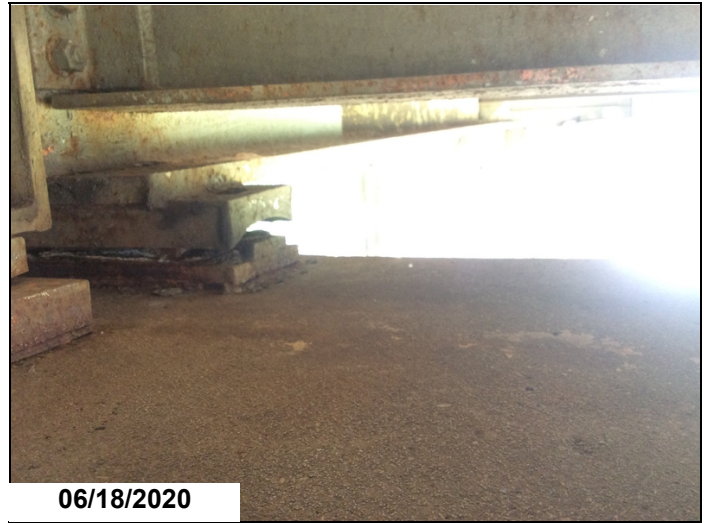
Bent 9 bearings on the ahead side have both anchor bolts rusted out on all five girders. This is typical at bents 10-12 also.

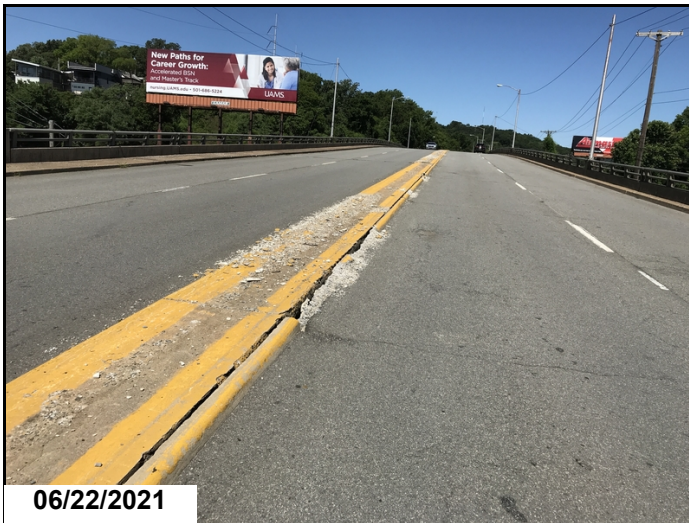
Left side of span 5: curb unit deteriorating in multiple locations.

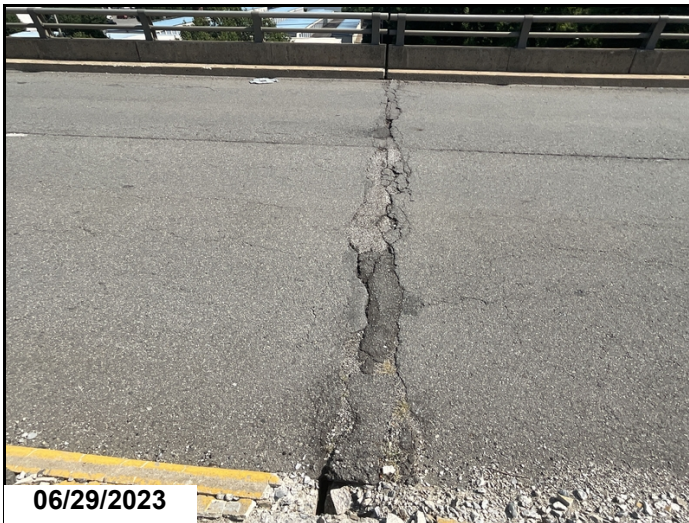
Most joints have spalls in asphalt overlay

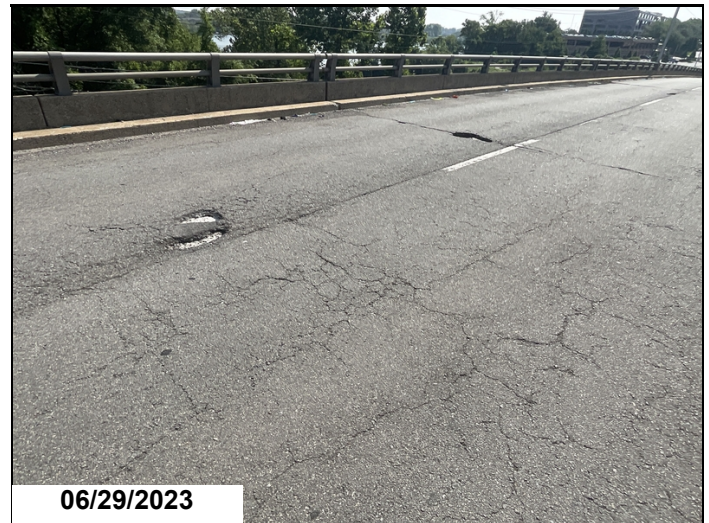
Spalls in asphalt overlay
