Asset #05781(Routine)

US 270- 6 Log 4.93 over WESTINGHOUSE RD, RR

Team Lead: Chris Doggett Inspection Date: 07/24/2023

General Observation

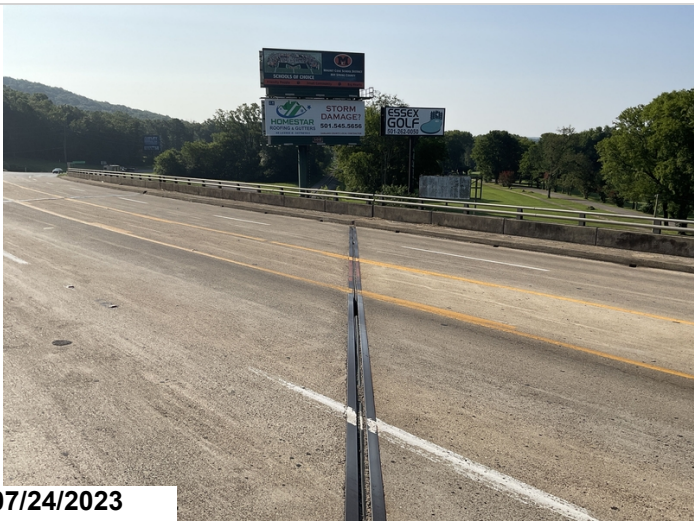
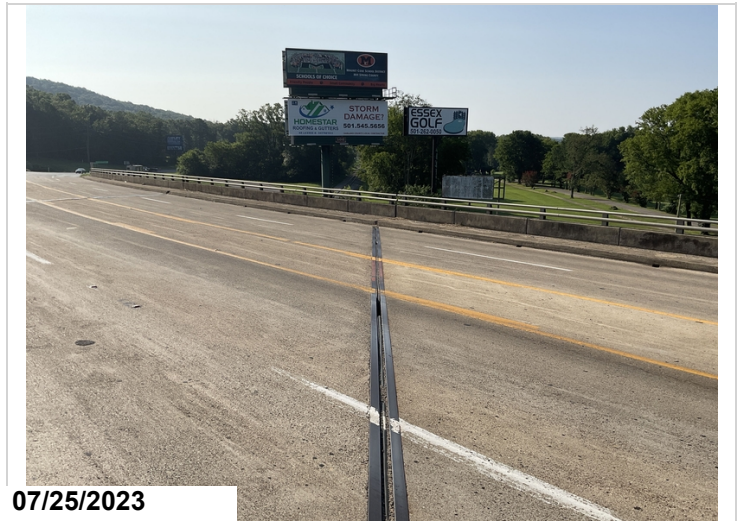
Bent 2: 5' of joint material missing or has lost bond allowing water to freely flow through.

Added routine maintenance to paint entire steel beams.

A-59 - Joint Repair Needed (Yes)

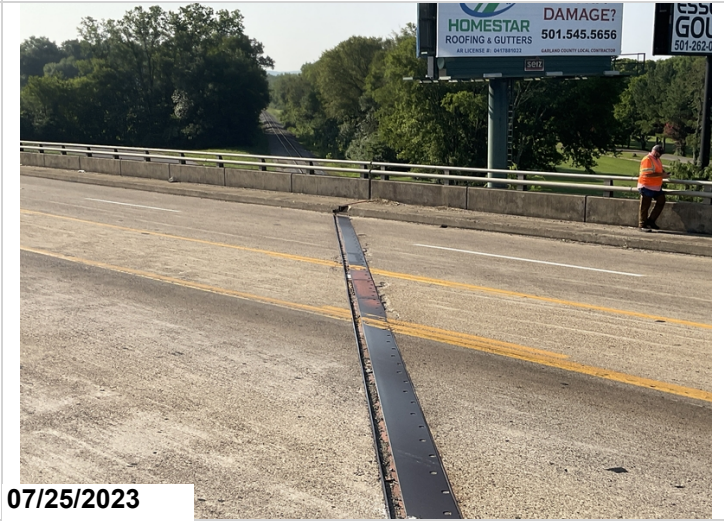
Bent 3: East bound lanes: the assembly joint is loose under traffic

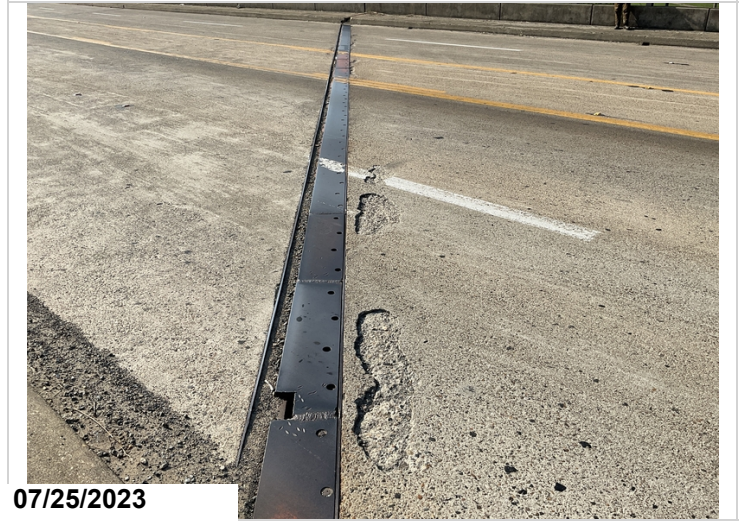
Span 2 , bent 2: multiple spalls adjacent to the joint. Approximately 20sf.

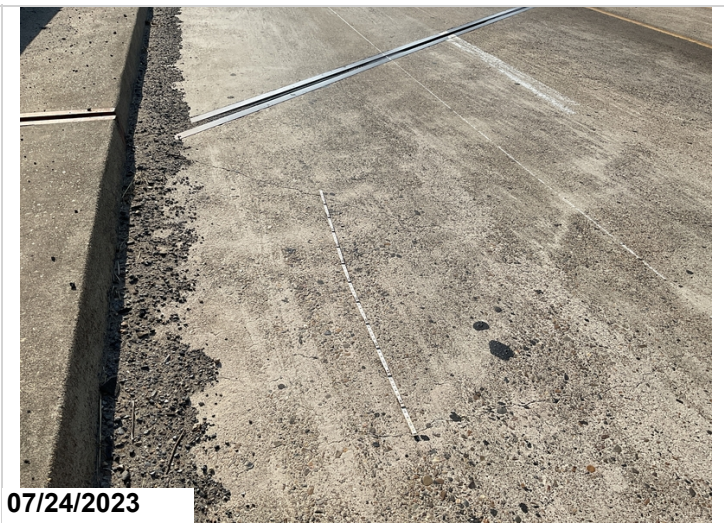
Span 3: large unsealed diagonal and transverse cracking. Average width is 0.030"

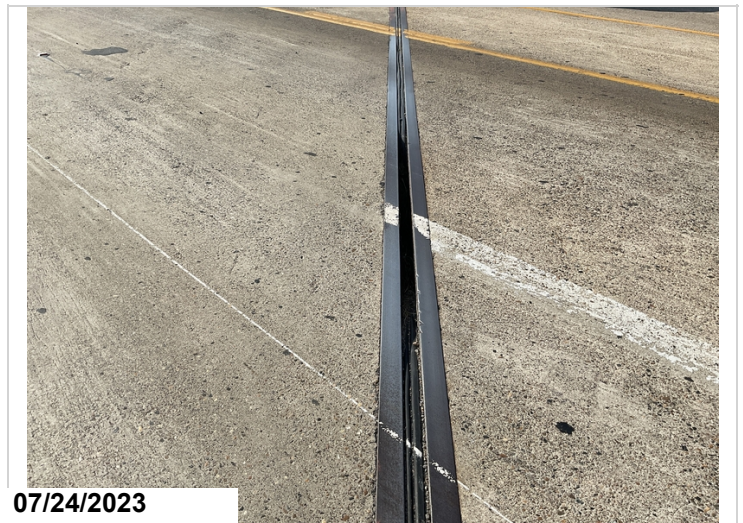
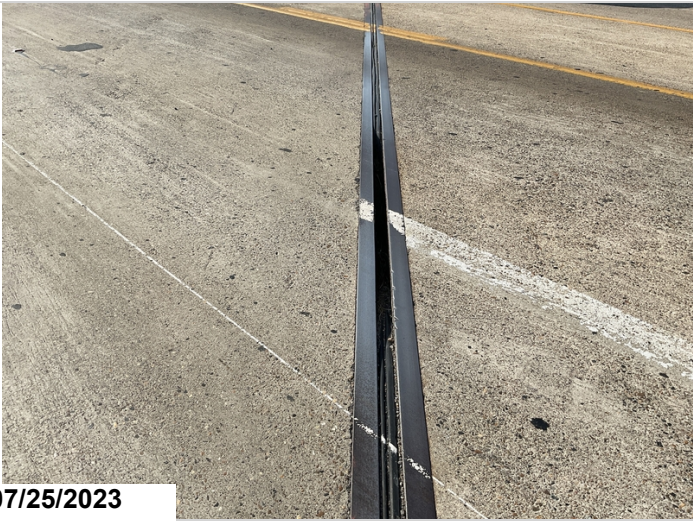
Bent 4: 5' of joint seal has lost it's bond and has dropped out.

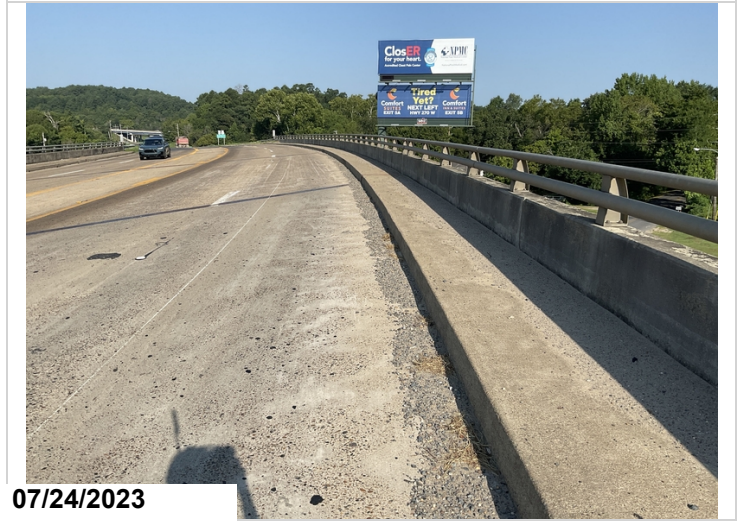
All spans with dirt and debris build up on the shoulders and sidewalk.

A-55 - Deck Washing Needed (Yes)

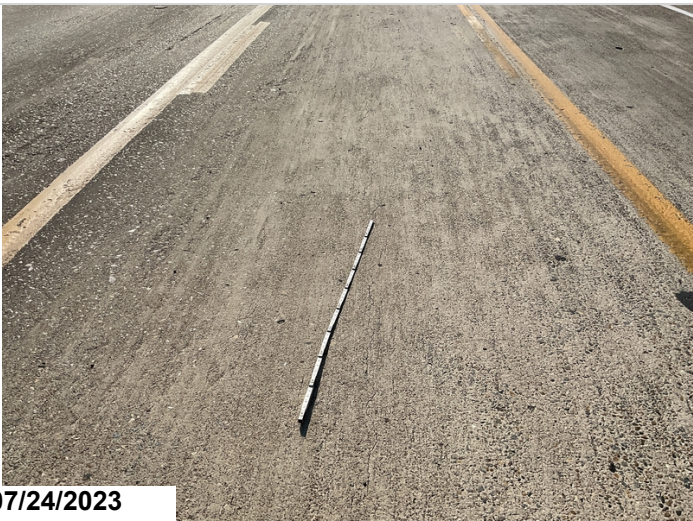
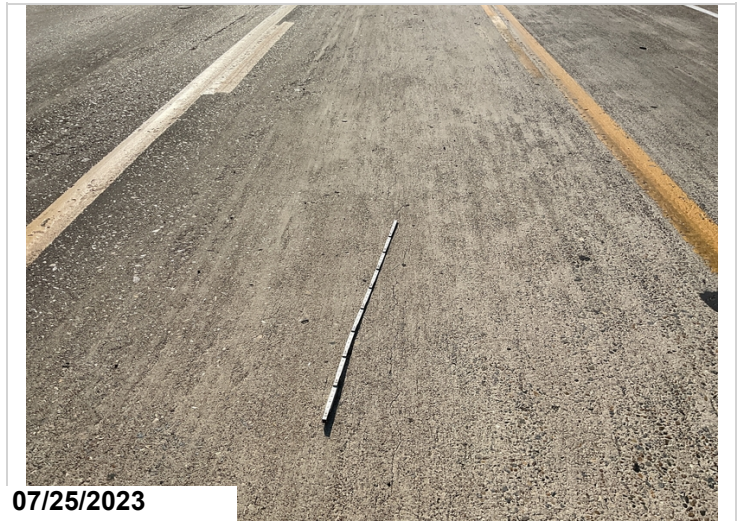
Span 4: multiple longitudinal cracks (0.025")

A-54 - Sealable Deck Cracks (Yes)

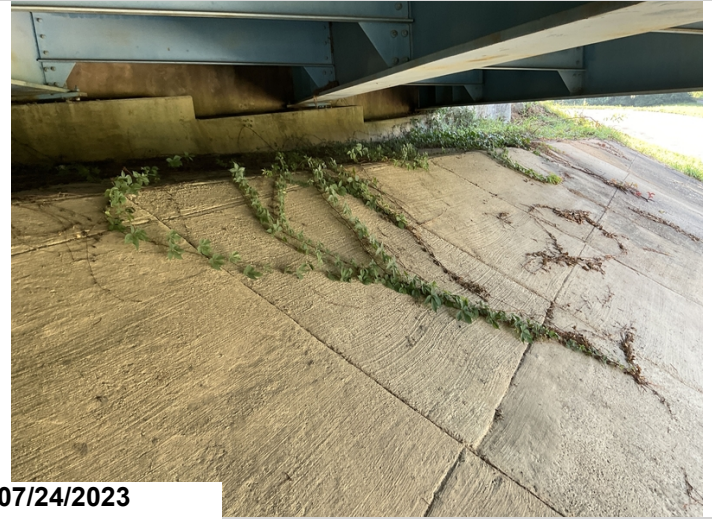
Vines at bent 5.

A-64 - Vegetation Removal Requested (Yes)

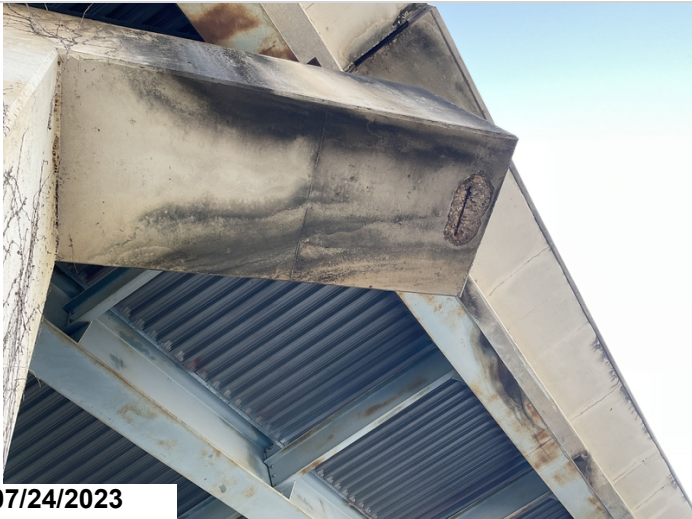
ELEMENTS	DESCRIPTION	UNITS	TOTAL	CS1	CS2	CS3	CS4
(234) Bent 2 cap has a delam on the back side. Bent 4 cap has 1 spall with exposed rebar. Debris buildup on caps due to leaking joints.							
302	Compression Joint Seal	LF	328	0	318	0	10
2320	Seal Adhesion	LF	328	0	318	0	10
(302) Bents 2 and 4 have sections of the seal that has lost bond and has dropped out allow water to freely flow. The remainder of all seals leak,							
303	Assembly Joint with Seal	LF	82	30	30	22	0
2350	Debris Impaction	LF	30	0	30	0	0
2370	Metal Deterioration or Damage	LF	44	22	0	22	0
(303) Debris build up in the center and westbound lanes. The joint is loose at bent 3, outside westbound lane.							
310	Elastomeric Bearing	EA	56	0	56	0	0
1000	Corrosion	EA	56	0	56	0	0
(310) All bearings have minor corrosion.							
330	Metal Bridge Railing	LF	646	646	0	0	0
331	Reinforced Concrete Bridge Railing	LF	646	646	0	0	0

Bent 4: bottom of cap spalled with exposed rebar. (1'x8")

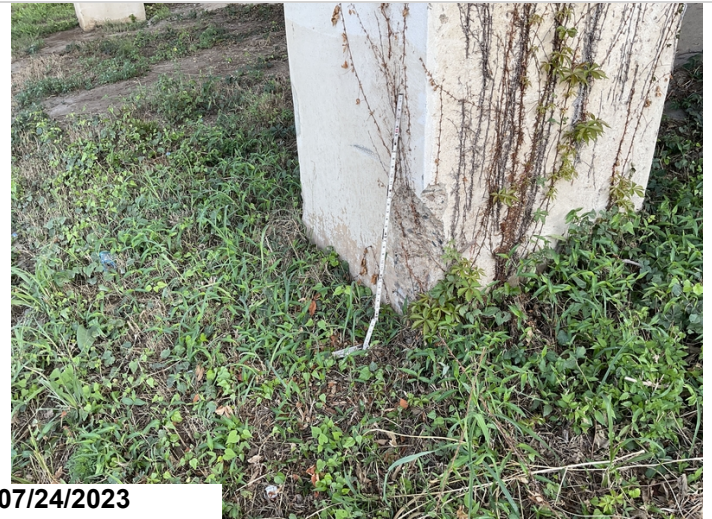
(205) Bent 4 column 3 has a large spall and two small spalls that have been patched							
210	Reinforced Concrete Pier Wall	LF	60	53	5	2	0
1090	Exposed Rebar	LF	2	0	0	2	0
1130	Cracking (RC and Other)	LF	5	0	5	0	0

Bent 4, column 3: spall to the bottom of column. (1'4" x 11")

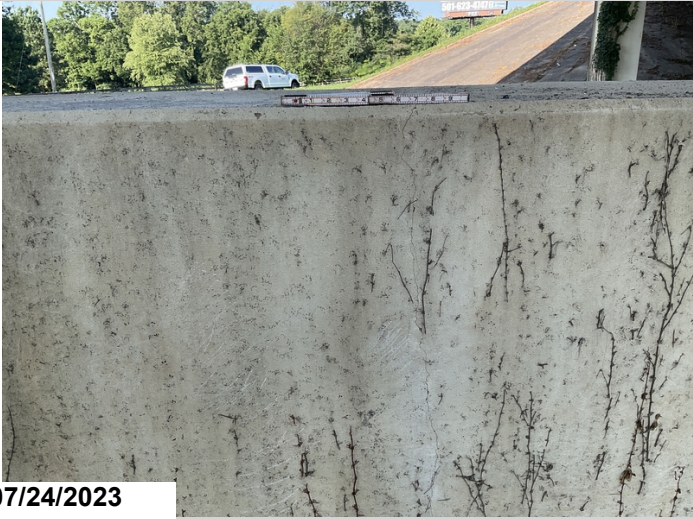
Bent 3: pier wall with couple full height vertical cracks up to 0.016"

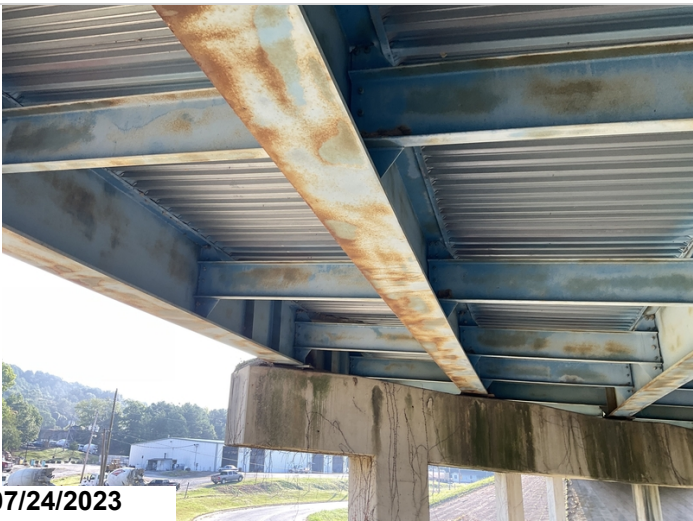
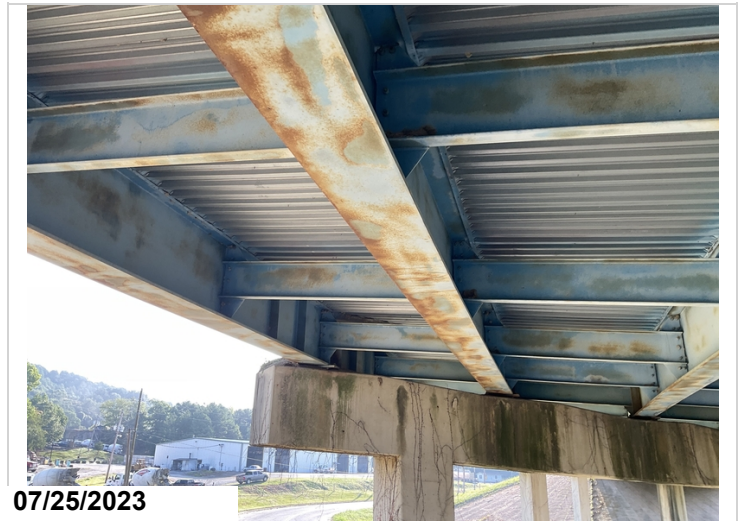
Chalking paint and freckled rust on all beams.

Span 1, girder 2: bottom flange with freckled rust.
2023

A-60 - Full Girder Painting Needed (Yes)

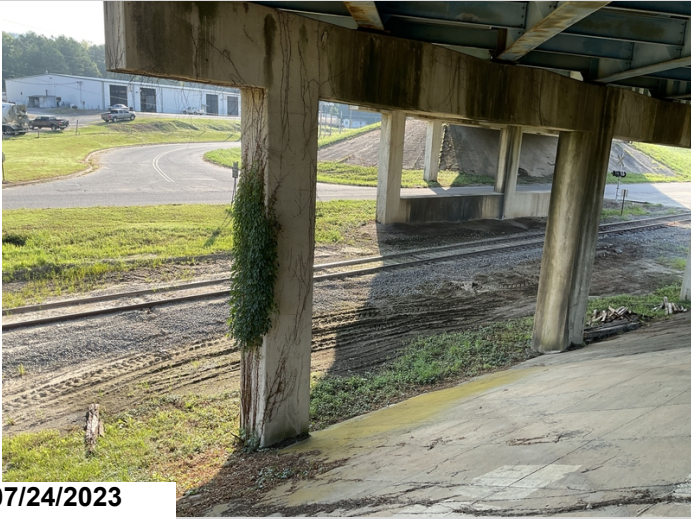
Bent 2, column 1: vines climbing up column.

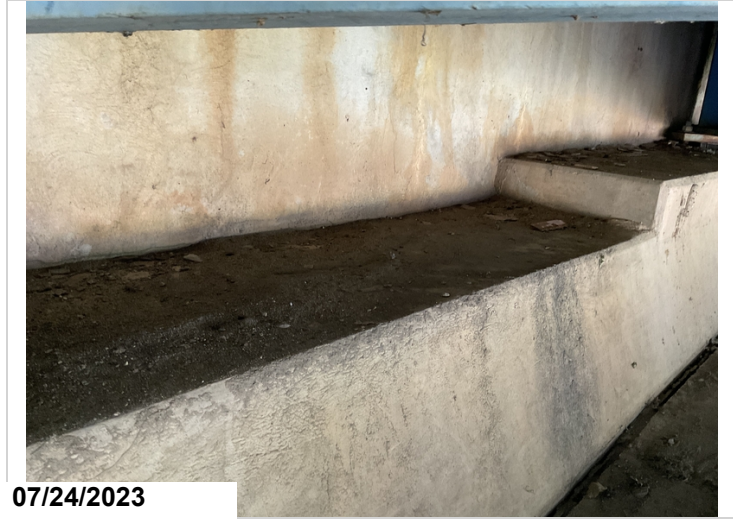
Bent 1: beam seat has dirt and debris

A-58 - Cap Cleaning/Flushing Needed (Yes)

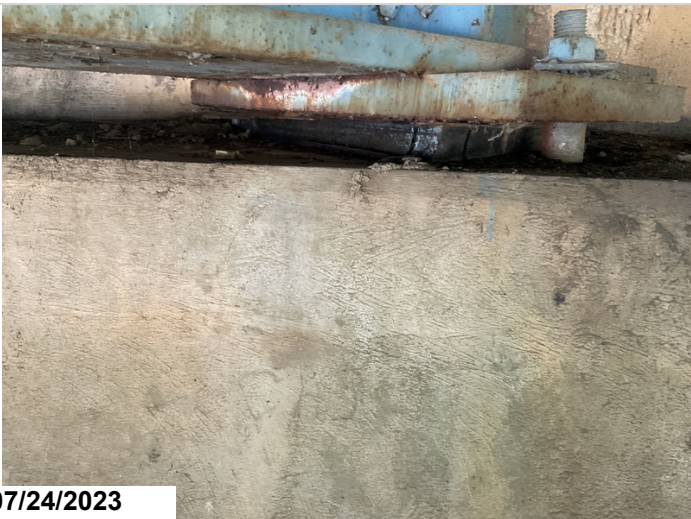
Bent 1, girder 6: active corrosion to all bearings is common throughout.

A-57 - Girder End and Bearing Painting Needed (Yes)

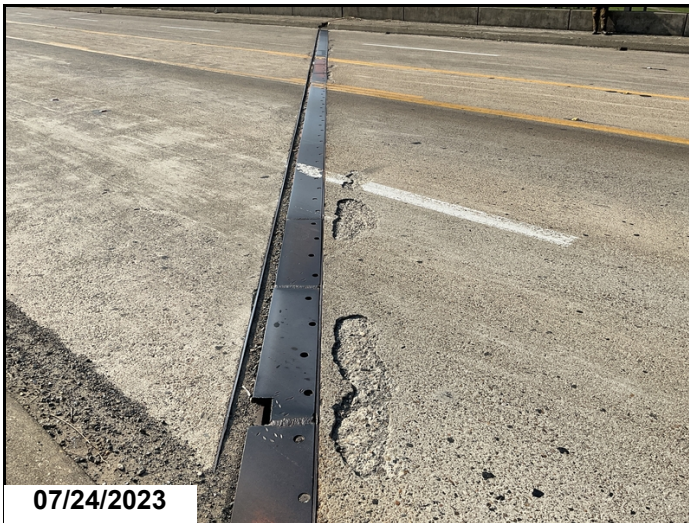
Deck span 2 has scattered spalls.

Span 2 , bent 2: multiple spalls adjacent to the joint.
Approximately 20sf.

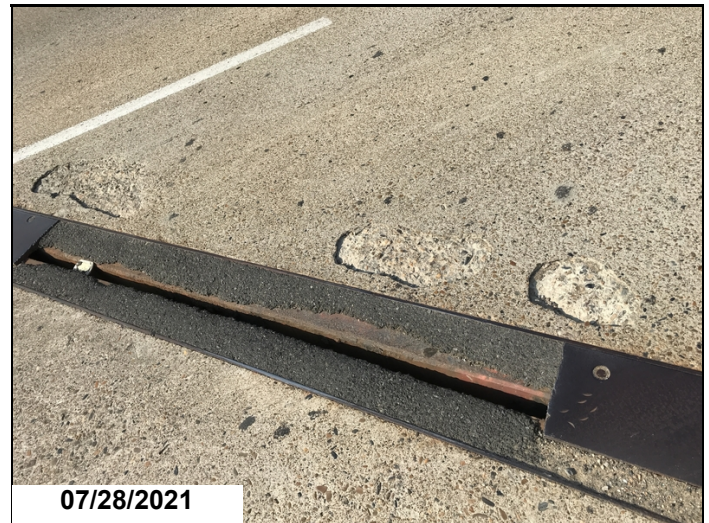
Deck span 2 at bent 3 has spalls.

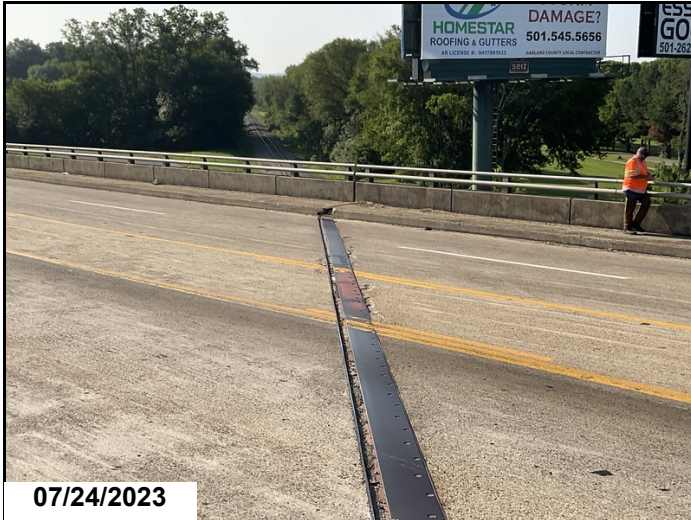
Bent 3: missing joint seal has been repaired.

State forces have repaired the missing joint armor.

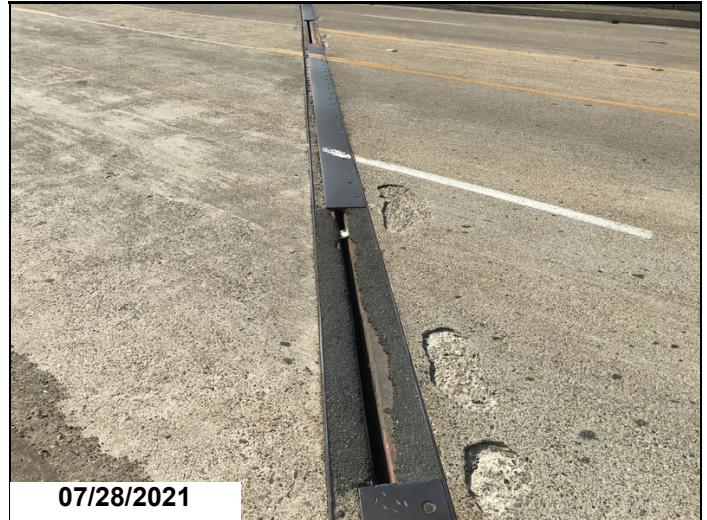
Bent 3 approx. 22 foot of joint armor missing.

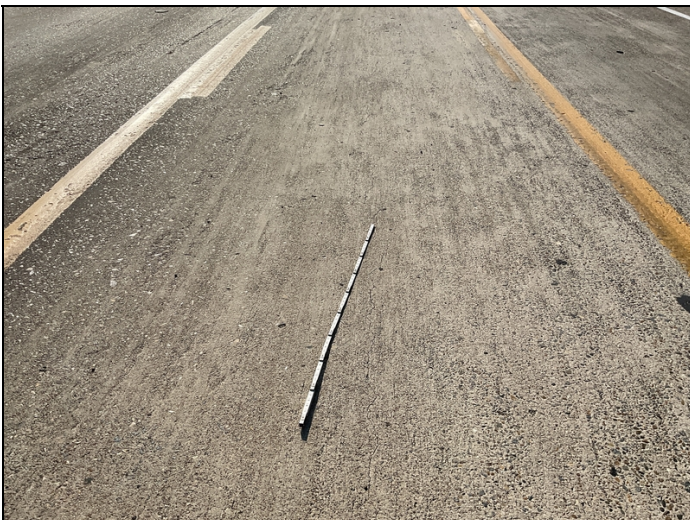
Span 4: multiple longitudinal cracks (0.025")

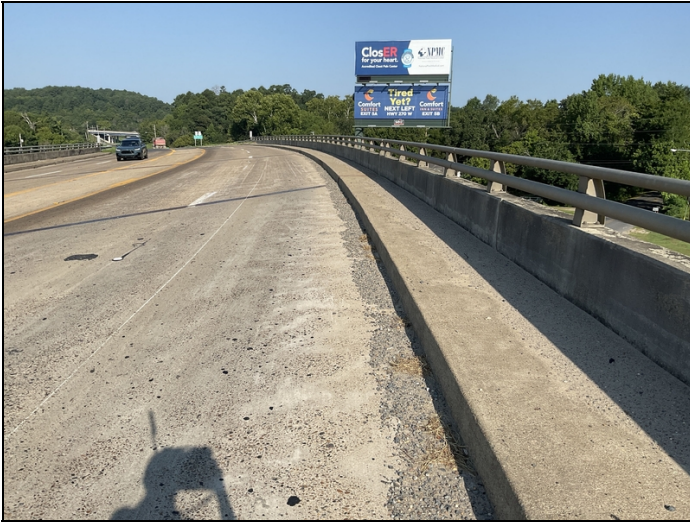
All spans with dirt and debris build up on the shoulders and sidewalk.

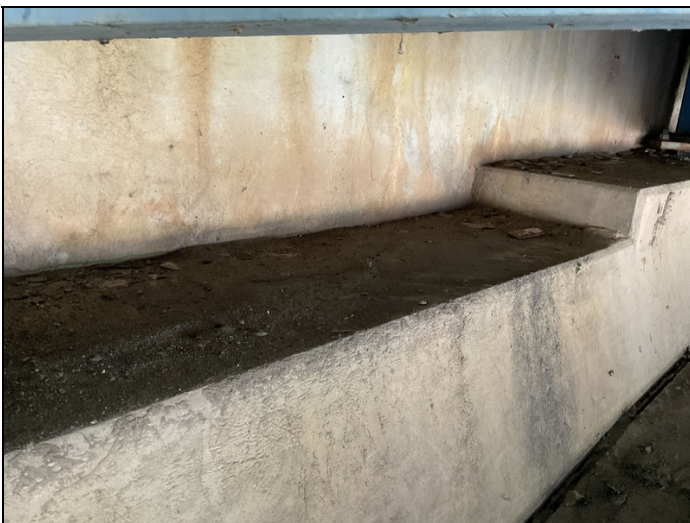
Bent 1: beam seat has dirt and debris

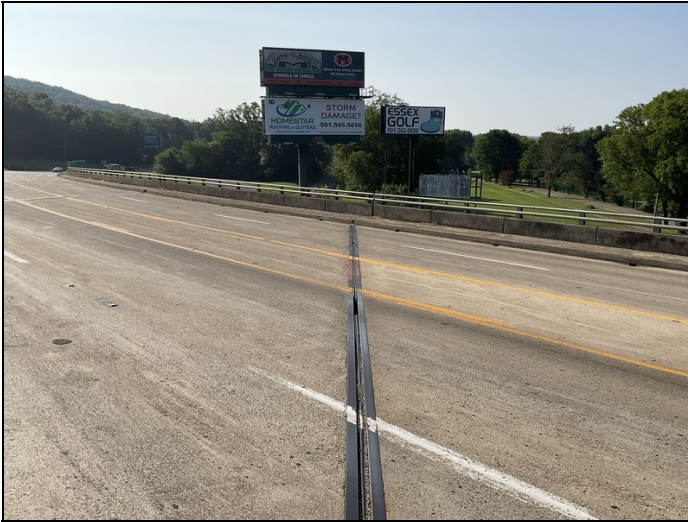
Bent 2: 5' of joint material missing or has lost bond allowing water to freely flow through.

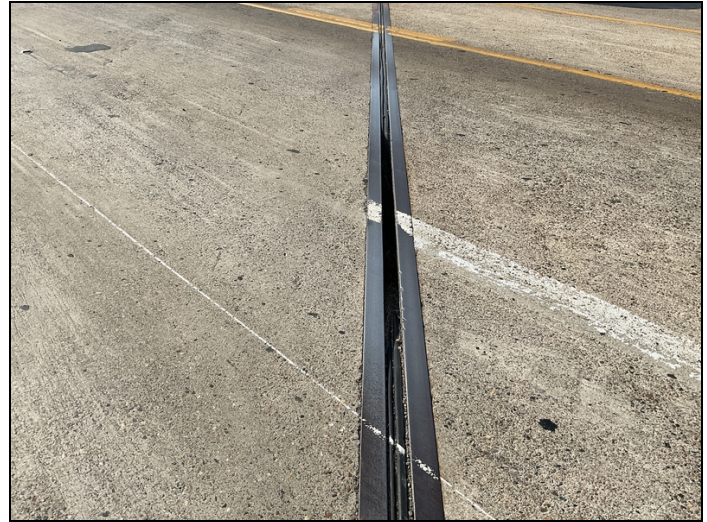
Bent 4: 5' of joint seal has lost it's bond and has dropped out.

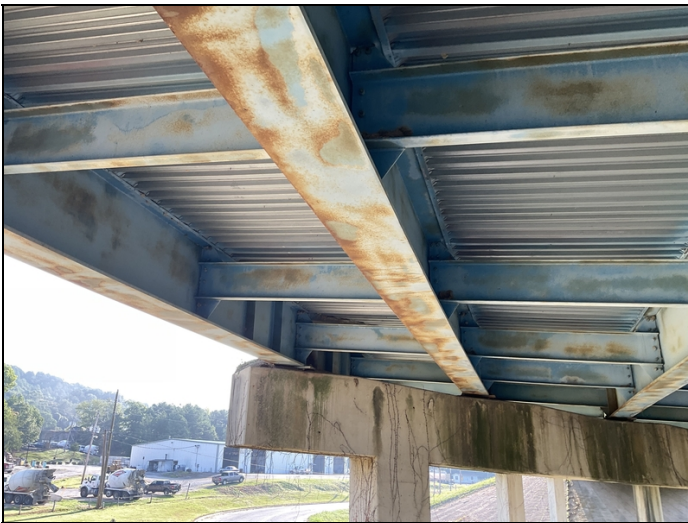
Span 1, girder 2: bottom flange with freckled rust.
2023

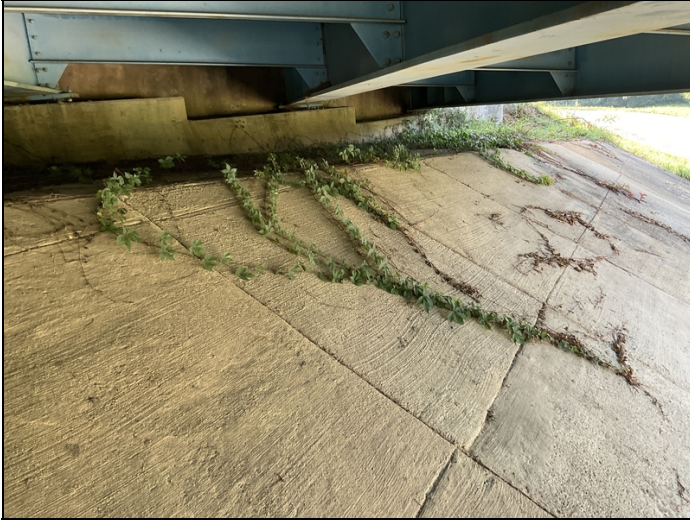
Vines at bent 5.

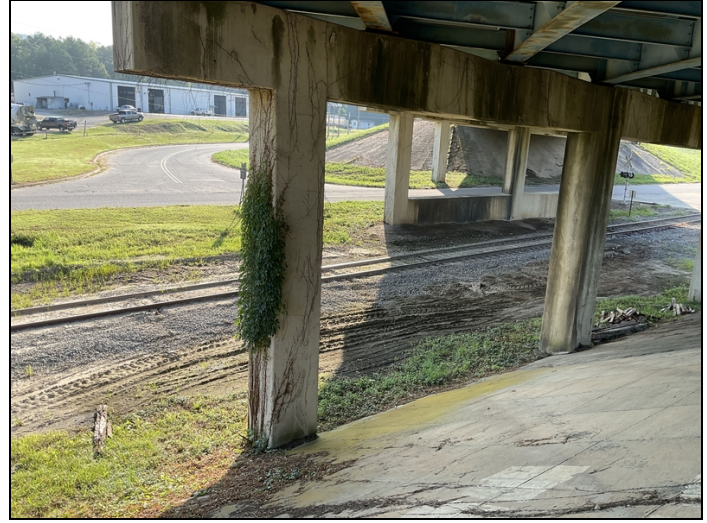
Bent 2, column 1: vines climbing up column.
