Asset #05811(Routine, Underwater type 2)

SH 300 Log 12.80 over MILL BAYOU

Location: 7.5 MI NO SH 10 JCT

Team Lead: Bryan Saunders Inspection Date: 02/10/2022

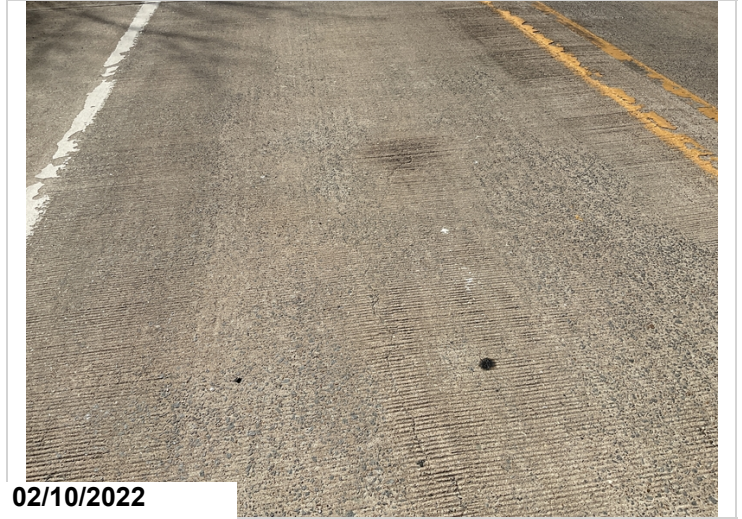
(38) Deck has small unsealed cracks. Span 1 approximately 5' from bent 1 has a small spall.							
215	Reinforced Concrete Abutment	LF	83	55	28	0	0
1130	Cracking (RC and Other)	LF	28	0	28	0	0

Deck cracks in span 1

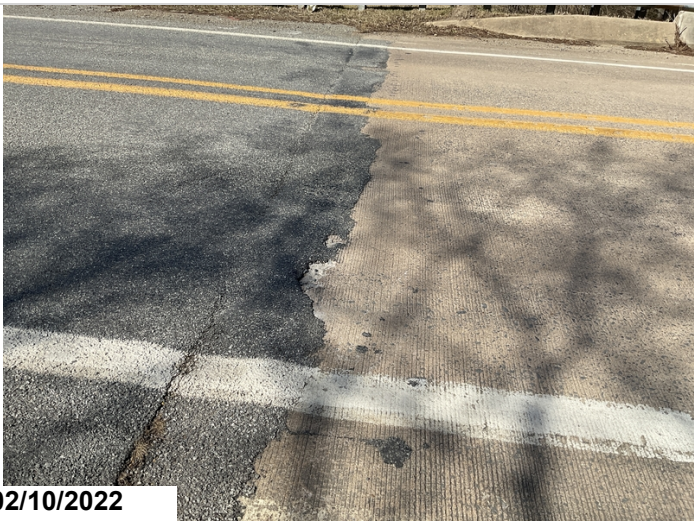
(321) Both approach slabs have scattered cracks and the east approach slab has a small spall that has been filled with asphalt							
331	Reinforced Concrete Bridge Railing	LF	280	280	0	0	0

Small spall at east approach slab is half full of asphalt

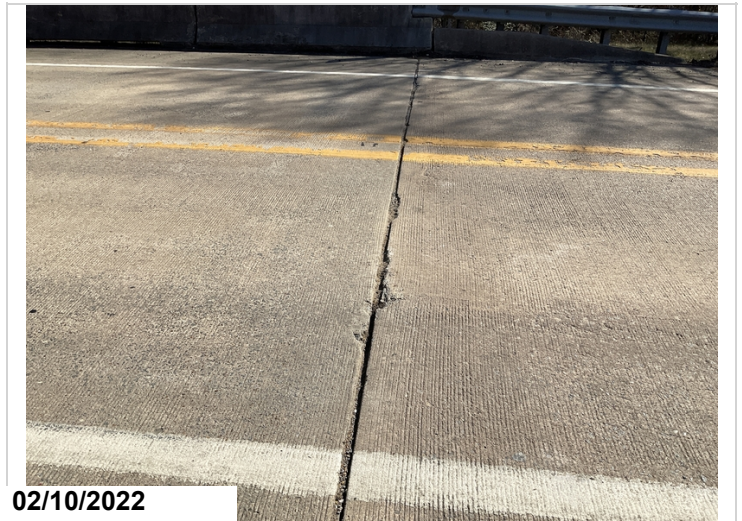
(301) Joint at bent 1 has 12' of missing and leaking joint Joint seal at bent 5 is missing in both lanes and is full of debris							
321	Reinforced Concrete Approach Slab	SF	1050	968	65	17	0
1080	Delamination/Spall/Patched Area	SF	2	0	0	2	0
1130	Cracking (RC and Other)	SF	80	0	65	15	0

Joint at bent 5

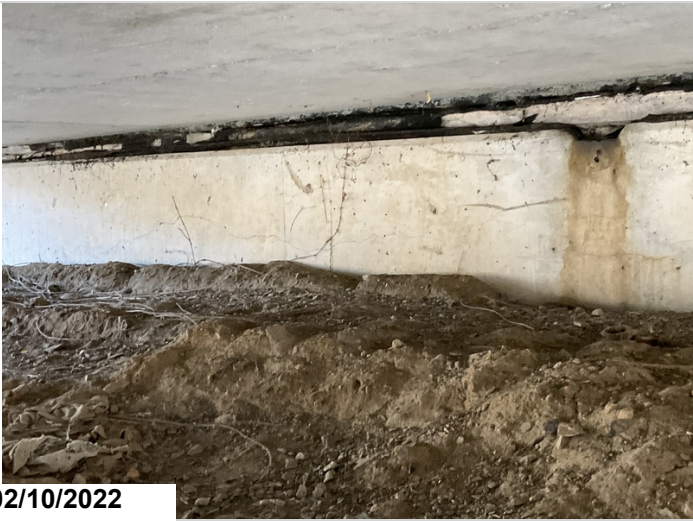
(215) Bent 1 abutment has horizontal crack on the right hand side							
227	Reinforced Concrete Pile	EA	21	18	3	0	0
1080	Delamination/Spall/Patched Area	EA	3	0	3	0	0
234	Reinforced Concrete Pier Cap	LF	105	105	0	0	0
301	Pourable Joint Seal	LF	175	55	70	50	0
2310	Leakage	LF	120	0	70	50	0

Horizontal crack at bent 1 abutment

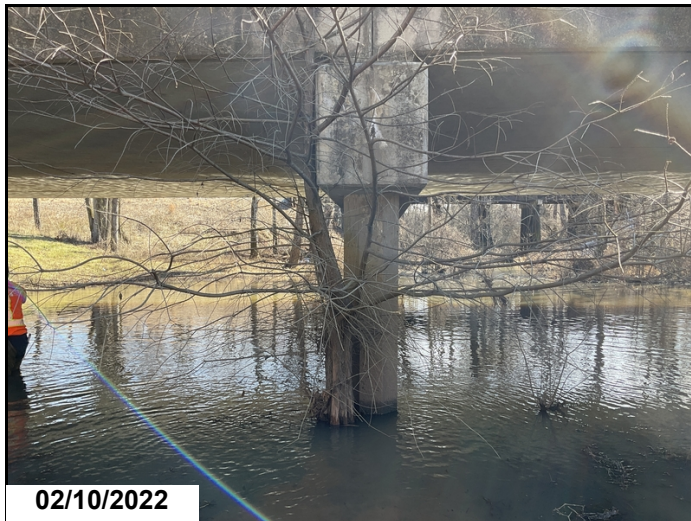
large tree growing at bent 3

Tree growing at bent 3

**Type of Work:** (Inactive) (Inactive) 1 - Clean
