Asset #05812(Routine)

SH 300 Log 16.96 over BIG MAUMELLE RIVER

Location: 3.3 MI N JCT SH 10

Team Lead: Bryan Saunders Inspection Date: 02/14/2022

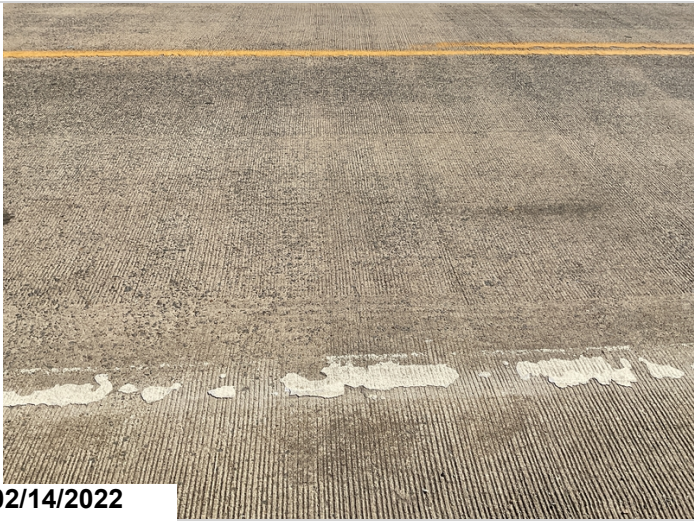
(12) deck has scattered unsealed cracks							
107	Steel Open Girder/Beam	LF	1375	1320	0	55	0
1000	Corrosion	LF	55	0	0	55	0
515	Steel Protective Coating	SF	10255	0	10200	55	0
3430	Oxide Film Degradation Color/Texture Adherence(Steel Protective Coatings)	LF	10255	0	10200	55	0

Deck cracks in span 5

A-54 - Sealable Deck Cracks

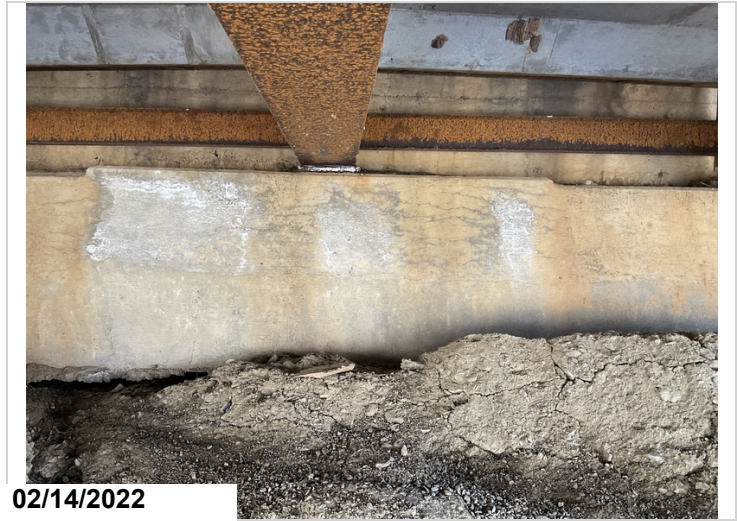
(215) Bent 6: the entire length of the beam seat is map cracked							
234	Reinforced Concrete Pier Cap	LF	128	102	26	0	0
1080	Delamination/Spall/Patched Area	LF	5	0	5	0	0
1090	Exposed Rebar	LF	1	0	1	0	0
1130	Cracking (RC and Other)	LF	20	0	20	0	0

Map cracks in the abutment at bent 6

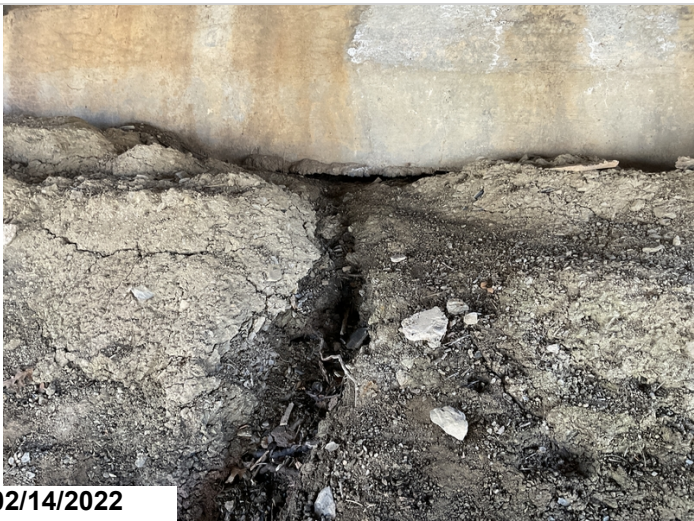
Erosion at bent 6 between girder 2 and 3

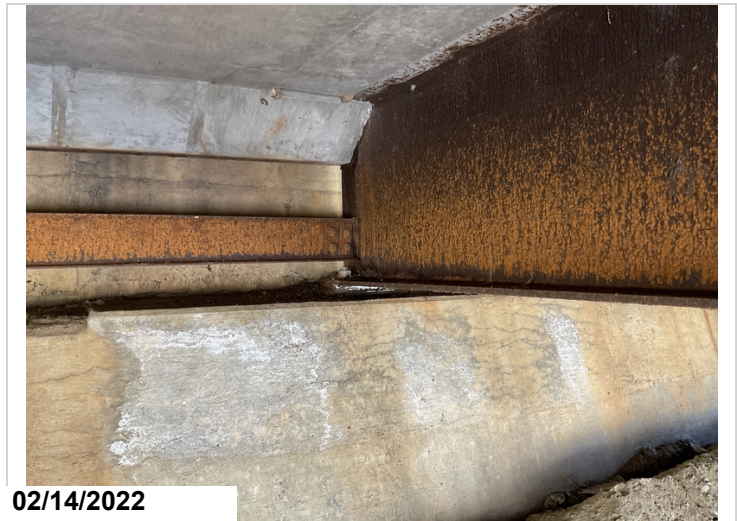
(313) Bearings at both abutments have corrosion and flaking rust

Bent 6 girder 3 bearing has corrosion and laminated rust

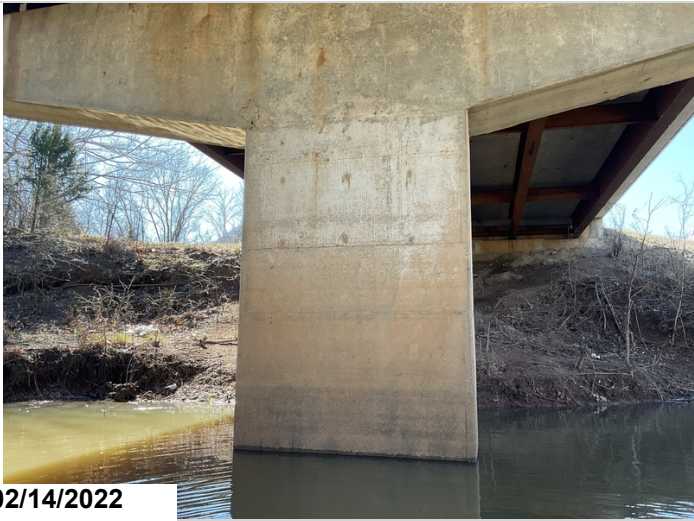
Bent 5 backside has large cracks and delamination

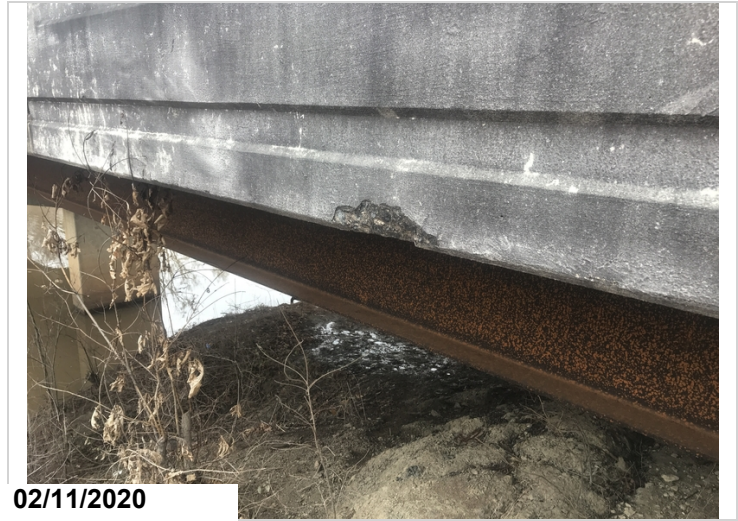
Span 5, right edge, spall.

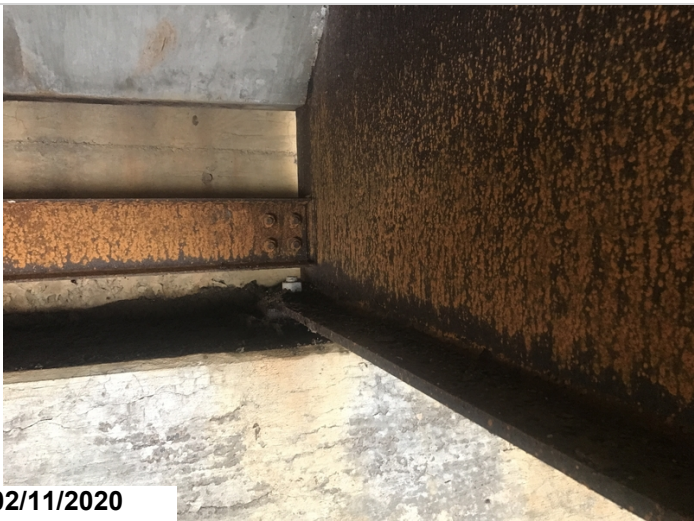
(107) Beam ends at both abutments have flaking rust to the lower flanges and upper webs. The beams ends at the interior bents have small areas of flaking rust in the upper web at haunch. due to leaking joints							
(515-107) laminating rust at beam ends at both abutments							
205	Reinforced Concrete Column	EA	4	0	4	0	0
1130	Cracking (RC and Other)	EA	4	0	4	0	0

Bt. 6, Bm. 3, bottom flange & web around hothead haunch has corrosion.

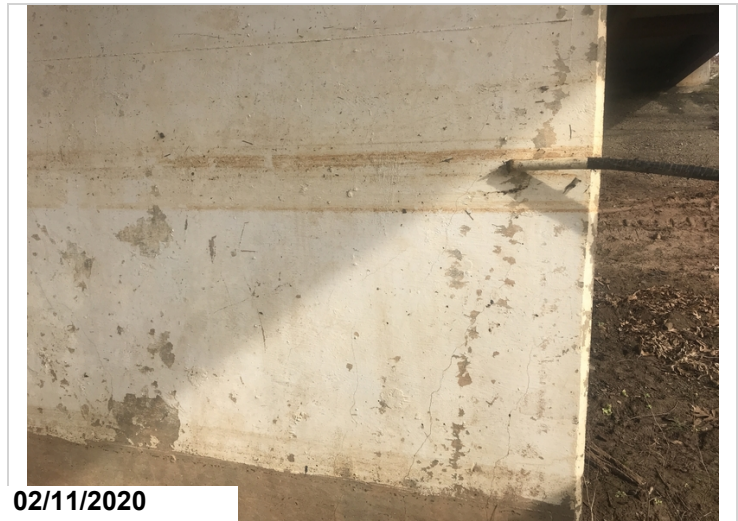
(205) The columns of bents 2, 3, 4 and 5 have small scattered cracks on the sides and faces.							
215	Reinforced Concrete Abutment	LF	82	32	50	0	0
1130	Cracking (RC and Other)	LF	50	0	50	0	0

Bt. 2 column, cracks up to 0.015"

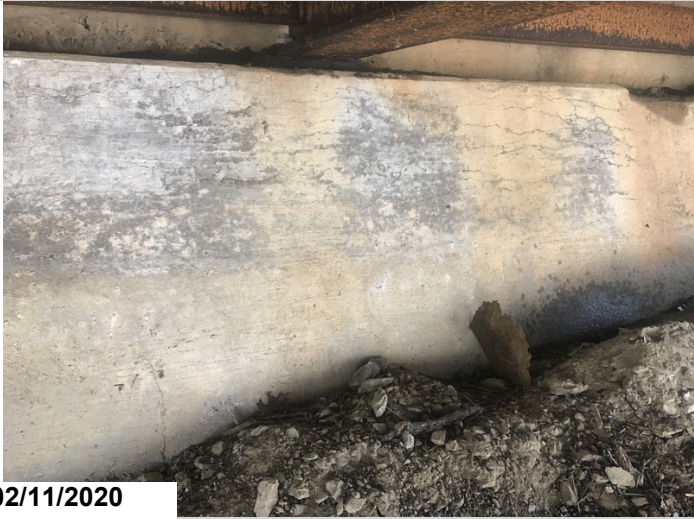
Bt. 6 abutment has horizontal cracking.

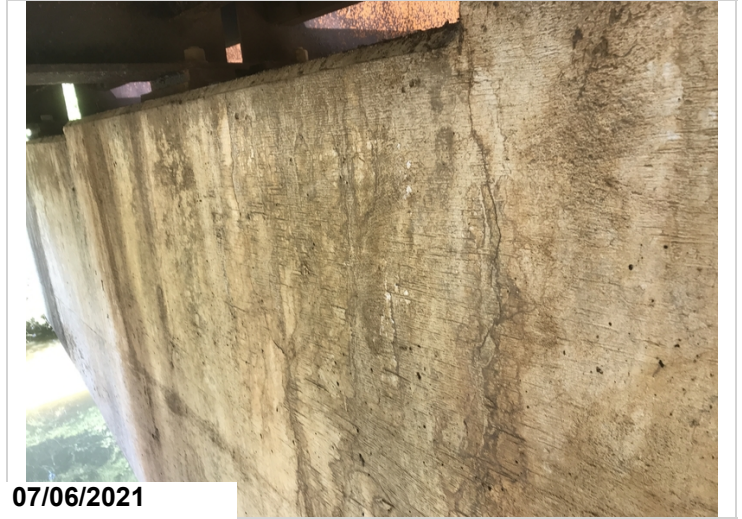
(234) Small cracks in all caps. 4' spall with rebar exposed at bent 4 backside(has been repaired 2/2022) bent 4 has small longitudinal and vertical cracks with rust staining							
302	Compression Joint Seal	LF	192	0	96	96	0
2310	Leakage	LF	192	0	96	96	0

longitudinal and vertical cracks and cracks with rust staining

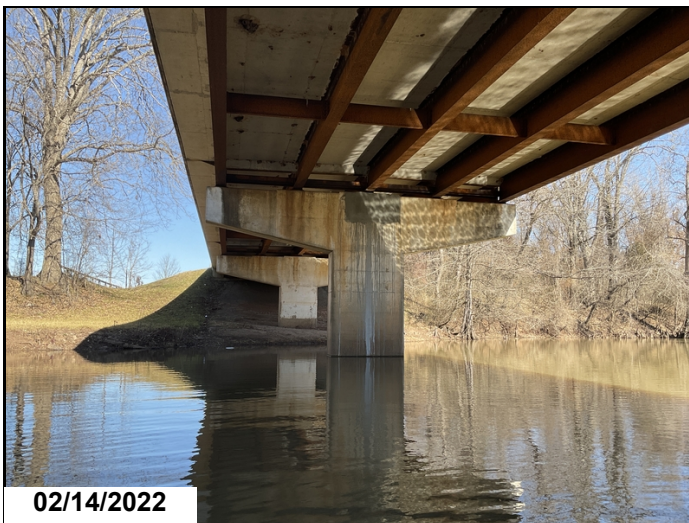
Bent 3 repair has been made to large spall under beam 3

state forces have repaired the large spall in the cap at bent 4 under girder 3

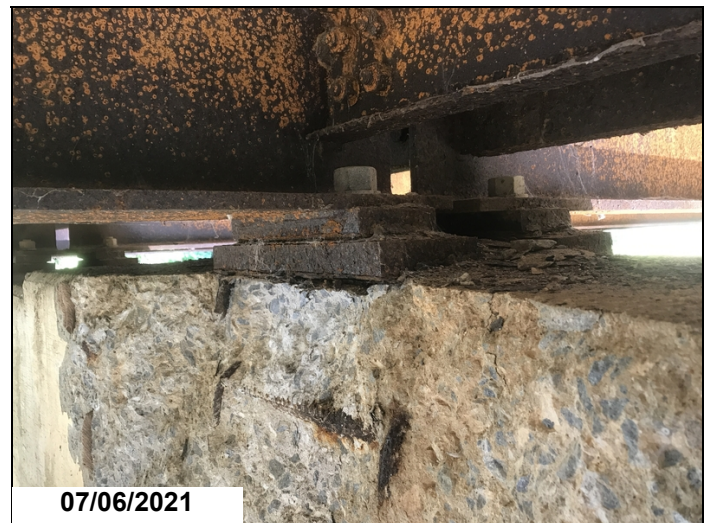
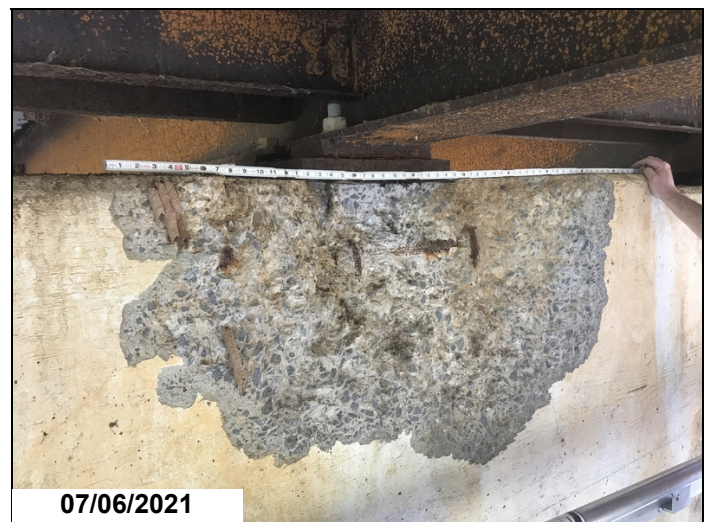
4' spall with rebar exposed at bent 4 backside under beam 3, 1 1/4" deep area under the bearing.

4' spall with rebar exposed at bent 4 backside

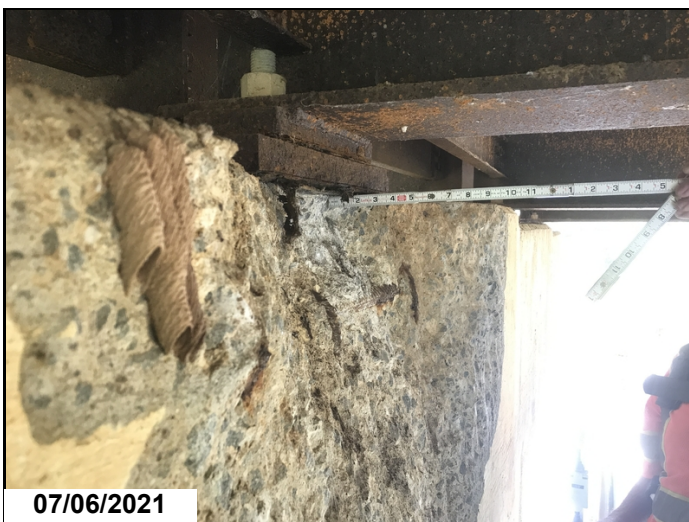
1 1/4 " loss of bearing area at the masonry plate at bent 4 backside

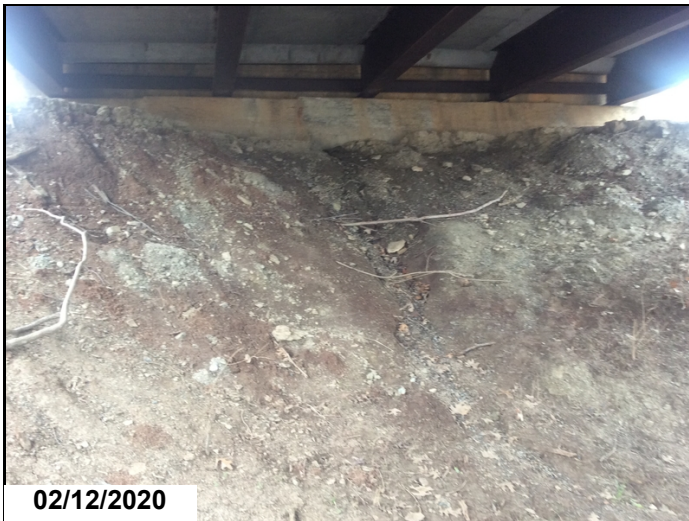
Embankment at Bent 6 (South end) : erosion action is undermining the abutment.

Embankment at Bent 6 (South end) has settled

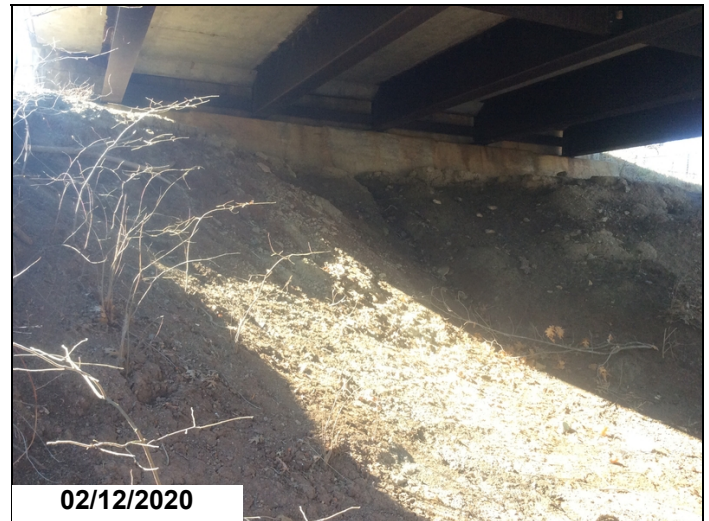
Looking at bent 6: runoff is eroding the embankment.

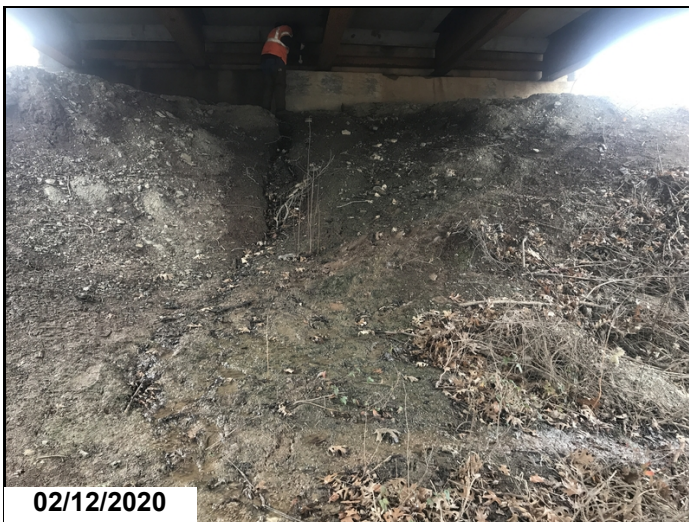
Erosion at Bt. 6.

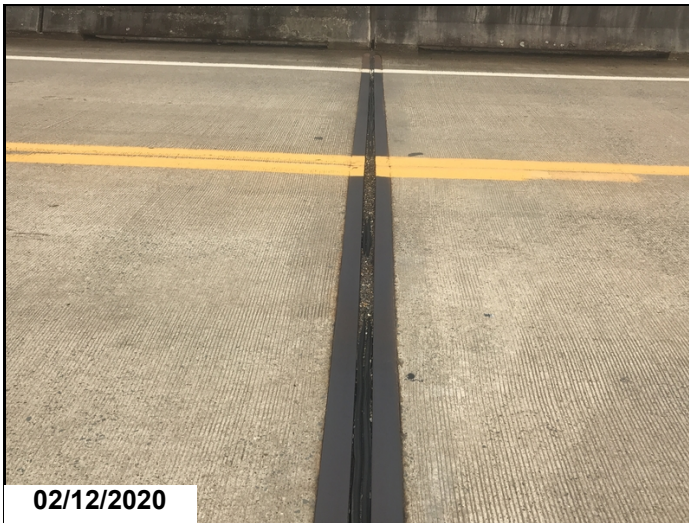
(302) Joint seals at bents 1,4&6 are torn and leaking.							
311	Movable Bearing	EA	25	0	25	0	0
1000	Corrosion	EA	25	0	25	0	0
313	Fixed Bearing	EA	25	0	15	10	0
1000	Corrosion	EA	25	0	15	10	0

Joint Seals have loss of adhesion and are leaking.

Bt. 4, joint seal has debris impaction & loss of adhesion.
