Asset #05813(Routine, Underwater type 2)

Sh 300 Log 18.22 over LITTLE MAUMELLE RIVER

Location: 1.9 MI N JCT SH 10

Team Lead: Bryan Saunders Inspection Date: 02/03/2022

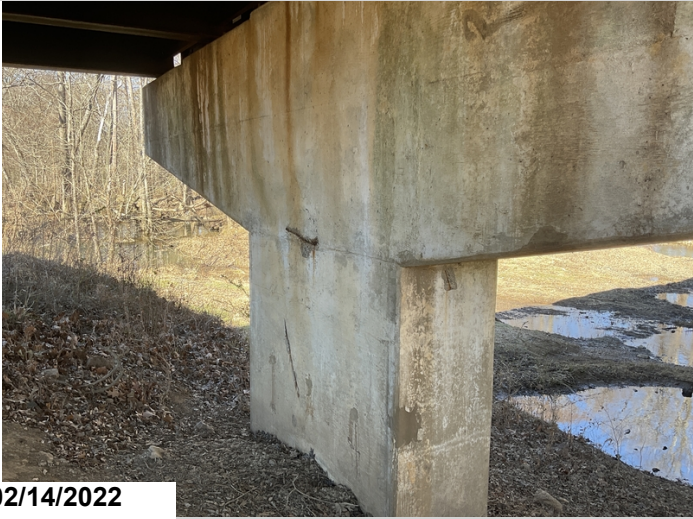
(205) All columns have scattered cracks. Columns 2,5 & 6 have small spalls with rebar.							
215	Reinforced Concrete Abutment	LF	94	79	15	0	0
1130	Cracking (RC and Other)	LF	15	0	15	0	0

Spall with rebar at bent 6

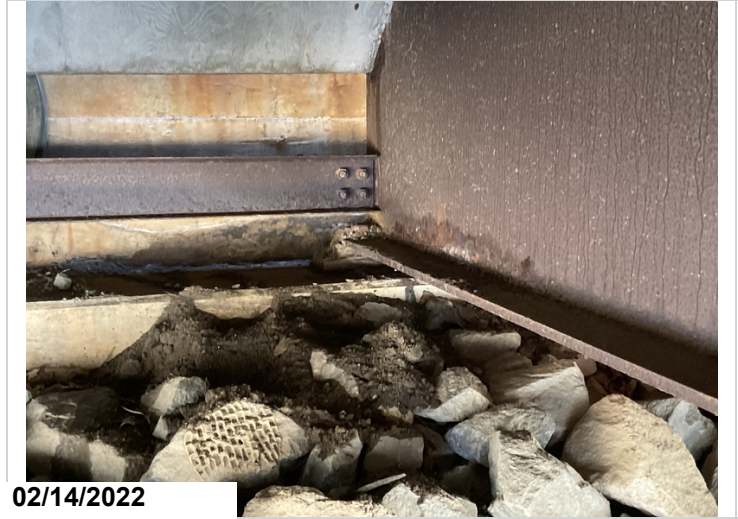
Bent 1 girder 3

(107) All beams have active flaking rust in the web at upper haunch. The beams at both abutments have active flaking rust at the bottom flange and lower web with girder 3 being the worst at both abutments See photo.							
205	Reinforced Concrete Column	EA	5	0	5	0	0
1090	Exposed Rebar	EA	3	0	3	0	0
1130	Cracking (RC and Other)	EA	2	0	2	0	0

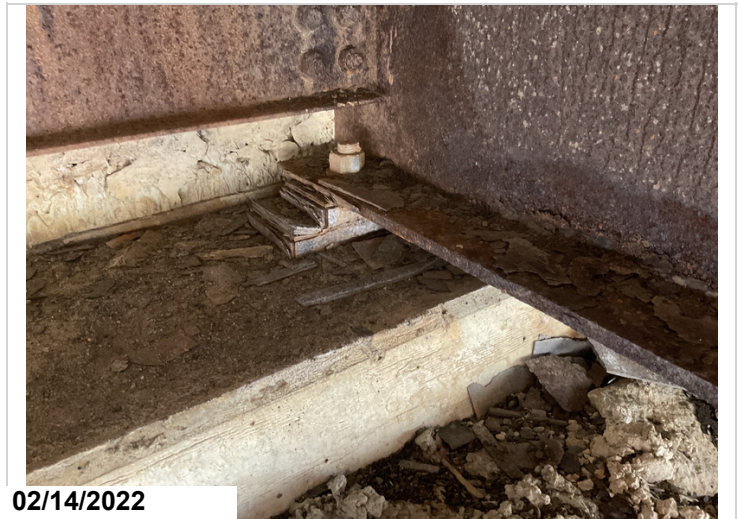
(313) Bearings at both abutments have laminating rust.							
321	Reinforced Concrete Approach Slab	SF	1050	690	360	0	0
1130	Cracking (RC and Other)	SF	360	0	360	0	0

Bent 7 girder 2 bearings

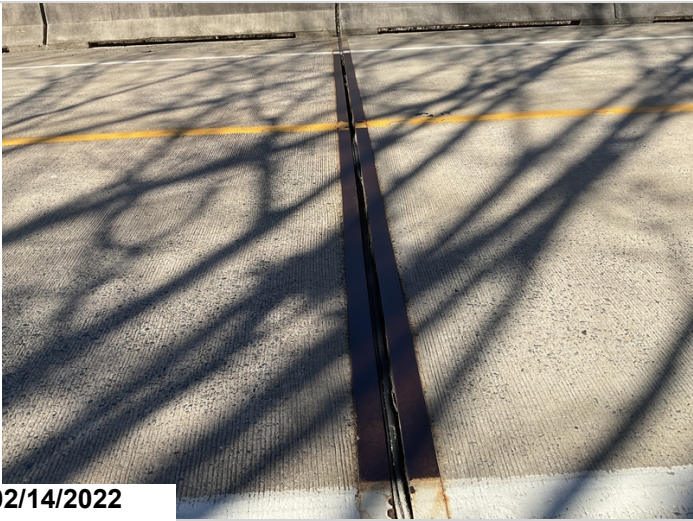
(302) joint at bent 1 and 6 has lost bond and fallen out . the joint at bent 1 has fallen out over girder 3 and is laying on the cap.							
311	Movable Bearing	EA	30	0	30	0	0
1000	Corrosion	EA	30	0	30	0	0
313	Fixed Bearing	EA	30	0	20	10	0
1000	Corrosion	EA	30	0	20	10	0

Joint at bent 6

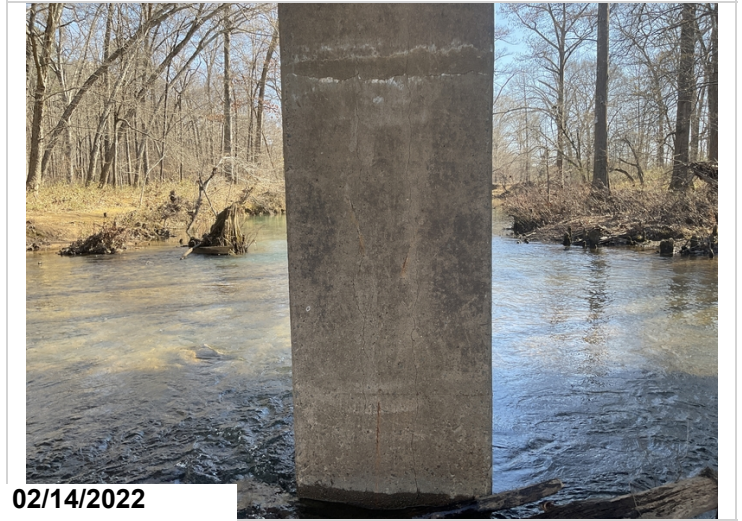
Cracks at bent 4 and 5

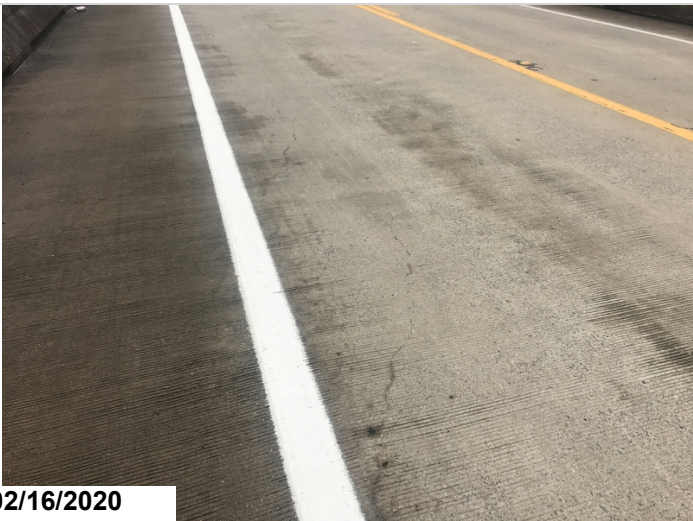
Span 2, cracks up to 0.020"

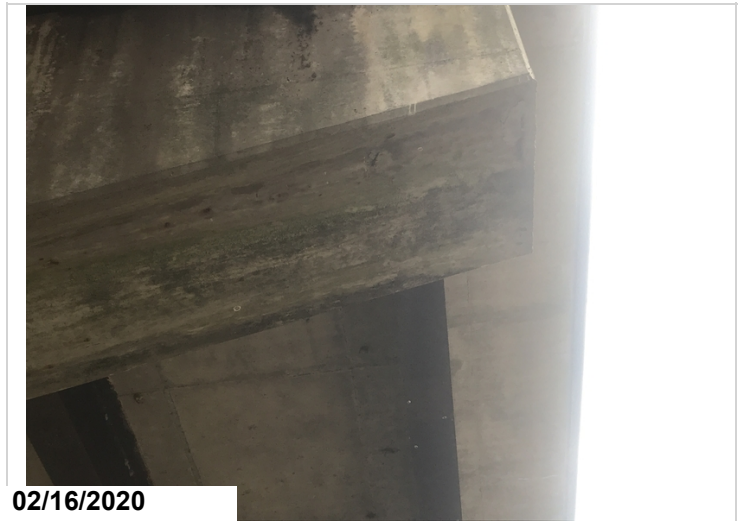
Bt. 3, cap, exposed rebar.

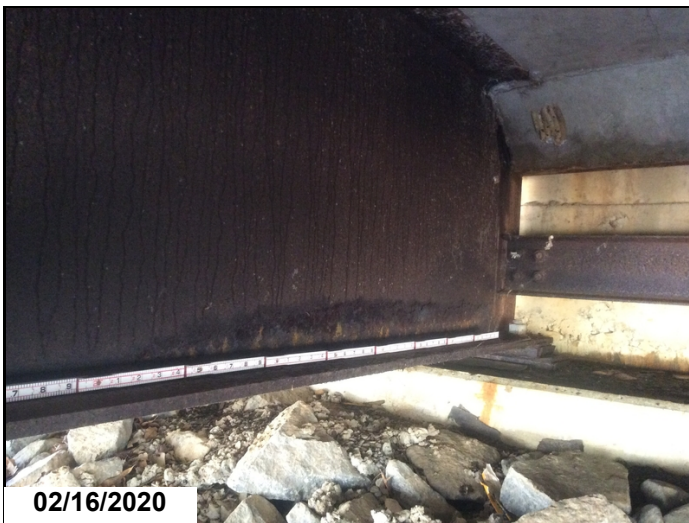
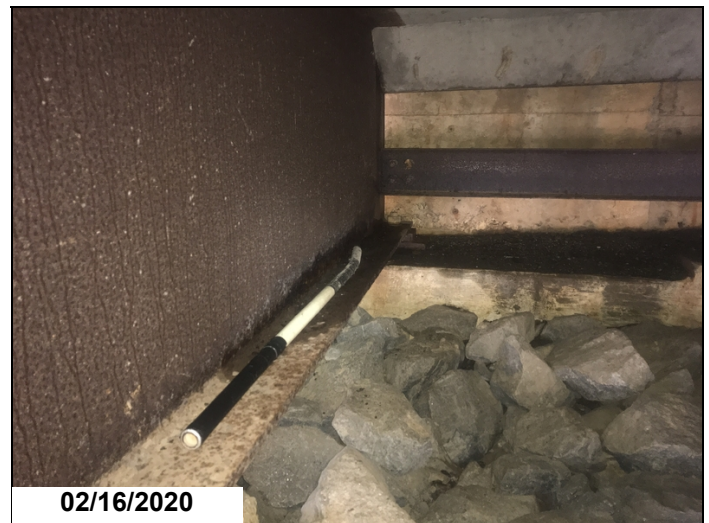
Bt. 1 Bm 4.

End of web and bottom flange of Beams 2 - 5 at both abutments.
Active rust due to missing joint seal.

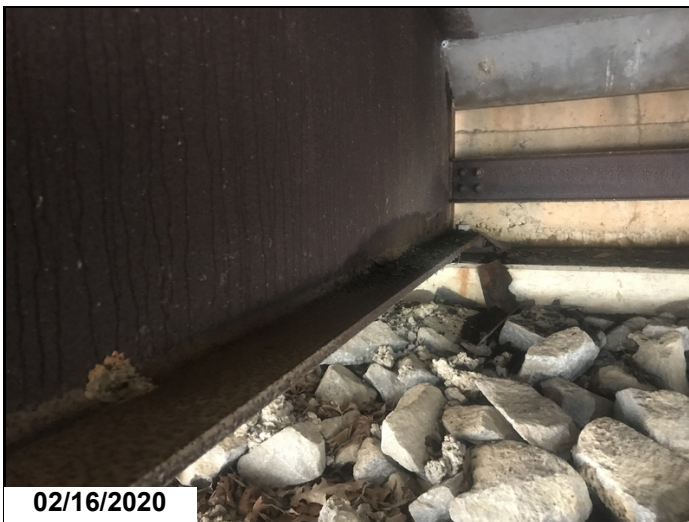
Bt. 7, Beam 4, active corrosion

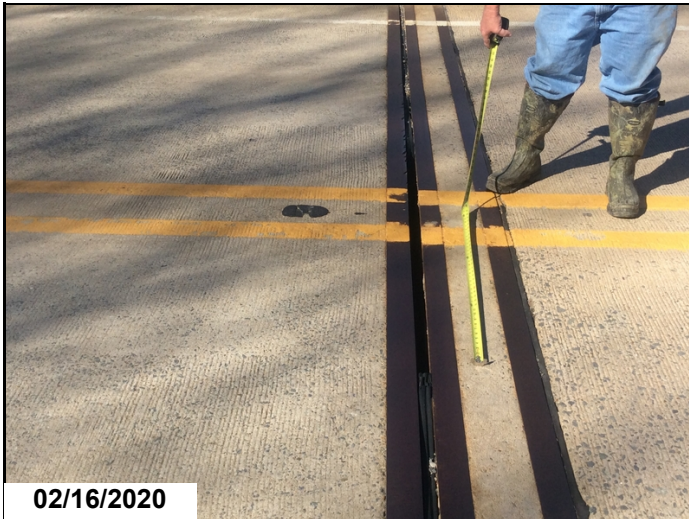
Abutment 1 has 5 feet of joint seal missing and has debris build-up around bearings.

Bent 1 abutment has 5 foot of joint seal missing

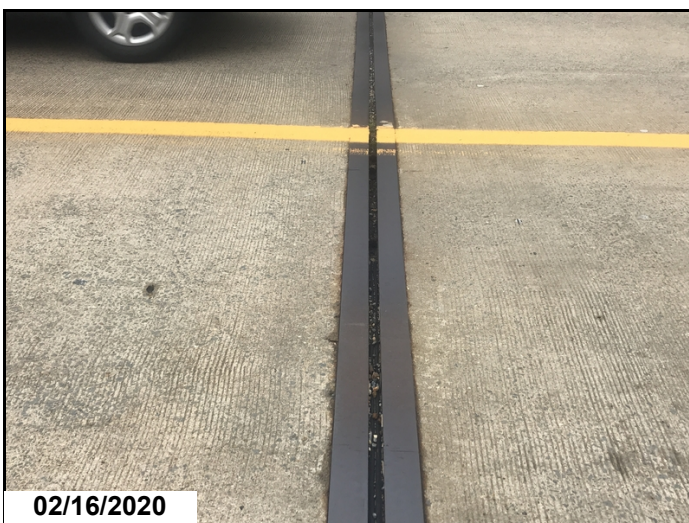
Bent 3 has 2 feet of joint seal dropped down.

Bt. 3, 3' of joint seal missing & debris impacted.

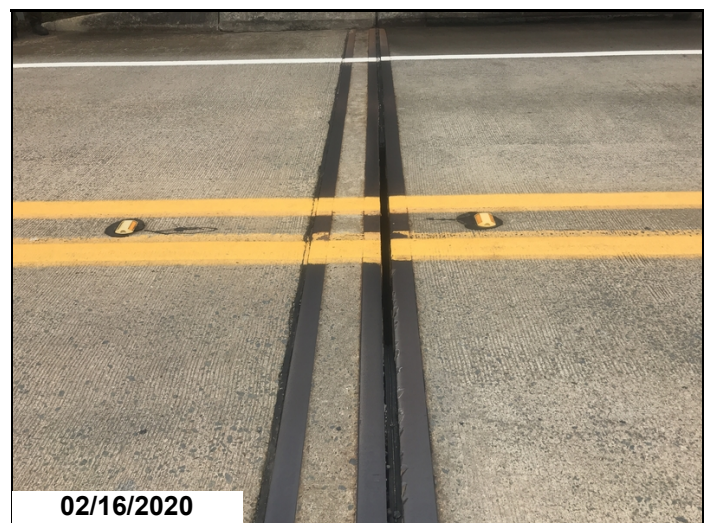
Bt. 1, 6' of joint seal missing.

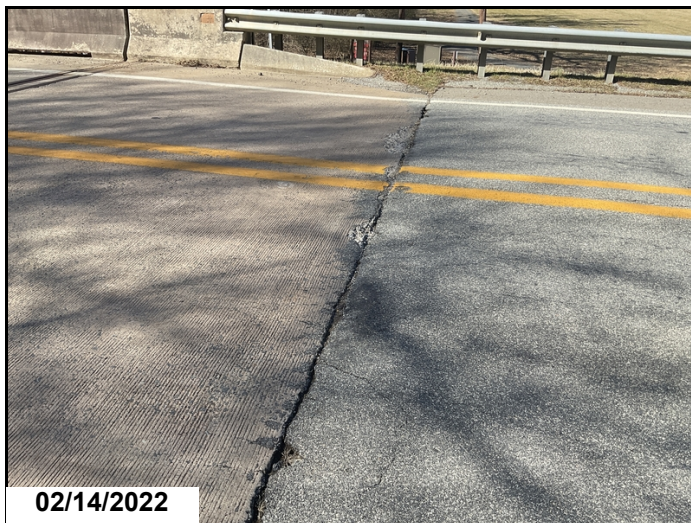
large spall at the approach slab at bent 1

Spall at bent 1 approach slab
