Route:300 Section:02 Log:16.54

Arnold Road ID:60x300x2xA, Arnold Log mile:16.514

Asset #M2814(Routine)
SH 300 Log 16.54 over Spillway Ditch
Location: 3.5 MI N SH 10
Team Lead: Shane Byrd Inspection Date: 02/13/2024

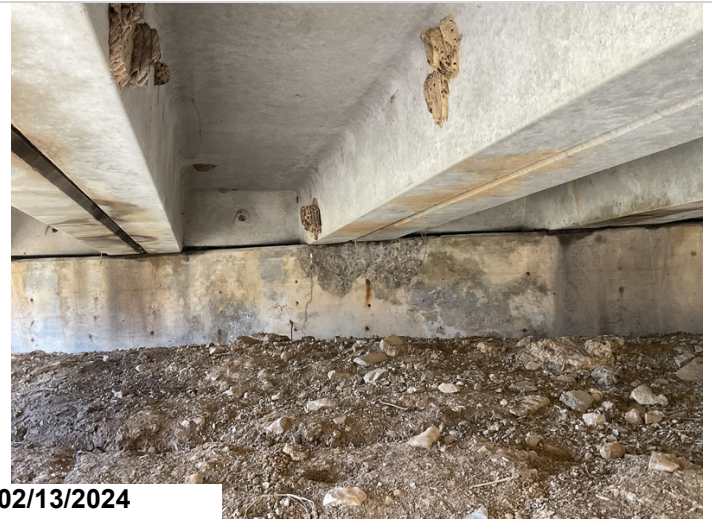
(215) Bent 6 large spalls under units 3,4&7.							
225	Steel Pile	EA	17	12	5	0	0
1000	Corrosion	EA	5	0	5	0	0
515	Steel Protective Coating	SF	1047	1007	0	0	40
3440	Effectiveness (Steel Protective Coatings)	EA	40	0	0	0	40

Bent 6 large spall under units 3 & 4.

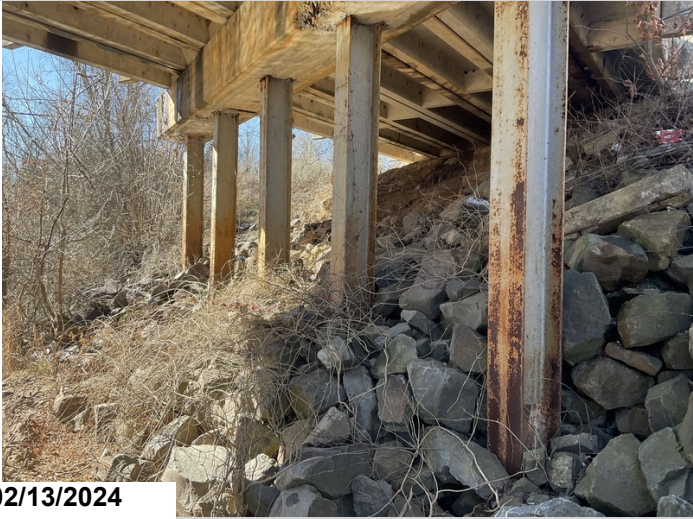
Bent 5 steel piles have active corrosion with minor pitting.

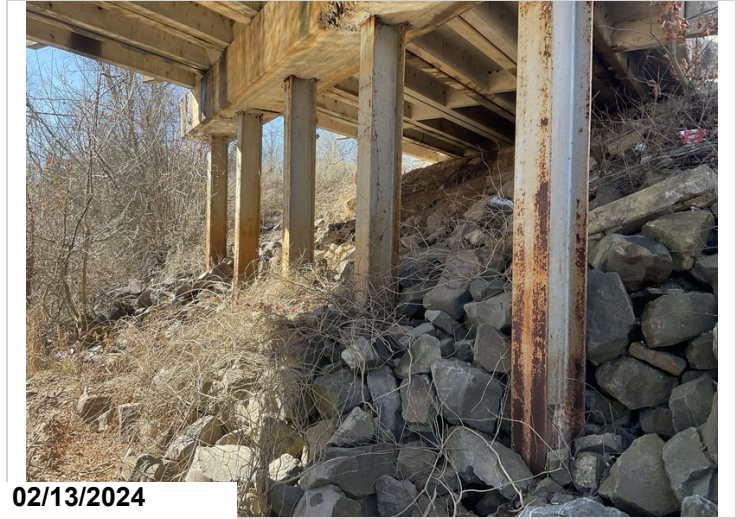
Bent 5 steel piles have active corrosion with minor pitting.

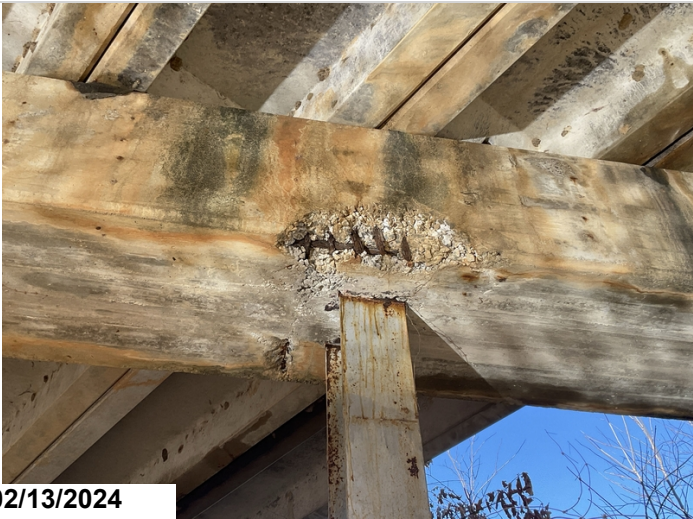
(234) Bent 2&4 cap back large delam under unit 1. Bent 5 exposed rebar on bottom of cap between columns 1,2&3. See photo. Bent 3 backside has map cracking							
330	Metal Bridge Railing	LF	316	316	0	0	0
515	Steel Protective Coating	SF	632	82	550	0	0
3440	Effectiveness (Steel Protective Coatings)	LF	550	0	550	0	0

Bent 5 cap back above pile 4 spall with exposed rebar. 50% section loss on rebar.

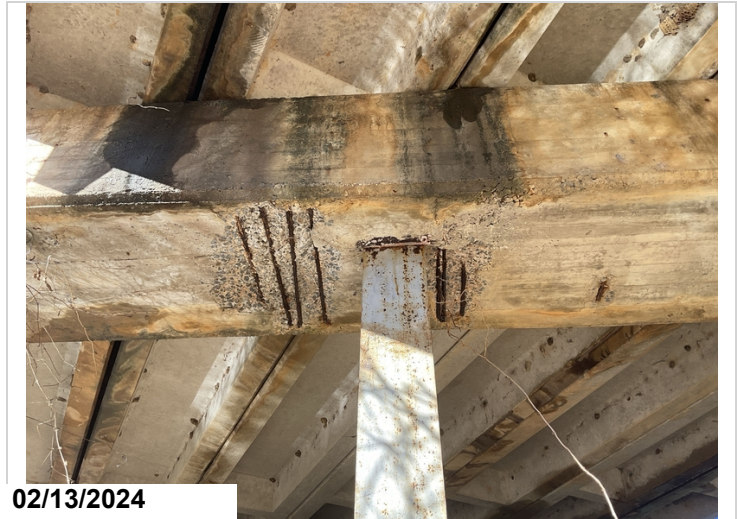
Bent 5 cap at pile 2 spall with exposed rebar at pile 2. 50% section loss to hoop bars.

Bents 2 and 5 cap spalls with exposed rebar. Hoop bars have 50 to 75 % section loss.

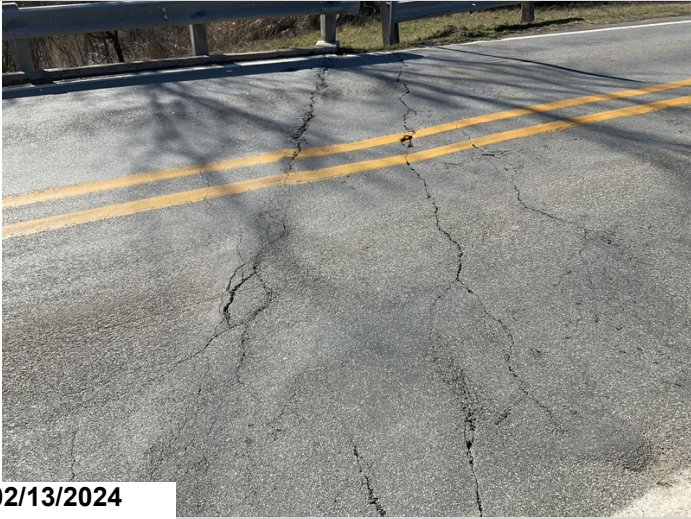
(16) No problems noted.							
(510-16) cracks in the wearing surface at both abutments							
110	Reinforced Concrete Open Girder/Beam	LF	1106	1091	0	15	0
1080	Delamination/Spall/Patched Area	LF	15	0	0	15	0

Bent 6 cracks in the asphalt wearing surface.

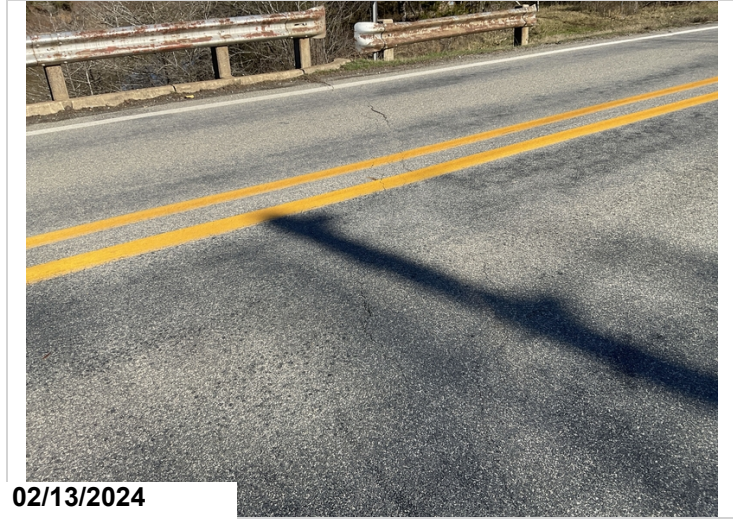
Bent 1 cracks in asphalt wearing surface.

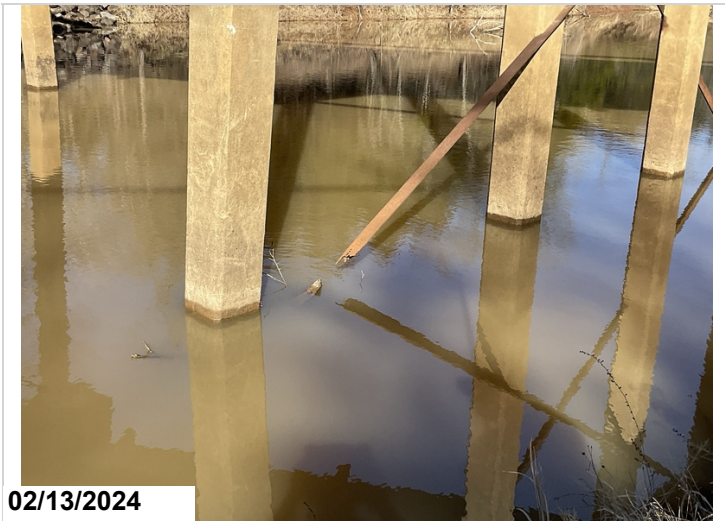
(225) Steel piles are encased in concrete X bracing in bent 2,3,4 are rusted in 2							
2022 Underwater - Bents 2 and 3: The steel cross bracing is severely corroded with 50% typical section loss. There is a 1'L section of 100% section loss of the diagonal cross brace between Piles 1 and 2 at Bent 2, and a 2'L section of 100% section loss of the diagonal cross brace between Piles 3 and 4 at Bent 3. This defect is incidental to the element.							
Bent 5 steel piles have active corrosion with minor pitting.							
(515-225) Steel pile at bent 5 paint system has failed.							
234	Reinforced Concrete Pier Cap	LF	140	103	12	25	0
1080	Delamination/Spall/Patched Area	LF	17	0	0	17	0
1090	Exposed Rebar	LF	8	0	0	8	0
1130	Cracking (RC and Other)	LF	12	0	12	0	0

Bent 2 cross bracing section loss.

Bent 2 and 3
X brace Rusted in half.

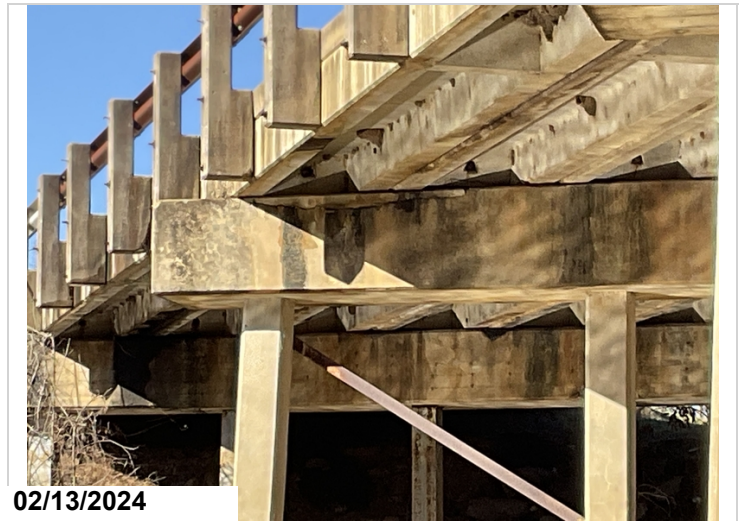
Bent 4 cap back above piles 1 & 2 large delam.

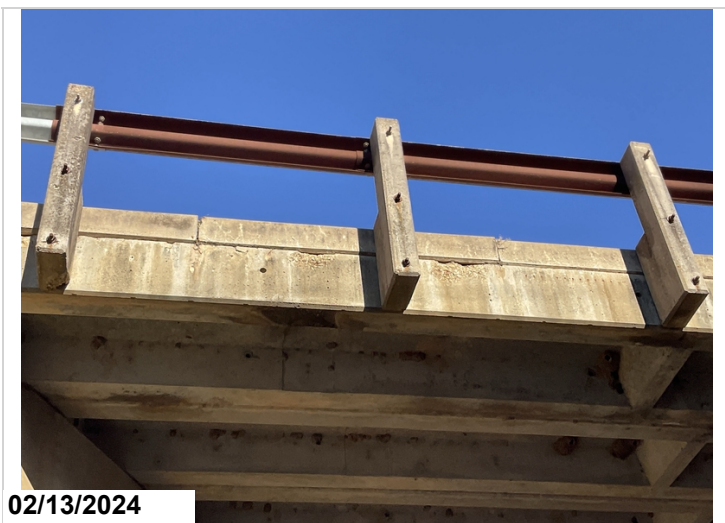
(110) Spalls on the side of unit 1 in span 1,2,3&4. Common on the side of unit 7 span 3.							
215	Reinforced Concrete Abutment	LF	84	74	6	4	0
1080	Delamination/Spall/Patched Area	LF	4	0	0	4	0
1130	Cracking (RC and Other)	LF	6	0	6	0	0

Span 1 girder 1 left side spalls.

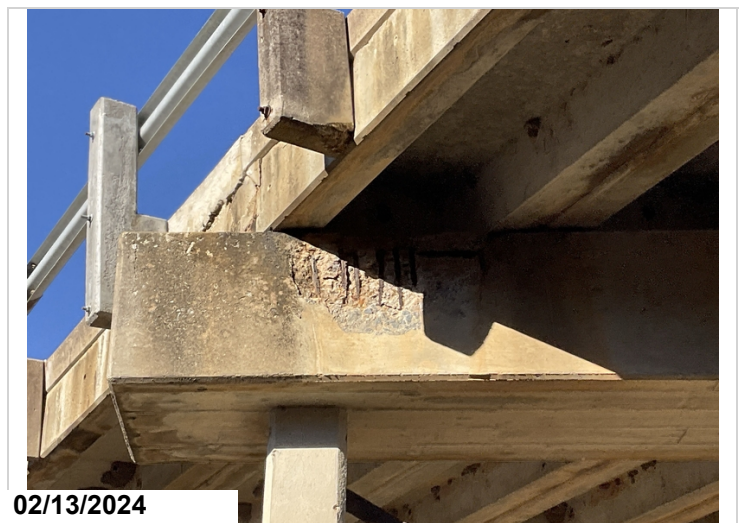
Bent 2 cap back right side spall with exposed rebar.

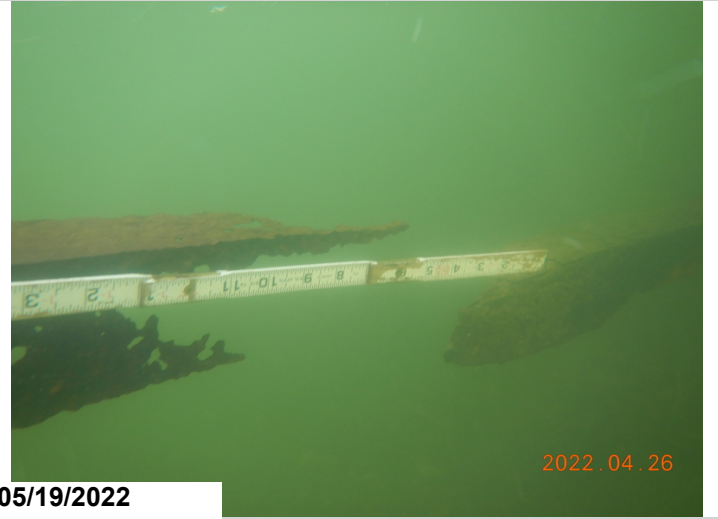
05/19/2022

Overall the substructure units are in good condition. There was corrosion found on the steel cross bracing, which is incidental to the steel pile element. This defect was previously identified in the Routine inspection and a maintenance order was created. There are no updates to the element level condition states as a result of this inspection.

BENTS 2 & 3, CORROSION ON CROSS BRACING WITH
UP TO 100% SECTION LOSS

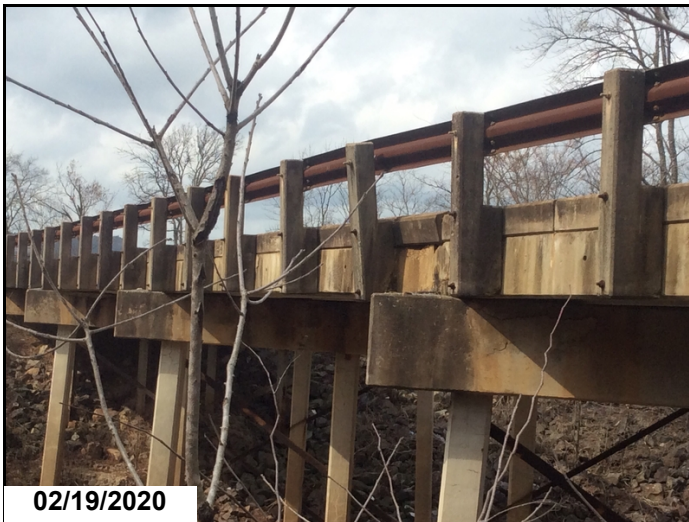
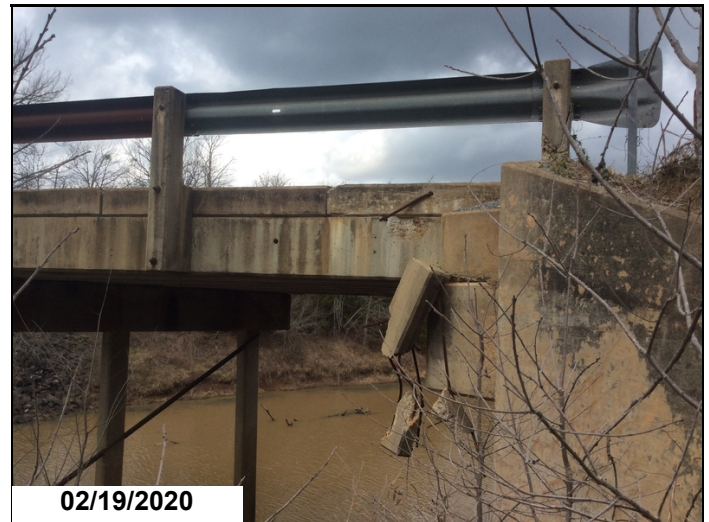
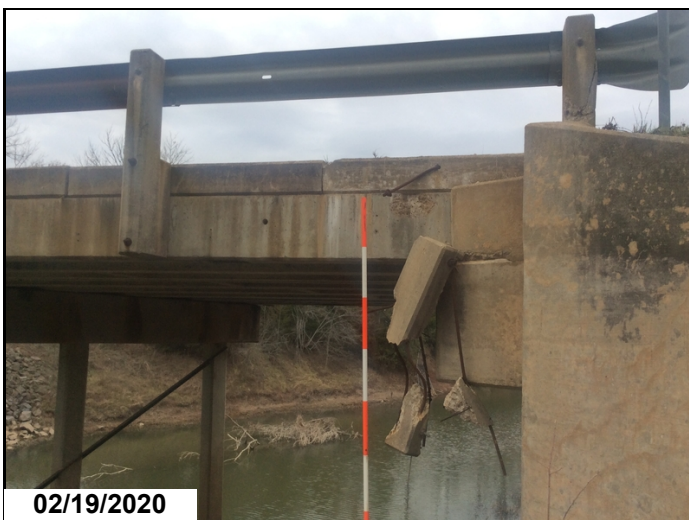
ELEMENTS	DESCRIPTION	UNITS	TOTAL	CS1	CS2	CS3	CS4
	<p>(330) Left bridge rail and post has damage from traffic impact at span 1&2.</p> <p>Accident report 1/30/18: right guard rail and post damaged. The guard rail that was damaged during this accident has been repaired. 2/21/18.</p> <p>(515-330) Steel bridge rail has freckling rust.</p>

Left bridge rail post at bent bent 1 damaged from traffic impact.

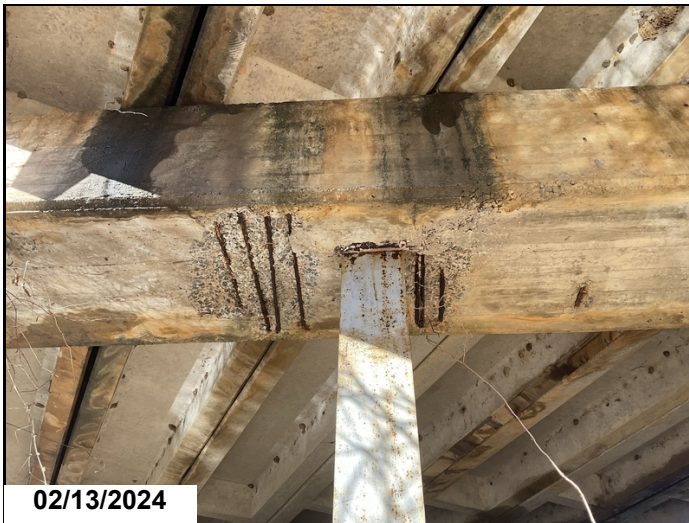
Bent 5 cap at pile 2 spall with exposed rebar at pile 2.
50% section loss to hoop bars.

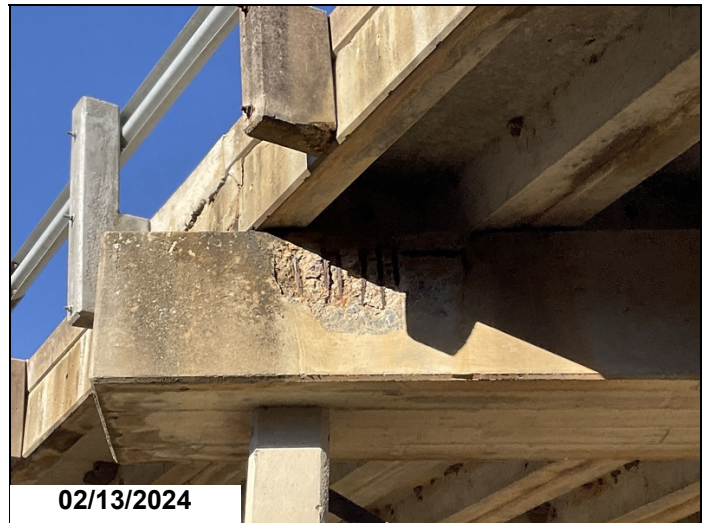
Bent 2 cap back right side spall with exposed rebar.
