Bridge 03989 Inspection Report

SH 13 Log 10.15 over COLLINS CREEK

Location: 0.7 MI NE JCT SH 236 & 13

Team Lead: Shane Byrd Inspection Date: 07/31/2024

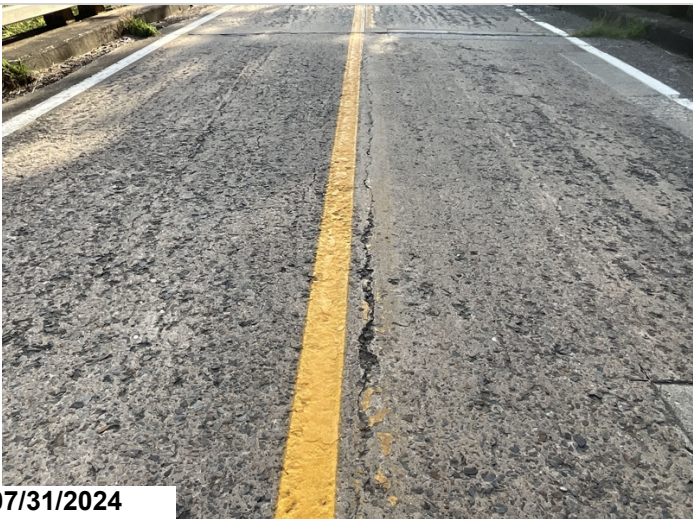
Span 2 longitudinal crack at centerline.

A-54 - Sealable Deck Cracks (Y)

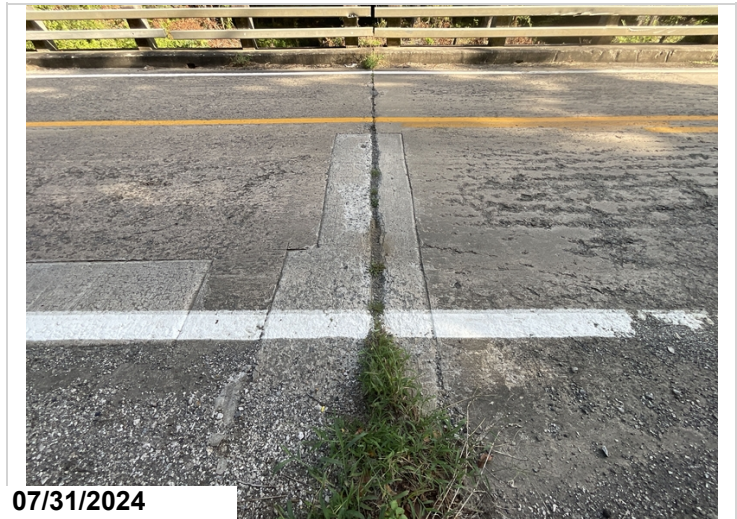
(301) All joint seals are missing and full of debris.							
330	Metal Bridge Railing	LF	150	129	15	6	0
7000	Damage	LF	21	0	15	6	0
(330) Bent 3 left bridge rail has damage due to traffic impact.

Bent 3 joint seal full of debris.

A-59 - Joint Repair Needed (Y)

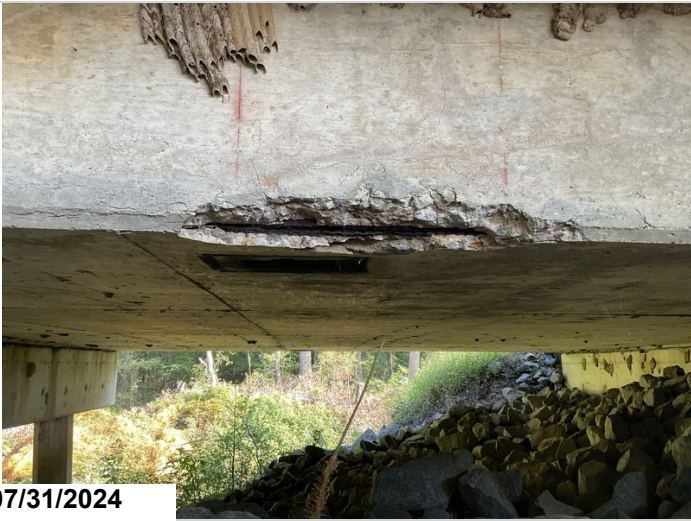
Span 3 right side spall with exposed rebar in side of deck.
CS3 2'.

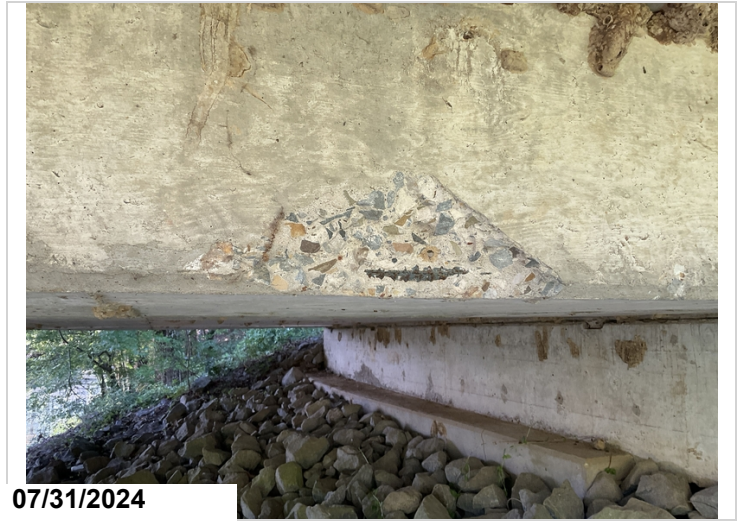
Span 1 left side spall with exposed rebar in side of deck.
CS3 1'.

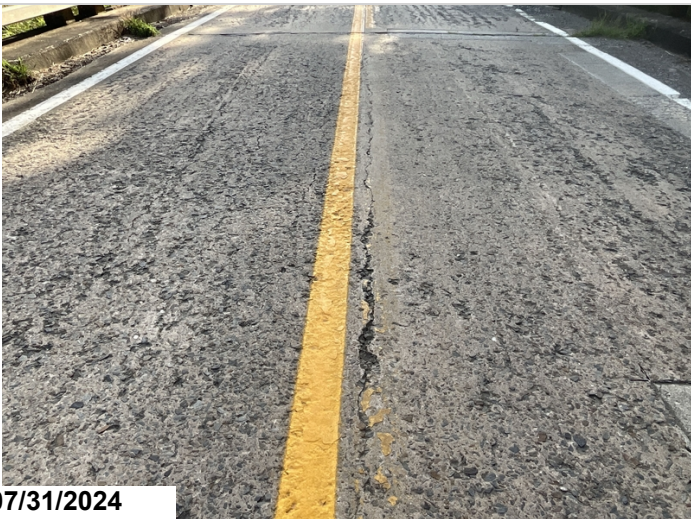
Span 2 longitudinal crack at centerline.

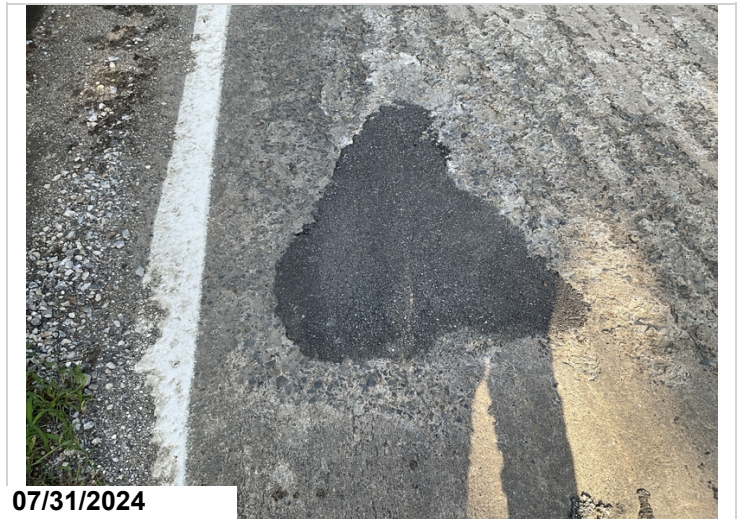
Span 3 spall filled with asphalt. 15'CS3

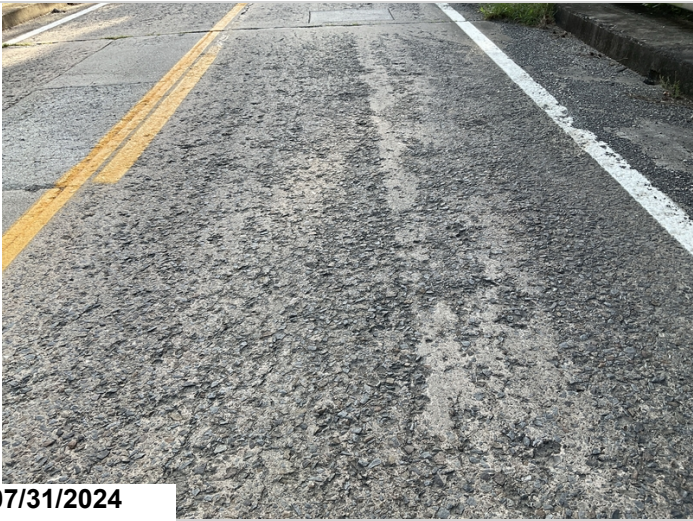
Span 1 abrasion in concrete deck.

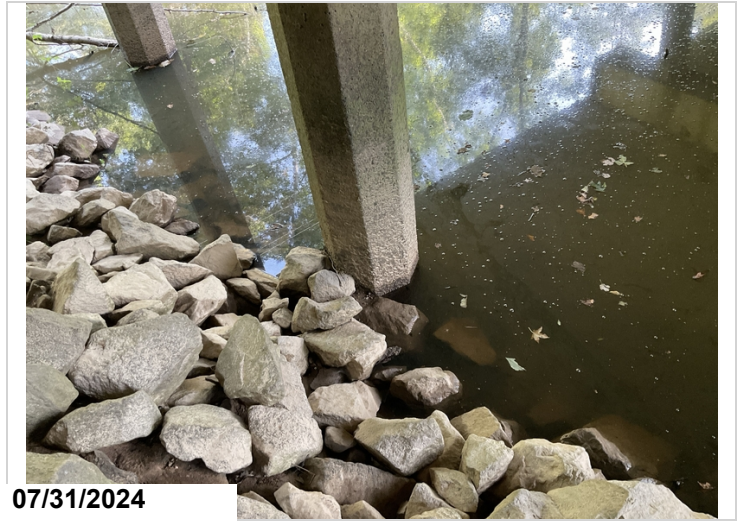
(215) Rip rap countermeasures still in place.							
227	Reinforced Concrete Pile	EA	6	0	4	2	0
1190	Abrasion/Wear (PSC/RC)	EA	6	0	4	2	0
(227) All pile have minor abrasion.							
234	Reinforced Concrete Pier Cap	LF	53	40	6	7	0
1080	Delamination/Spall/Patched Area	LF	2	0	2	0	0
1090	Exposed Rebar	LF	7	0	0	7	0
1130	Cracking (RC and Other)	LF	4	0	4	0	0

Bent 2 pile 2 minor abrasion at waterline. Common all piles this bent.

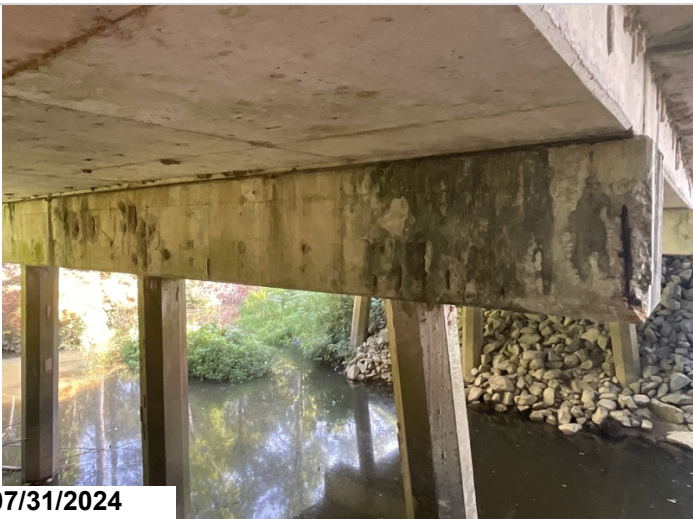
(234) Spalls with exposed rebar and delamination on the back face of cap at bent 2. CS3 7'.							
301	Pourable Joint Seal	LF	48	0	0	48	0
2310	Leakage	LF	48	0	0	48	0

Bent 2 cap back spalls with exposed rebar. CS3 7'.

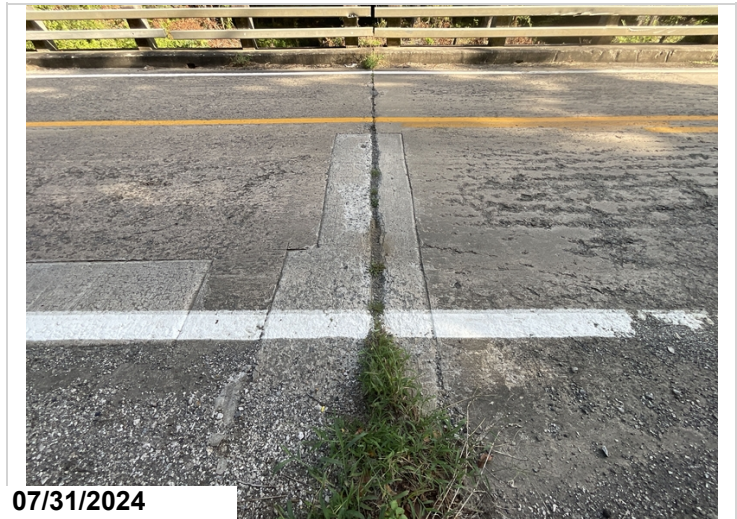
Bent 3 joint seal full of debris.

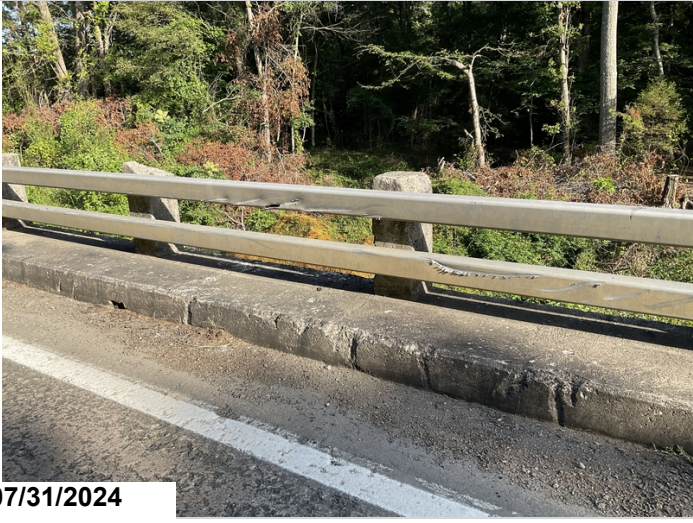
Span 3 left bridge rail damaged due to traffic impact.

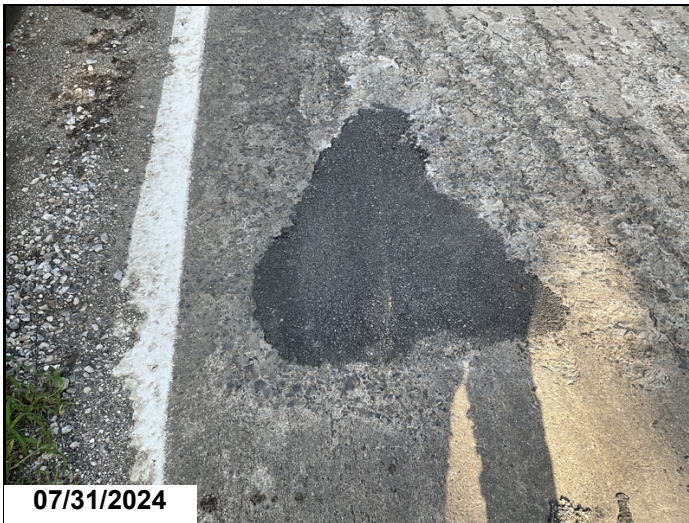
Span 3 spall filled with asphalt. 15'CS3

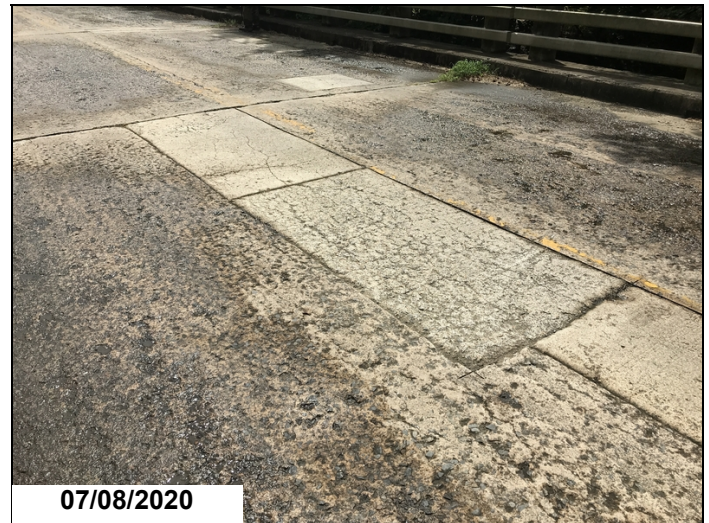
Deck has small spalls and heavy scaling.

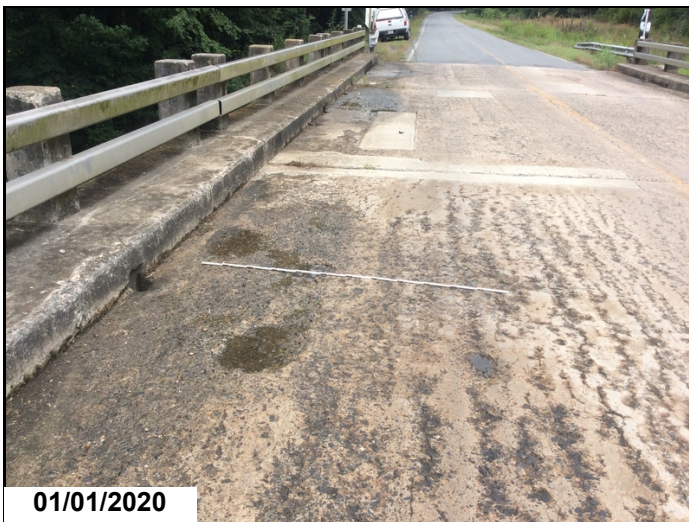
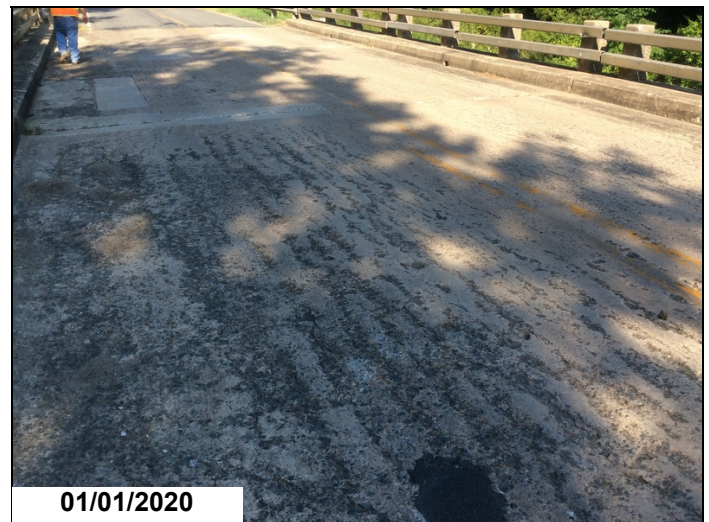
(38) All spans have heavy abrasion, patches and cracks. See photo. Small spall in span 3 all other spalls have been patched with asphalt. Span 1&3 have spalls with exposed rebar on side of slab Deck span 1 80' of patches. CS2 80'. Deck span 2 69' of patches. CS2 69'. Deck span 3 10' of patches. CS2 10'. Deck span 3 has a 3'x5' spall filled with asphalt. CS3 15'. Deck Span 2 has longitudinal crack at centerline.							
215	Reinforced Concrete Abutment	LF	86	86	0	0	0

Overview of deck with heavy abrasion, cracks and patches.

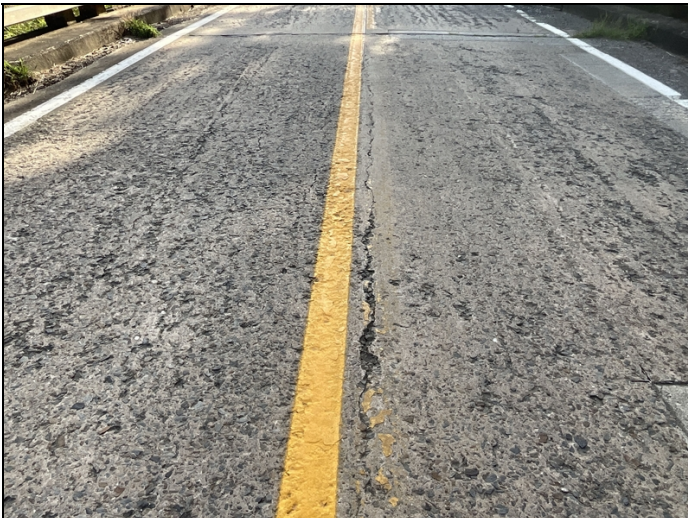
Span 2 longitudinal crack at centerline.

A-54 - Sealable Deck Cracks (Yes)

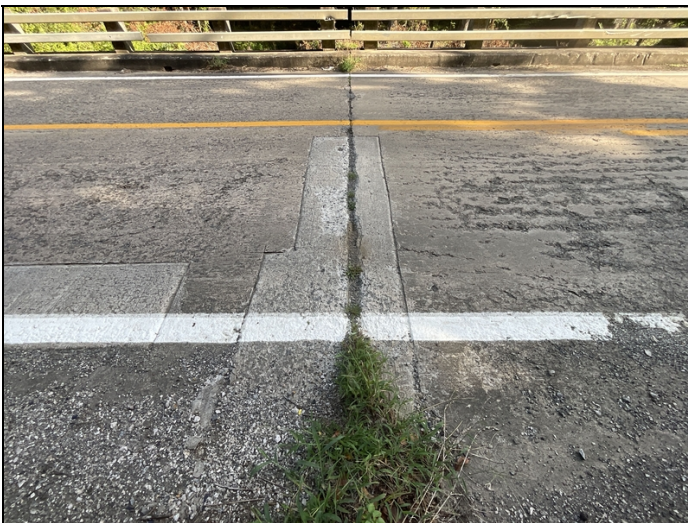
All joints are full of debris and missing.

Bent 3 joint seal full of debris.

A-59 - Joint Repair Needed (Yes)
