Bridge 06163 Inspection Report

Asset #06163(Routine, Underwater type 2)

SH 13 10/0Log 6.76 over WATTENSAW BAYOU

Team Lead: Joseph Rapier Inspection Date: 08/28/2025

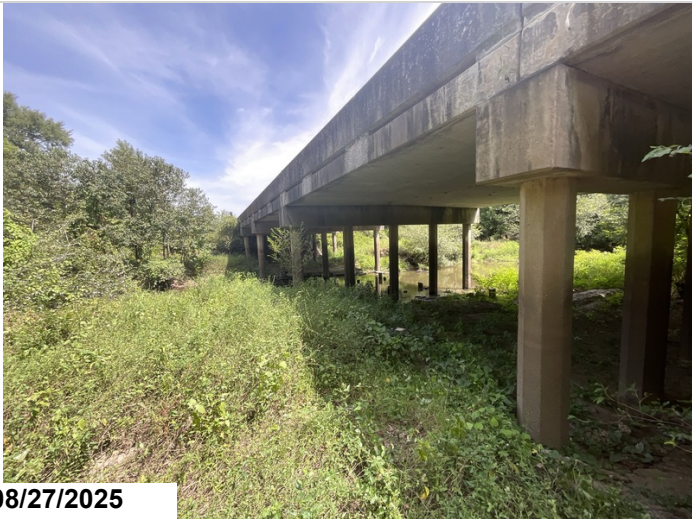
Elevation.

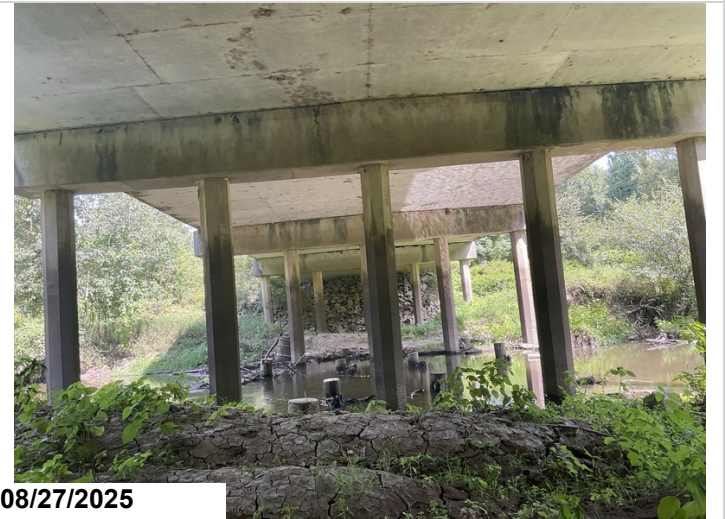
Overall the superstructure is in very good condition. Scattered cracking in the undersurface.

Undersurface view.

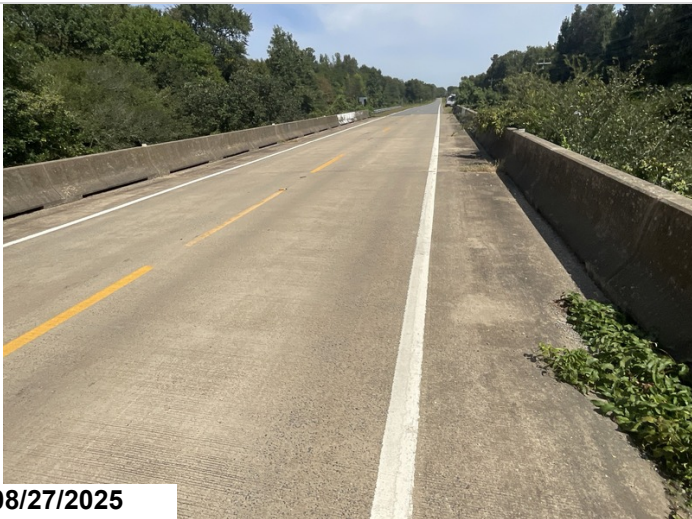
Overall the deck is in very good condition. Minor longitudinal cracks in span 1,4 and 5

Deck view.

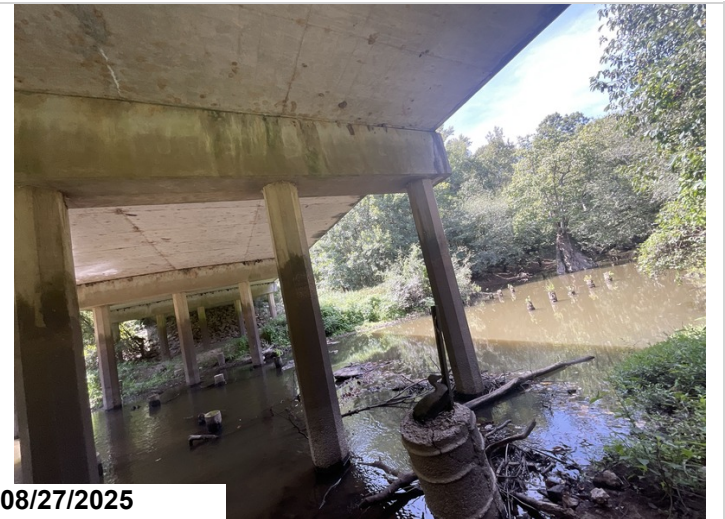
General cap condition.

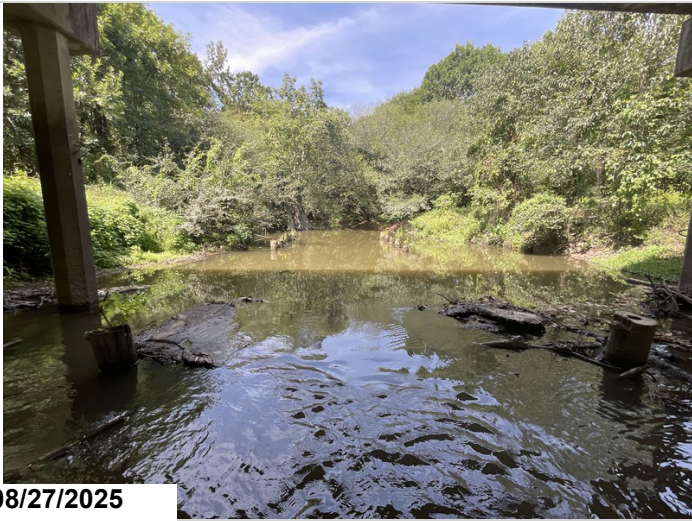
Channel looking upstream.

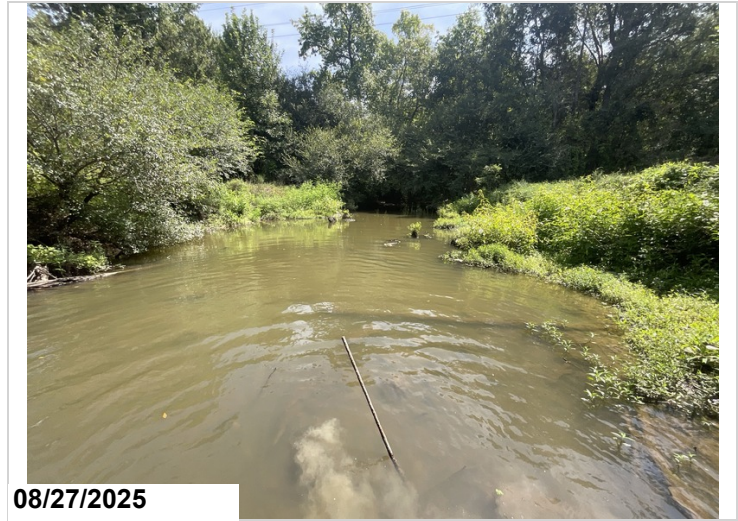
Channel looking downstream.

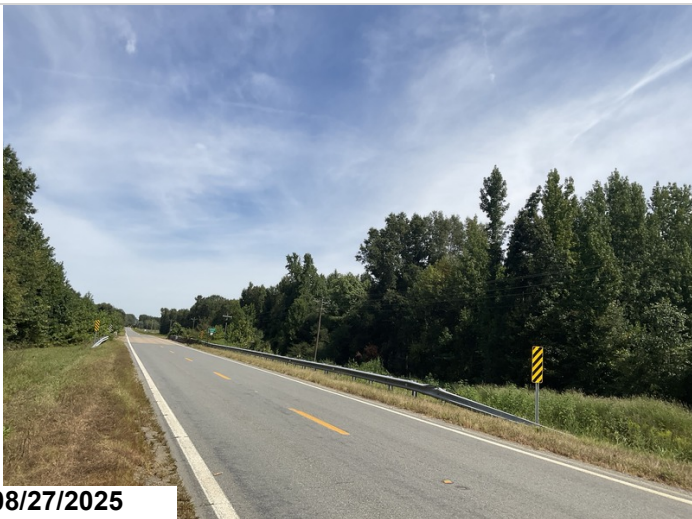
Inventory looking north.

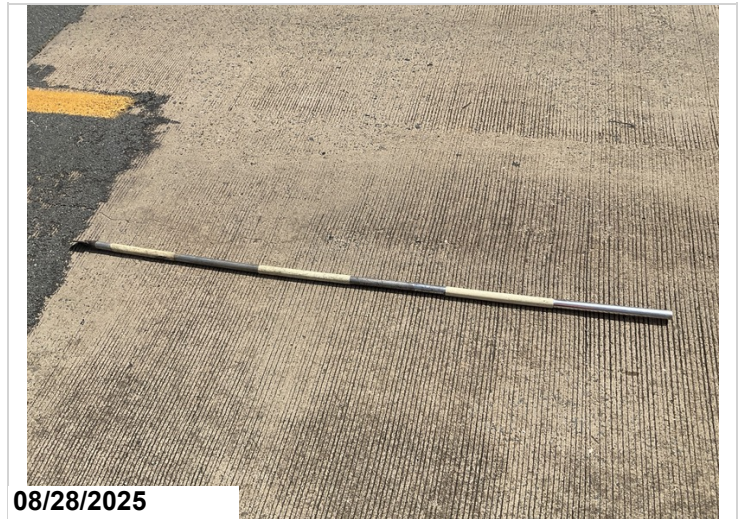
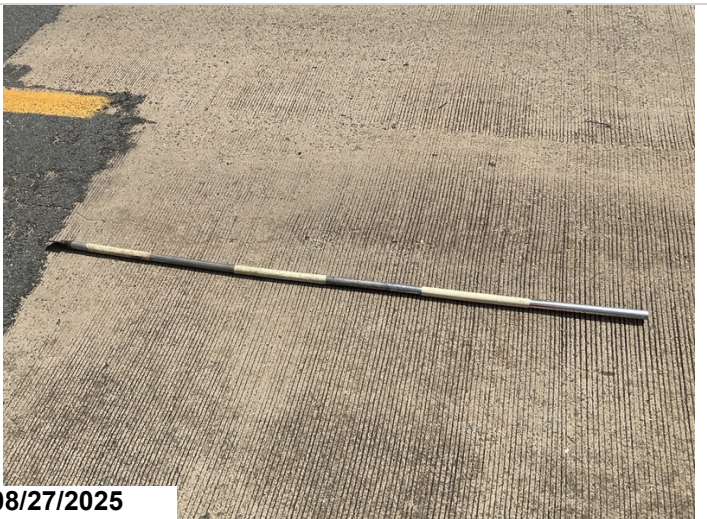
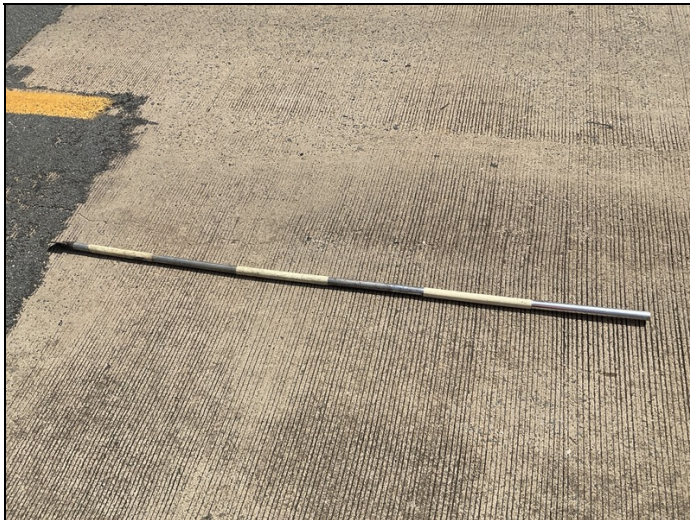
Span 5, at bent 6: cracking. CS2- 6'

Span 5, at bent 6: longitudinal cracking. CS2- 6'

Deck cracks in span 1,4 and 5

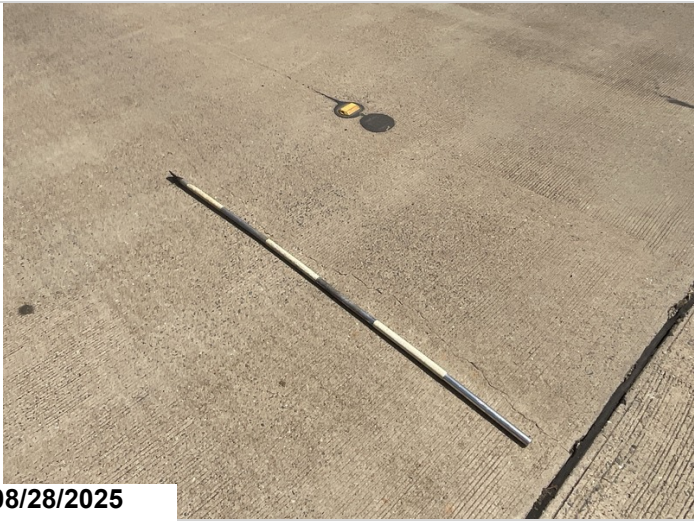
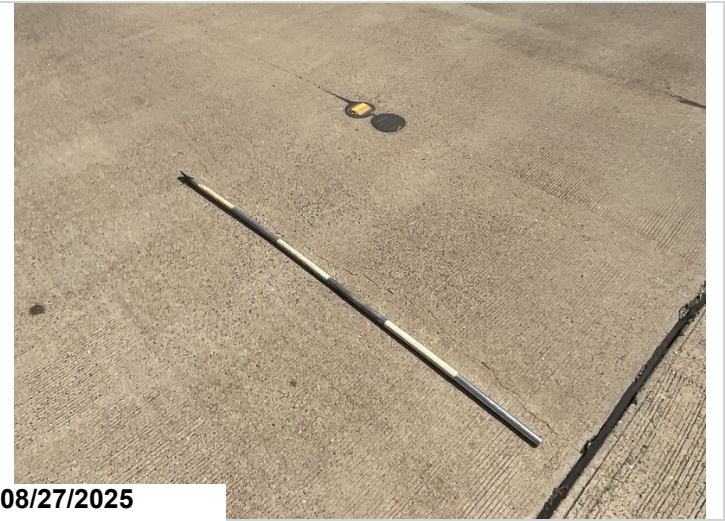
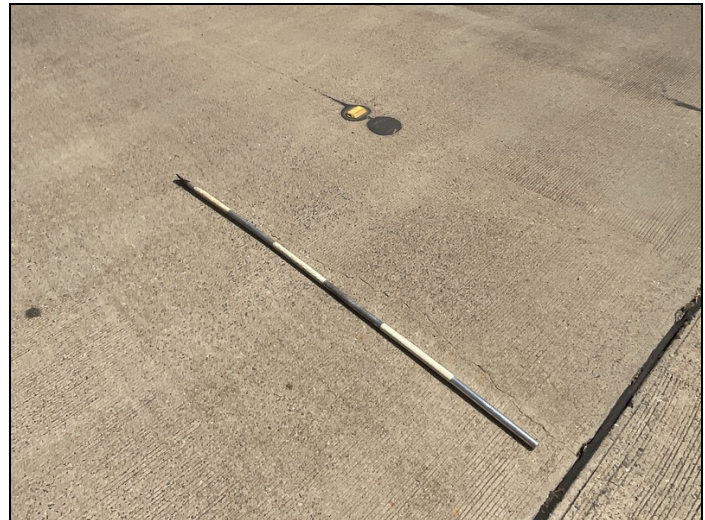
Bent 4, span 4: cracking. CS2- 7'

Bent 4, span 4: longitudinal cracking. CS2- 7'

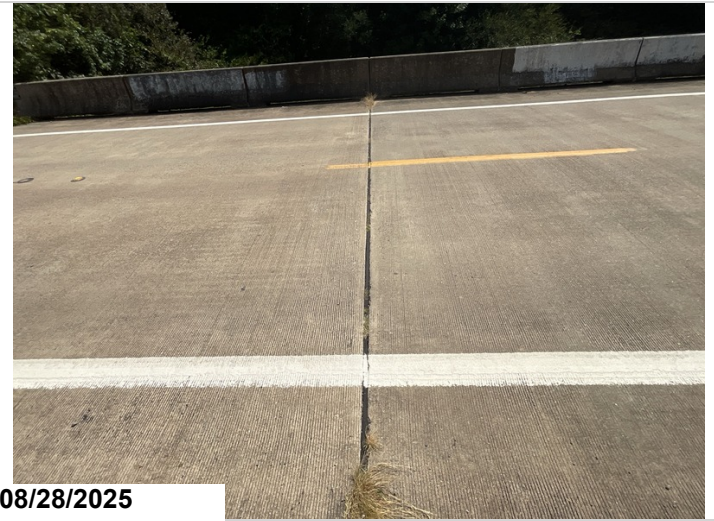
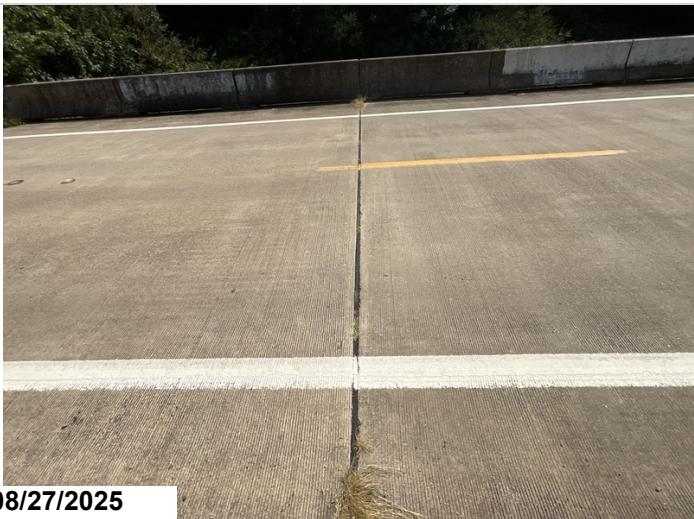
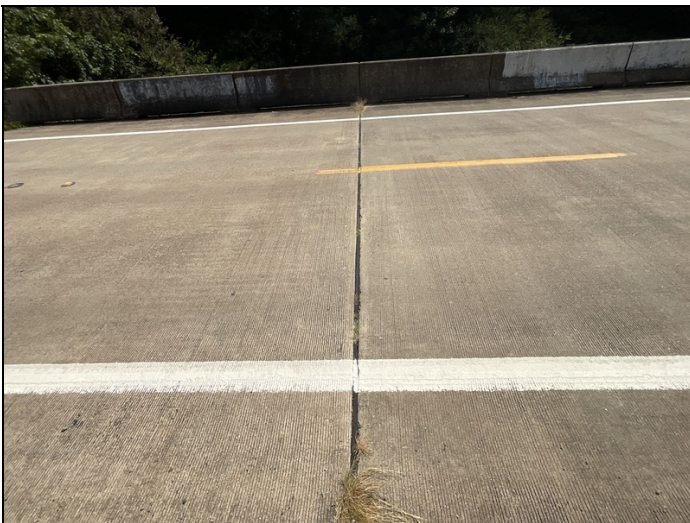
Bent 5, pourable joint seal: has lost adhesion. CS2-34'

The pourable joint seal at all bents has lost adhesion. CS3-130'

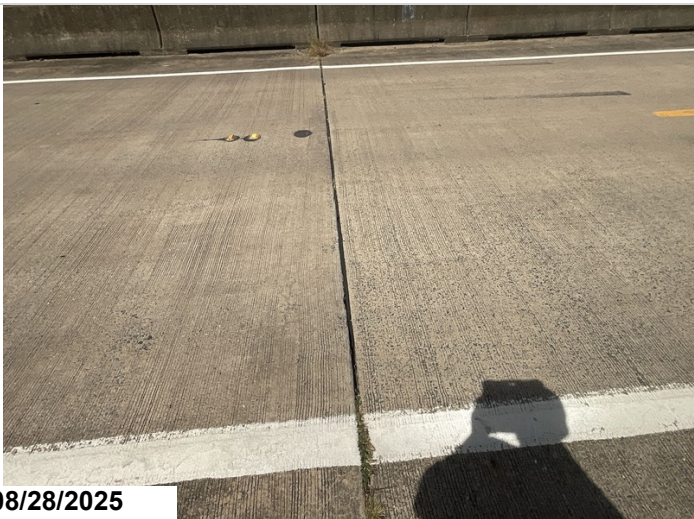
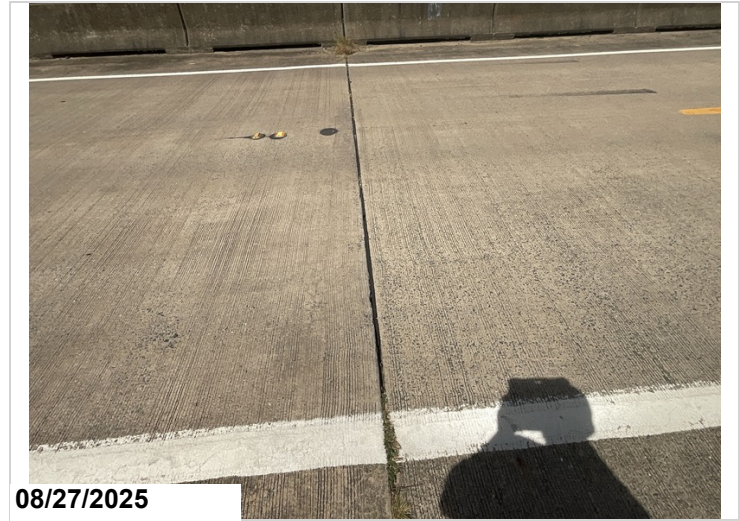
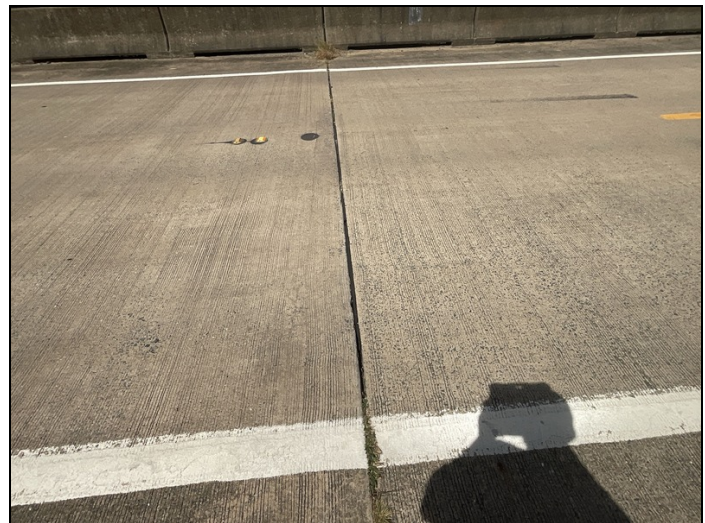
Bent 3, pourable joint seal: has lost adhesion. CS2-34'

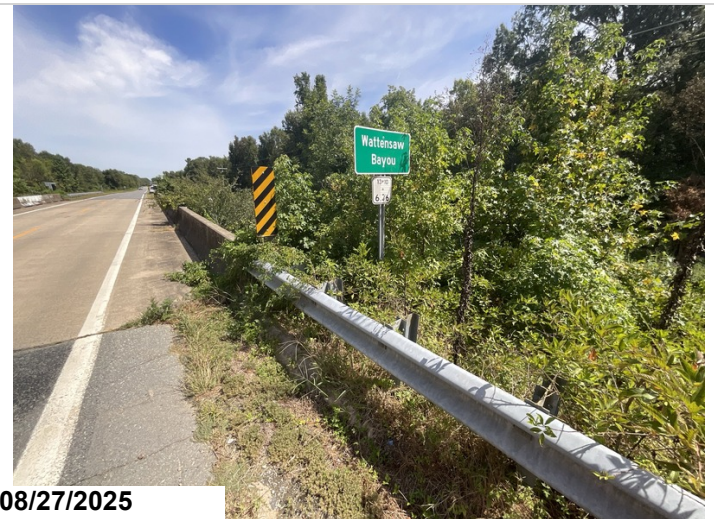
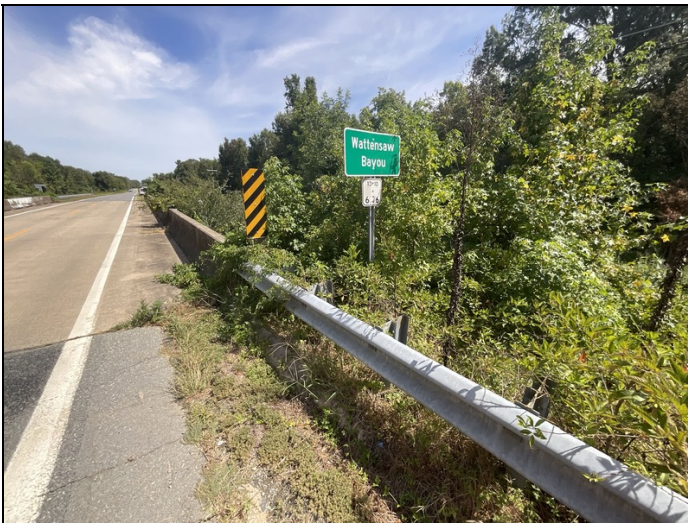
Bent 1, right side: vegetation growth restricting access.

All 4 corners of bridge has debris making it hard to access.

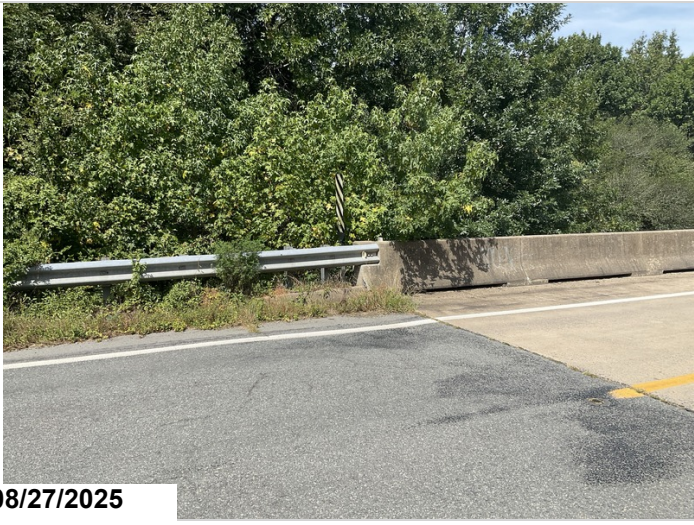
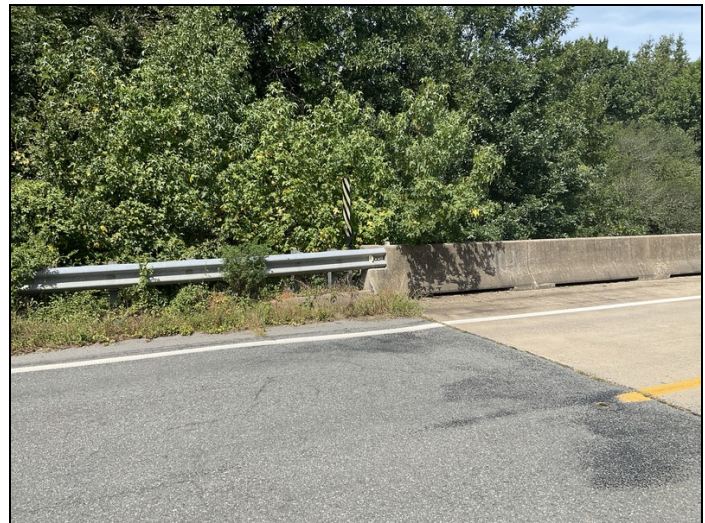
Bent 1, left side: vegetation growth restricting access.

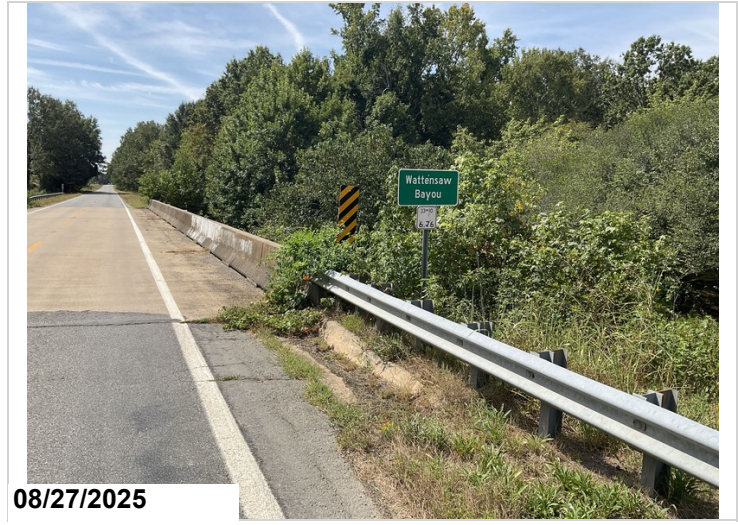
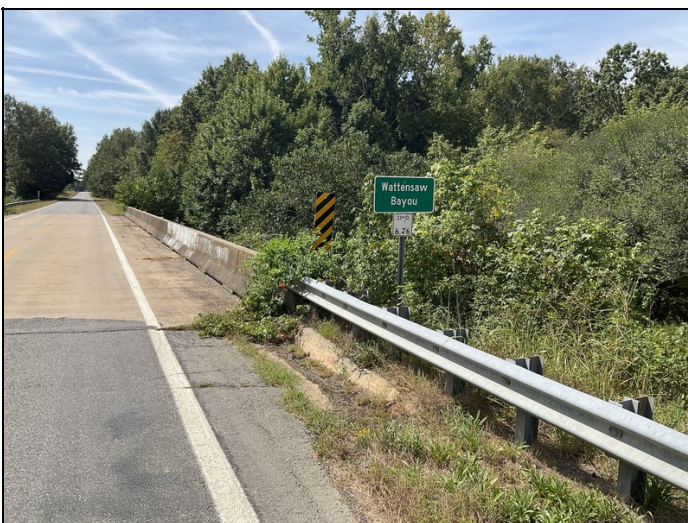
Bent 6, left side: vegetation growth restricting access.

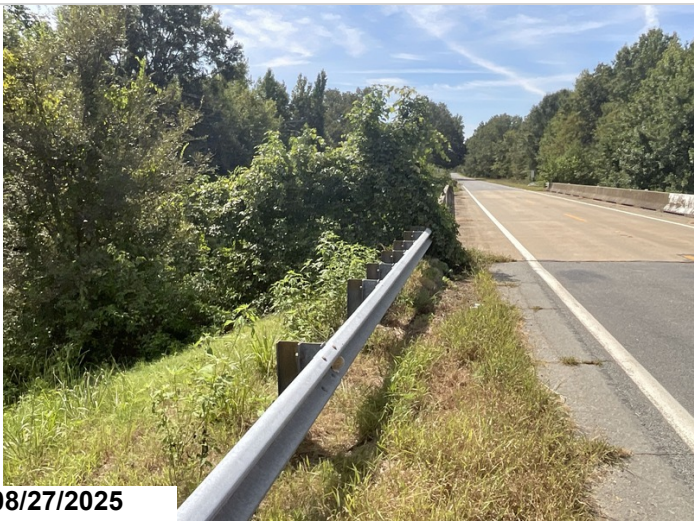
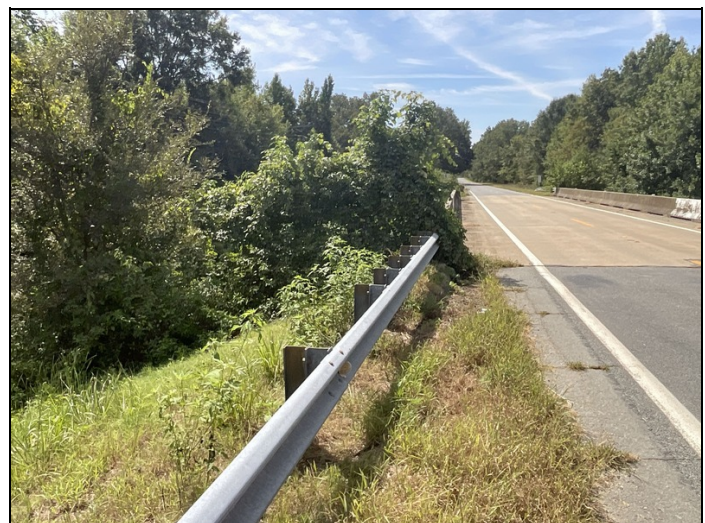
Bent 6, right side: vegetation growth restricting access.

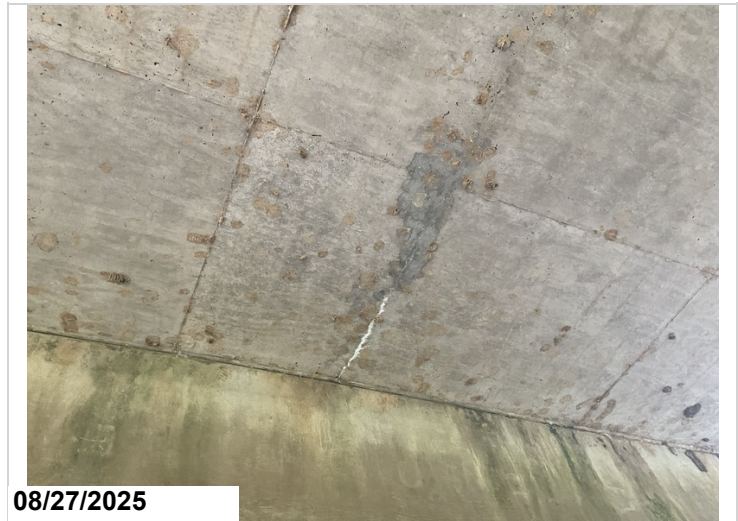
Span 4, at bent 4: cracking with efflorescence staining. CS2-2'

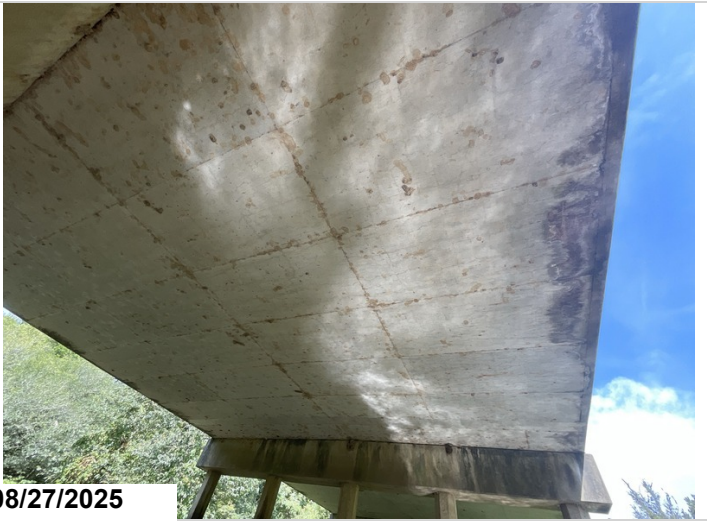
Span 3: insignificant hairline map cracking throughout the entire span.

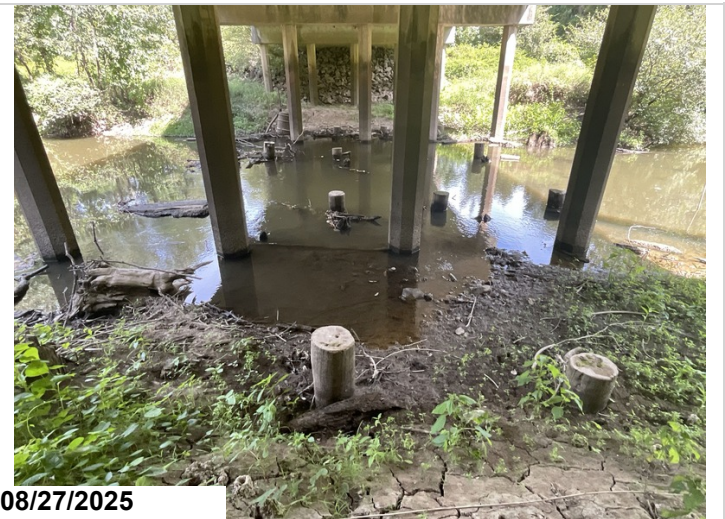
Bent 3: all pile have abrasion. CS2- 4 ea

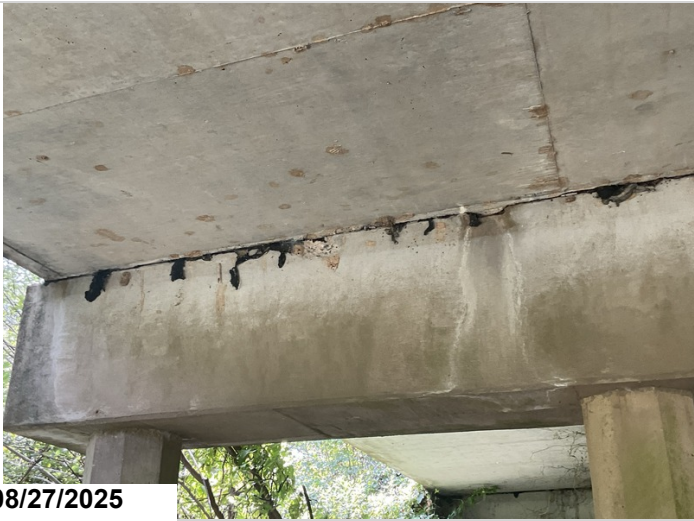
Bent 2, ahead side, between piles 1 & 2: small spall. CS2-1'

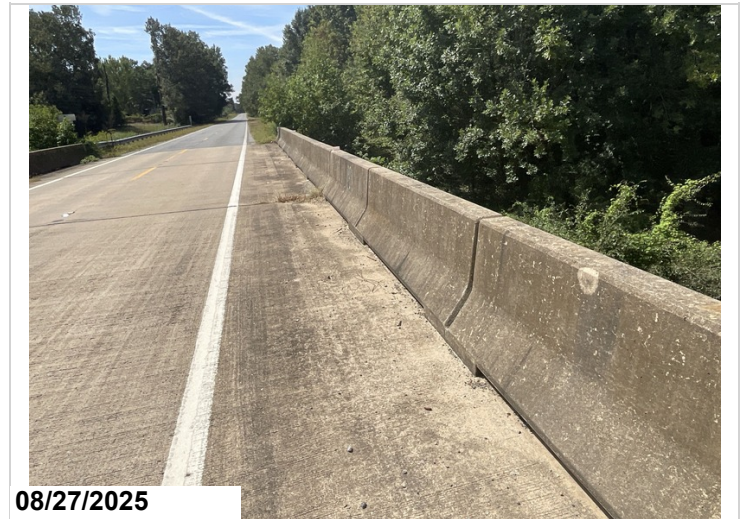
(331) Bridge rail has scattered cracks.

General bridge rail condition.
