Bridge 02713 Inspection Report

Asset #02713(Posting Sign Verification)

SH 5-9 Log 5.57 over BRODIE CREEK

Team Lead: Chris Doggett Inspection Date: 02/26/2025

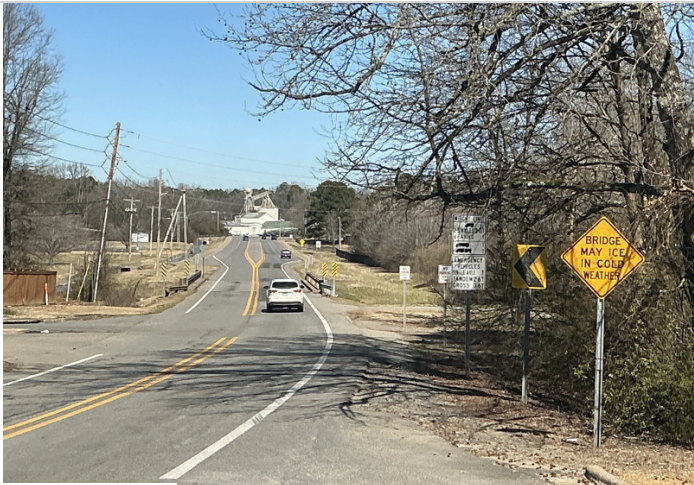
New load posting sign looking east.

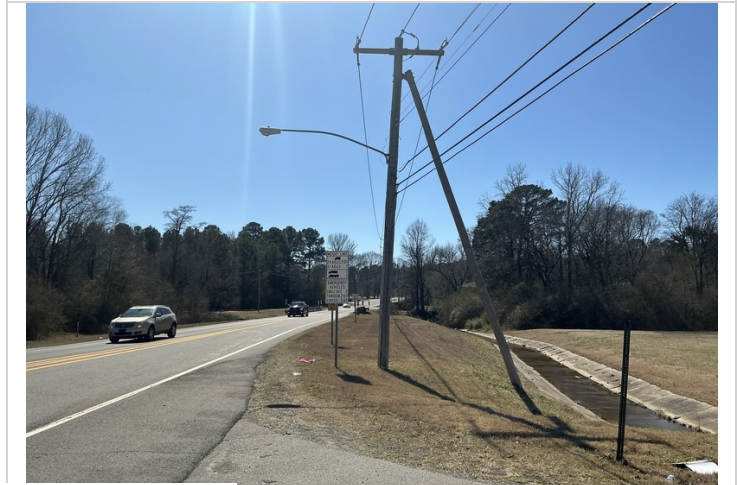
New load posting sign looking west.

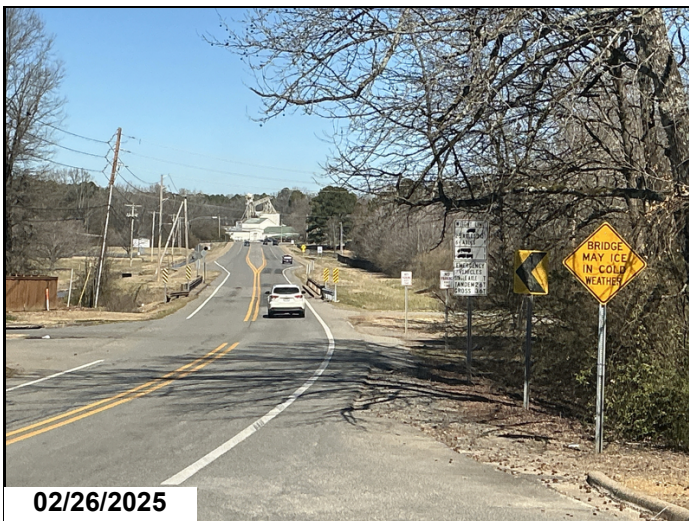
New Recommended Posting Limits for New Load Rating Vehicles and/or Emergency Vehicles:

Posting Vehicle New Recommended Load Posting on NEW Posting Sign

Single Unit (2-5 axles) 30 Tons

EV Tandem 26 Tons

EV Gross 36 Tons

New load posting sign looking east.

State forces have installed new signs that reflect the recommended posting.

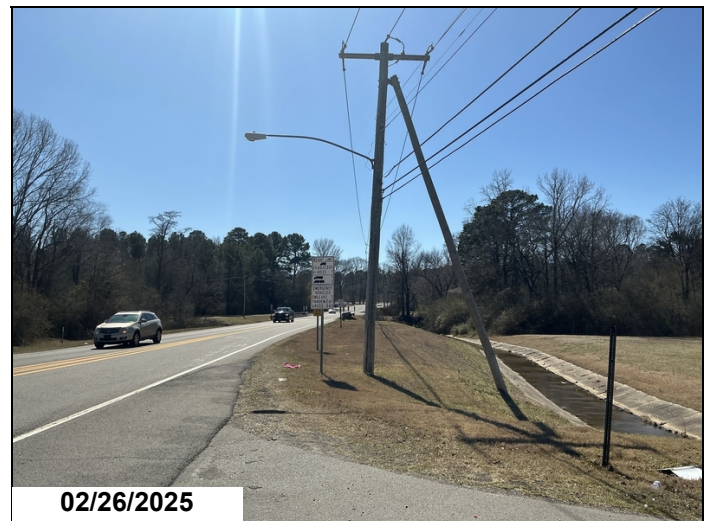
New load posting sign looking west.

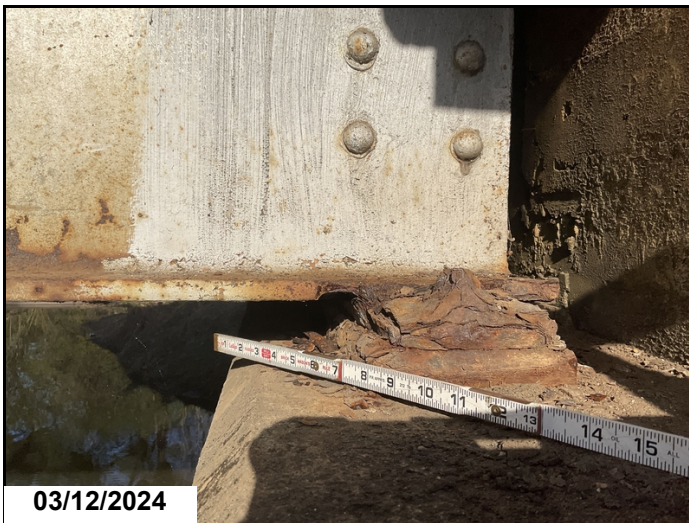
Span 3 Bent 4 girder 4 & 5 has 3/8" pitting to lower flange at bearing area. 2' CS3

Span 3 Bent 4 girder 5 has 3/8" pitting to lower flange at bearing area.

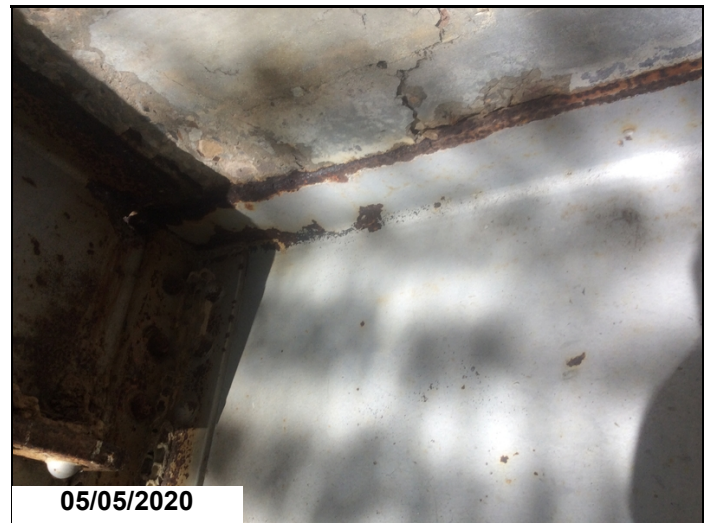
Bent 3 girder ends 1 thru 4 and the top flange at diaphragm all spans have active rust with pitting.

Span 3 beam 3 active rust to top flange at diaphragm mid span. Common all spans.

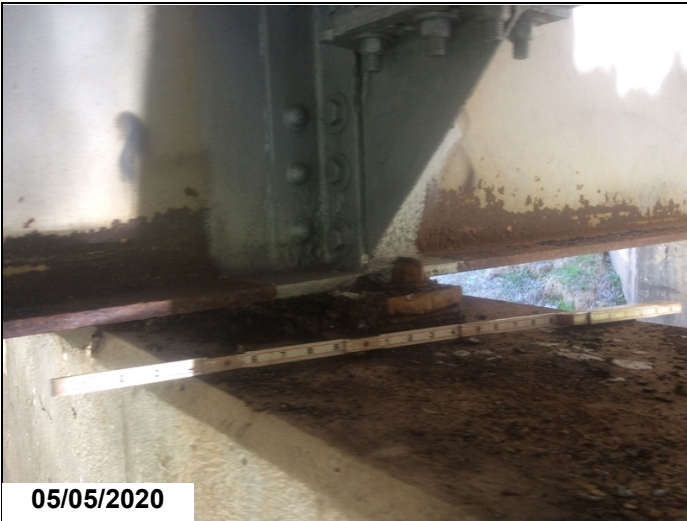
Bent 3 spans 2 and 3 active rust with pitting up to 1/8" deep to bottom flange and lower web. Common beams 1 thru 4.

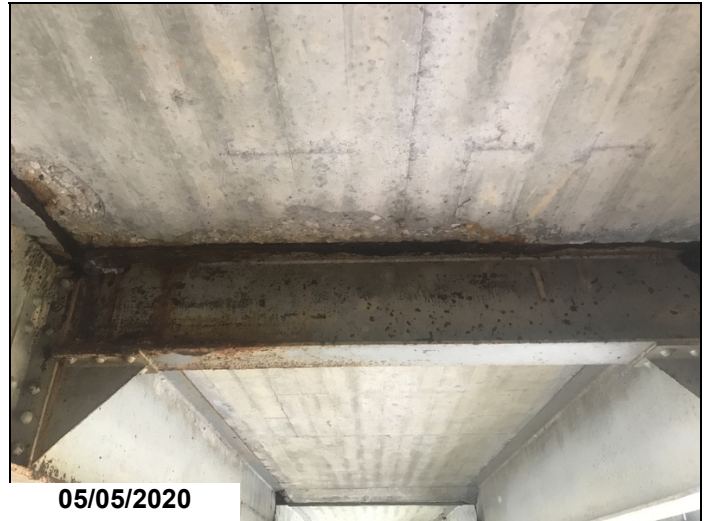
Span 1, diaphragm between Bm 3 & 4, top flange has corrosion.

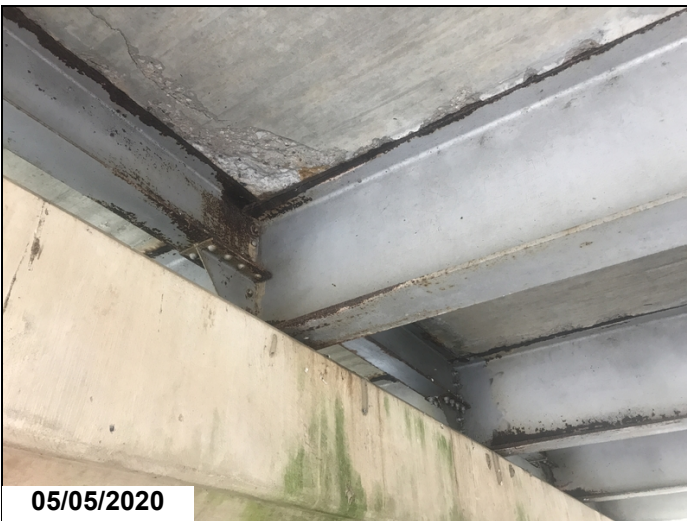
Bt. 3, corrosion on top & bottom flange.

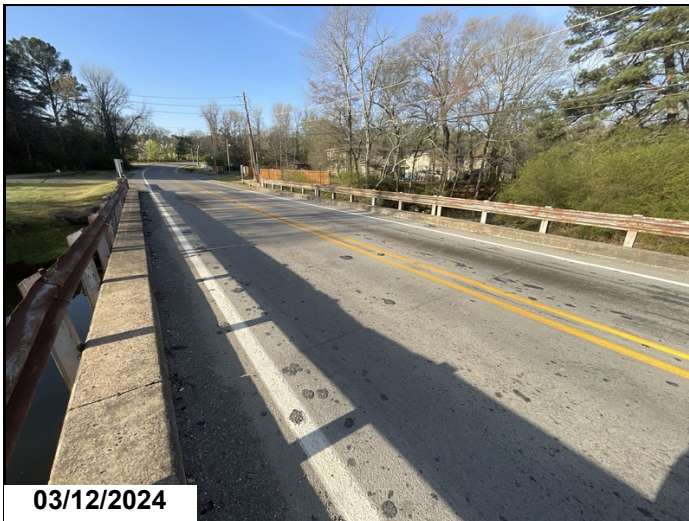
Moderate to large unsealed cracks in all spans. (0.040 inch avg.)

Cracks have been sealed with polymer overlay.

Cracks have been sealed with polymer overlay.

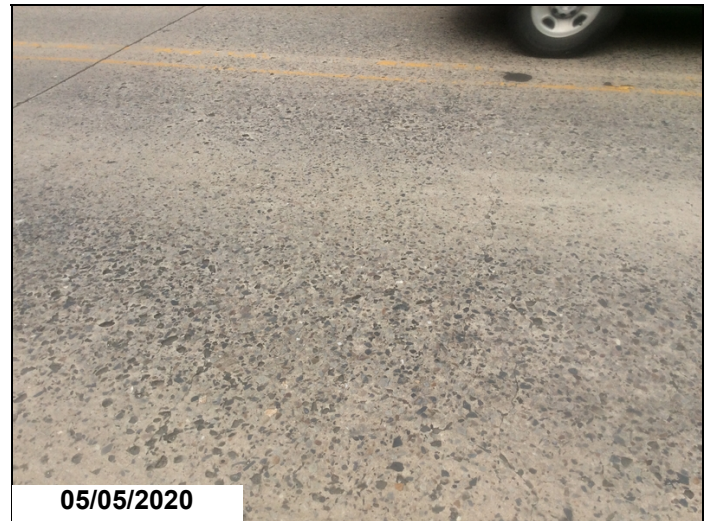
Span 3 large unsealed cracks and abrasion. Up to 0.040".

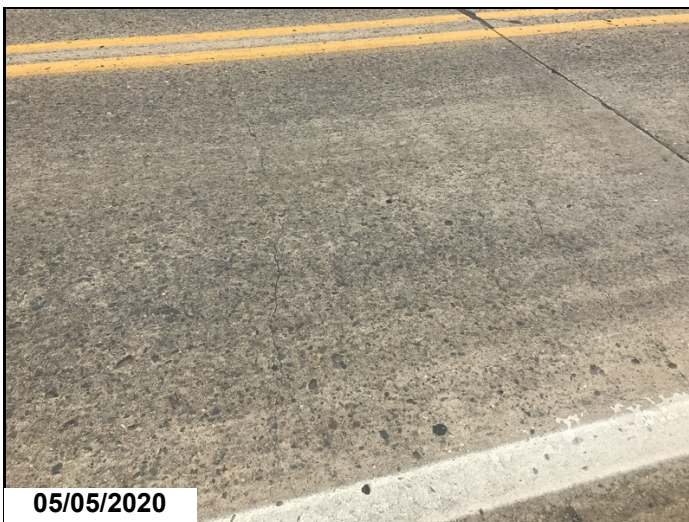
Span 3 large unsealed cracks and abrasion. Up to 0.040".

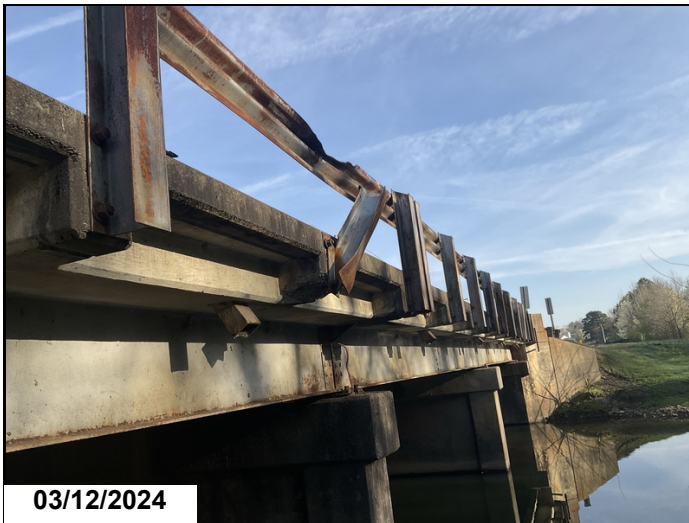
03/12/2024

Span 1 Right side bridge rail is damaged due to traffic impact.

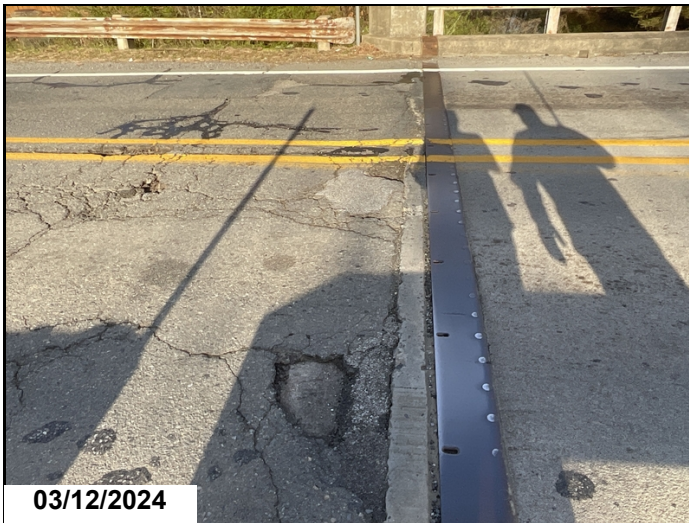
Approach south end of bridge has potholes in the asphalt.
