Bridge 05308 Inspection Report

Route:5 Section:09 Log:3.28

Team Lead: Chris Doggett, Inspection Date: 07/22/2025

SH 5 Log 3.28 over I 430-LOG 1.24

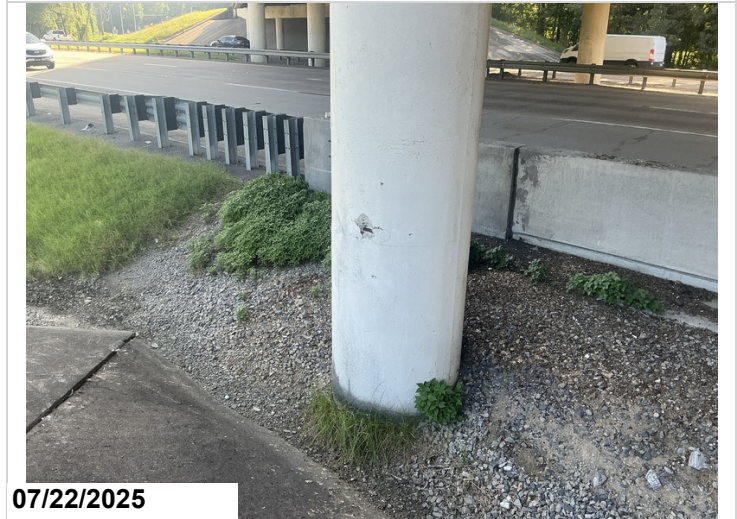
(205) Bent 2 column 1 back spall with exposed rebar.							
215	Reinforced Concrete Abutment	LF	225	214	11	0	0
1120	Efflorescence/Rust Staining	LF	3	0	3	0	0
1130	Cracking (RC and Other)	LF	8	0	8	0	0

Bent 2, column 1: small spall with exposed rebar. CS3-1

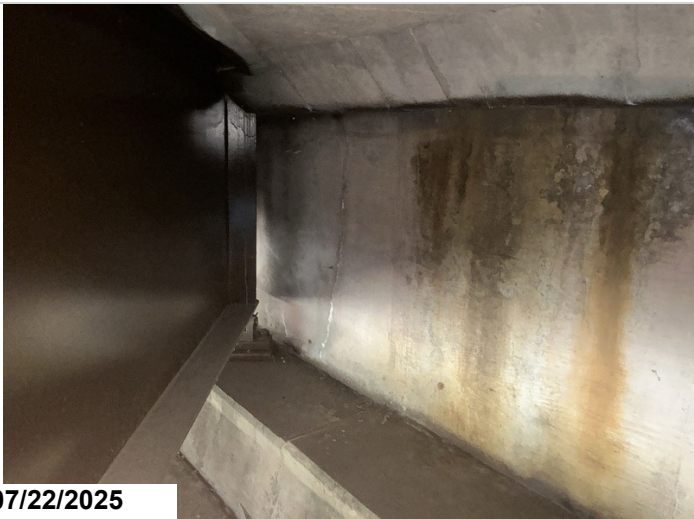
(215) Minor vertical cracks in both backwalls.							
234	Reinforced Concrete Pier Cap	LF	157	156	0	1	0
1090	Exposed Rebar	LF	1	0	0	1	0
(234) Cap at bent 3, left of column 1: small spall with rebar.							
303	Assembly Joint with Seal	LF	209	0	209	0	0
2350	Debris Impaction	LF	209	0	209	0	0

Bent 1: vertical crack with efflorescence staining common to both backwalls.

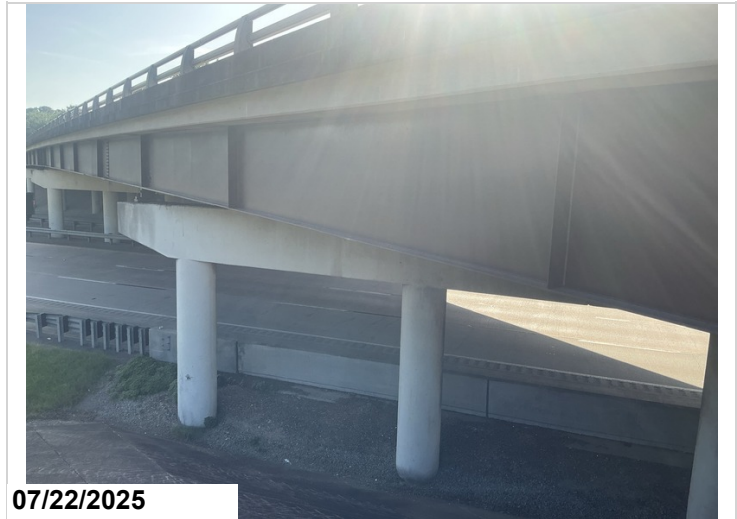
The steel protective coating is in good condition.

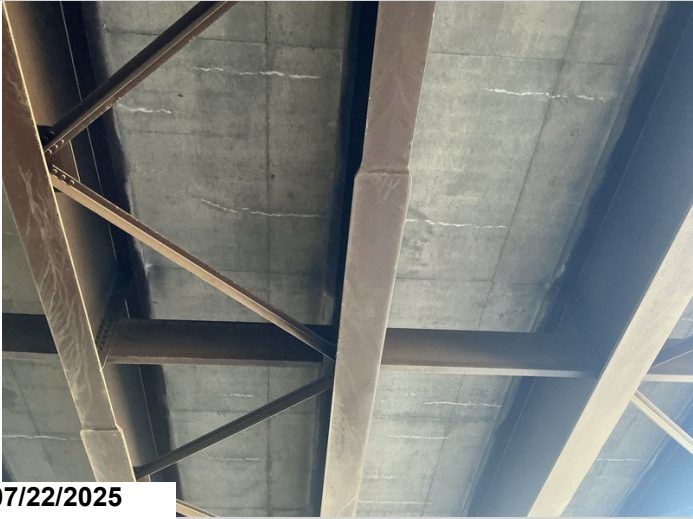
Overall this bridge is in satisfactory condition. The deck has numerous moderate sized cracks that reflect through to the undersurface with efflorescence staining. There are also multiple open spalls with exposed rebar.

Span 3: deck cracking reflecting through to the undersurface with efflorescence staining.

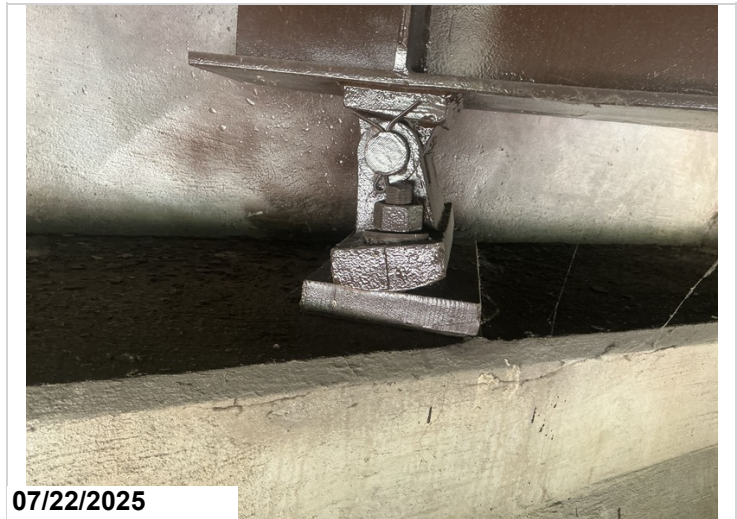
(303) Both joints have sand and gravel impaction							
311	Movable Bearing	EA	36	27	9	0	0
2210	Movement	EA	9	0	9	0	0
(311) All bearings have been repainted. Bent 5 all movable bearing are rotated back.							
313	Fixed Bearing	EA	9	9	0	0	0

Bent 5: general condition of the bearings are good. All bearings at this bent are rotated back.

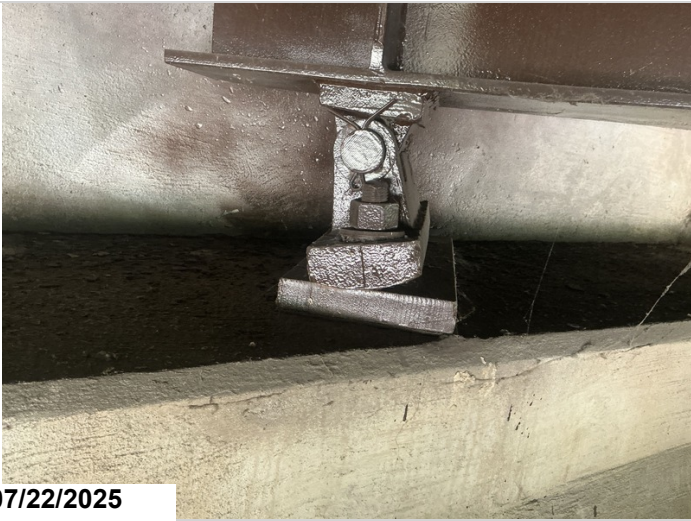
Bent 5: general condition of the bearings are good.

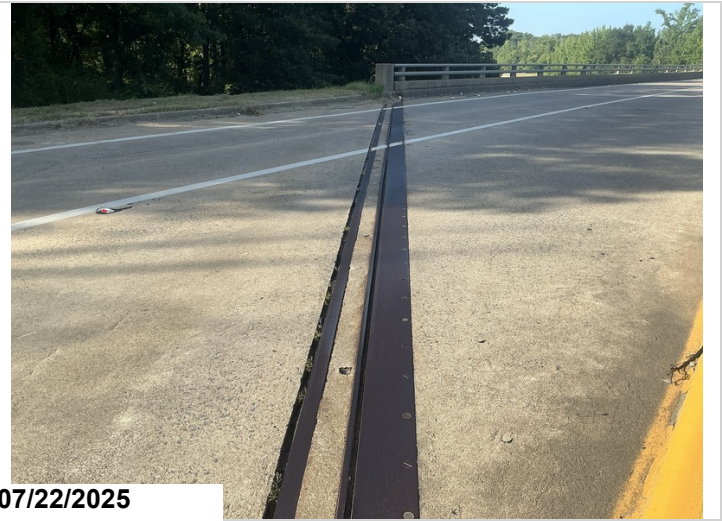
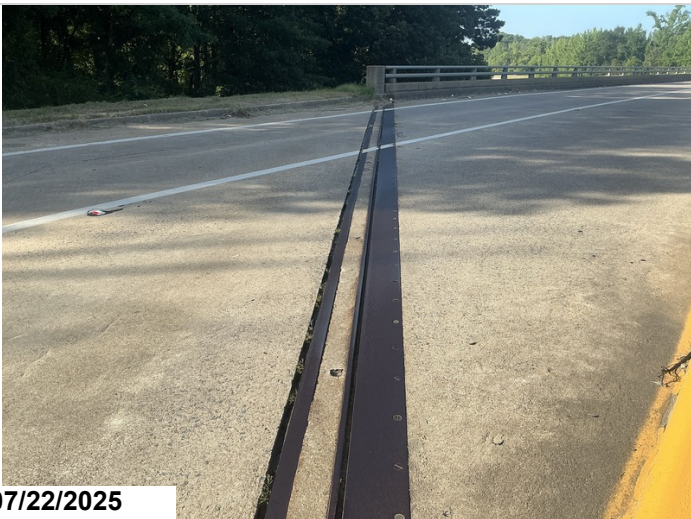
The assembly joints are in good condition. Both joints have material in them near the gutter lines.

A-56 - Joint Cleaning/Flushing Needed (Yes)

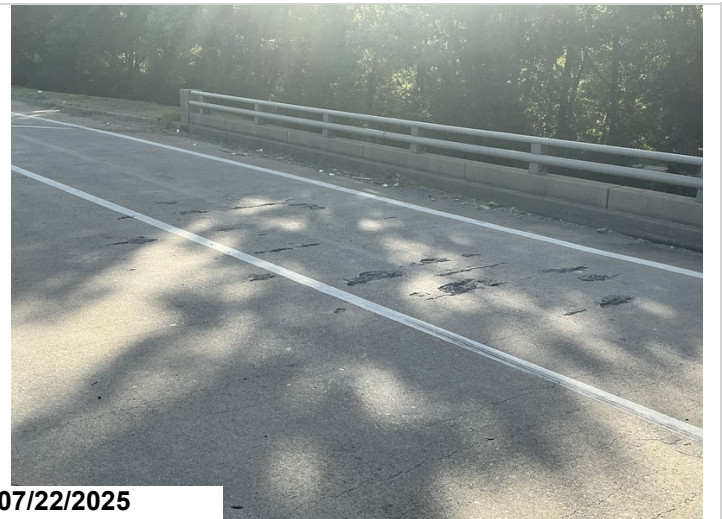
(12) Span 4 north bound lanes has spalls with rebar and delaminations. The deck all spans have large unsealed transverse cracks up to 1/8" wide on two to four foot centers that reflect thru to the soffit showing light efflorescence.							
107	Steel Open Girder/Beam	LF	3620	3617	3	0	0
7000	Damage	LF	3	0	3	0	0
515	Steel Protective Coating	SF	42535	42517	0	0	18
3420	Peeling/Bubbling/Cracking	SF	18	0	0	0	18

Span 4, northbound lanes: there are multiple spalls with exposed rebar. CS3-33sf

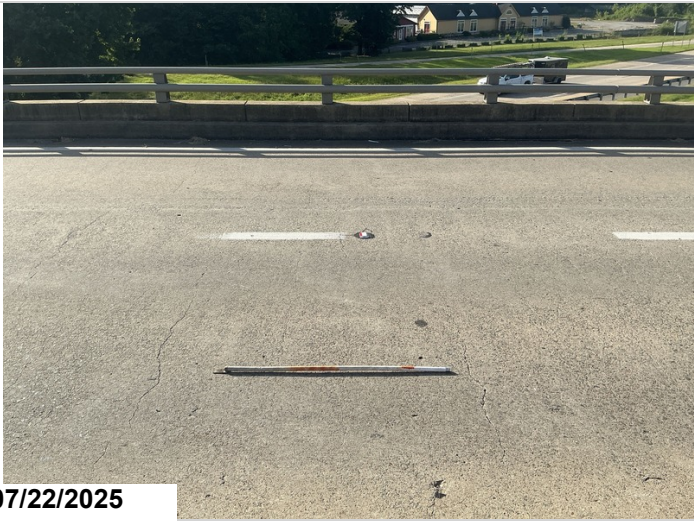
Span 2: the deck with numerous unsealed transverse cracks at a 2' spacing and up to 0.060" in width.

A-54 - Sealable Deck Cracks (Yes)

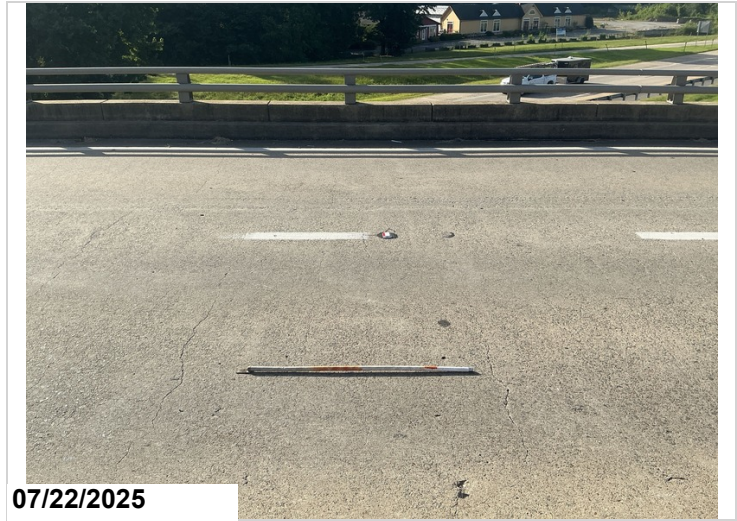
Span 2: the deck with numerous unsealed transverse cracks at a 2' spacing and up to 0.060" in width.

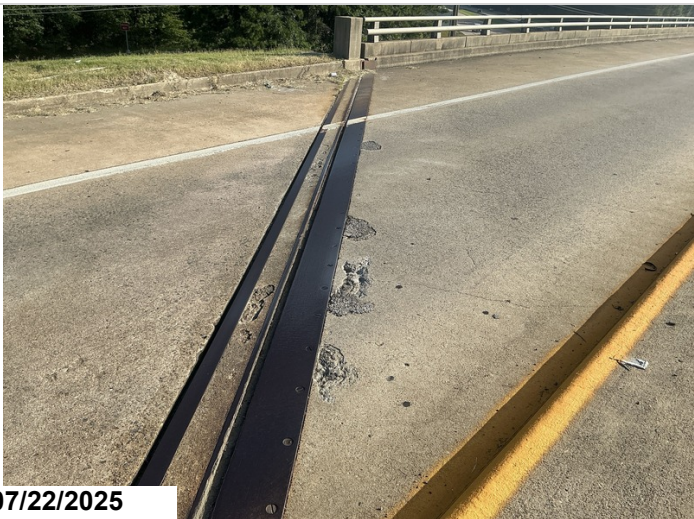
Span 1: multiple spalls filled with asphalt adjacent to the joint. CS3-4

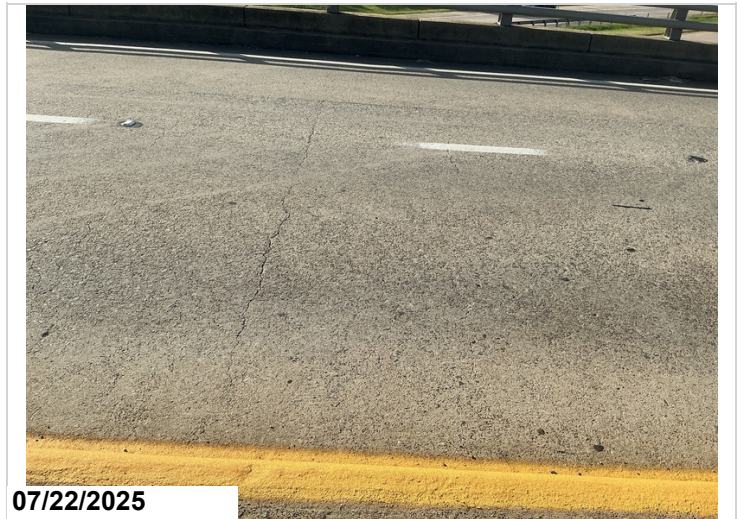
Span 1, northbound side: large unsealed transverse cracks up to 0.060" in width.

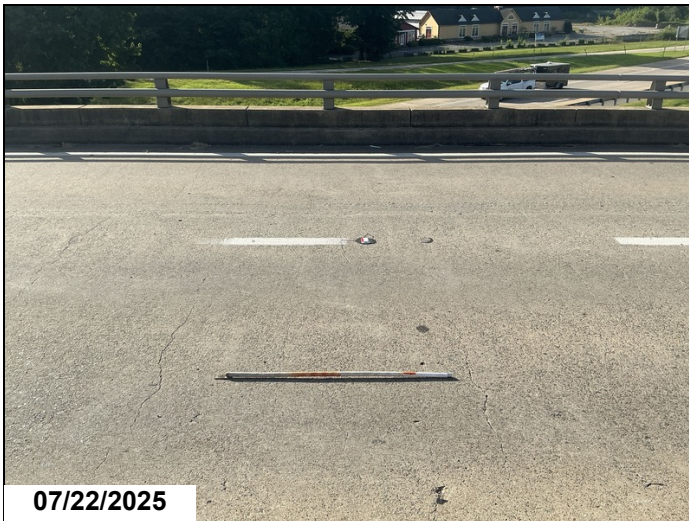
Moderate to large, unsealed transverse cracks.

Avg. width 0.060 with some 1/8 inch to 3/16 inch wide at the surface.

Span 2: the deck with numerous unsealed transverse cracks at a 2' spacing and up to 0.060" in width.

Type of Work: Deck Repair

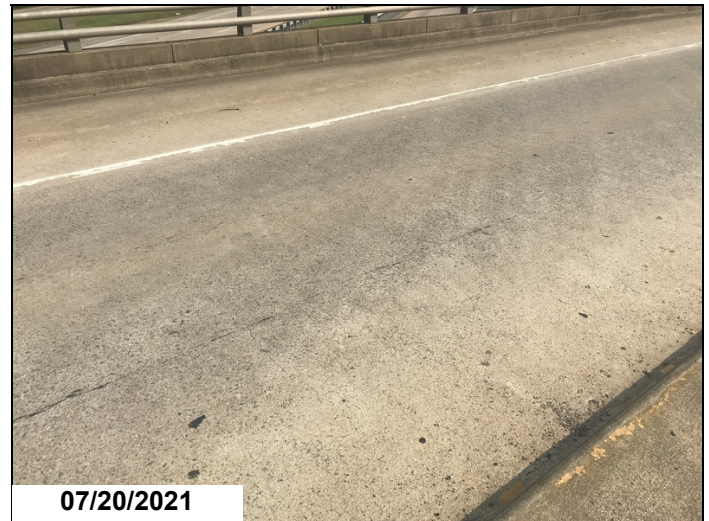
Deck cracks

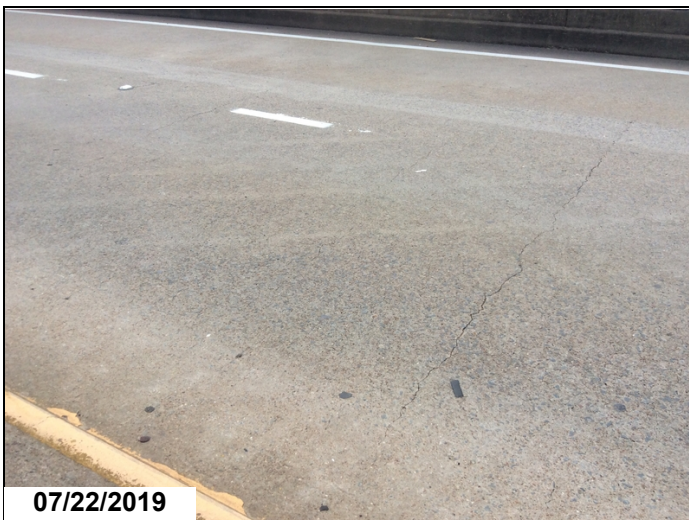
Span 1 large unsealed cracks up to 0.060"

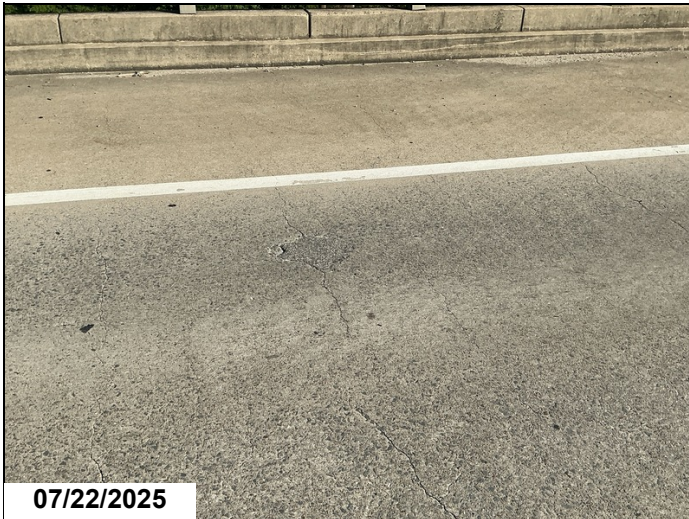
Span 2: spall that has been patched with asphalt.

Type of Work: Repair (General)

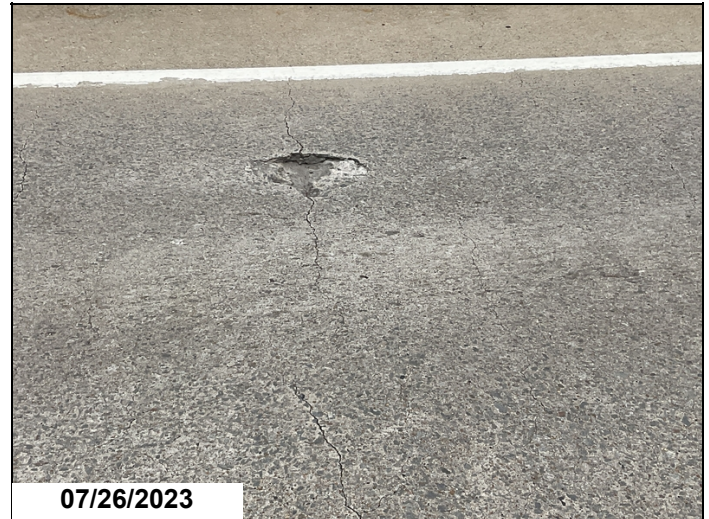
Span 4 North bound has small spalls with rebar exposed.
Span 2 south bound lane spall with exposed rebar.

Span 2 deck south bound lane spall with exposed rebar.

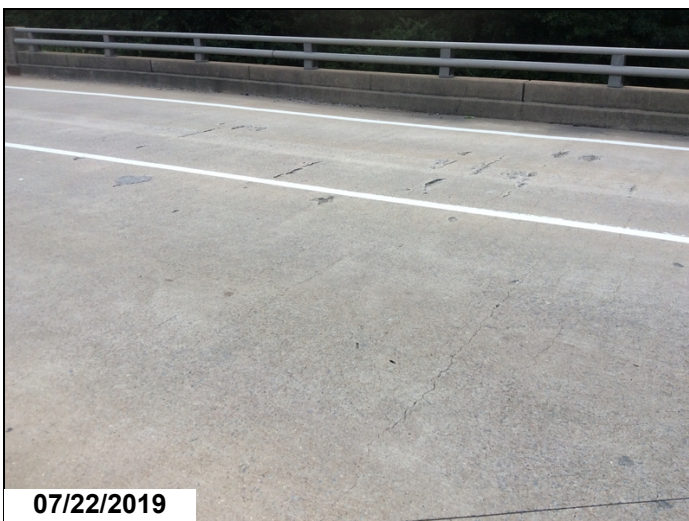
Span 4 northbound lanes spalls with exposed rebar

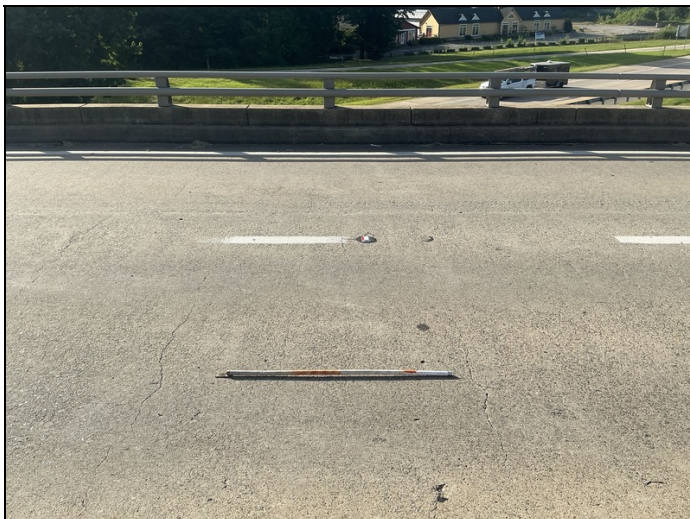
Deck surface All spans Moderate to large, unsealed transverse cracks. Avg. width 0.060 with some 1/8 inch to 3/16 inch wide at the surface.

Span 2: the deck with numerous unsealed transverse cracks at a 2' spacing and up to 0.060" in width.
