Bridge 07210 Inspection Report

Asset #07210(Routine)
SH 70 over MCHENRY CREEK
Location: 0.5 MI NE OF I-430

Team Lead: Chris Doggett Inspection Date: 04/16/2025

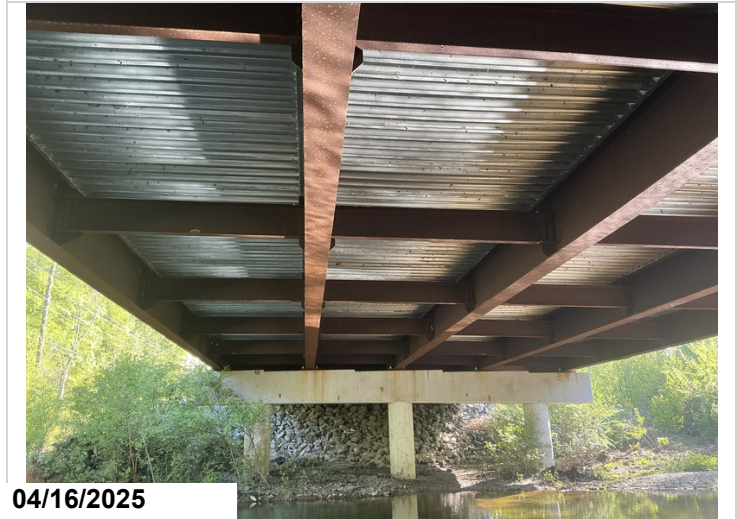
Undersurface view

The superstructure is in very good condition with the weathering steel has a dark patina firmly attached.

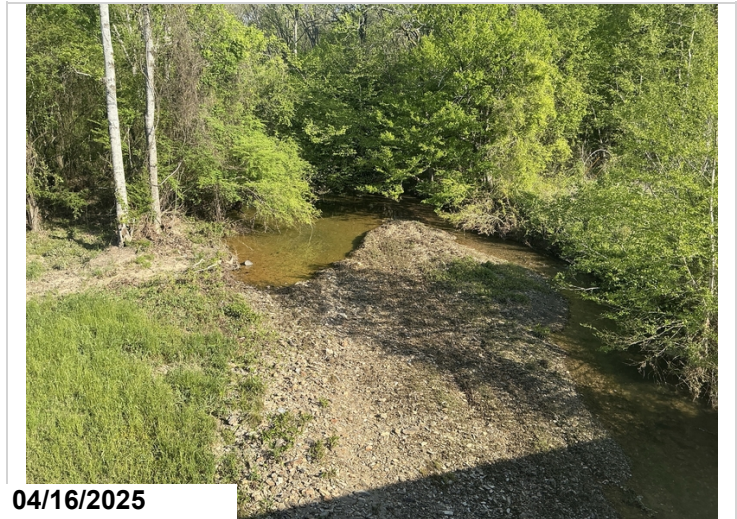
Channel looking upstream

The channel is well vegetated and protected with dumped rip rap.

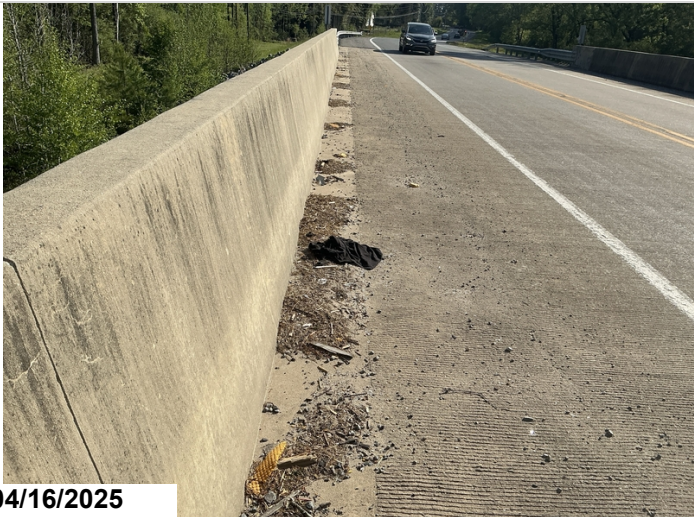
Gutterline full of debris

A-55 - Deck Washing Needed (Yes)

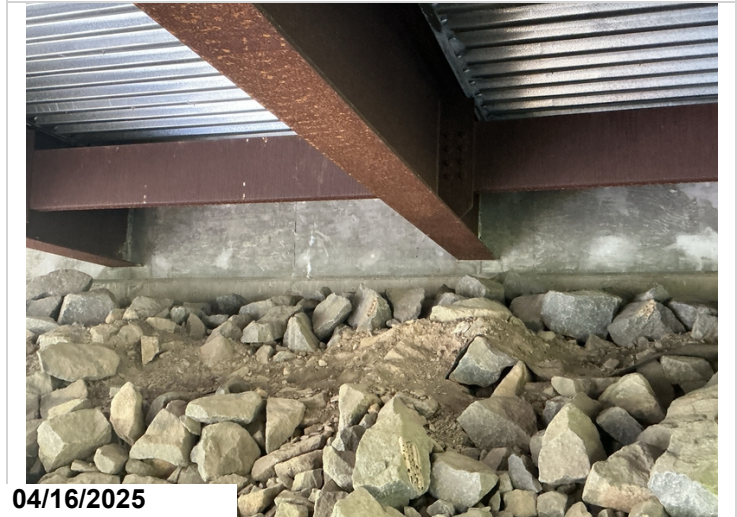
The substructure is in very good condition. There is one small vertical cracks at the bent 1 backwall.

(215) Small crack in both abutments Bent 1 has vertical crack with efflorescence. CS2-3'							
234	Reinforced Concrete Pier Cap	LF	82	82	0	0	0
(234) No deficiencies observed.							
313	Fixed Bearing	EA	10	10	0	0	0

Bent 1: multiple vertical cracks with efflorescence staining.

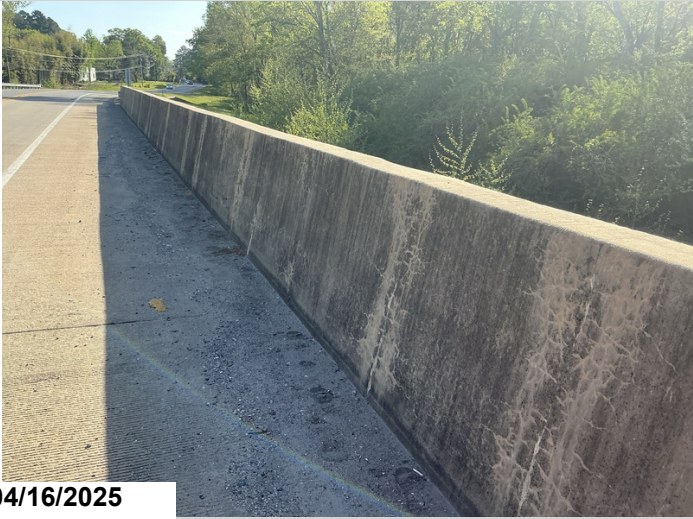
(331) Numerous vertical cracks in both rails. CS2-52'

Right concrete railing with numerous vertical cracks at a 4' spacing.

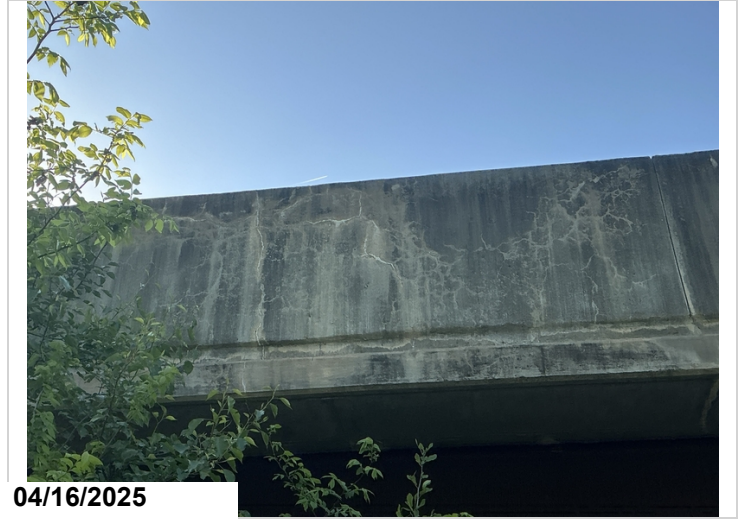
Span 1: left rail with large section of map cracking and efflorescence staining.

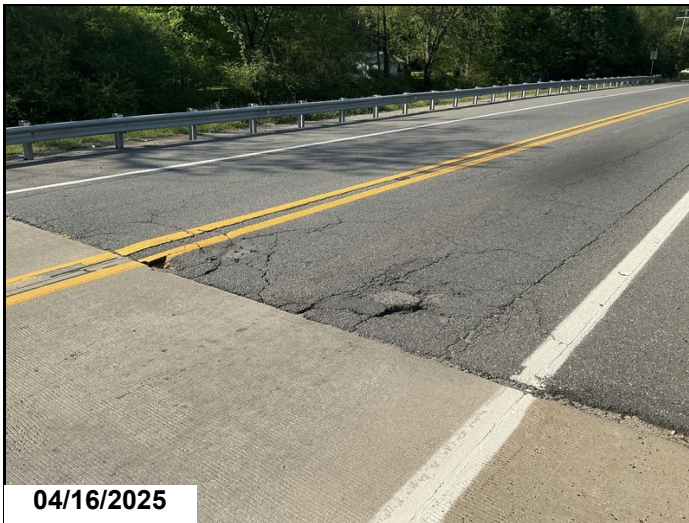
Both at the south and north sides of the bridge the approaching roadway has pot holes.

The south approaching pavement with a couple of pot holes.

Type of Work: Approach Leveling/Maintenance

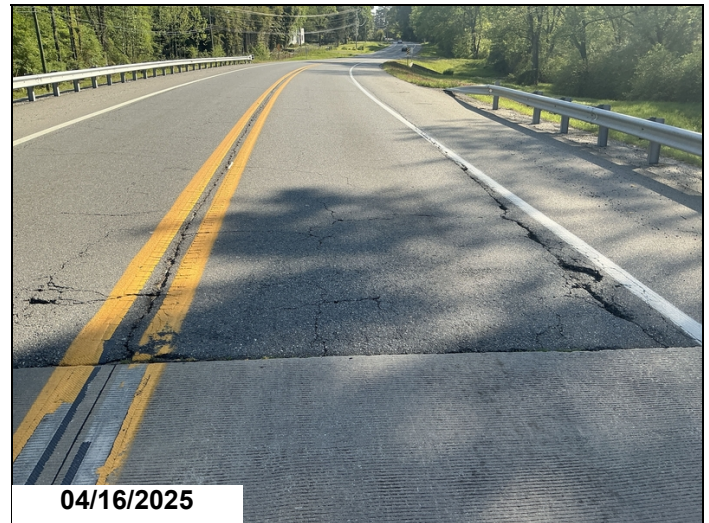
North approach with pot holes.

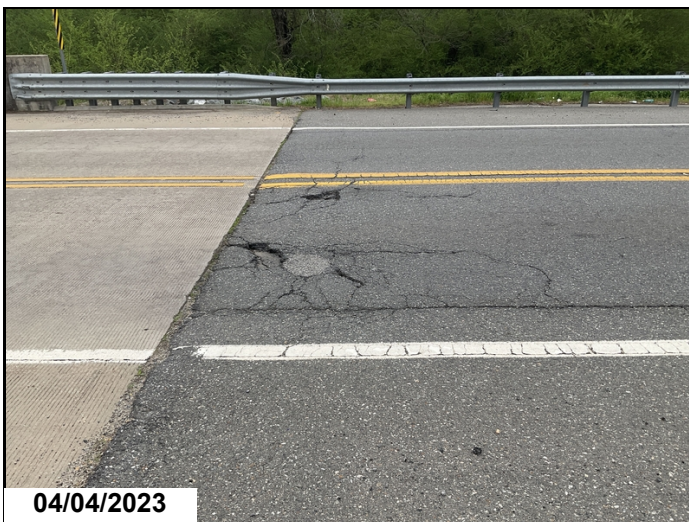
South asphalt roadway pot holes in the approach roadway

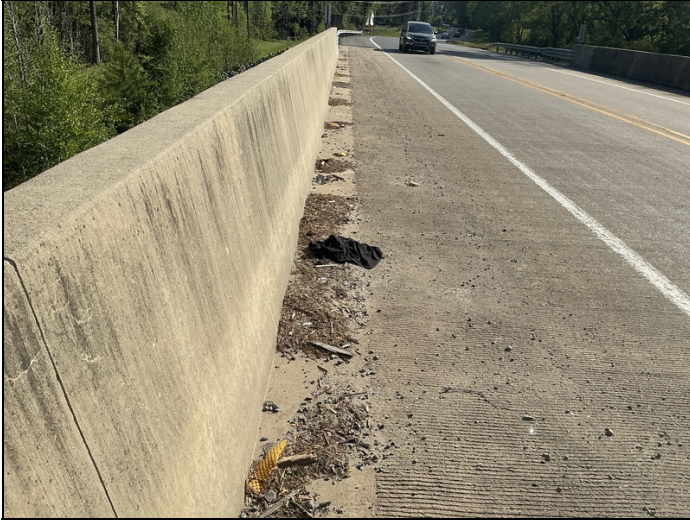
Gutterline full of debris
