## Bridge 07284 Inspection Report

US 70/Roosevelt Rd over Rice St. & UPRR

Location: 1 MI E of Jct Asher Rd

Team Lead: Jonathan Gonzalez Inspection Date: 09/05/2025

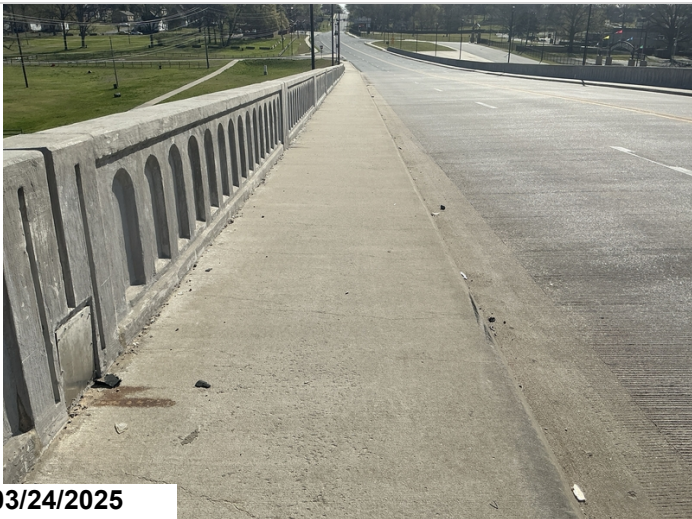
Overall the deck is in good condition. Transverse and longitudinal cracks on the deck in all spans. 0.010 to 0.015 crack width.  
The sidewalk has numerous unsealed transverse cracks at an average spacing of 4 feet. This is common to the opposite sidewalk.

The sidewalk has numerous unsealed transverse cracks at an average of 4 foot spacing. This is common to the opposite sidewalk.

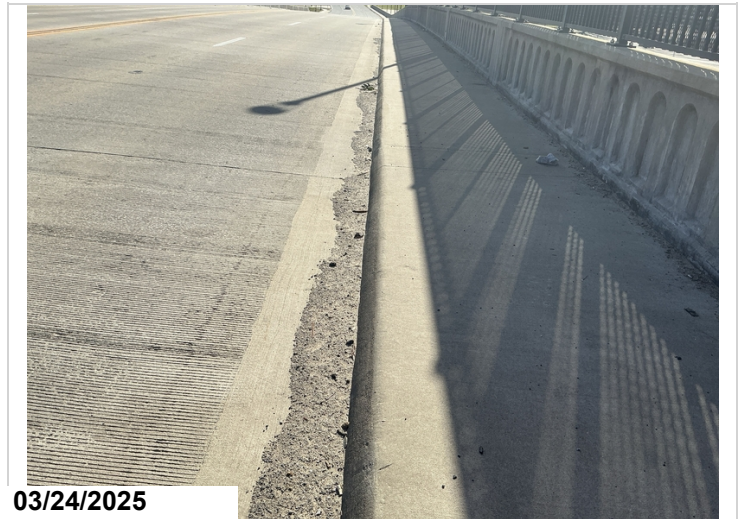
Debris in the right gutter line

**A-55 - Deck Washing Needed (Yes)**

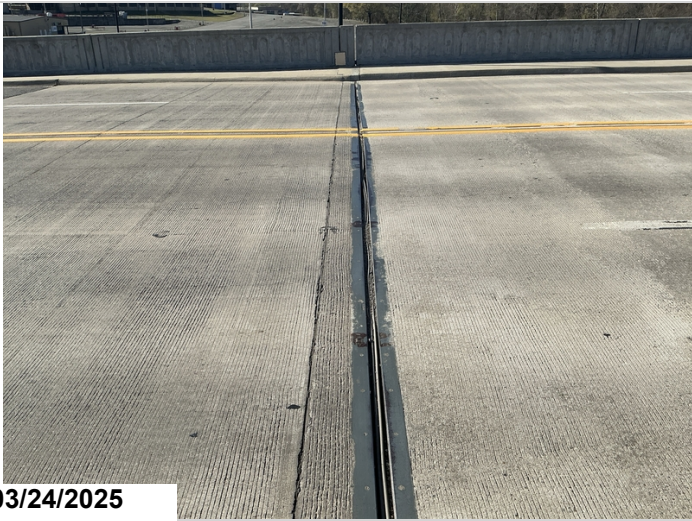
(302) Joints have scattered sections that have lost bond allowing dirt and water to flow on to beam ends.							
Debris impaction typical of all joints.							
305	Assembly Joint without Seal	LF	39	39	0	0	0

Bent 6: joint seal full of debris.

**A-56 - Joint Cleaning/Flushing Needed (Yes)**

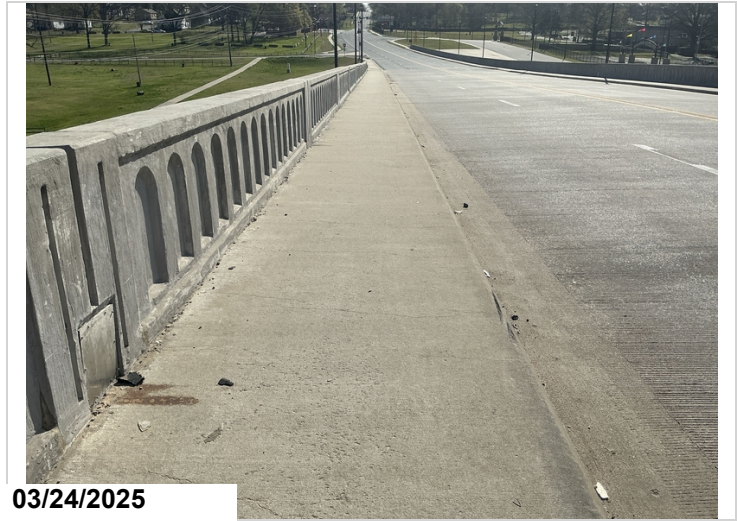
The sidewalk has numerous unsealed transverse cracks at an average of 4 foot spacing. This is common to the opposite sidewalk.

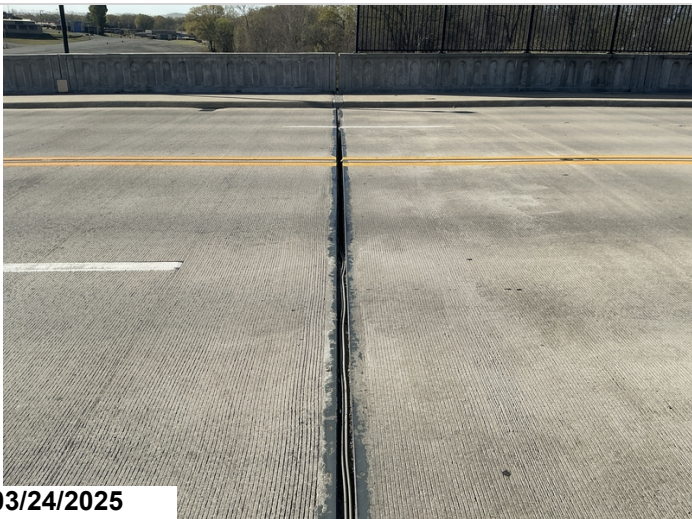
Bent 4: joint seal has fallen at the middle 2 lanes. CS4-20'

**A-59 - Joint Repair Needed (Yes)**

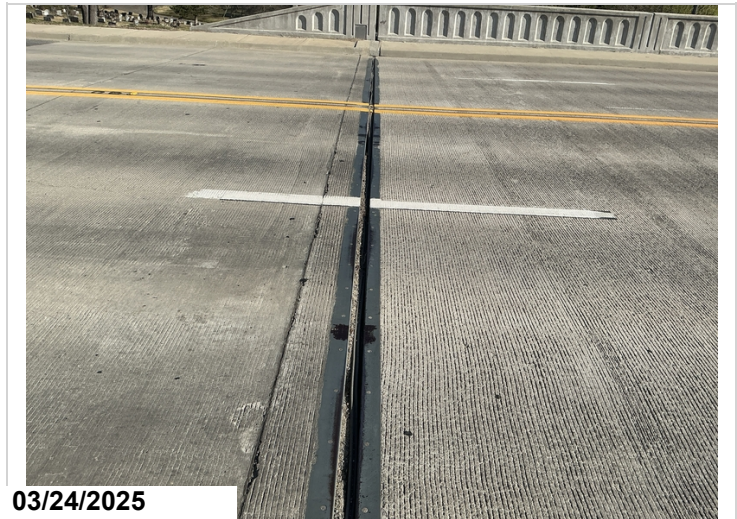
Bent 1: joint seal is full of debris.

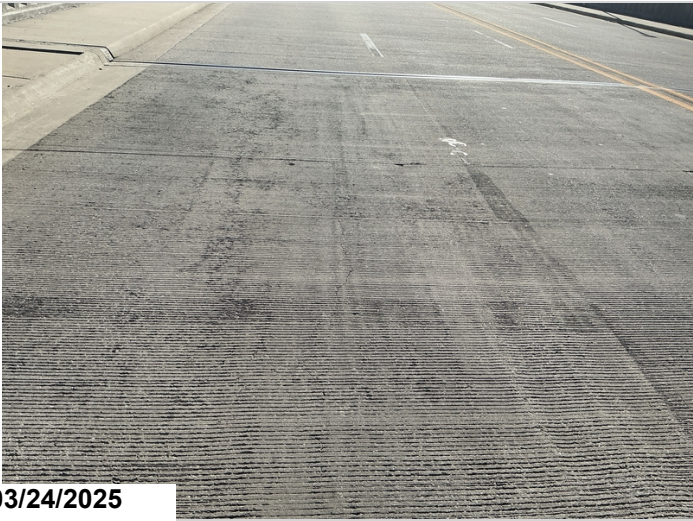
(321) Both approach slabs have Longitudinal cracks.

West approach slab with large longitudinal cracking.

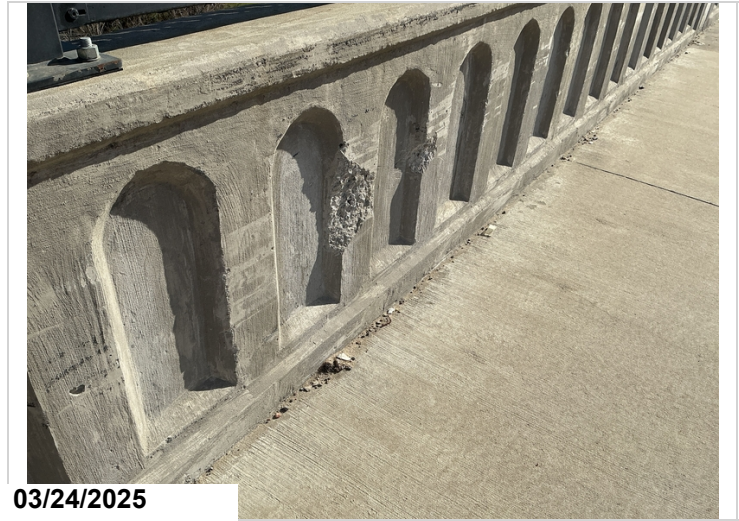
Span 2, left rail: spall due to vehicle impact. CS3-2'

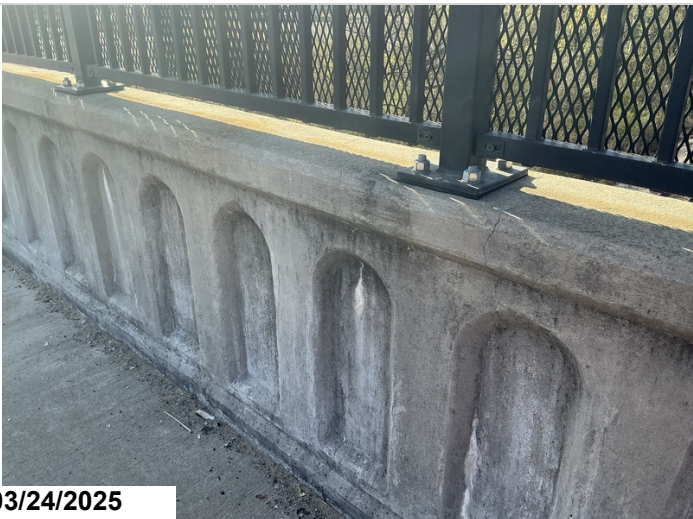
ELEMENTS	DESCRIPTION	UNITS	TOTAL	CS1	CS2	CS3	CS4
331	Reinforced Concrete Bridge Railing	LF	1320	1127	193	0	0
1120	Efflorescence/Rust Staining	LF	137	0	137	0	0
1130	Cracking (RC and Other)	LF	56	0	56	0	0
(331) Vertical cracks and cracks with efflorescence in both bridge rails.

Right rail with numerous vertical cracks with efflorescence staining.

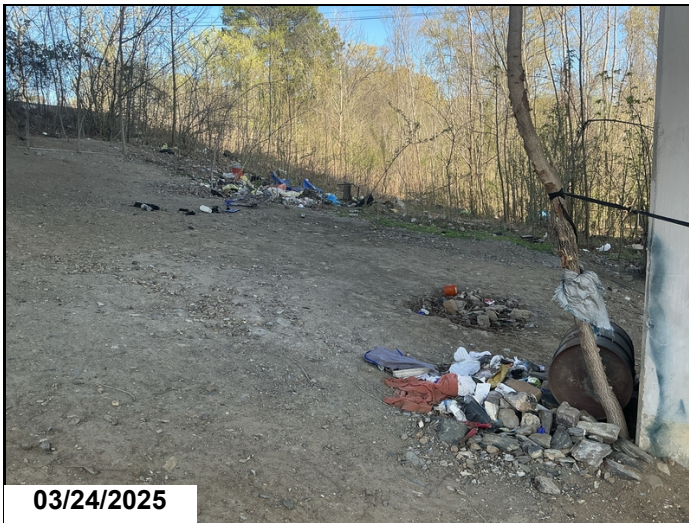
Span 2: homeless encampment and trash.

**Status:** Monitor

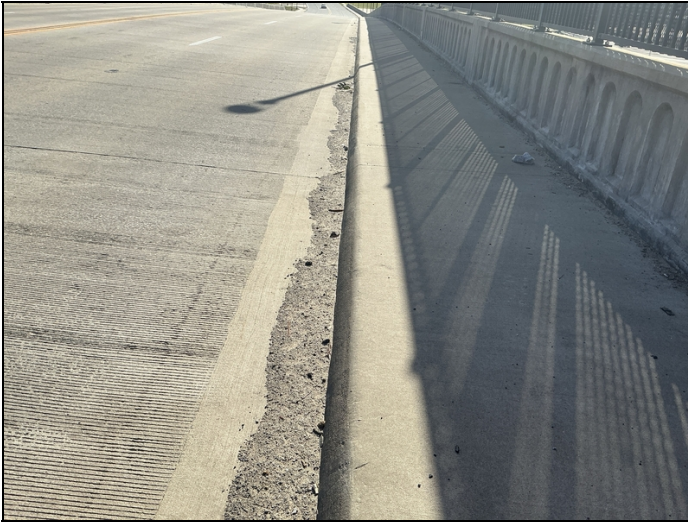
Debris in the right gutter line

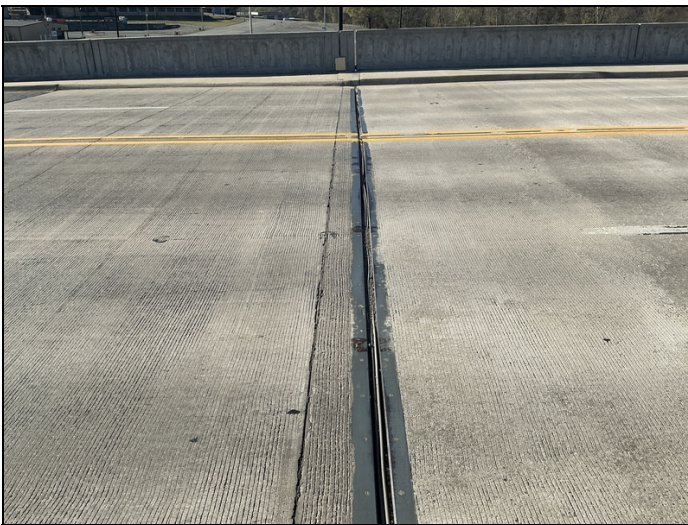
Bent 6: joint seal full of debris.
