## Bridge M0129 Inspection Report

Route:70 Section:12 Log:1.016

Team Lead: Chris Doggett, Inspection Date: 10/01/2025

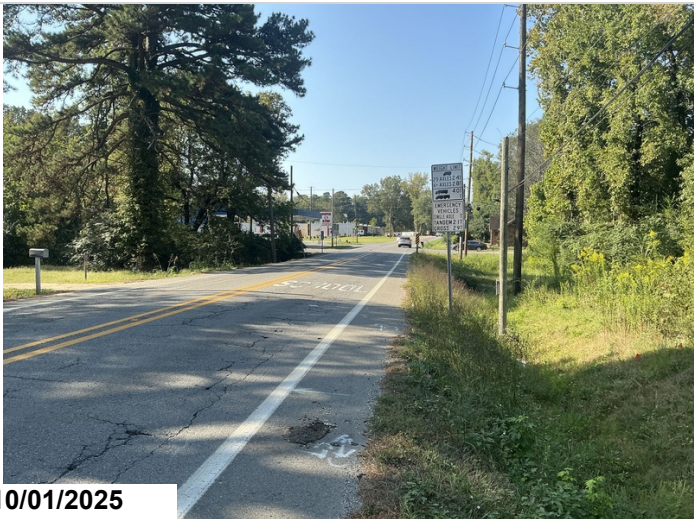
Load posting sign looking west.

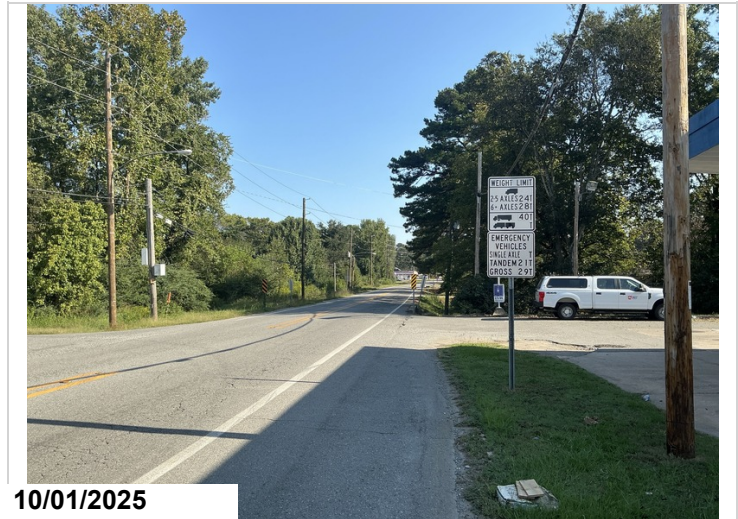
Load posting sign looking east.

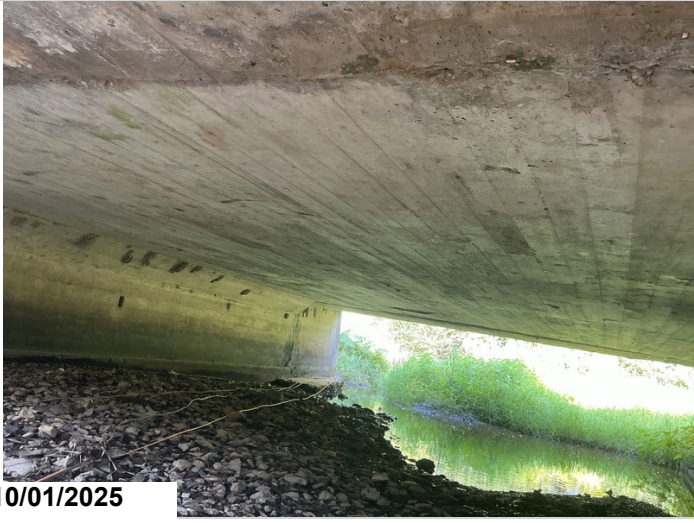
Under surface view

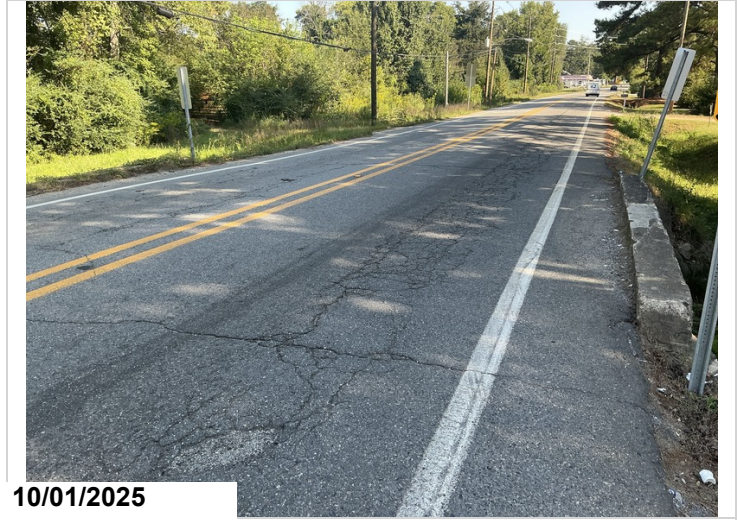
Deck view

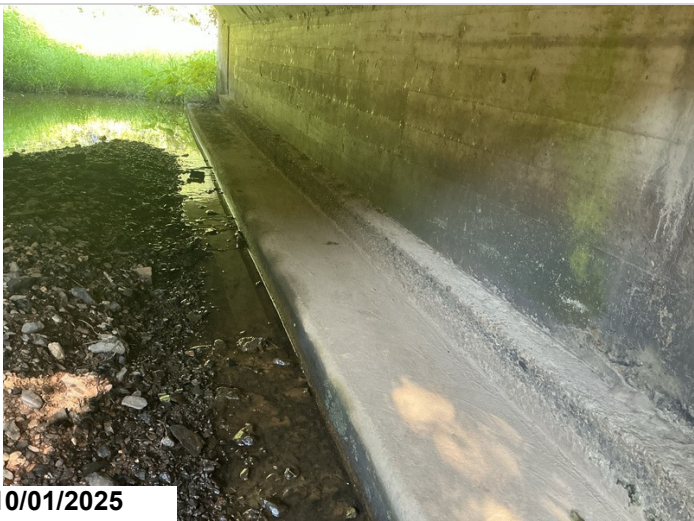
(220) Footings exposed at both abutments.

Bent 2: footing is exposed and the countermeasure is working as intended.

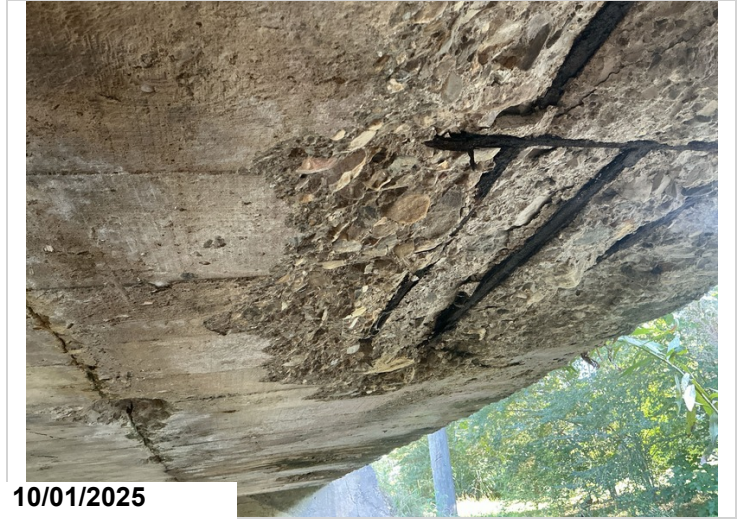
(38) Deck has dirt and gravel fill with asphalt wearing surface. The undersurface has multiple large spalls with exposed rebar that has measurable section loss. CS3- 18sf of spalling, CS3-16' delam (510-38) Map cracking all throughout the asphalt wearing surface.							
215	Reinforced Concrete Abutment	LF	93	86	2	5	0
1080	Delamination/Spall/Patched Area	LF	5	0	0	5	0
1130	Cracking (RC and Other)	LF	2	0	2	0	0

The undersurface has multiple large spalls with exposed rebar that has measurable section loss. CS3- 18sf of spalling, CS3-16' delam

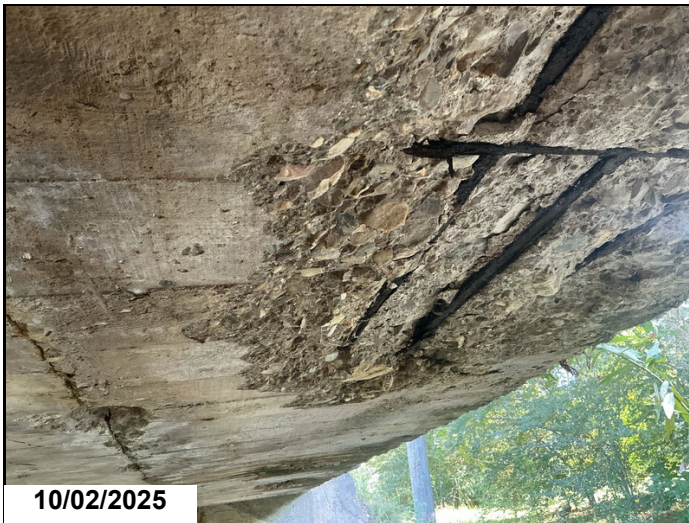
10/02/2025

Undersurface has large spalls with rebar exposed at the south west end of the bridge.

The undersurface has multiple large spalls with exposed rebar that has measurable section loss. CS3- 18sf of spalling, CS3-16' delam 2025

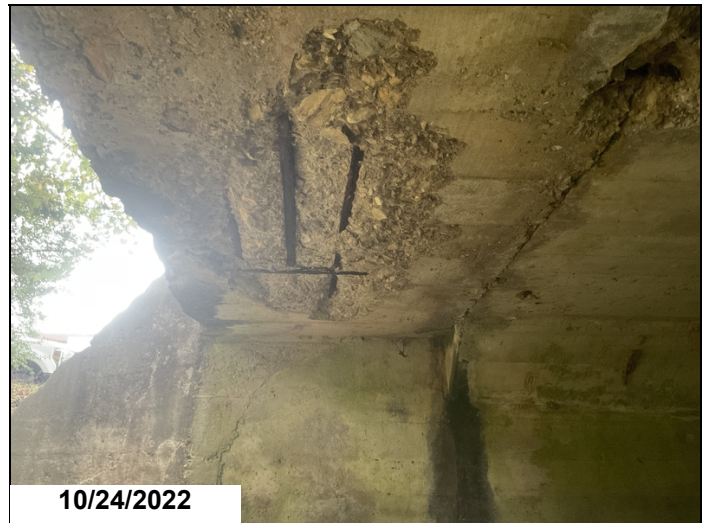
10/24/2022

Spall with exposed rebar towards bent 1 right side soffit.

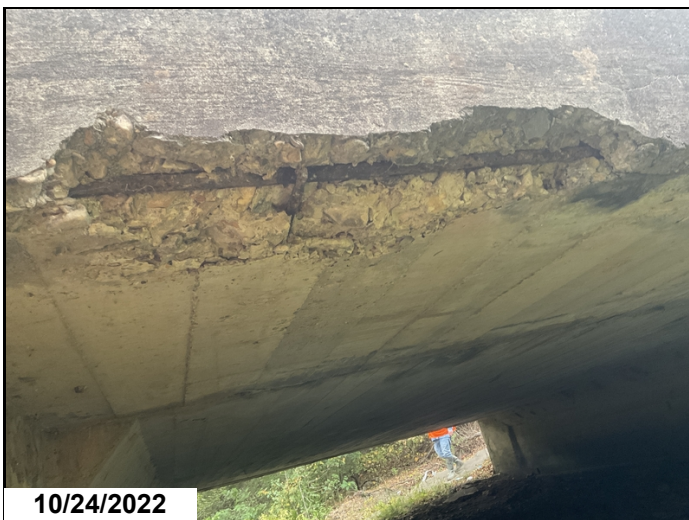
10/24/2022

Spall with exposed rebar towards bent 2 left side soffit.

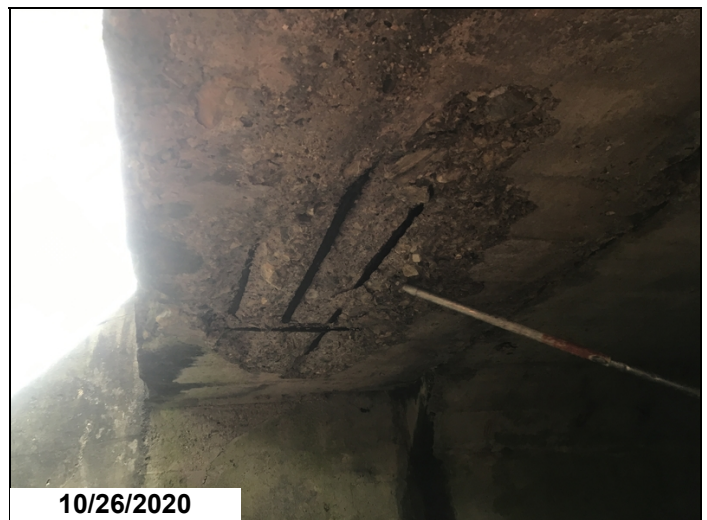
10/26/2020

Large spall with rebar exposed in the soffit

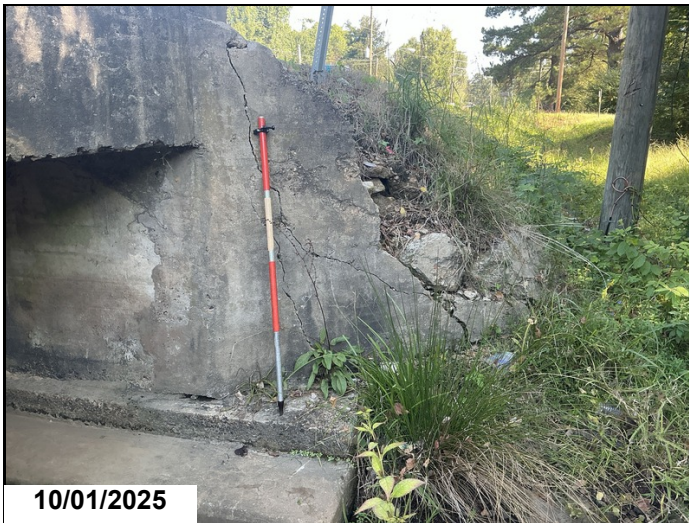
Right wing wall at bent 2 is damaged from traffic impact

Right wing wall at bent 2 is damaged from traffic impact.  
2025

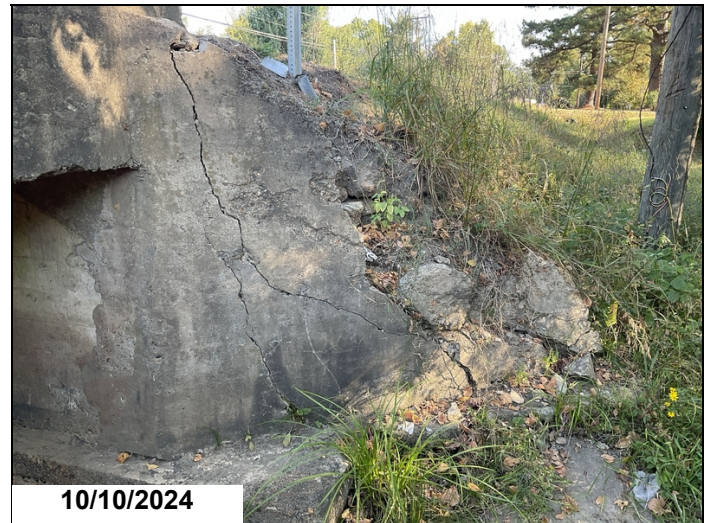
Right wing wall at bent 2 is damaged from traffic impact.  
2024

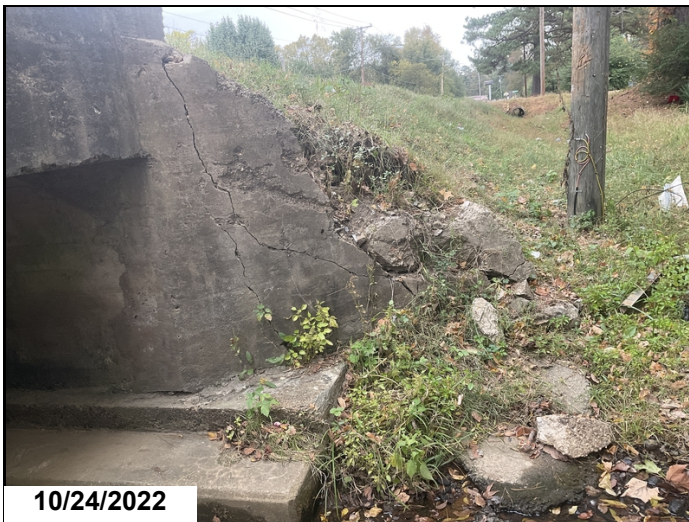
Right wing wall at bent 2 is damaged from traffic impact

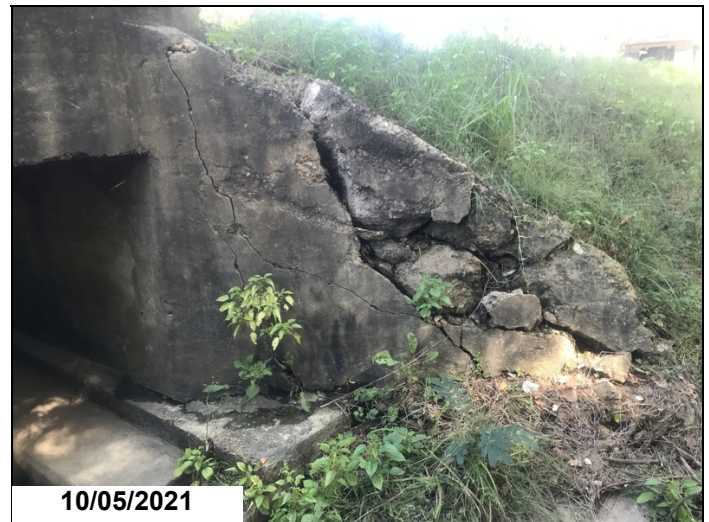
Right side at bent 2, damage to wing wall.

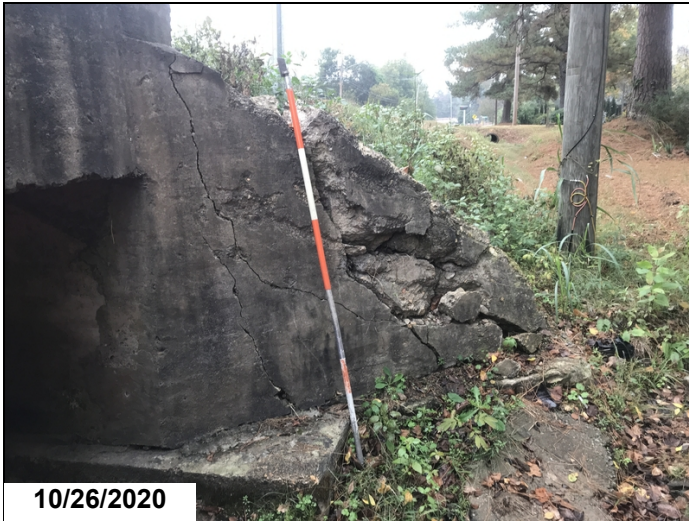
Southeast wing wall impact damage

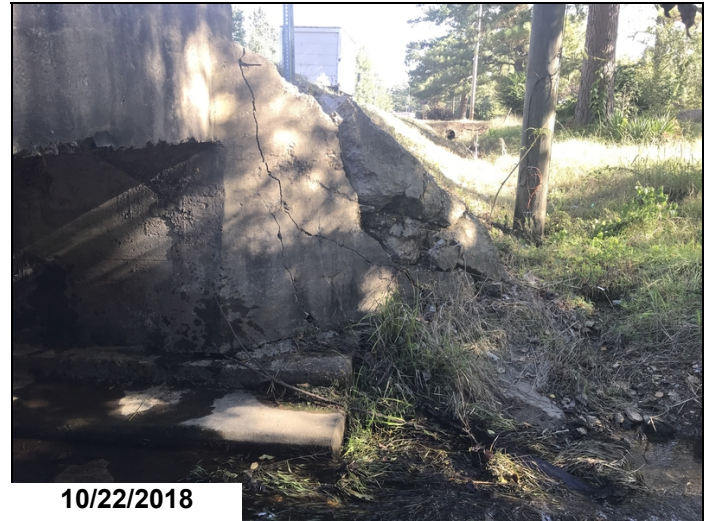
Right wing wall at bent 2 damaged from traffic impact

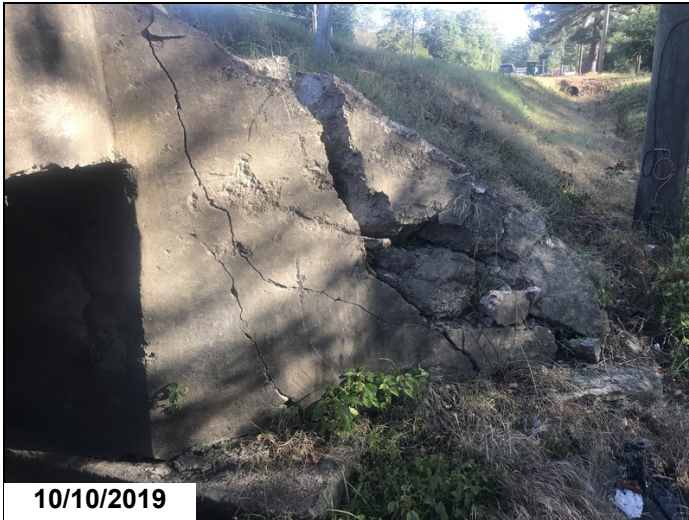
Right wing wall at bent 2 is damaged from traffic impact
