## Bridge 07635 Inspection Report

Route:63 Section:11 Log:10.7

Team Lead: Joseph Rapier, Inspection Date: 11/13/2025

Asset #07635 (Initial, Routine)  
US 63 Log 10.70 over WOLF BAYOU  
Location: 2.5 M N OF SH 86 WEST

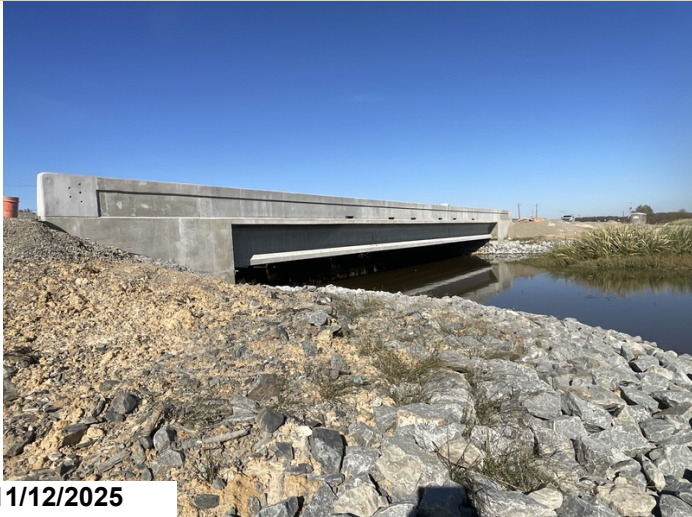
Elevation.

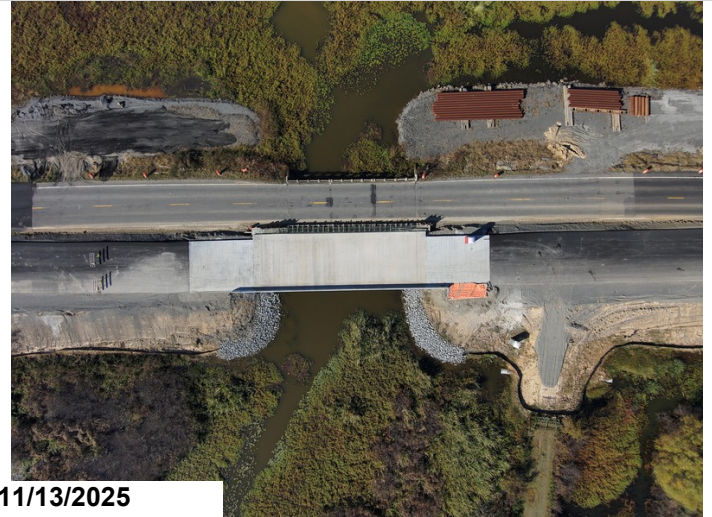
Deck overview.

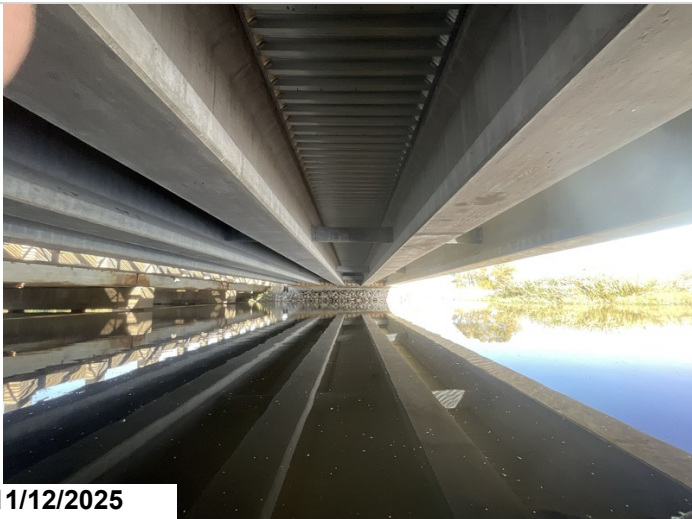
Undersurface view.

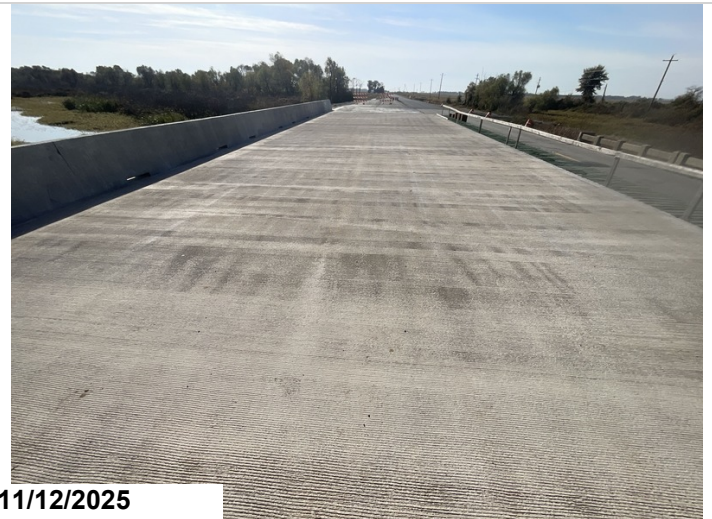
Overall the deck is in very good condition. There were no notable defects observed at the time of this inspection. The structure is under staged construction.

Deck view.

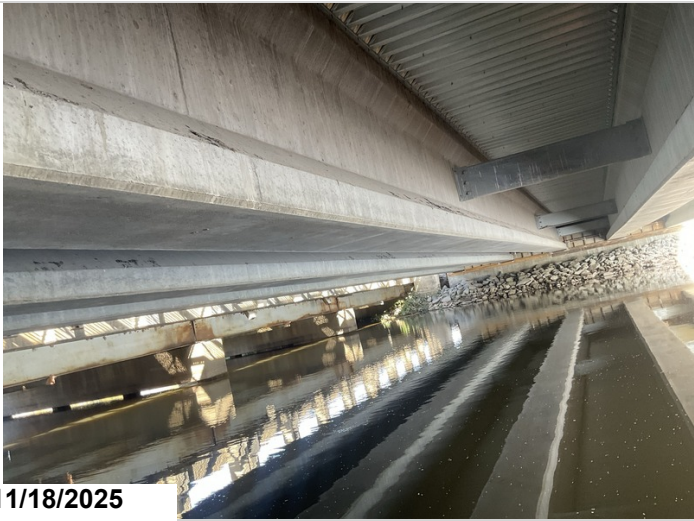
General prestressed concrete girder condition.

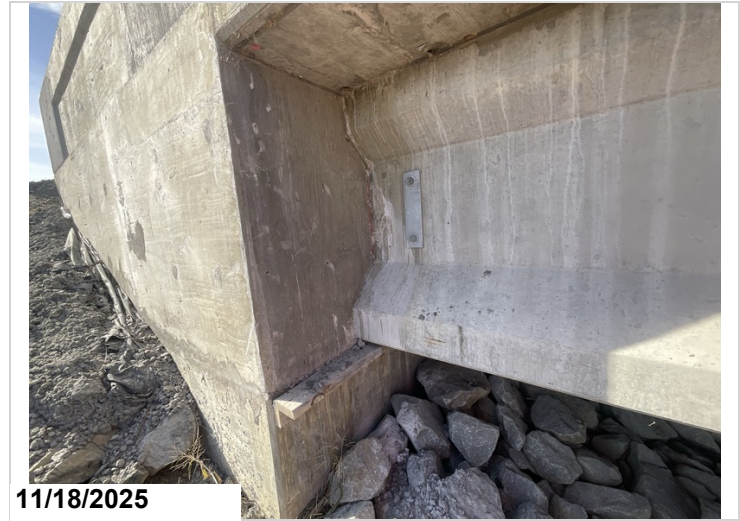
Integral abutment.

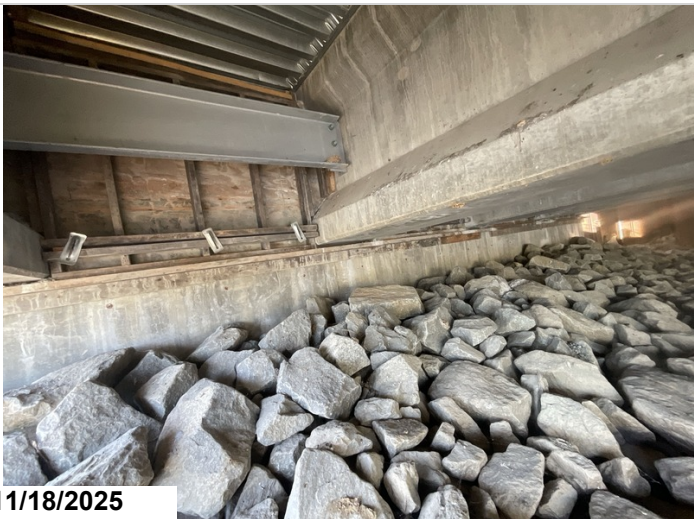
Bent 2: integral abutment overview.

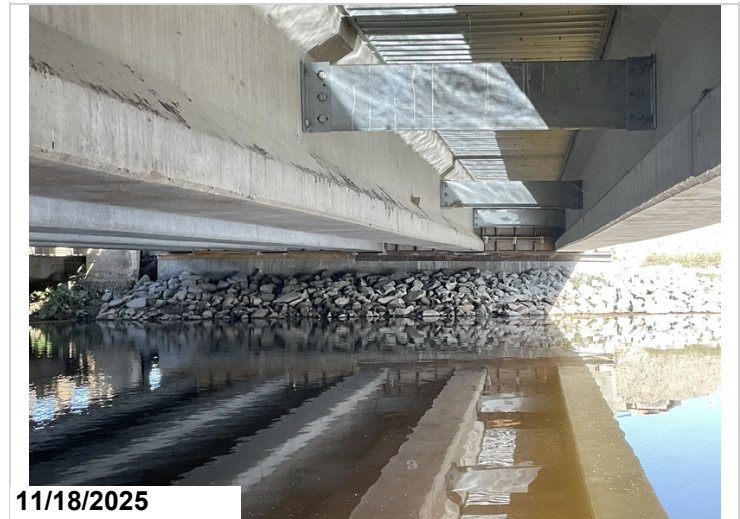
Bent 1: integral abutment overview.

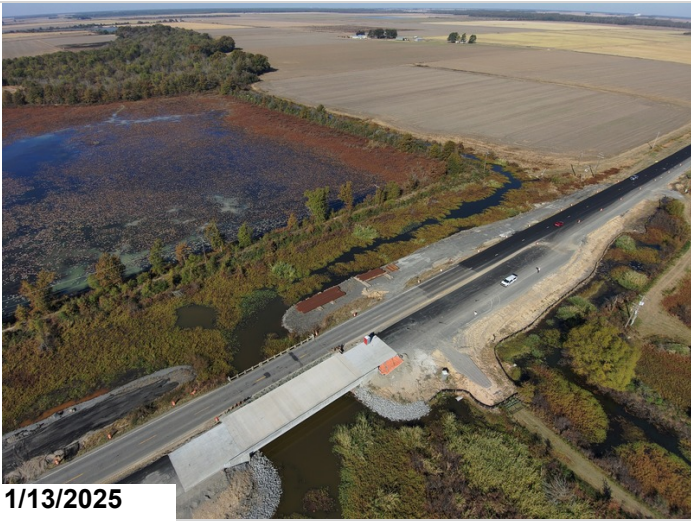
Channel looking west.

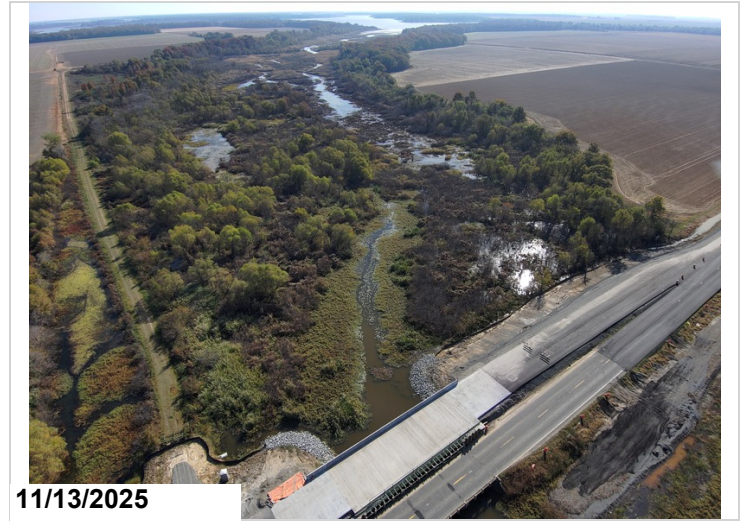
Channel looking east.

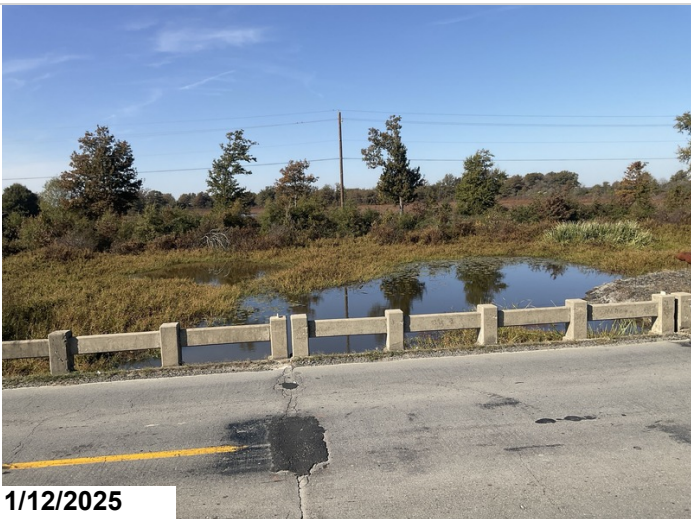
Channel looking west.

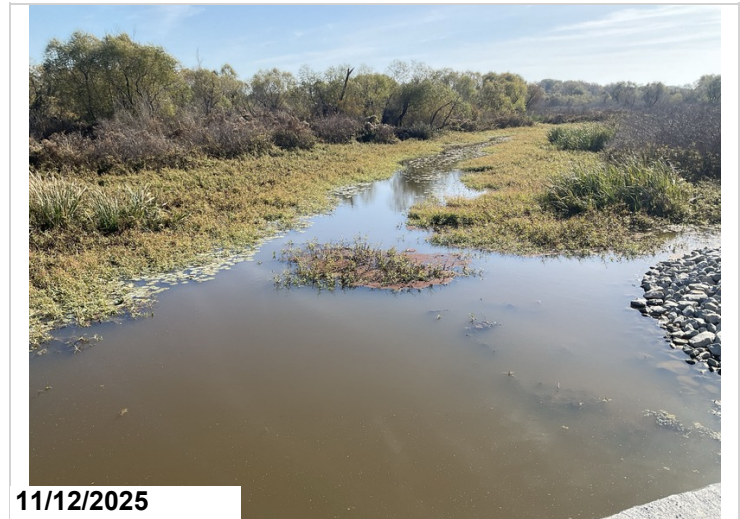
Channel looking east.

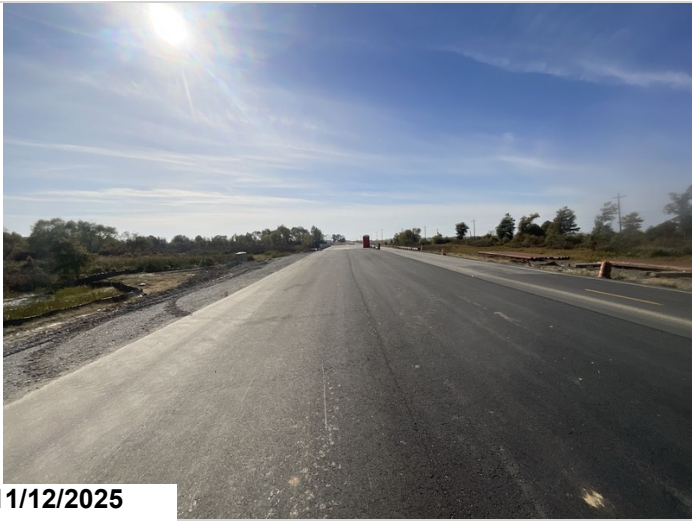
Inventory looking south.

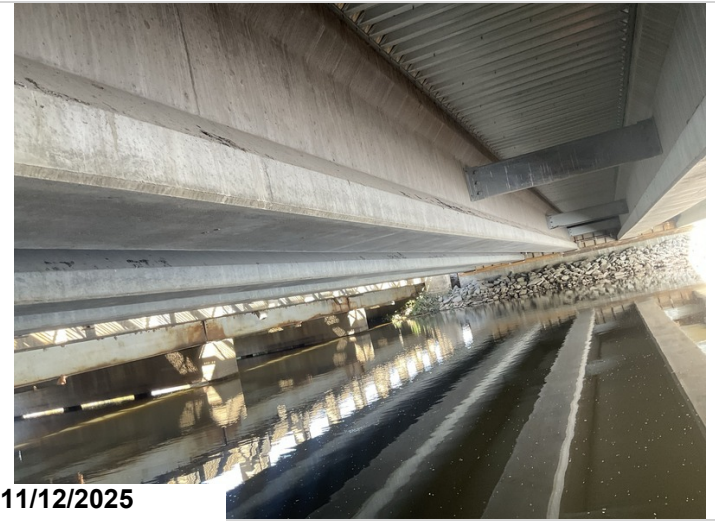
General prestressed concrete girder condition.

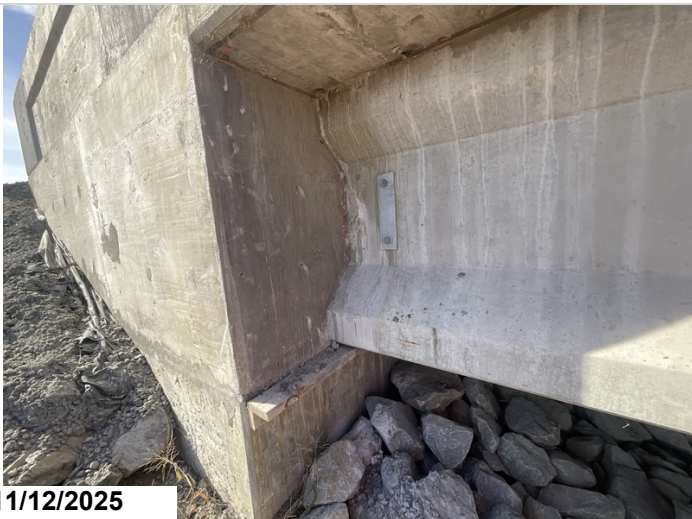
Integral abutment.

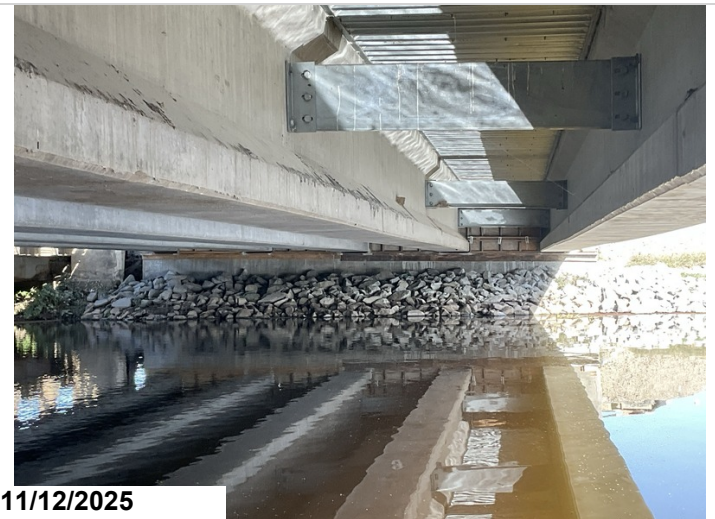
Bent 1: integral abutment overview.

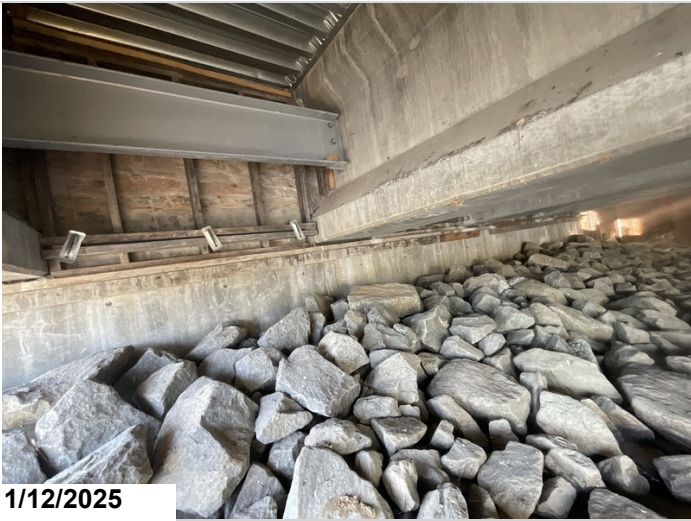
Bent 2: integral abutment overview.

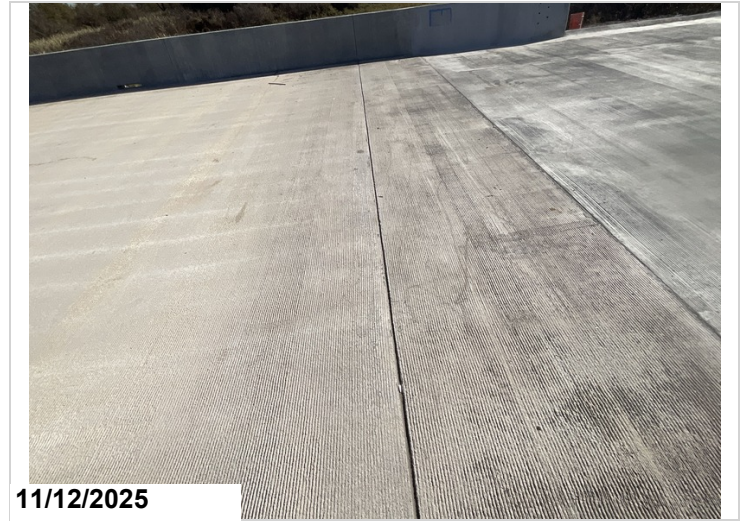
Bent 2, joint seal: general pourable joint seal condition.

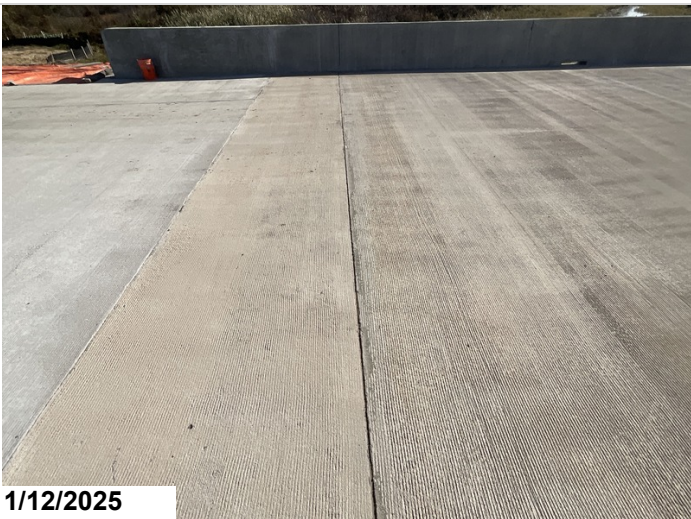
Bent 1, joint seal: general pourable joint seal condition.

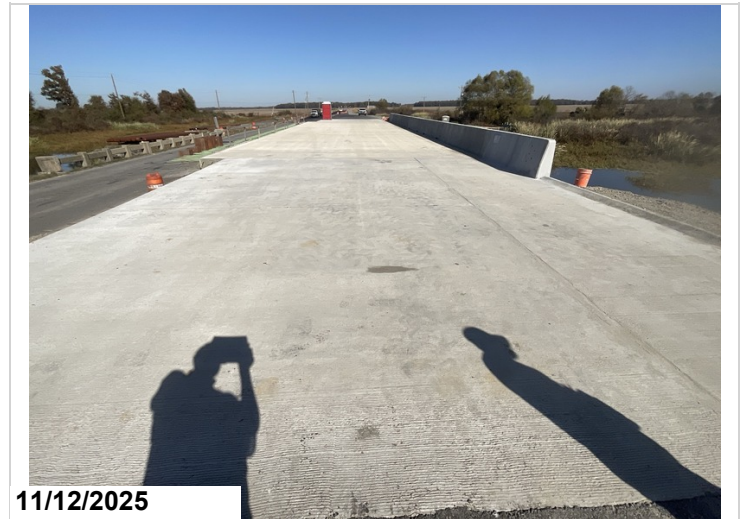
Bent 2, approach slab: general approach slab condition.  
(South approach slab)

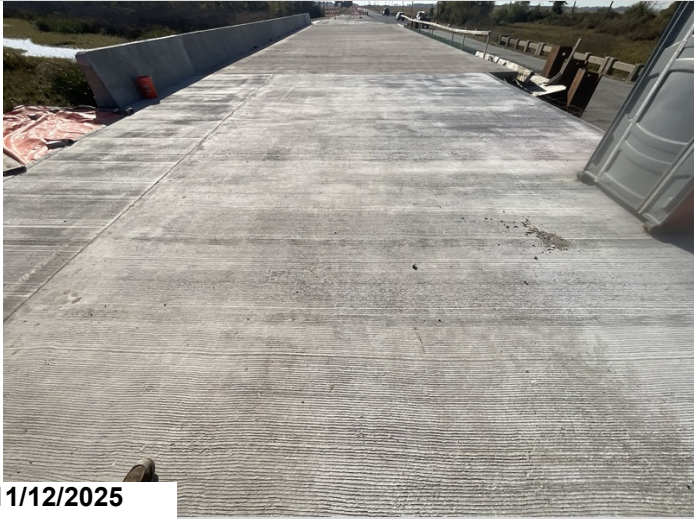
Bent 1, approach slab: general approach slab condition.  
(North approach slab)

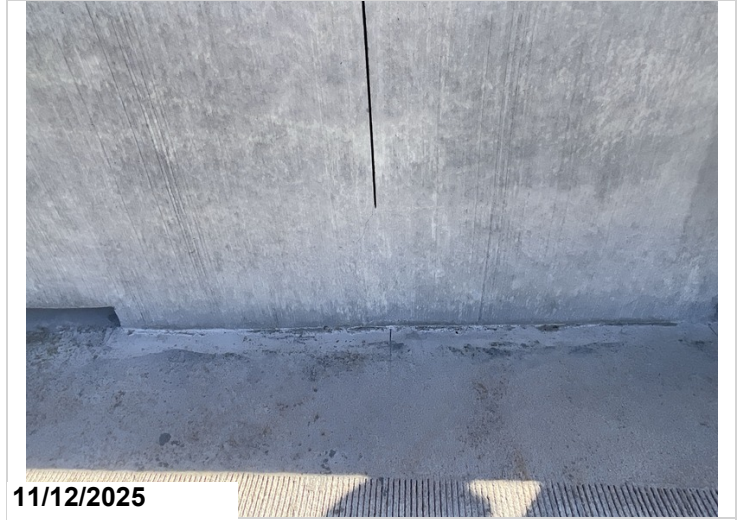
(331) Structure is under staged construction. Reinforced concrete bridge railing quantity at the time of this inspection 99LF. 11/12/2025 Left rail: cracking measuring 0.012"at each saw cut relief. CS2-6'

Left rail: cracking measuring 0.012" at each saw cut relief.  
CS2-6'
