Bridge 07636 Inspection Report

Route:63 Section:11 Log:8.69

Asset #07636(Initial, Routine)
US 63 Log 8.69 over LAGRUE CREEK RELIEF
Location: 1.9 M S OF SH 86 EAST
Team Lead: Joseph Rapier Inspection Date: 11/13/2025

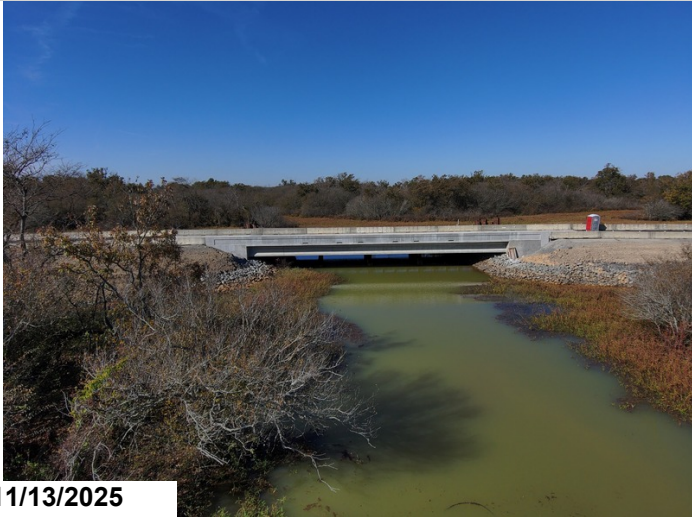
Elevation.

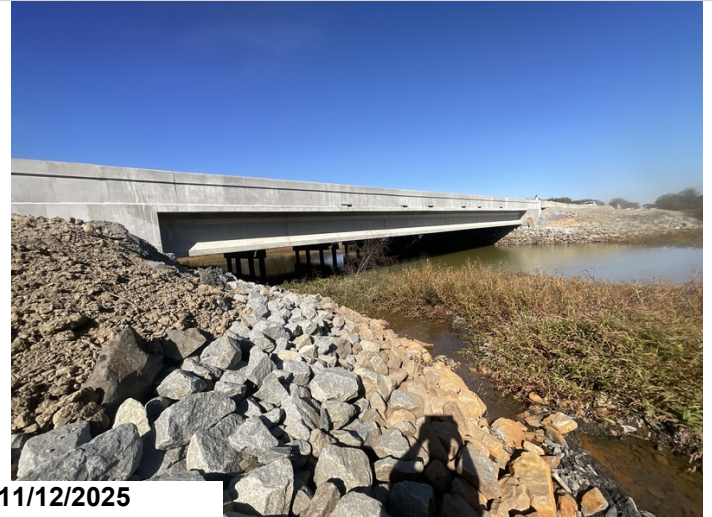
Elevation.

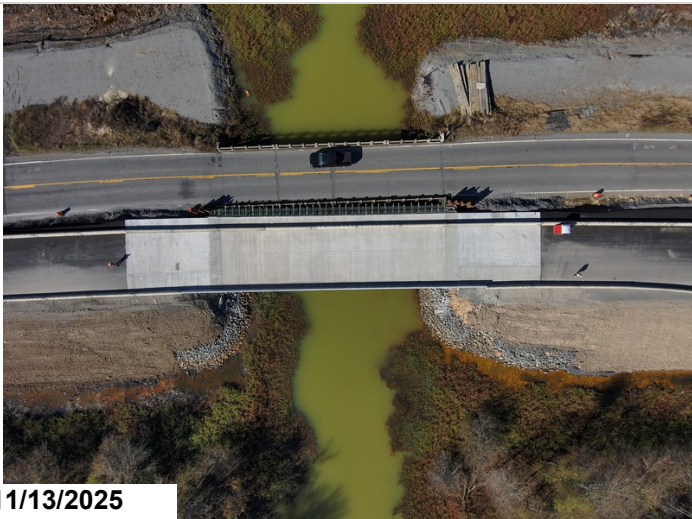
Overall the deck is in very good condition. There were no notable defects observed at the time of this inspection. The structure is under staged construction.

Deck view overview.

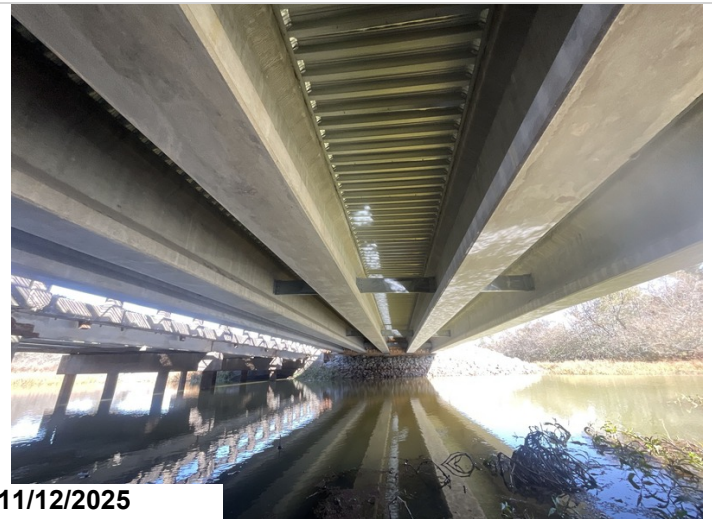
Undersurface.

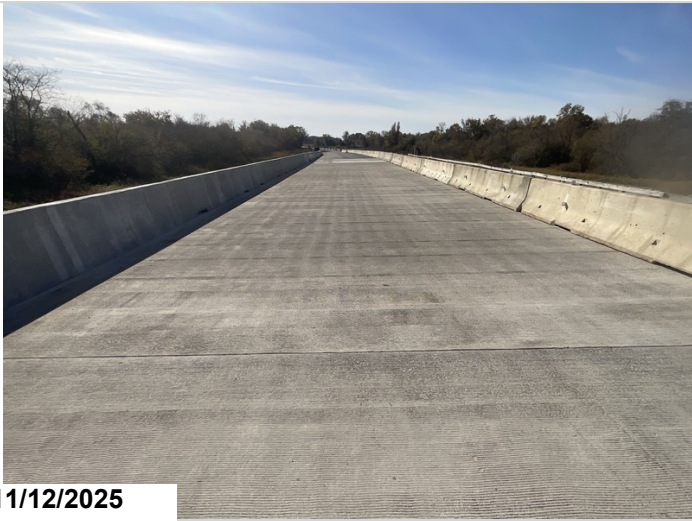
Deck view.

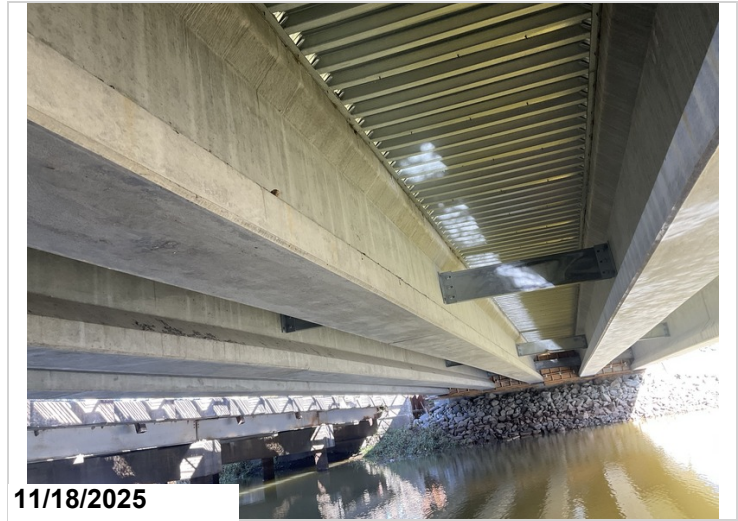
Overall the superstructure is in very good condition. There were no notable defects observed at the time of this inspection. The structure is under staged construction.

General superstructure overview.

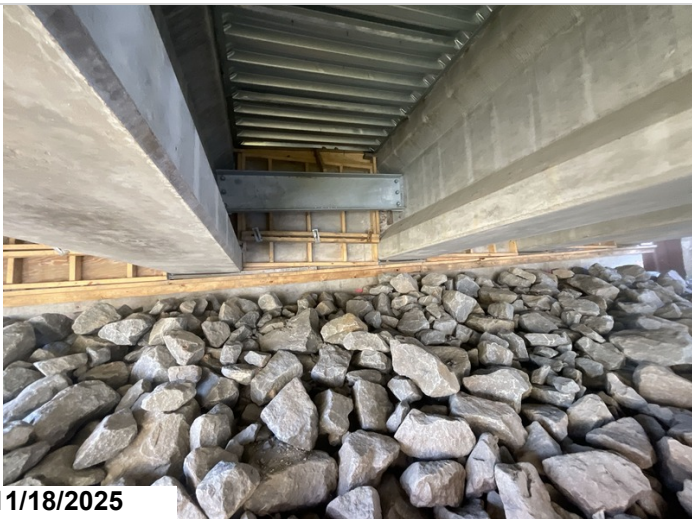
Bent 2: integral abutment overview.

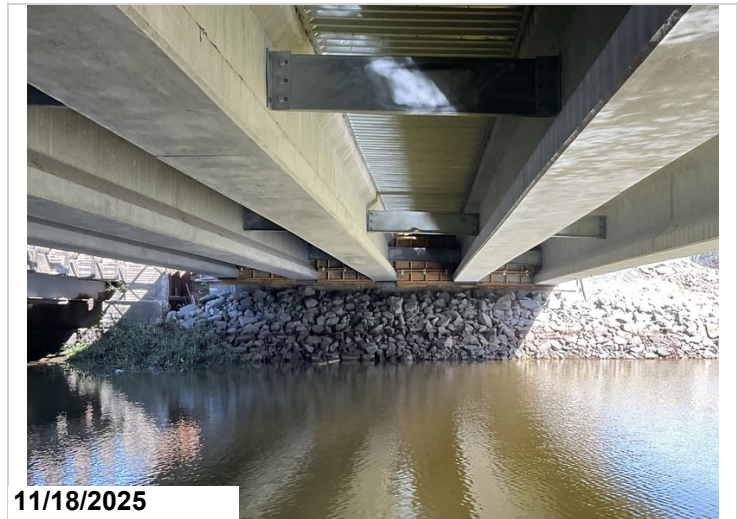
Bent 1: integral abutment overview.

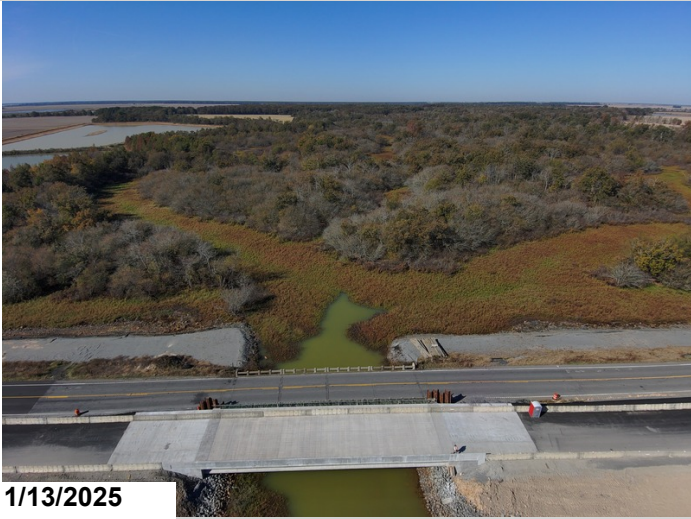
Channel looking west.

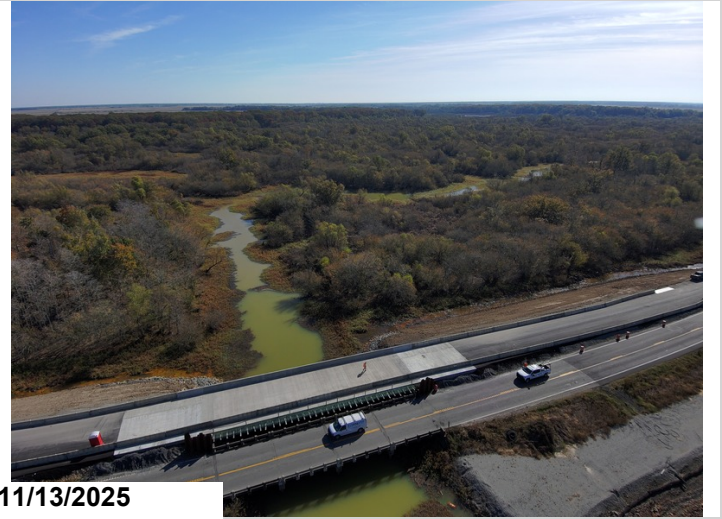
Channel looking east.

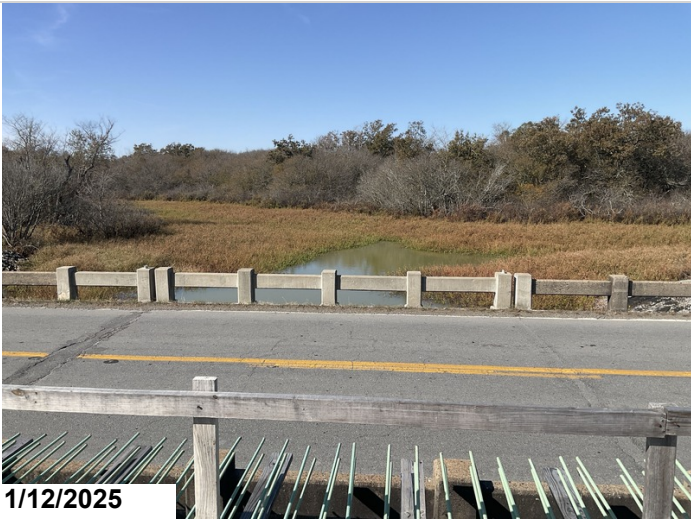
Channel looking west.

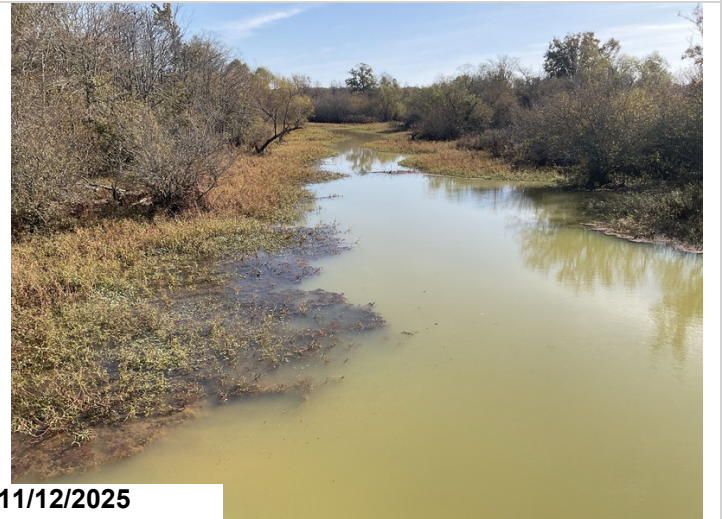
Channel looking east.

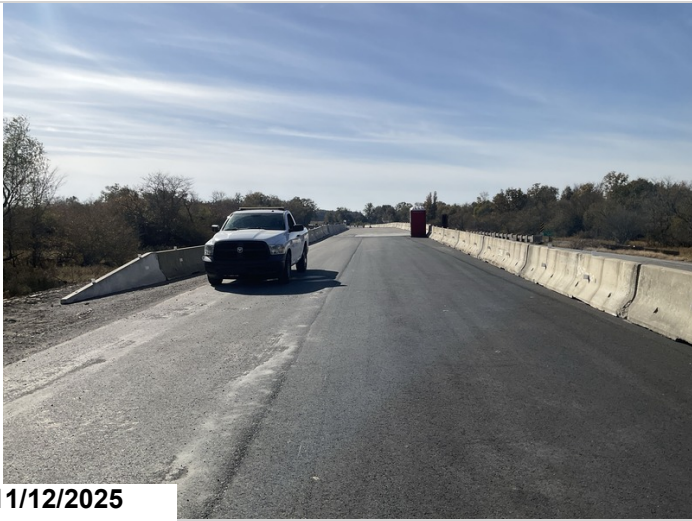
Inventory looking south.

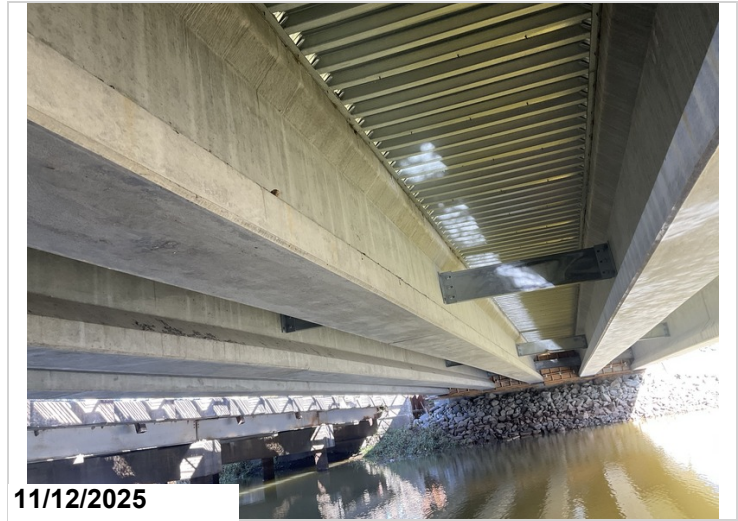
General prestressed concrete girder condition.

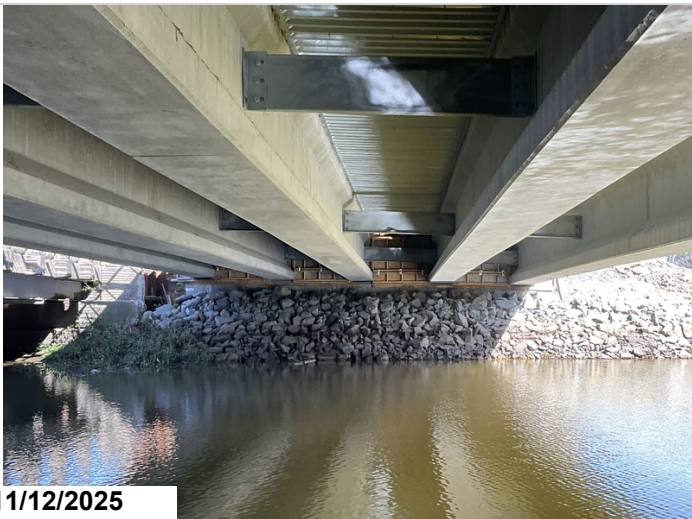
Overall the substructure is in very good condition. There were no notable defects observed at the time of this inspection. The structure is under staged construction.

Bent 1: integral abutment overview.

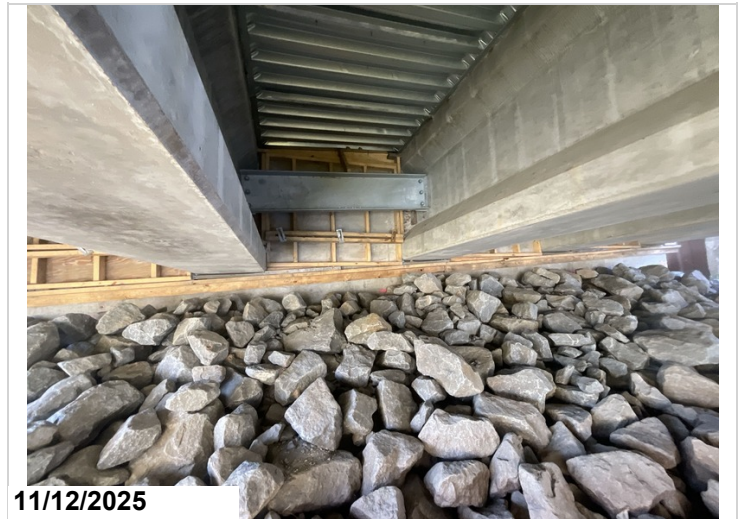
Bent 2: integral abutment overview.

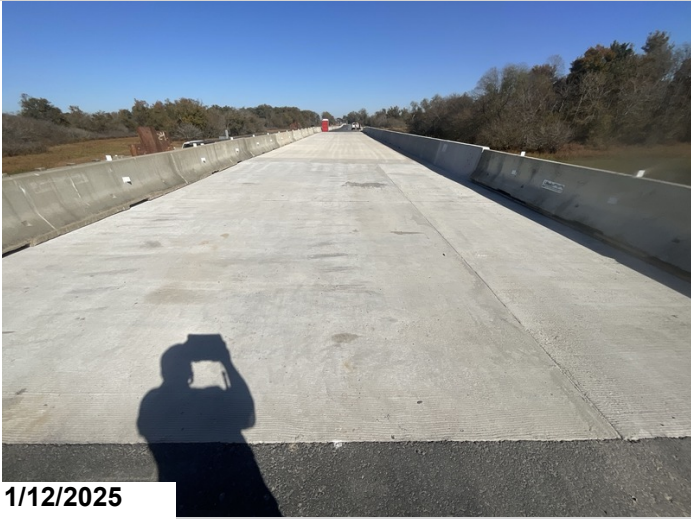
Bent 2, approach slab: general approach slab condition.
(South approach slab)

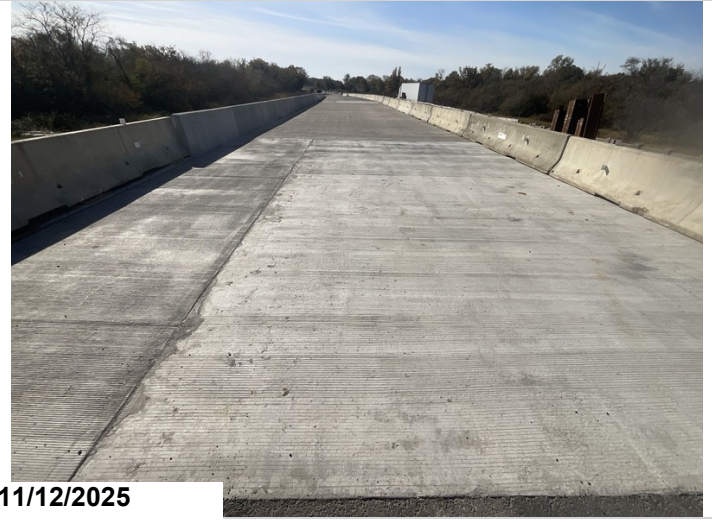
Bent 1, approach slab: general approach slab condition.
(North approach slab)

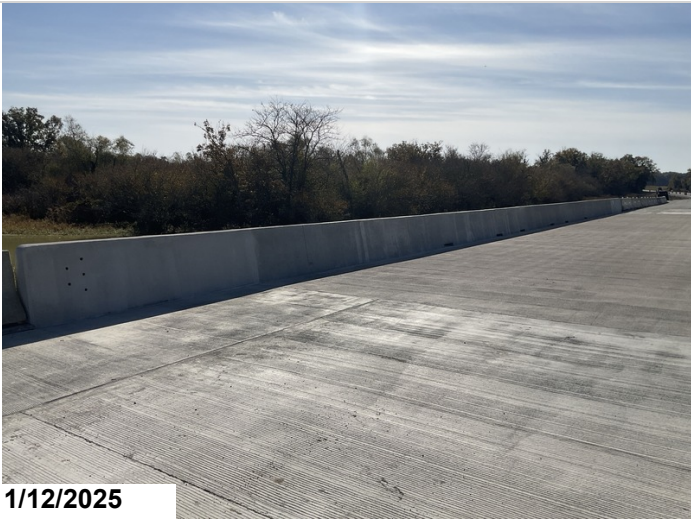
331	Reinforced Concrete Bridge Railing (331) Structure is under staged construction. Reinforced concrete bridge railing quantity at the time of this inspection 109LF. 11/12/2025	LF	218	218	0	0	0

General reinforced concrete bridge railing condition.
