Bridge 07637 Inspection Report

Asset #07637 (Initial, Routine)

US 63 Log 8.51 over LAGRUE CREEK

Location: 1.5 M S OF SH 86 EAST

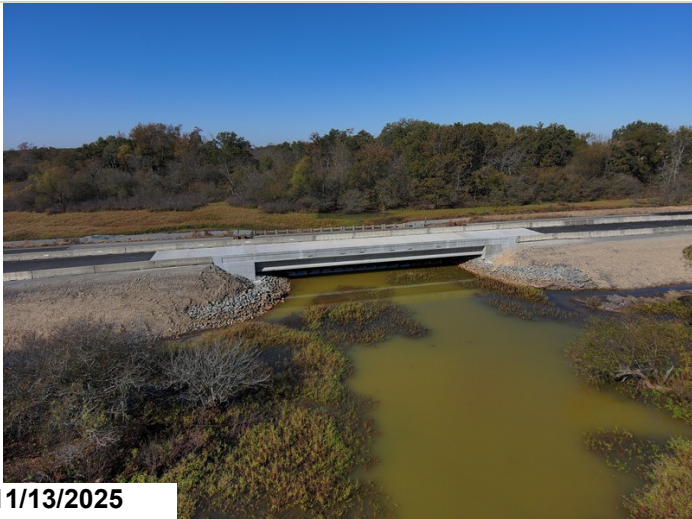
Elevation.

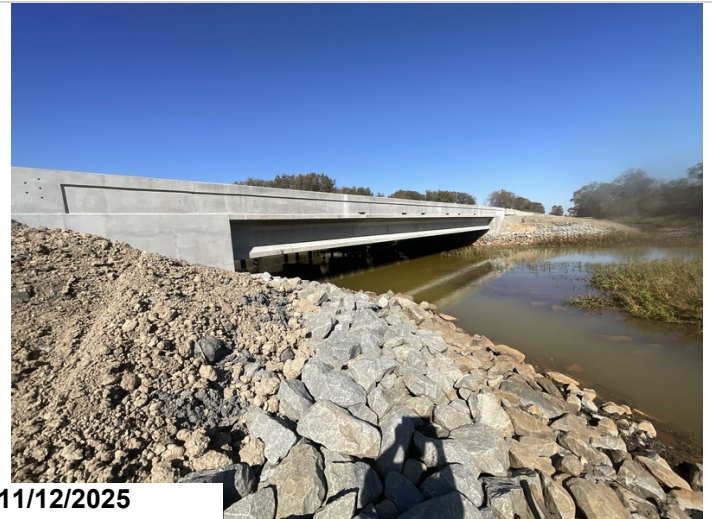
Elevation.

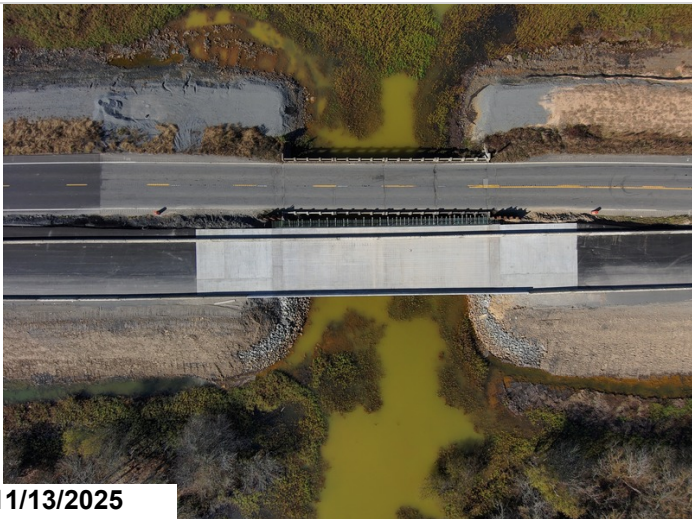
Overall the deck is in very good condition. There were no notable defects observed at the time of this inspection. The structure is under staged construction.

Deck overview.

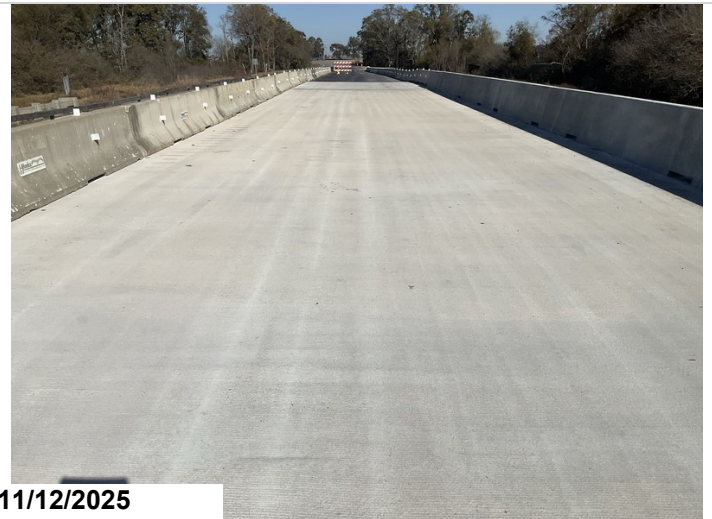
Deck.

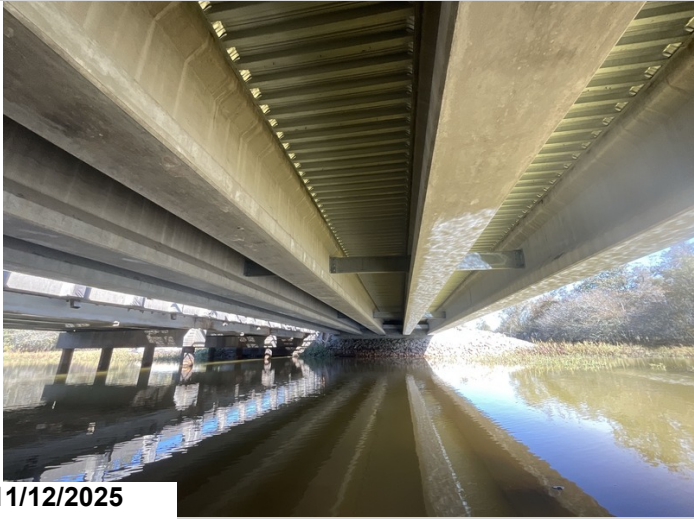
Undersurface view.

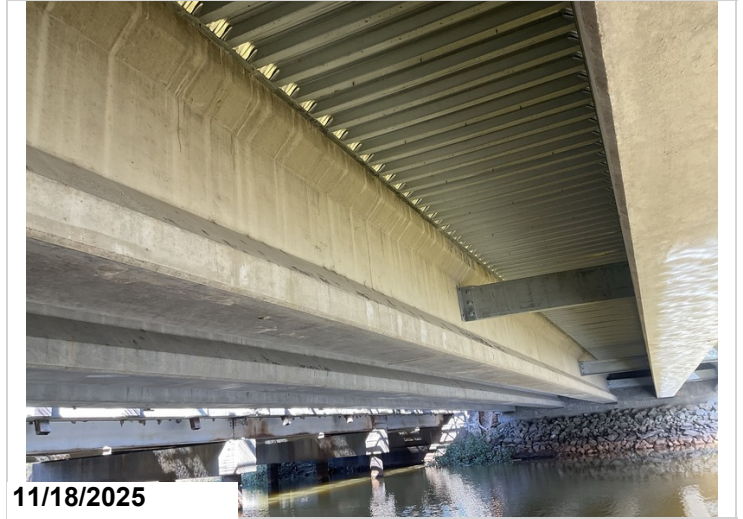
Overall the superstructure is in very good condition. There were no notable defects observed at the time of this inspection. The structure is under staged construction.

General superstructure overview.

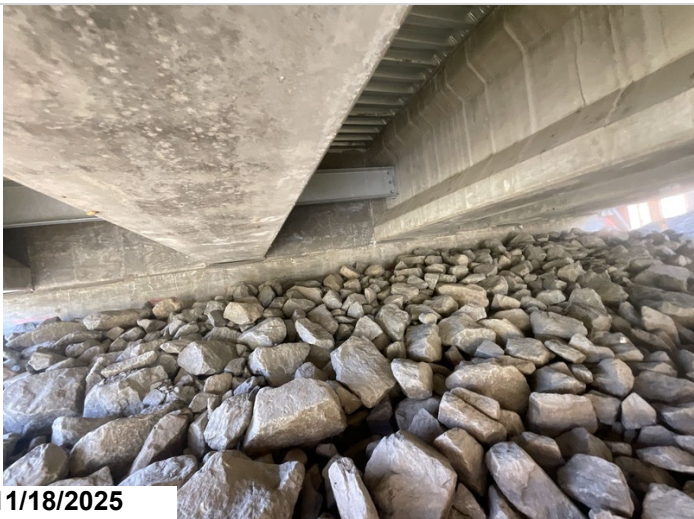
Bent 2: integral abutment overview.

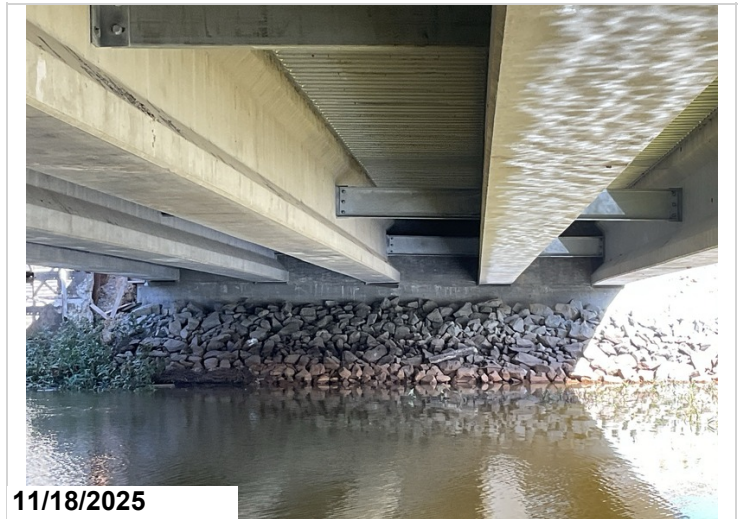
Bent 1: integral abutment overview.

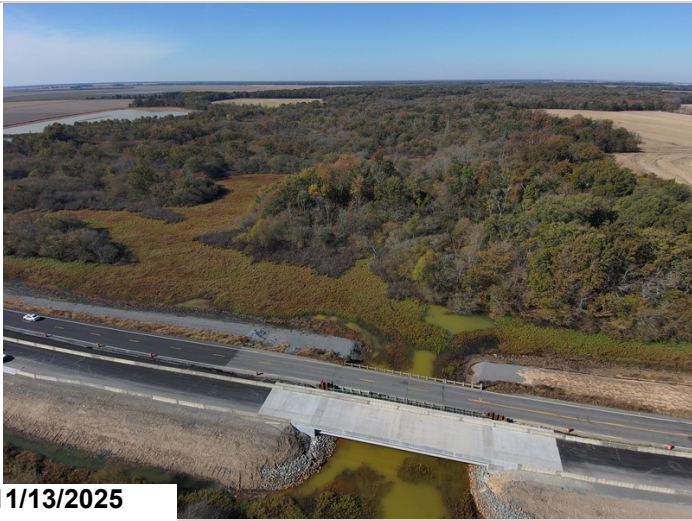
Channel looking west.

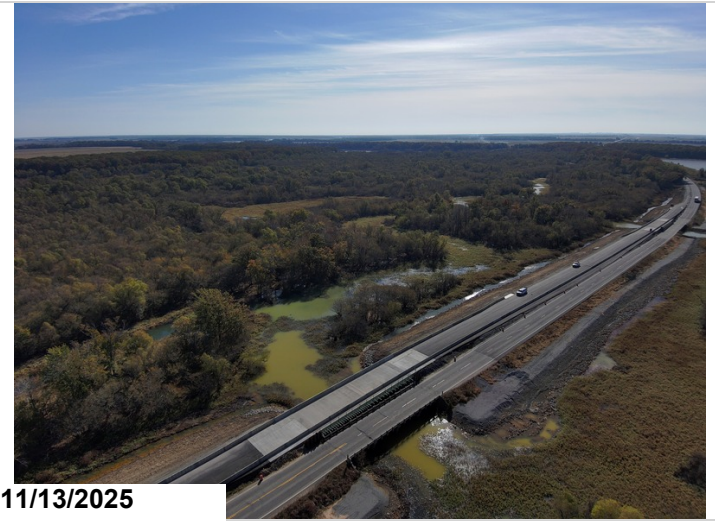
Channel looking east.

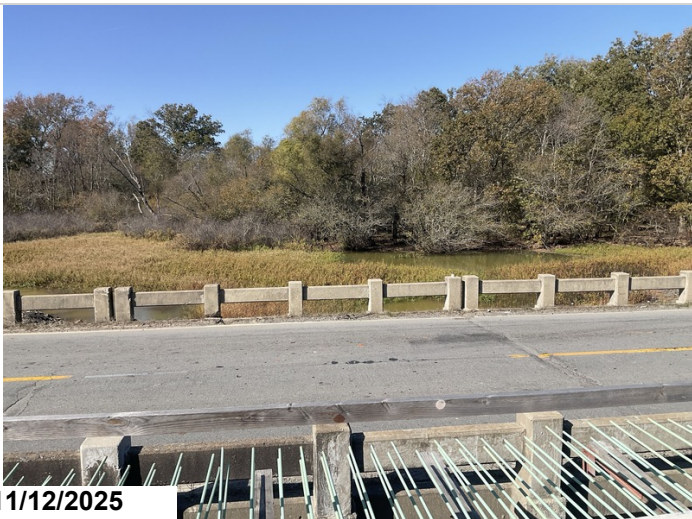
Channel looking west.

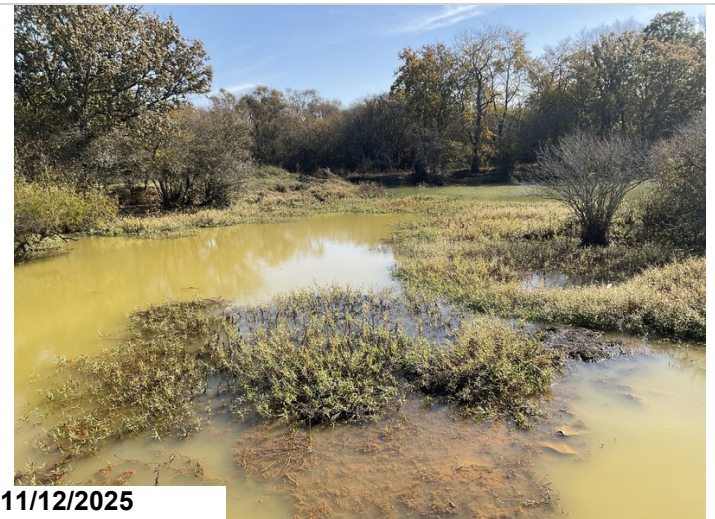
Channel looking east.

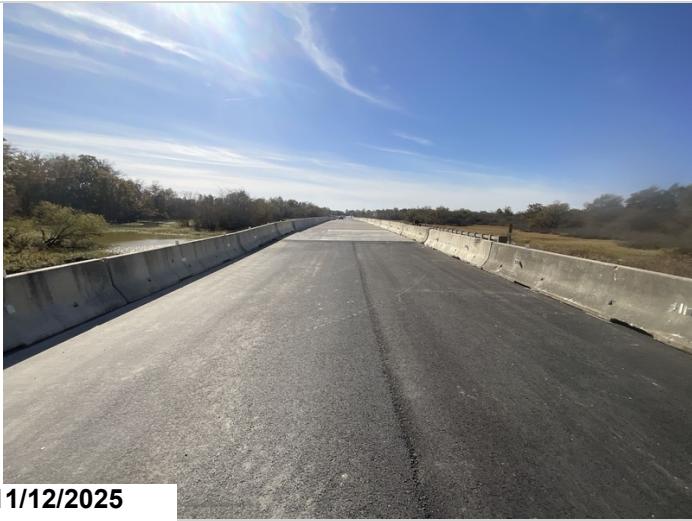
Inventory looking south.

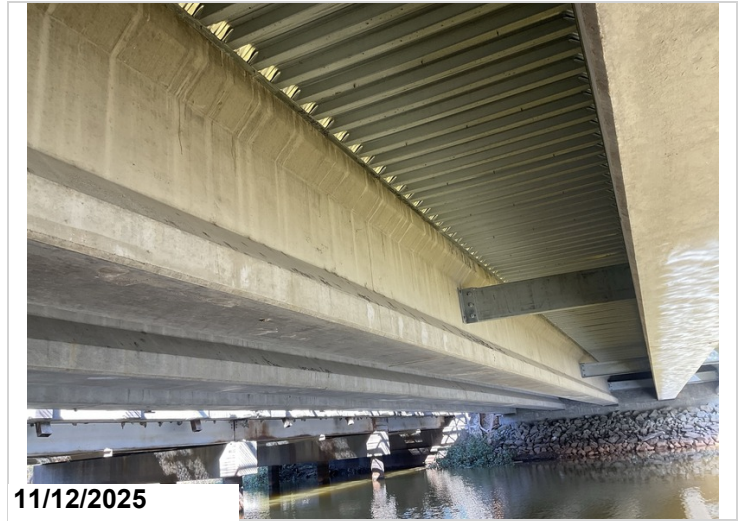
General prestressed concrete girder condition.

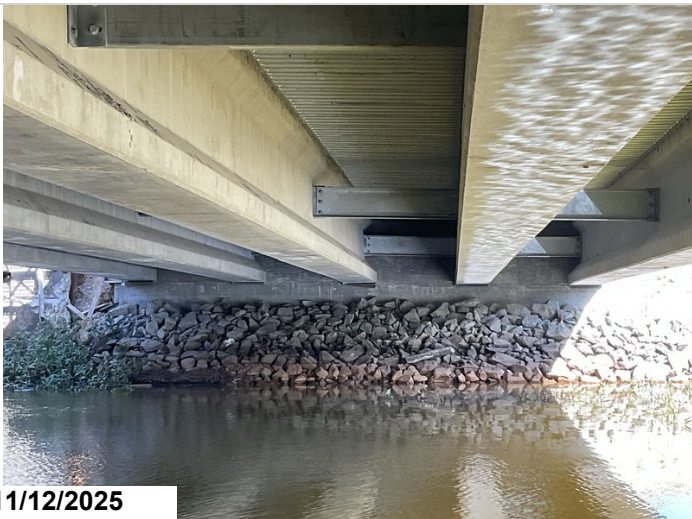
Bent 1: integral abutment overview.

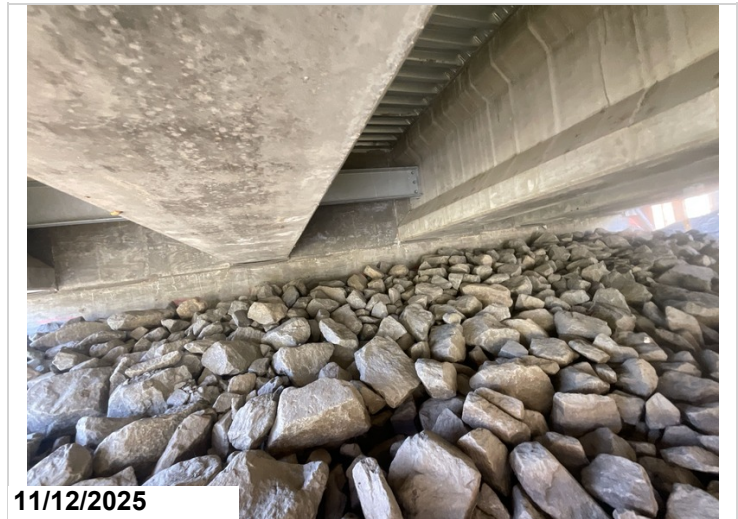
Bent 2: integral abutment overview.

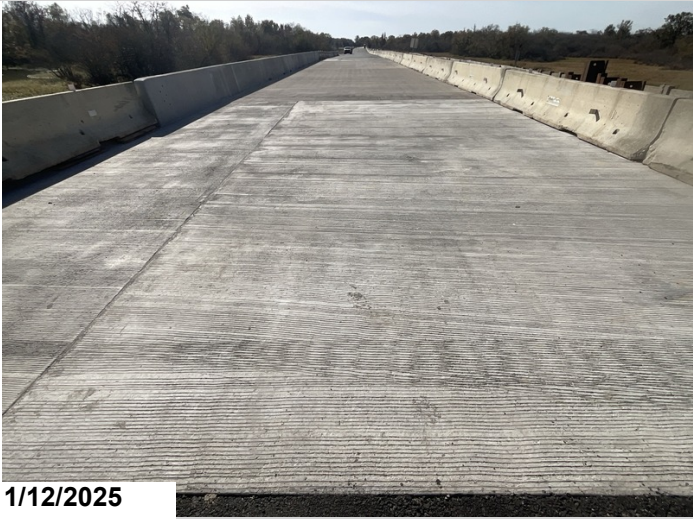
Bent 1, approach slab: general approach slab condition.
(North approach slab)

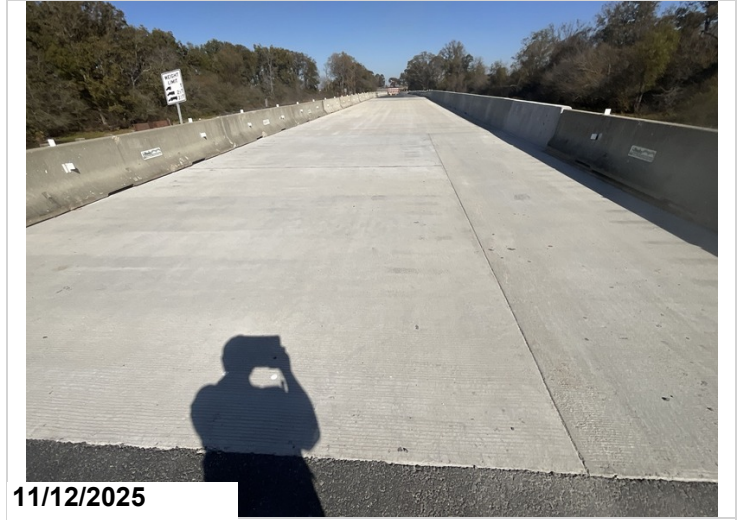
Bent 2, approach slab: general approach slab condition.
(South approach slab)

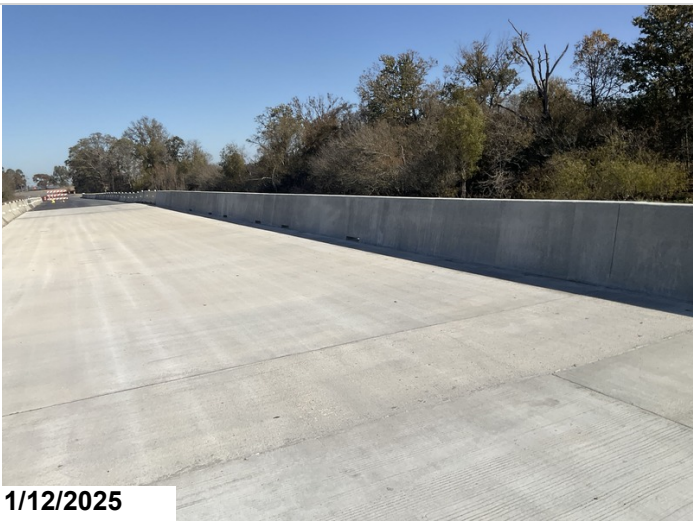
General reinforced concrete bridge railing condition.
