## Bridge M0350 Inspection Report

Asset #M0350(Routine)  
US 63 Log 6.39 over CREEK  
Location: 0.7 MI N JCT SH 86

Team Lead: Bryan Saunders Inspection Date: 03/12/2024

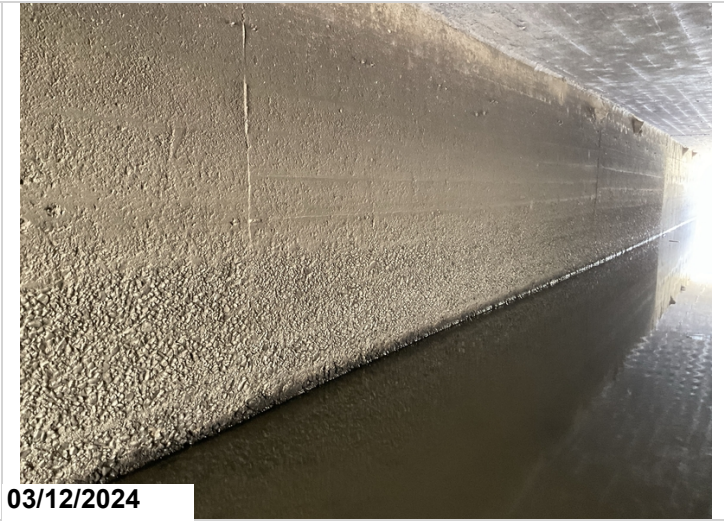
ELEMENTS	DESCRIPTION	UNITS	TOTAL	CS1	CS2	CS3	CS4
241	Reinforced Concrete Culvert	LF	212	84	128	0	0
1090	Exposed Rebar	LF	3	0	3	0	0
1130	Cracking (RC and Other)	LF	9	0	9	0	0
1190	Abrasion/Wear (PSC/RC)	LF	116	0	116	0	0
(241) The box culvert has been extended in the past. Minor abrasion on the wall of original culvert. Scattered cracks in the wall of extended culvert. Exposed rebar in barrels 1&3

Abrasion to walls

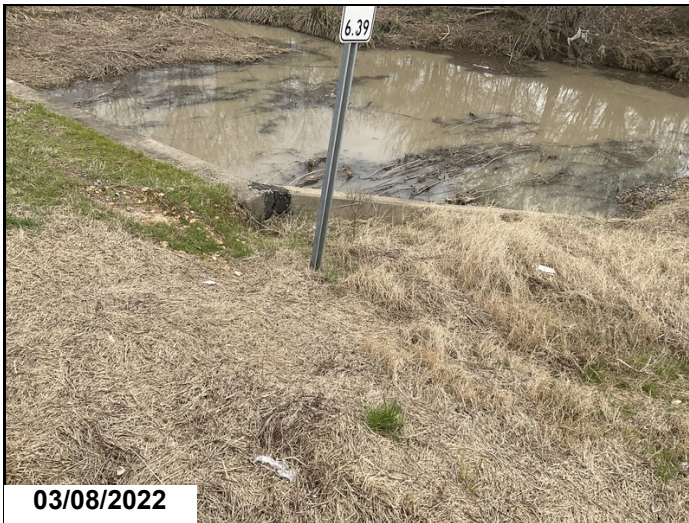
Erosion has caused a sink hole behind the southeast wing wall.

**Priority:** D- Routine

**Type of Work:** Repair (General)
