## Bridge 06982 Inspection Report

US 270-8 Log 0.93 over I-30 Log 99.65

Team Lead: Caleb Lambert Inspection Date: 07/10/2025

## Inspection Notes

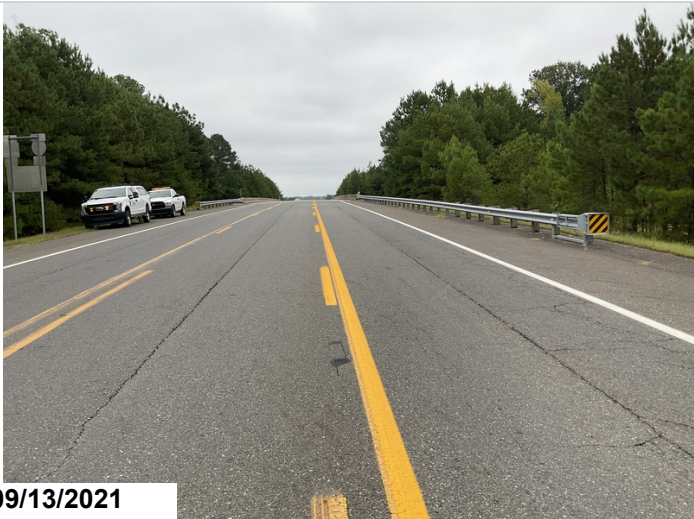
09/13/2021

Approach eastbound
