## Bridge 06981 Inspection Report

Route:270 Section:08 Log:4

Asset #06981 (Routine)  
US 270 Log 4.00 over UPRR  
Location: .3 MI NW US 67

Team Lead: Keith Harris Inspection Date: 09/10/2025

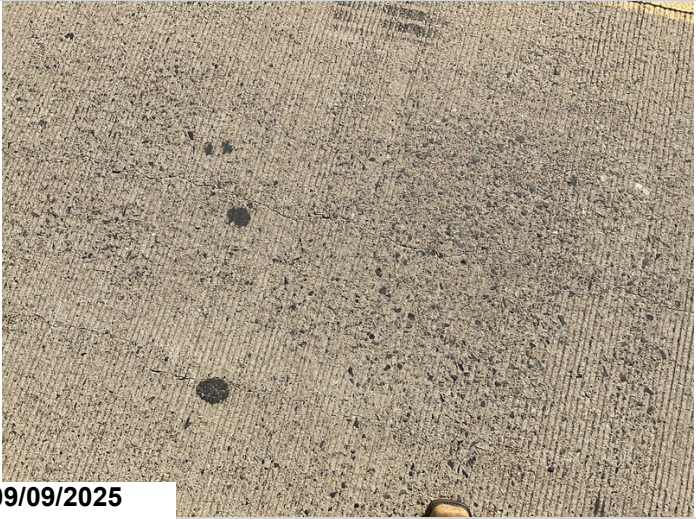
(12) Deck has unsealed horizontal and transverse cracks up to 0.040" with span 3 having the worst case.1571SF CS2 The overhangs have cracks with efflorescence. 81SF CS2							
107	Steel Open Girder/Beam	LF	1092	1092	0	0	0
515	Steel Protective Coating	SF	9282	0	9282	0	0
3430	Oxide Film Degradation Color/Texture Adherence(Steel Protective Coatings)	SF	9282	0	9282	0	0

Unsealed cracks in the deck up to 0.040".

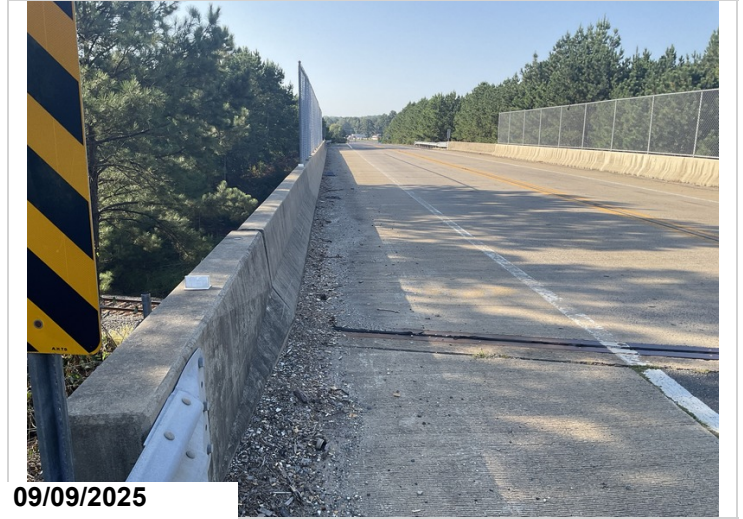
Debris has accumulated on both shoulders.

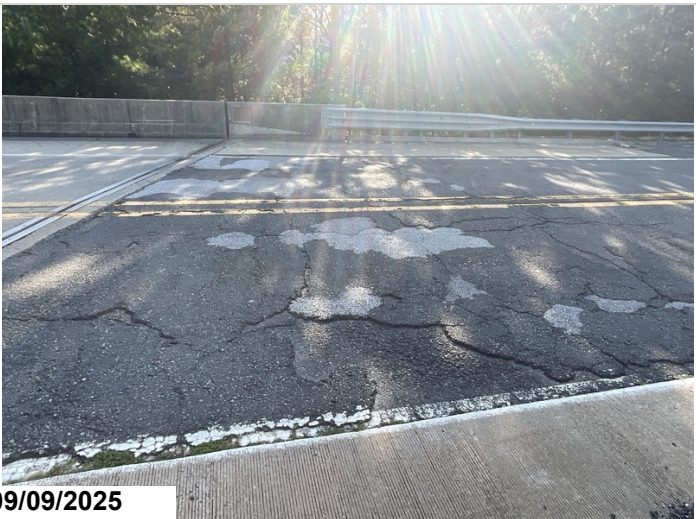
Eastbound approach has potholes.

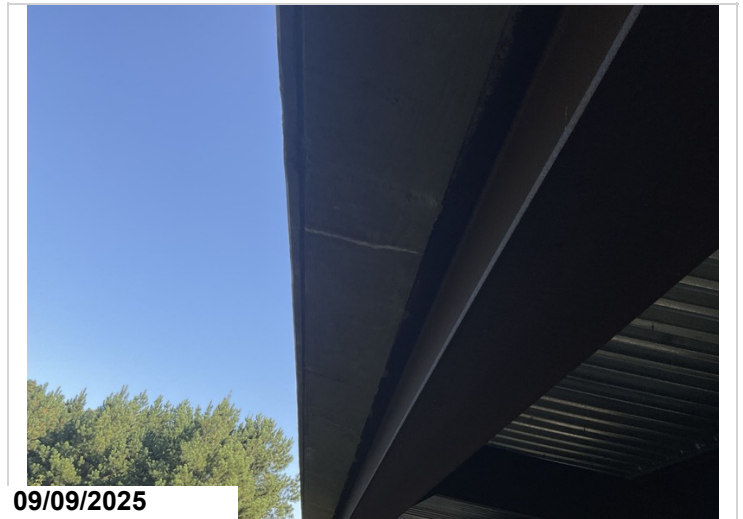
Span 3 right overhang crack with efflorescence. 1SF CS2

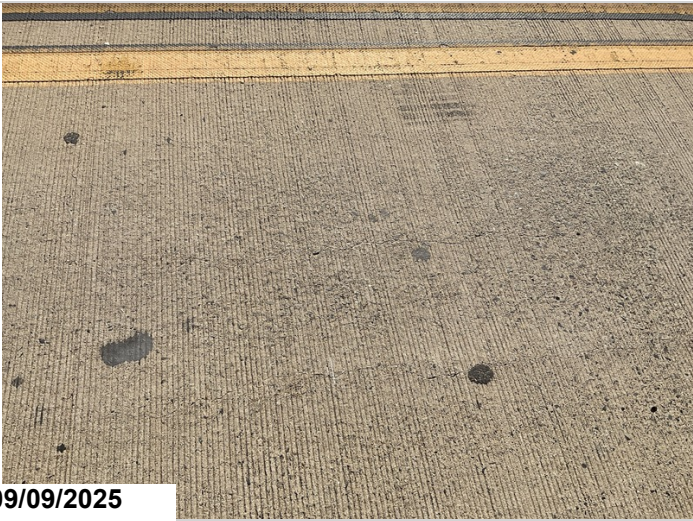
Longitudinal cracks in the deck 0.040". 10SF CS2

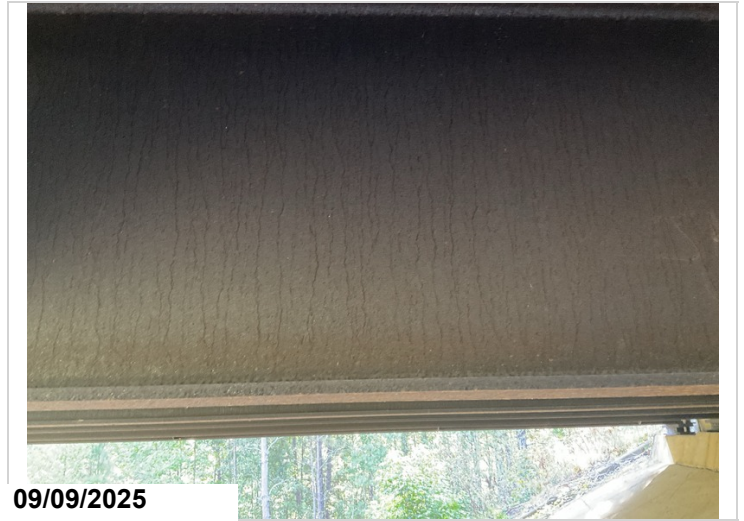
(107) No deficiencies observed this inspection. (515-107) All girders have a granular texture.9282SF CS2							
205	Reinforced Concrete Column	EA	4	4	0	0	0

Typical condition for all girders. All girders have a granular texture.

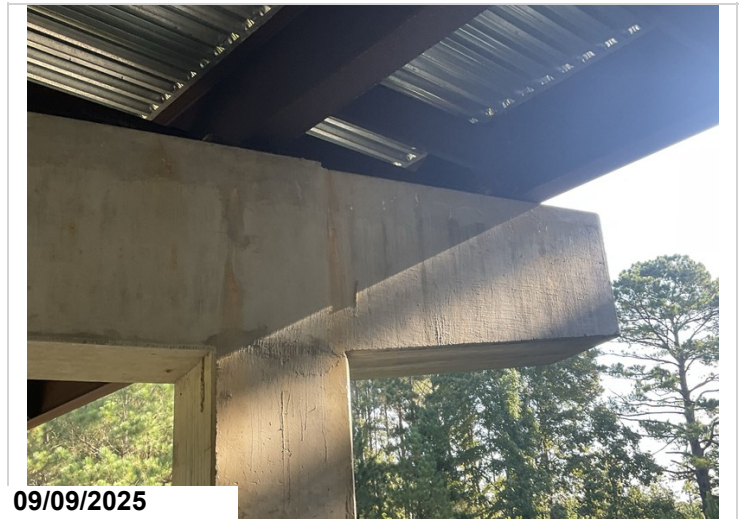
(234) Both caps have horizontal cracks with efflorescence. 32LF CS2							
302	Compression Joint Seal	LF	86	45	41	0	0
2340	Seal Cracking	LF	41	0	41	0	0
(302) Joints seals at bents 1&4 are cracked and leaking. 41LF CS2							
310	Elastomeric Bearing	EA	24	12	0	12	0
1000	Corrosion	EA	12	0	0	12	0

Bent 3 ahead left side cracks with efflorescence. 12LF CS2

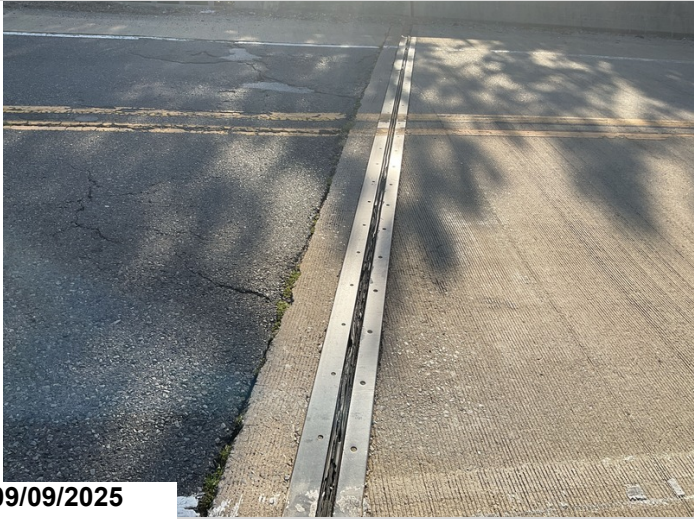
Bent 1 southbound lane joint seal is damaged. 22LF CS2

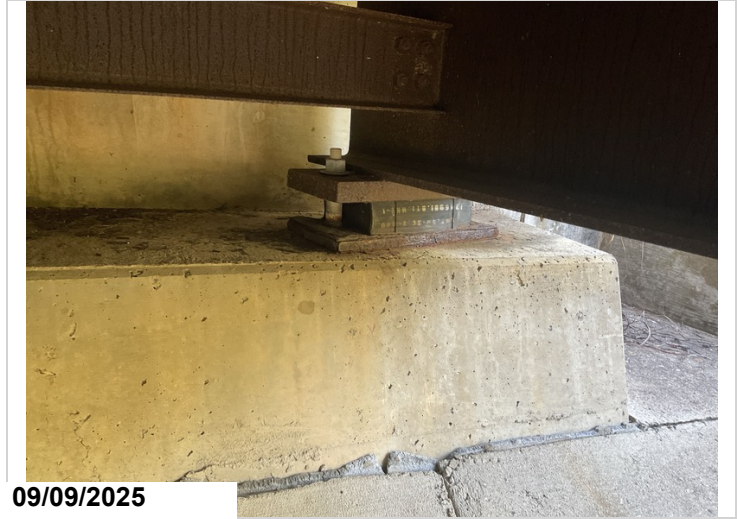
(310) Masonry plates have heavy corrosion and laminating rust at both abutments. 12EA CS3							
331	Reinforced Concrete Bridge Railing	LF	364	267	97	0	0
1130	Cracking (RC and Other)	LF	97	0	97	0	0

Bent 4, bearing 6, masonry plate has laminating rust. 1EA  
CS3  
Common all bearings at bents 1&4.

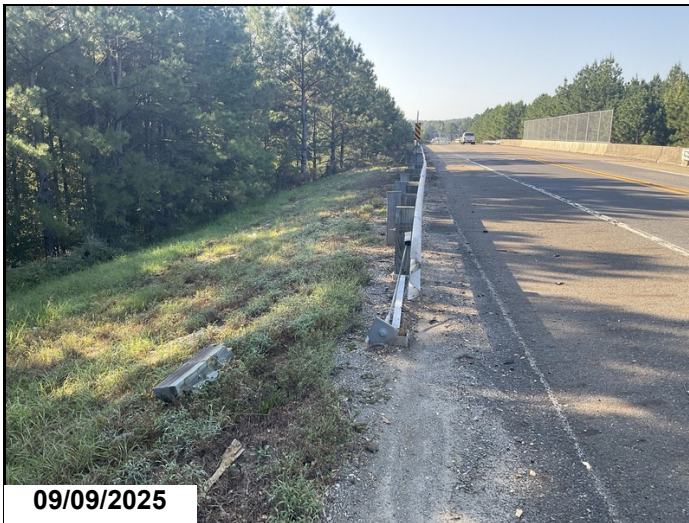
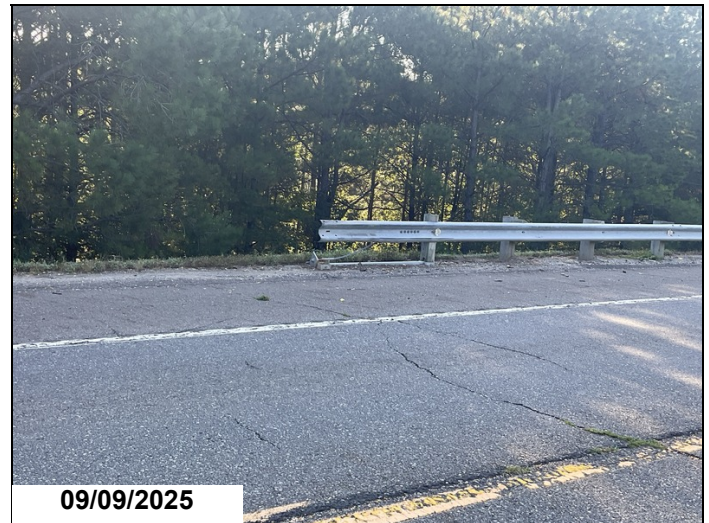
Northeast guardrail damaged from traffic impact.

**Type of Work:** Repair (General)

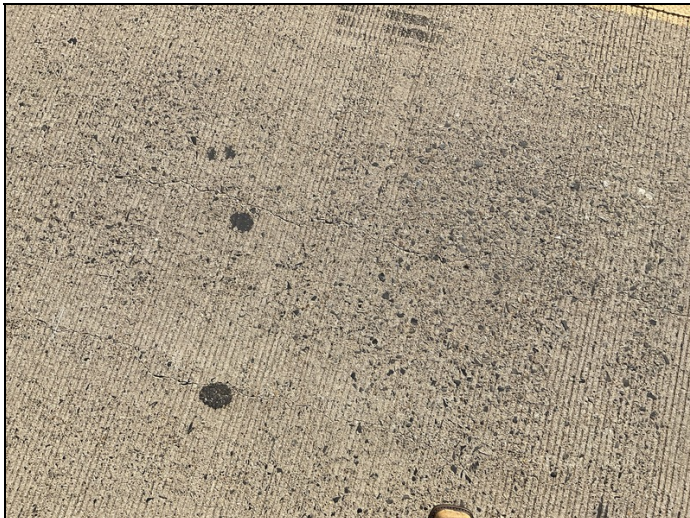
Unsealed cracks in the deck up to 0.040".

### A-54 - Sealable Deck Cracks (Yes)

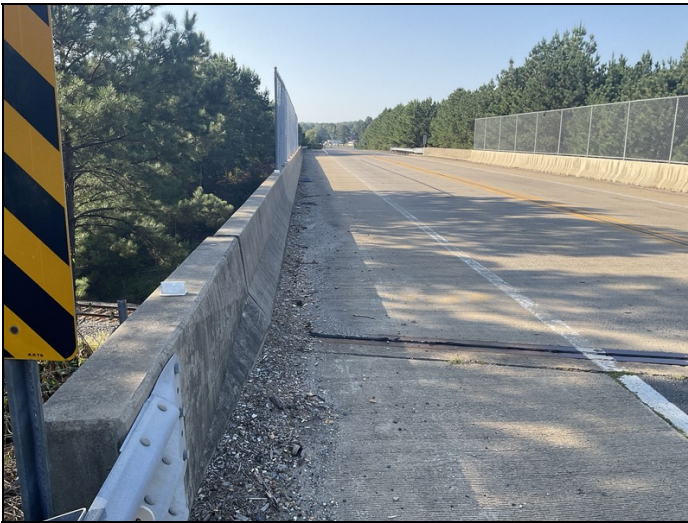
Debris has accumulated on both shoulders.

**A-55 - Deck Washing Needed (Yes)**

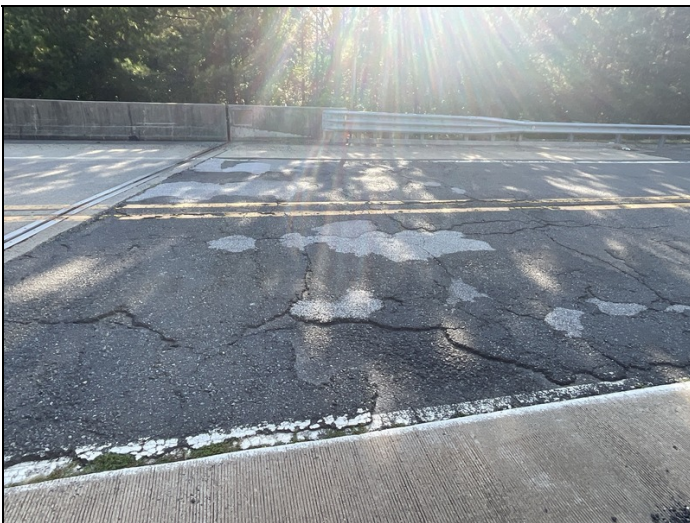
Eastbound approach has potholes.

**A-66 - Approach minor pothole/leveling needed (Yes)**  
Eastbound approach has potholes.
