Bridge 06179 Inspection Report

Asset #06179(Routine)

SH 7-9 Log 4.20 over OUACHITA RV-LAKE HAMILT

Team Lead: Chris Doggett **Inspection Date:** 09/29/2022

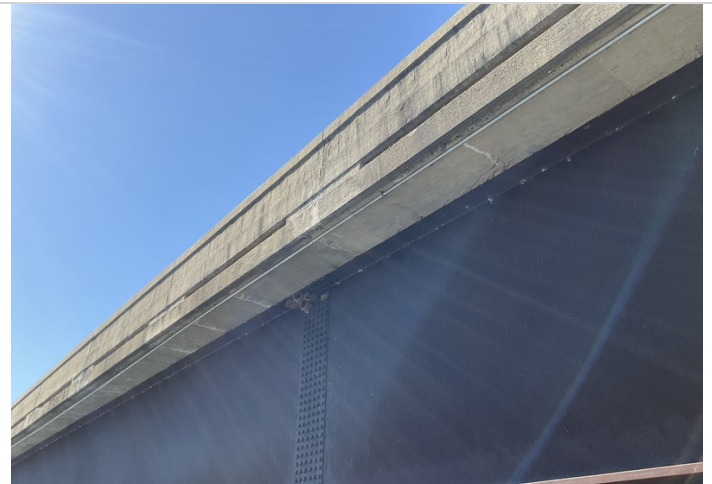
Span 5: Overhang has transverse cracking with efflorescence staining.

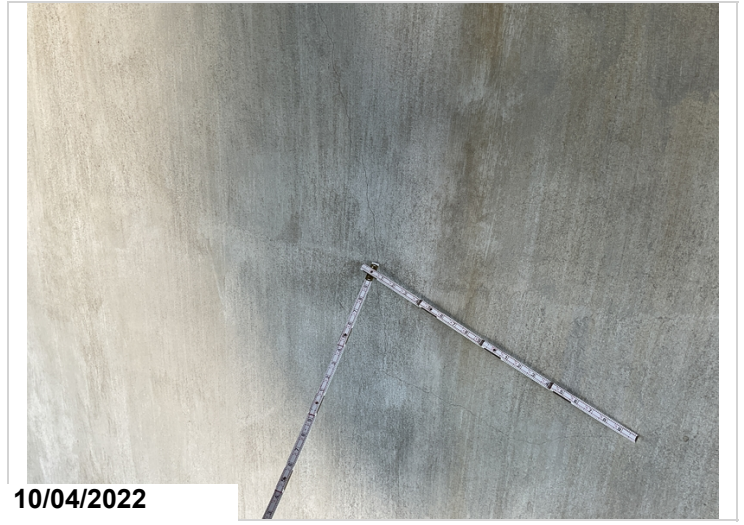
(234) Horizontal and vertical cracks and cracks with efflorescence bents 2 through 7.							
302	Compression Joint Seal	LF	71	62	9	0	0
2310	Leakage	LF	9	0	9	0	0

Backside of bent 3: Vertical and diagonal cracking up to 0.020".

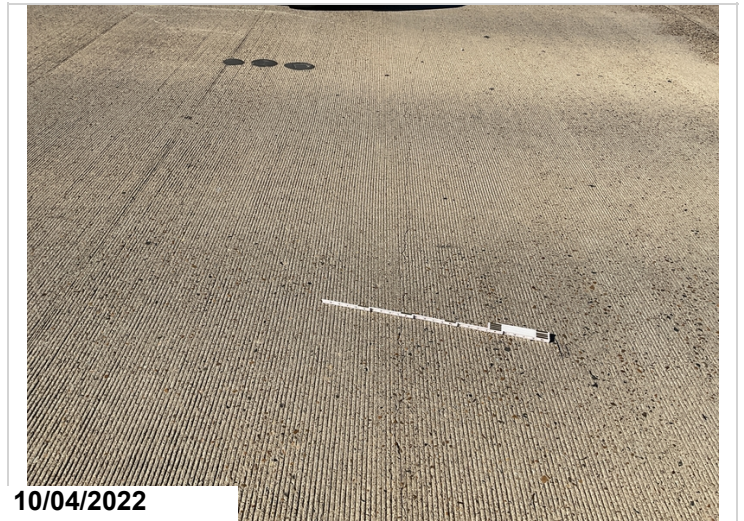
Span 5: unsealed transverse cracks. Common to all spans.

Deck all spans large unsealed cracks.

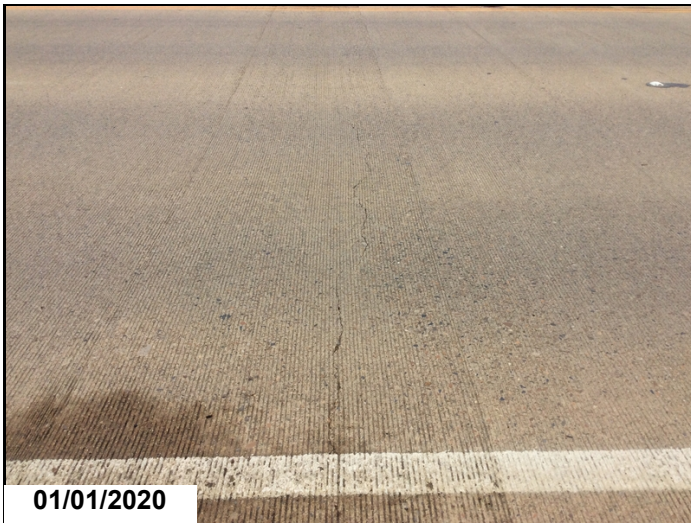
Transverse crack in span 2.

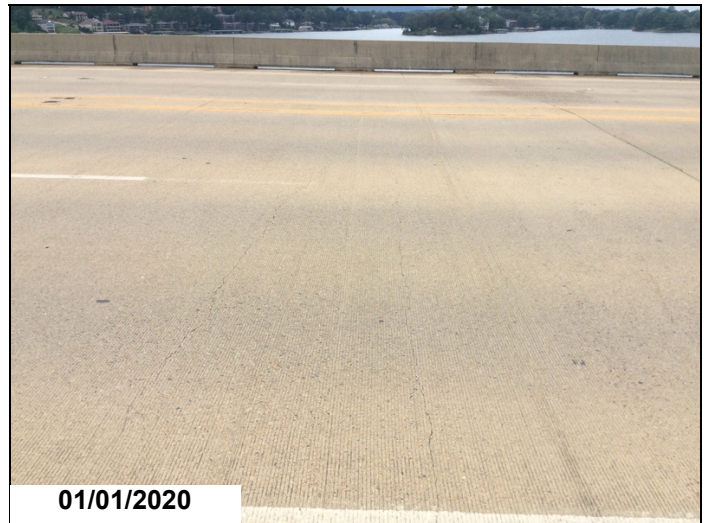
Span 5 transverse cracks.

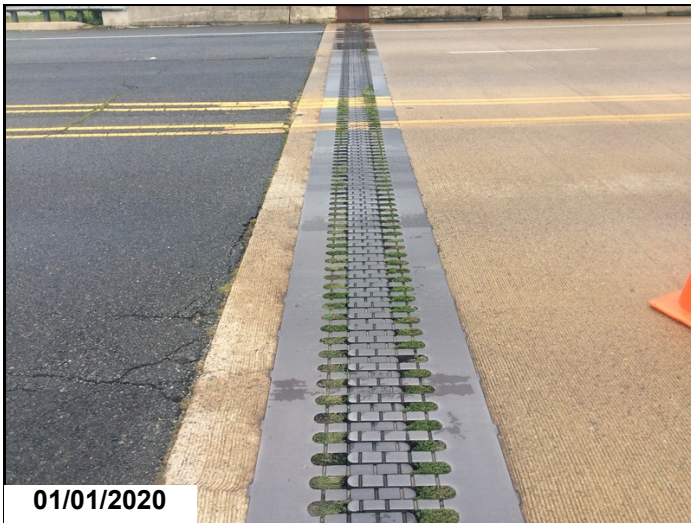
(302) Joint seal is leaking.							
303	Assembly Joint with Seal	LF	142	0	142	0	0
2350	Debris Impaction	LF	142	0	142	0	0
(303) Both finger joints are full of debris.

Both of the finger joints are full of debris.

Bent 8 joint is full of debris.

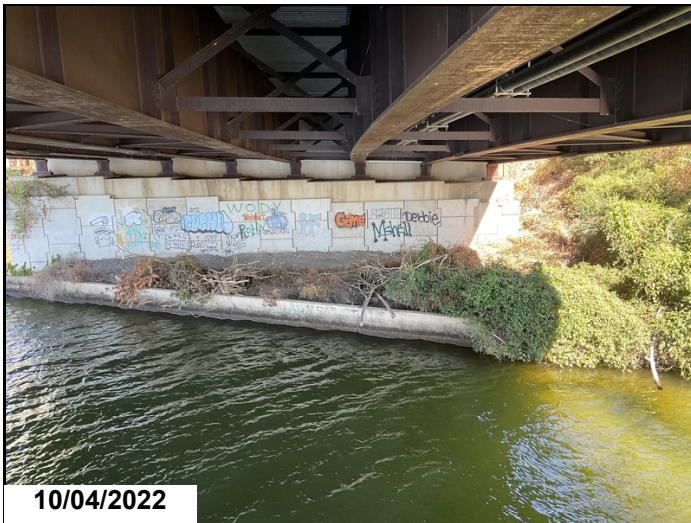
North abutment vegetation growing on MSE wall

State forces have cut the majority of the vines and vegetation at the north abutment.

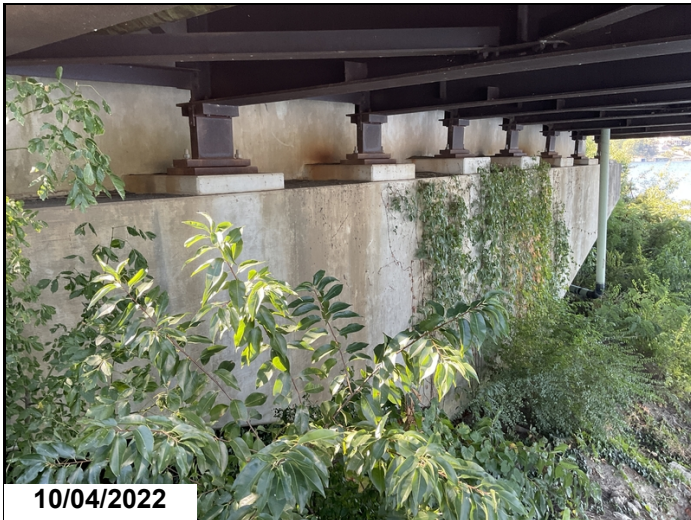
Bent 2: vines climbing up cap.
