Bridge #06814(Routine)
U.S.278 S-13 LM4.5 over SALINE RIVER

Location: 1.2 MILES WEST SH 172

Team Lead: Rickie Bratton Inspection Date: January 27, 2021

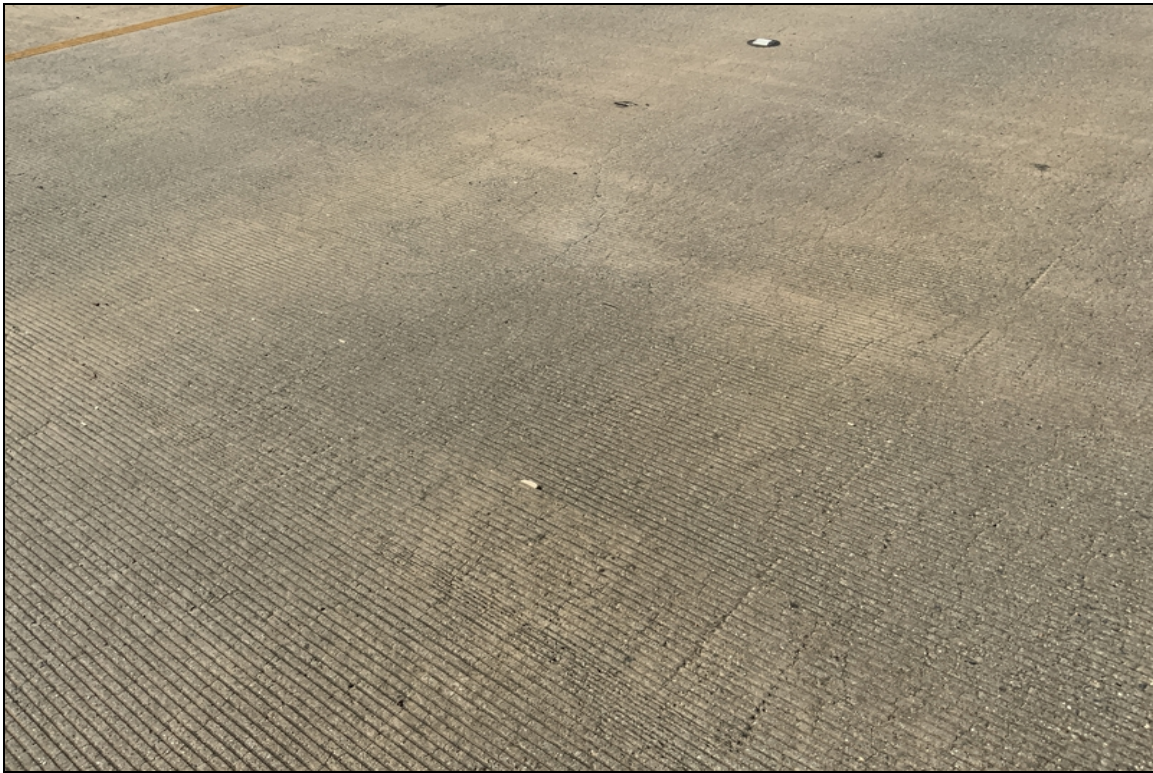
Span 5 map cracks

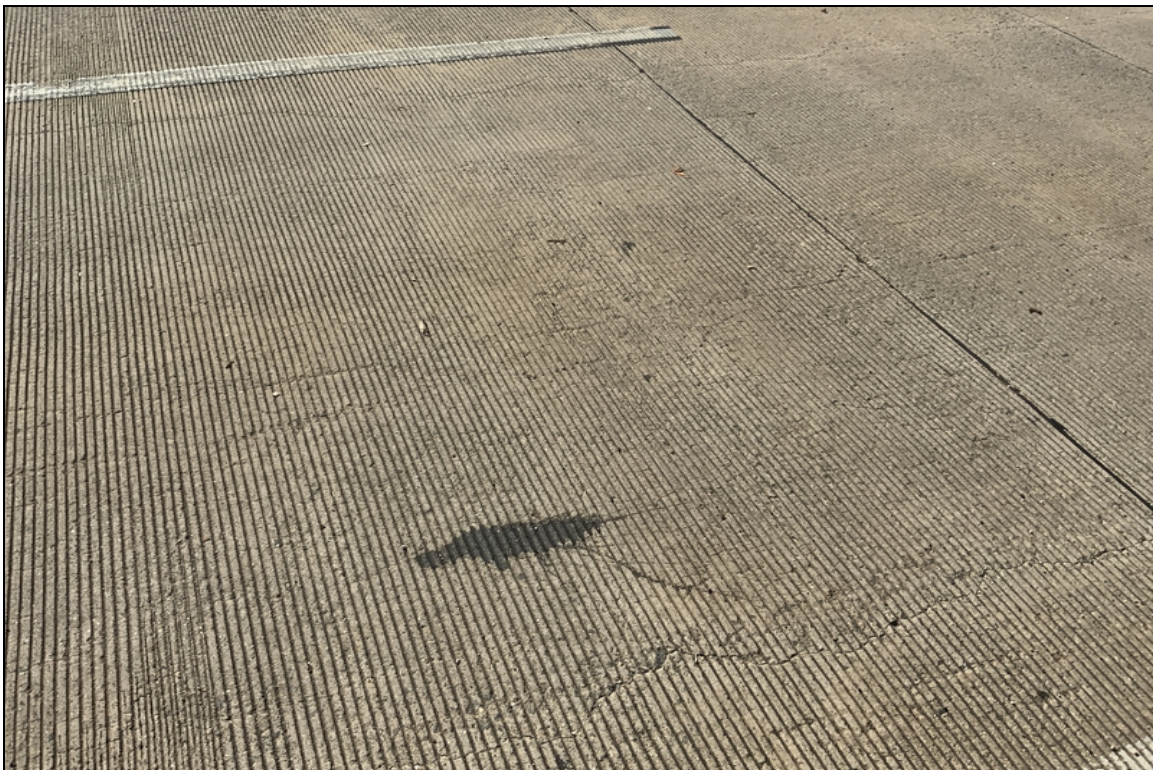
Span 6 map cracks

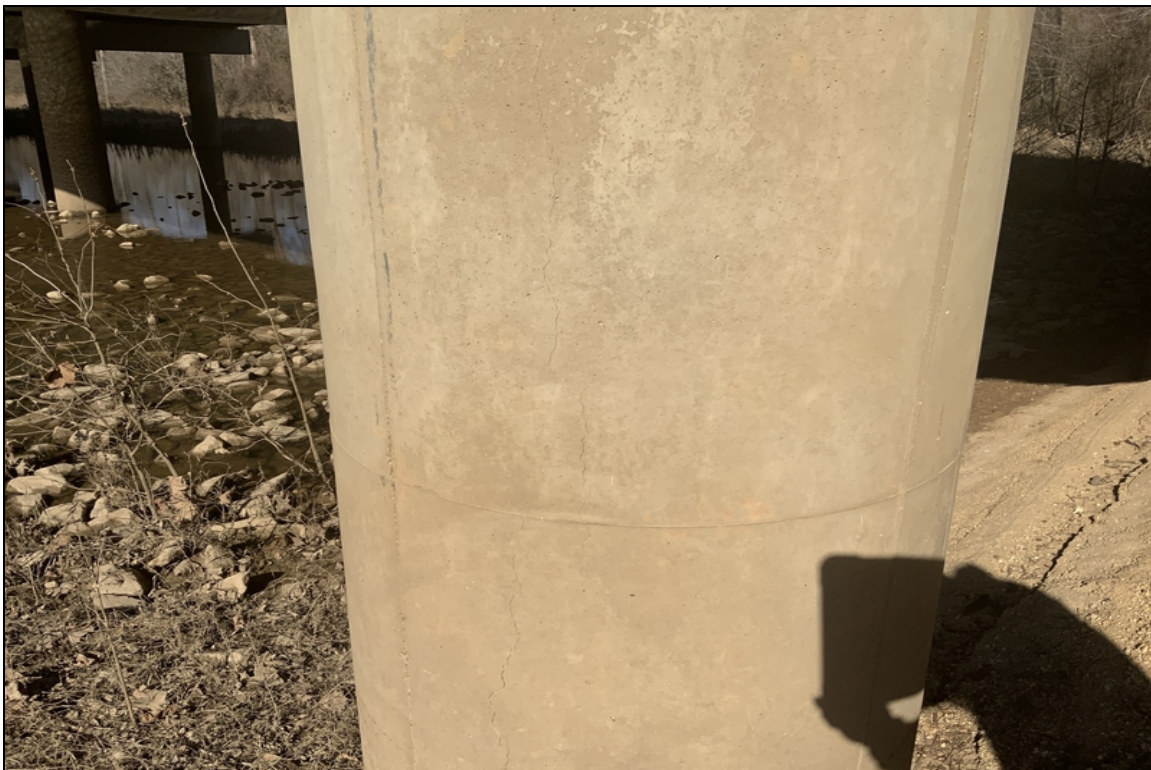
(205)	Bent 27 column 4 , vertical cracks near ground line.						
234	Reinforced Concrete Pier Cap	LF	2128	2128	0	0	0
(234)	Bent 24 pier cap on Rt. end has several cracks from leaks in joint material above the cracks.						
302	Compression Joint Seal	LF	780	0	0	736	44
2310	Leakage	LF	20	0	0	0	20
2330	Seal Damage	LF	24	0	0	0	24
2340	Seal Cracking	LF	20	0	0	20	0
2350	Debris Impaction	LF	716	0	0	716	0

Bent 27 column 4, vertical cracks, 0.030

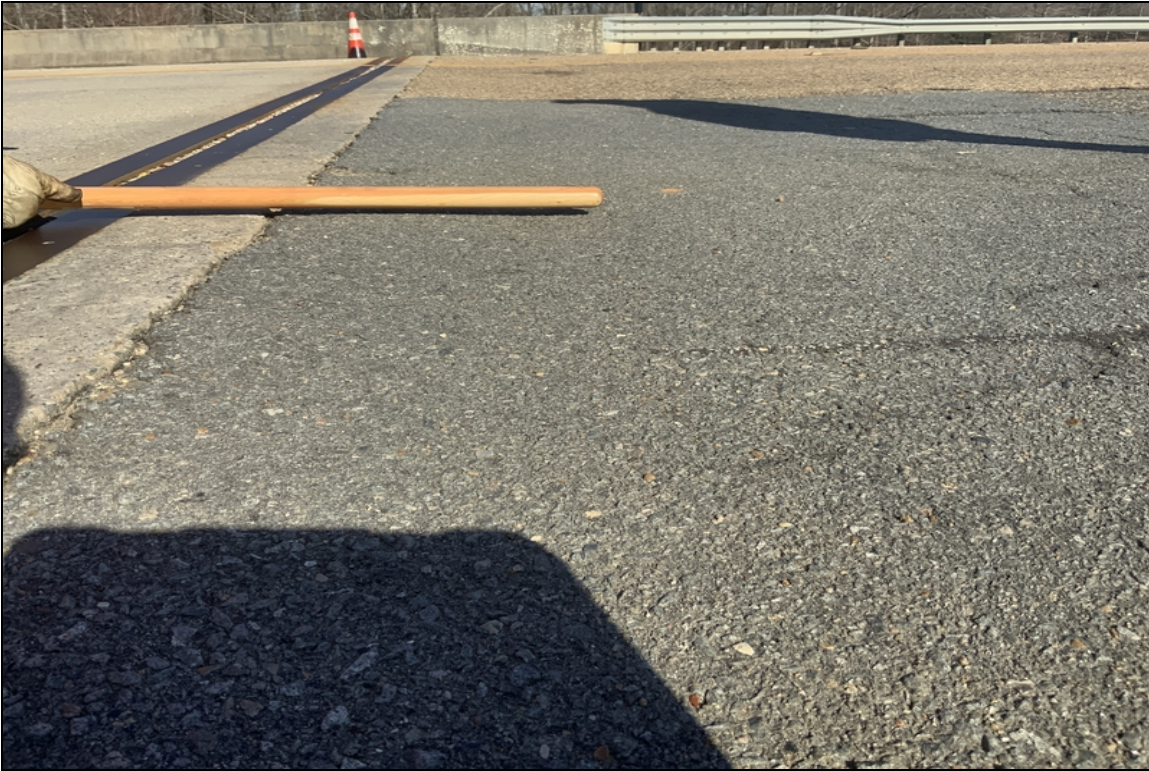
End approach 1" 1/2 settlement

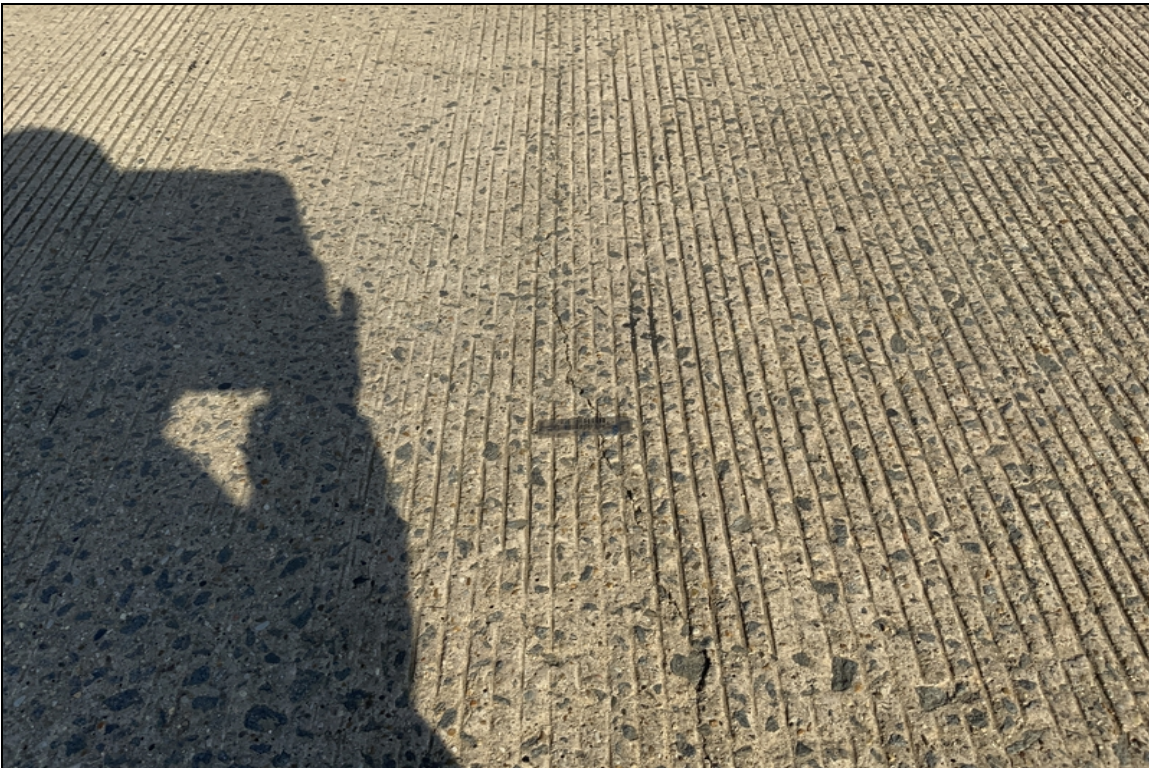
Span 7, transverse deck cracks 0.040

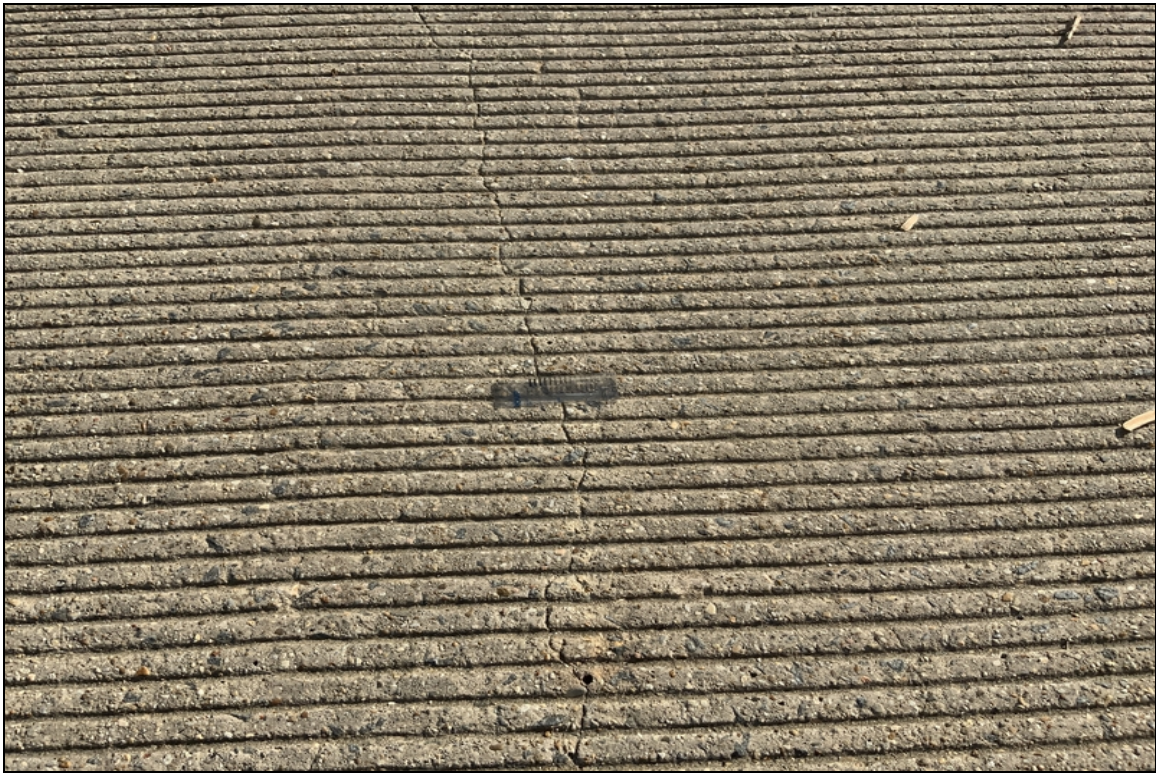
Span 6 deck crack, max 0.040

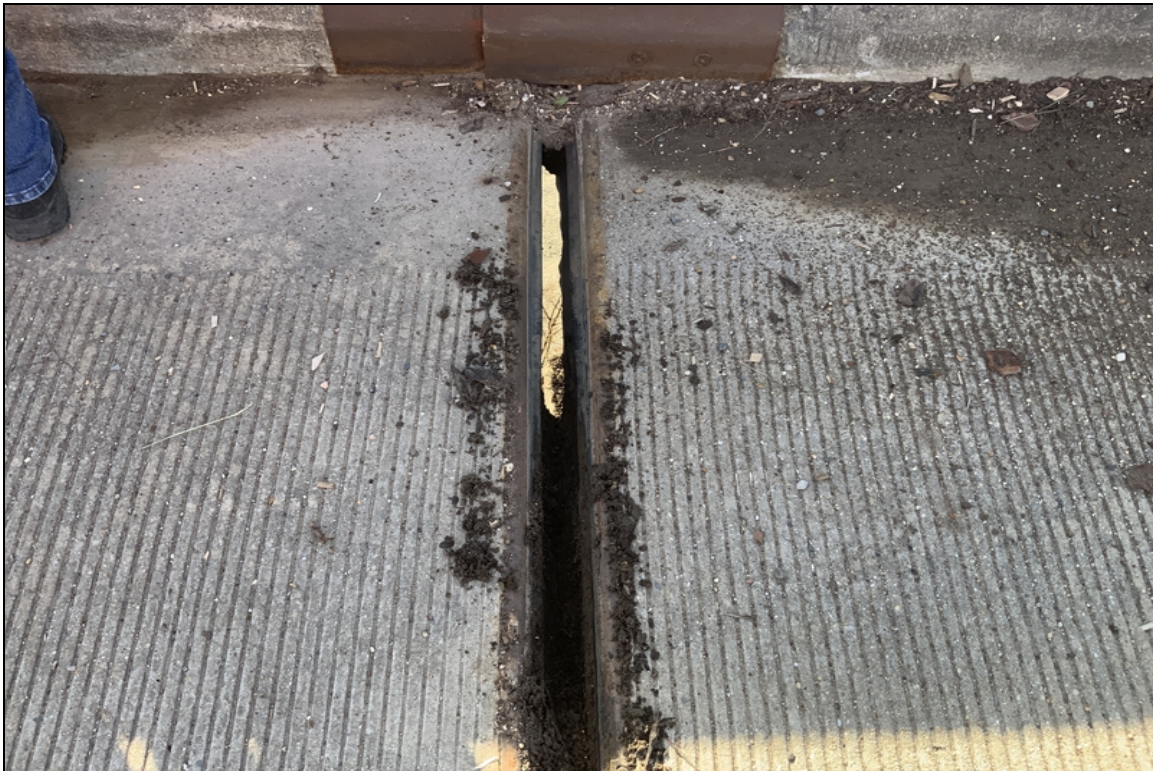
(302)	Dirt and debris built up in joints typical of all joints. Bents 5, 8, 12, 16, 20, & 24 Rt. there are holes in joint material near the ends of the joint material that is allowing dirt, debris, and road salts onto girder ends, and the ends of the pier caps, this is typical of all the open joints on both sides of the bridge.						
310	Elastomeric Bearing	EA	296	296	0	0	0
331	Reinforced Concrete Bridge Railing	LF	3520	3520	0	0	0
1130	Cracking (RC and Other)	LF	0	0	0	0	0

Bent 5 joint missing end, approx 2 feet

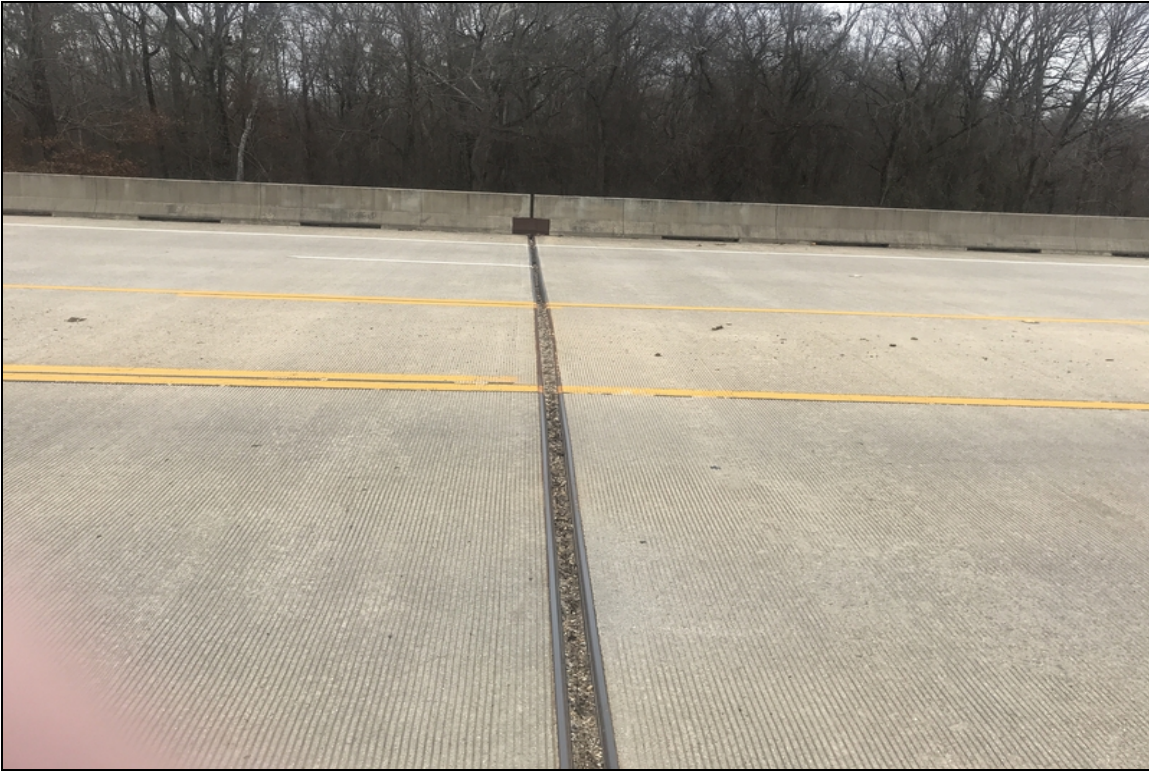
Joint between span 1 and 2. Dirt and debris.

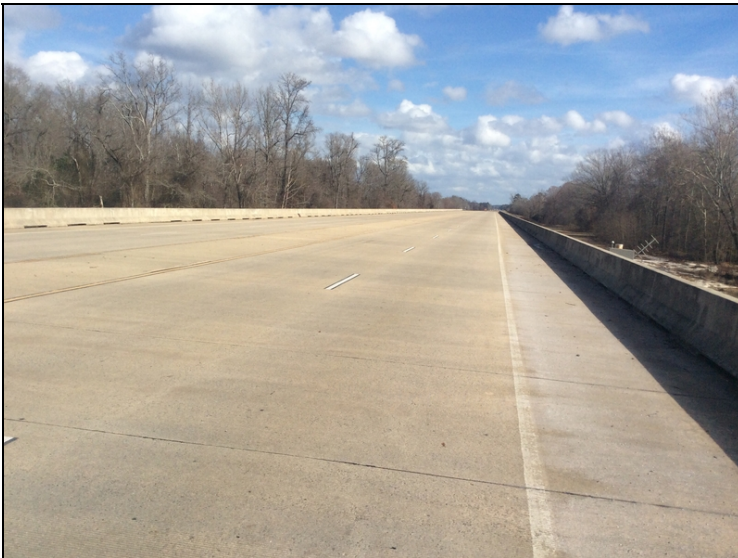
Deck --- all spans.
Sealable transverse and longitudinal cracks.

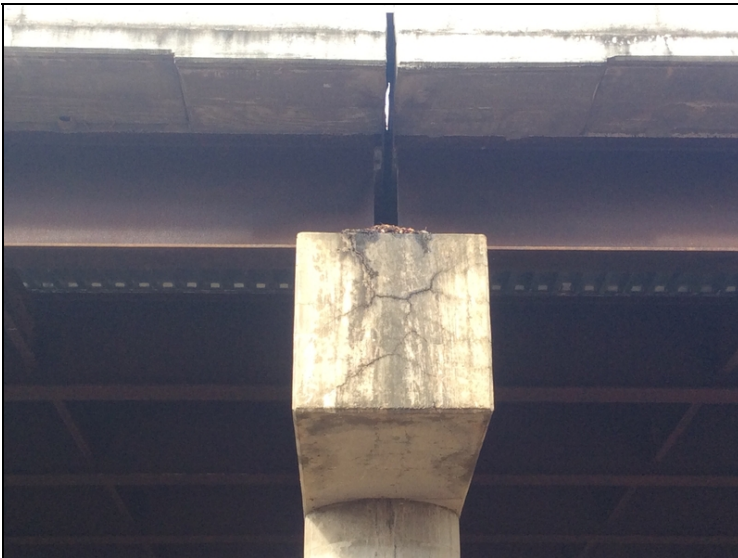
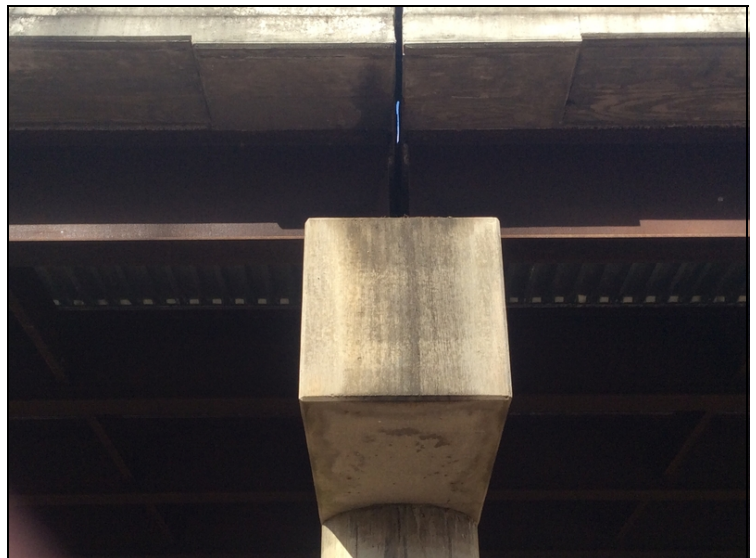
Strip seal joint material @ all expansion joints.

Has failed at both ends of each joint, allowing water and road salts on all outside bearing plates and cap ends. Wet debris have built up on the cap ends @ the expansion joints. 01/11/2017 JPR -- No change in the joint material and there is wet debris on top of the caps at these locations.

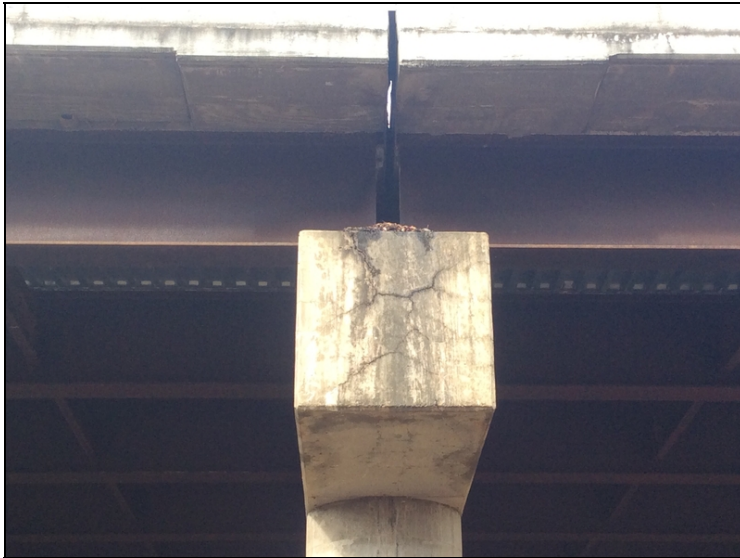
Bent 24 pier cap on Rt. end has several large cracks from leaks in joint material above the cracks, Bent 24 Lt. pier cap has some cracks on the end of the cap also, Bent 12 pier cap on Rt. end has several cracks on the end of the cap. Bent 24 has small tree growing from cap.

Bent 24 pier cap on Rt. end has several cracks from leaks in joint material above the cracks.

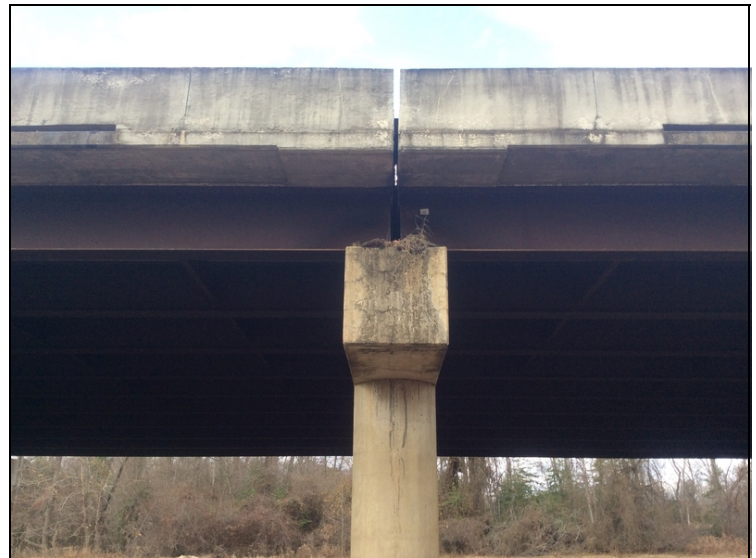
Bent 12 Rt. side, large hole in joint material approx. 1 1/2' long & 3/4" - 1" wide, allowing dirt, debris, & road salts to get through to girder ends & top of caps.

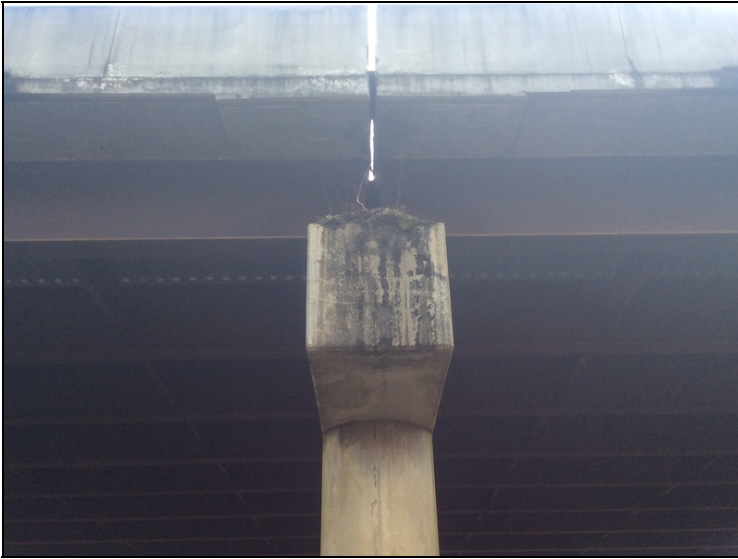
Bent 24 Lt. side large crack in joint material approx.
2 1/2' long & 1" wide, allowing dirt, debris, & road
salts to get through to girder ends & top of cap.

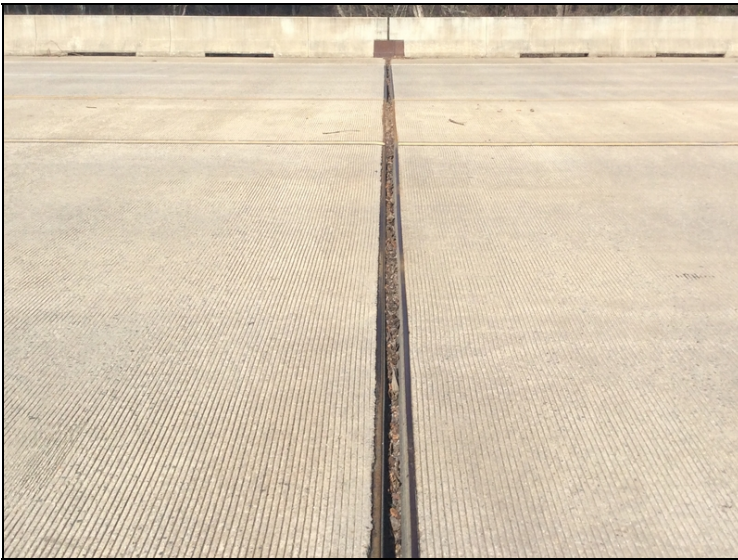
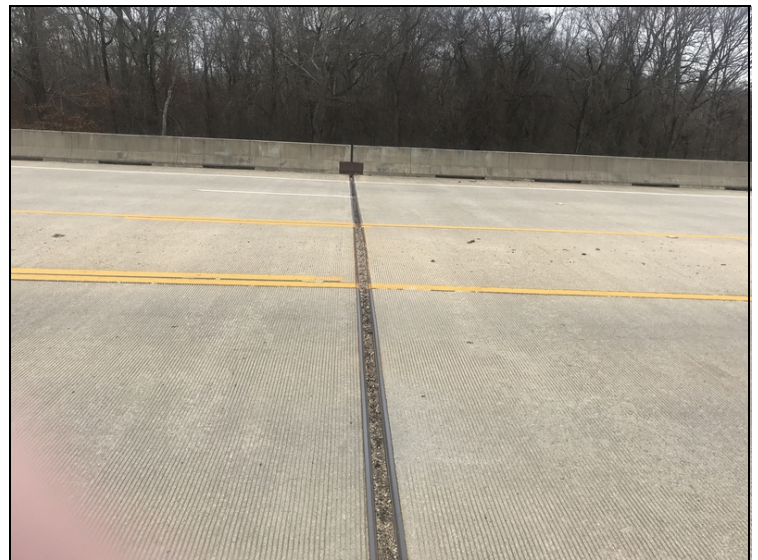
Dirt and debris built up in joints typical of all joints

Joint between span 1 and 2. Dirt and debris.
