Bridge #06815(Routine)

US 278 S13 LM 5.78 over FLAT BRANCH

Team Lead: Rickie Bratton Inspection Date: November 22, 2021

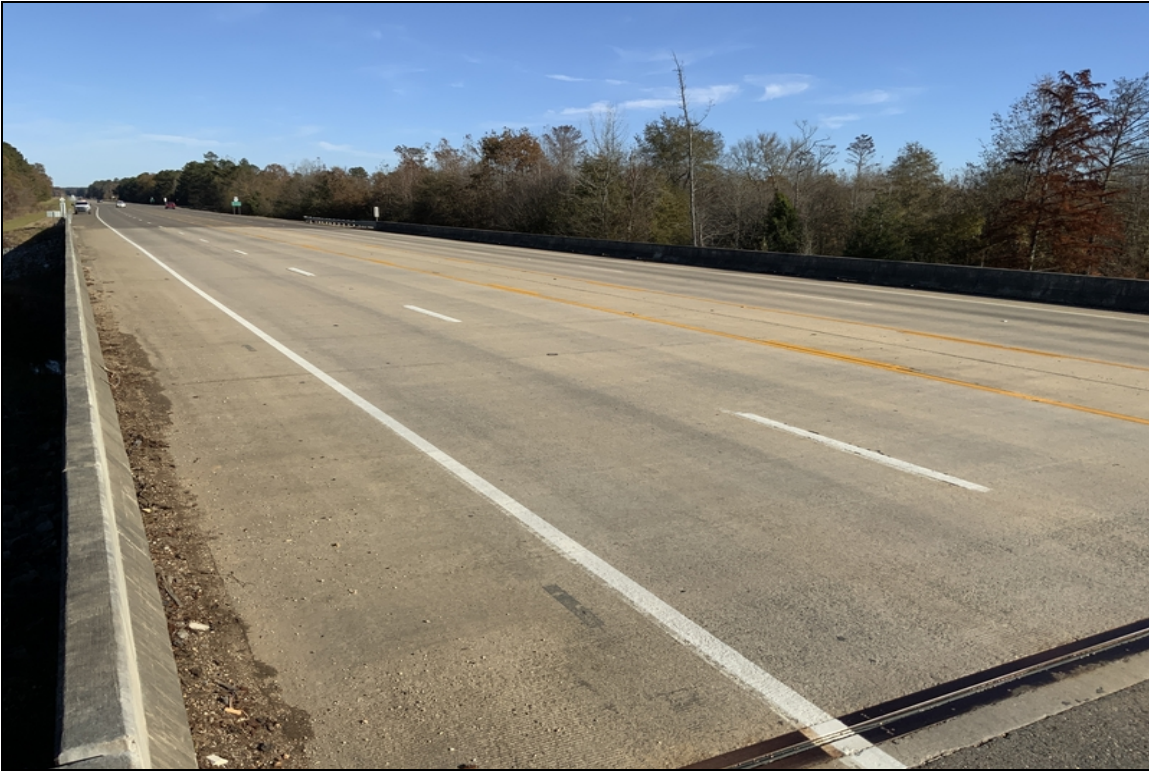
Deck overview.

Numerous cracks all spans. Longitudinal cracking throughout , minor abrasions, exposed aggregates. some deck cracking along joint seals. Seals leaking and losing bond.

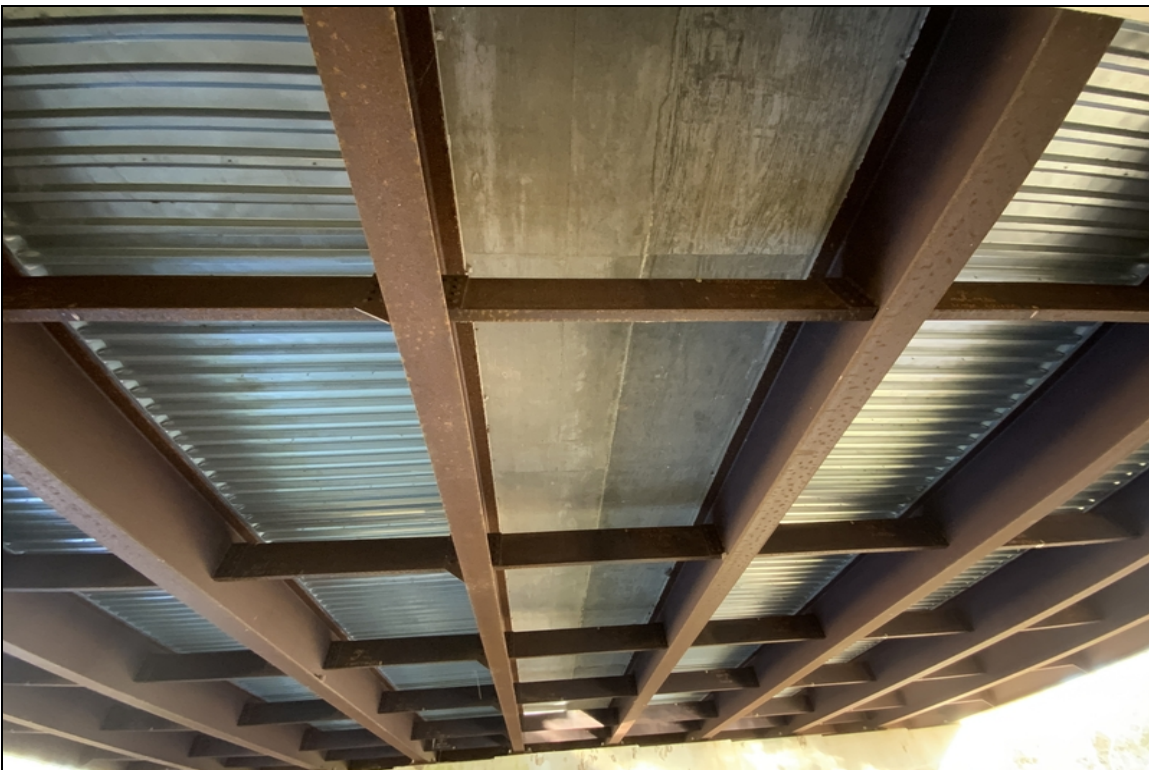
Span 3 soffit overview.

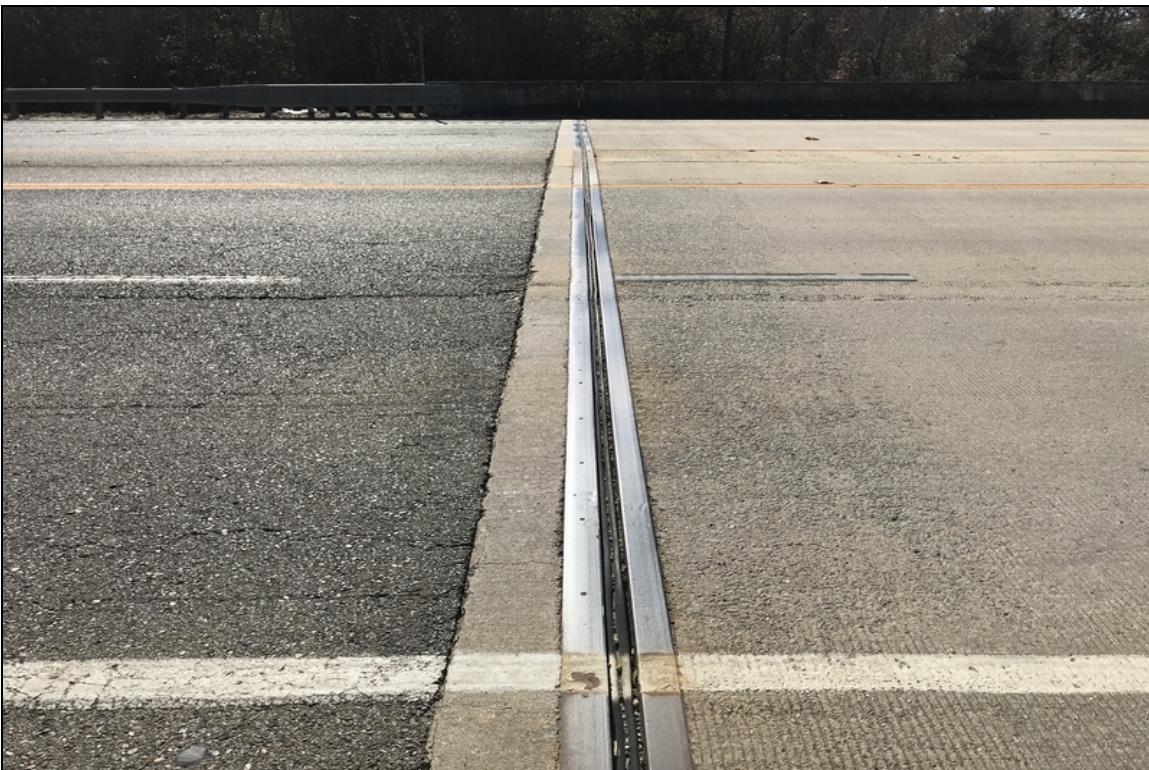
(302)	Losing bond and leaking. Cracked areas of deck edge along joints. 11/19/2019 JPR -- These notes refer to the sawed joints that are also poured, these are not expansion joints but are controlled joints and they are not considered joints in the elements.						
310	Elastomeric Bearing	EA	60	60	0	0	0
331	Reinforced Concrete Bridge Railing	LF	510	510	0	0	0

Abutment 2 joint material.

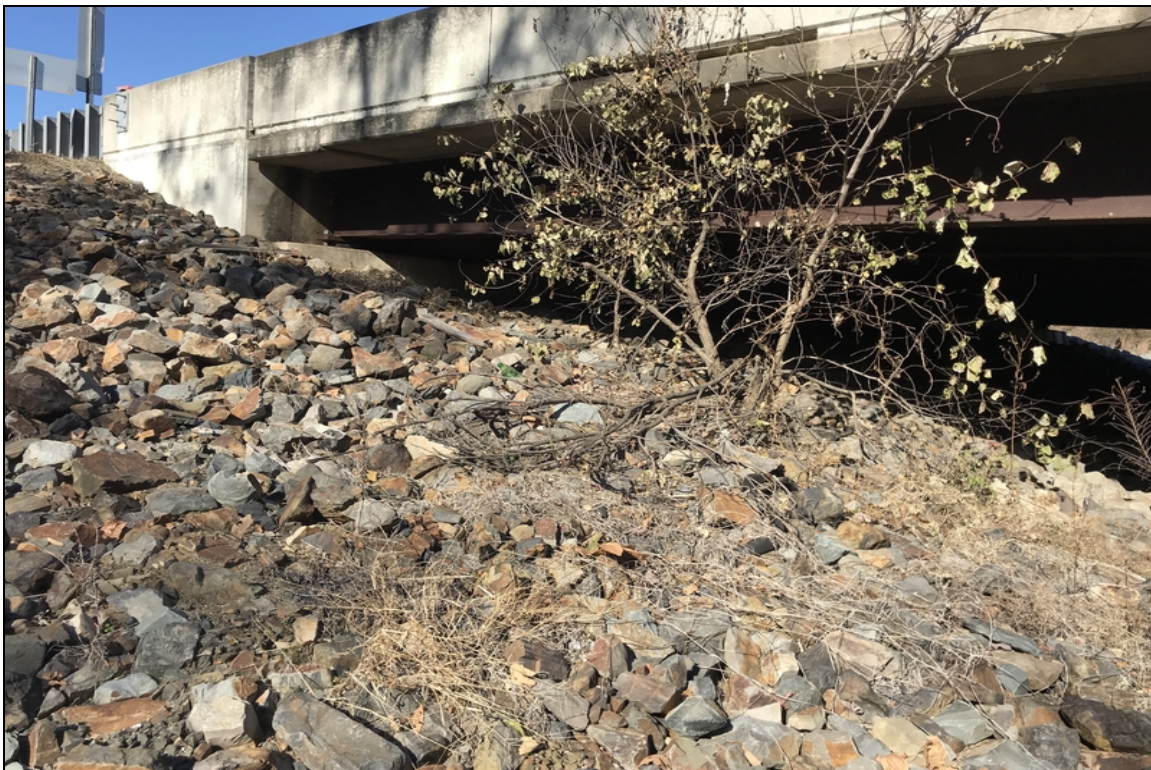
Vegetation right side

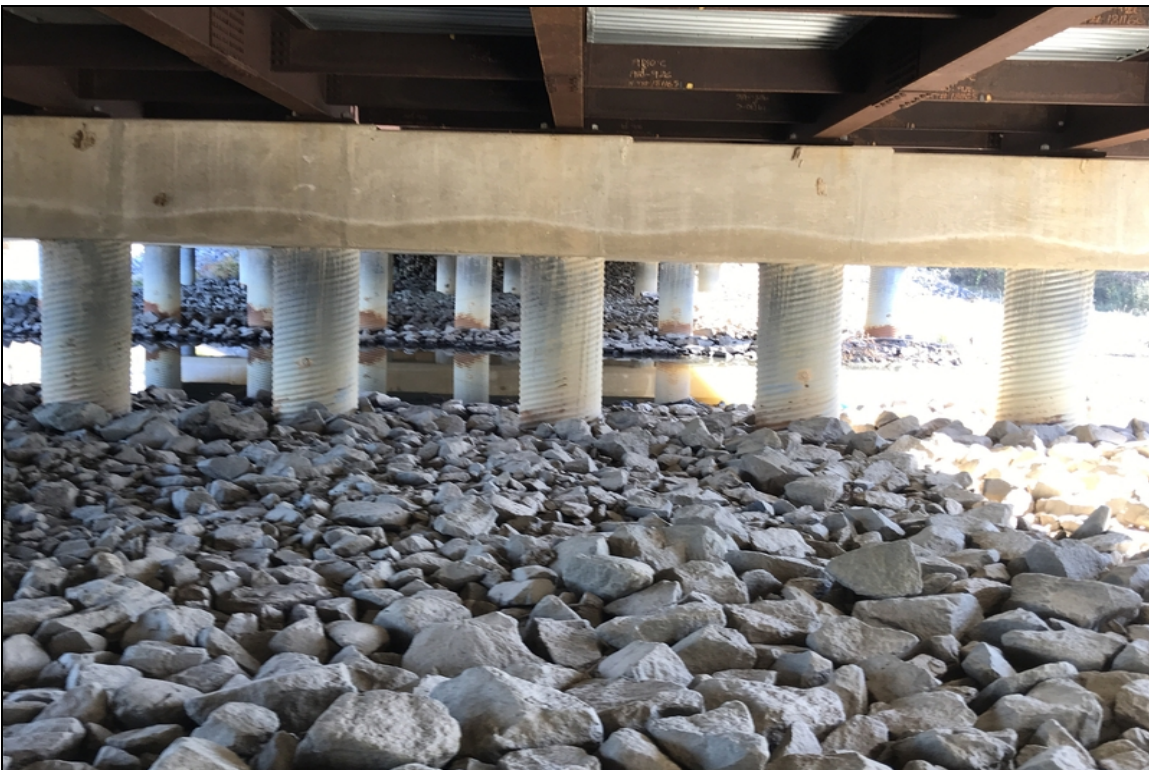
Bent 4 in casement beginning to rust

11/19/2019 JPR -- The corrugated steel pipe that was used as an encasement are beginning to rust, especially Bents 3 & 4.

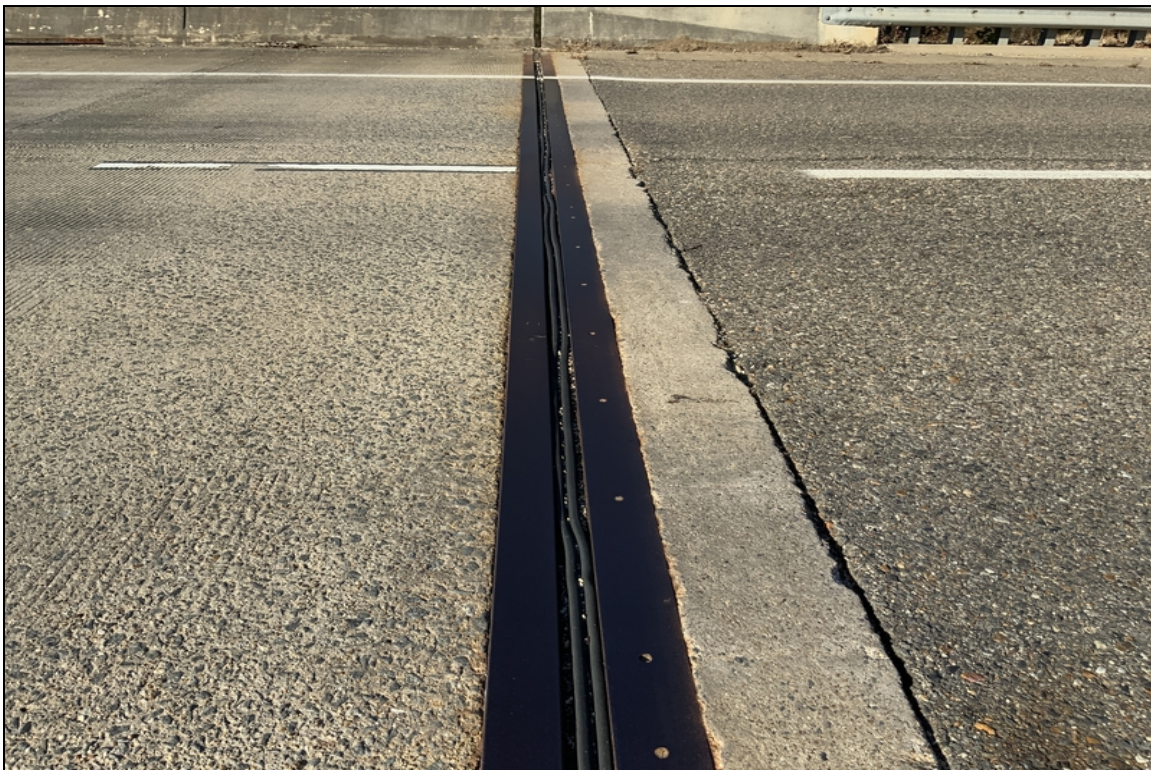
Bent 6 joint seal has lost adhesion and is leaking.
