Bridge #01476(Routine)
US 67 S-5 LM 0.60 over CANEY CREEK
Location: .6 MI N JCT SH 53

Team Lead: Jimmy Reynolds Inspection Date: November 08, 2021

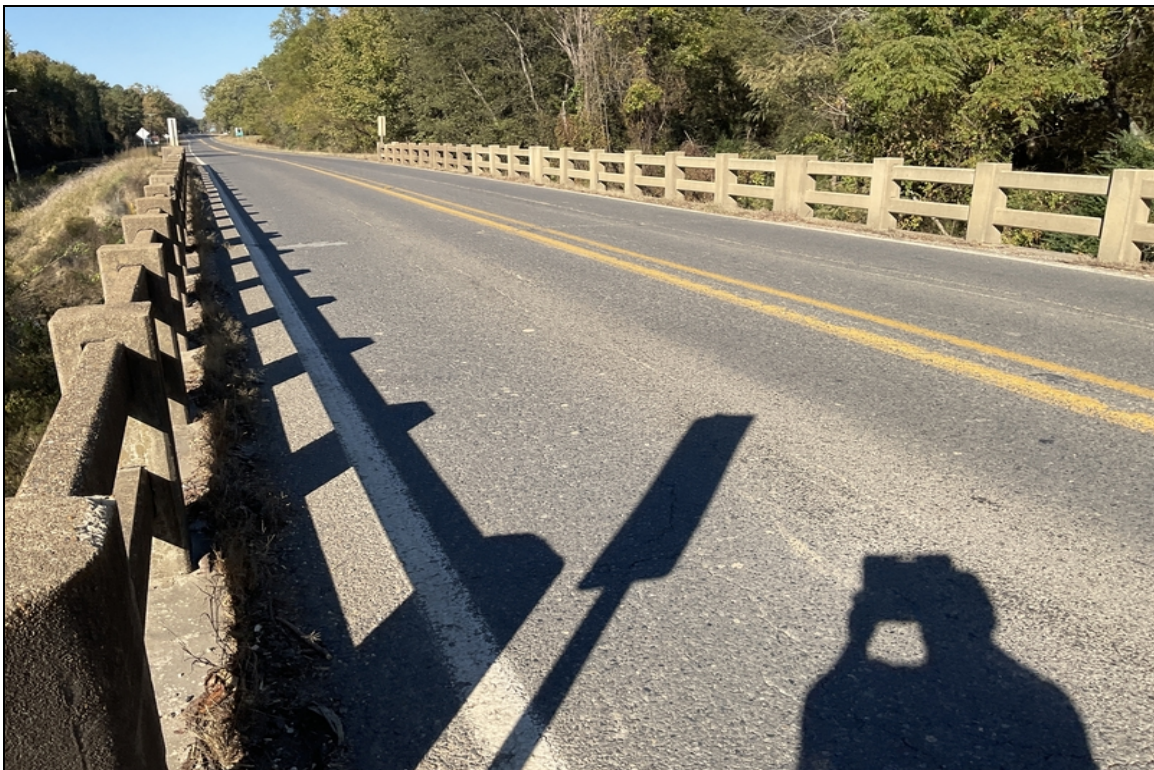
Deck

(16)							
AC OL has some visible cracks and has a long gouged area possibly from an object being dragged across the deck.							
110	Reinforced Concrete Open Girder/Beam	LF	420	413	0	7	0
1090	Exposed Rebar	LF	7	0	0	7	0

AC OL has some visible cracks and has a long gouged area possibly from an object being dragged across the deck.

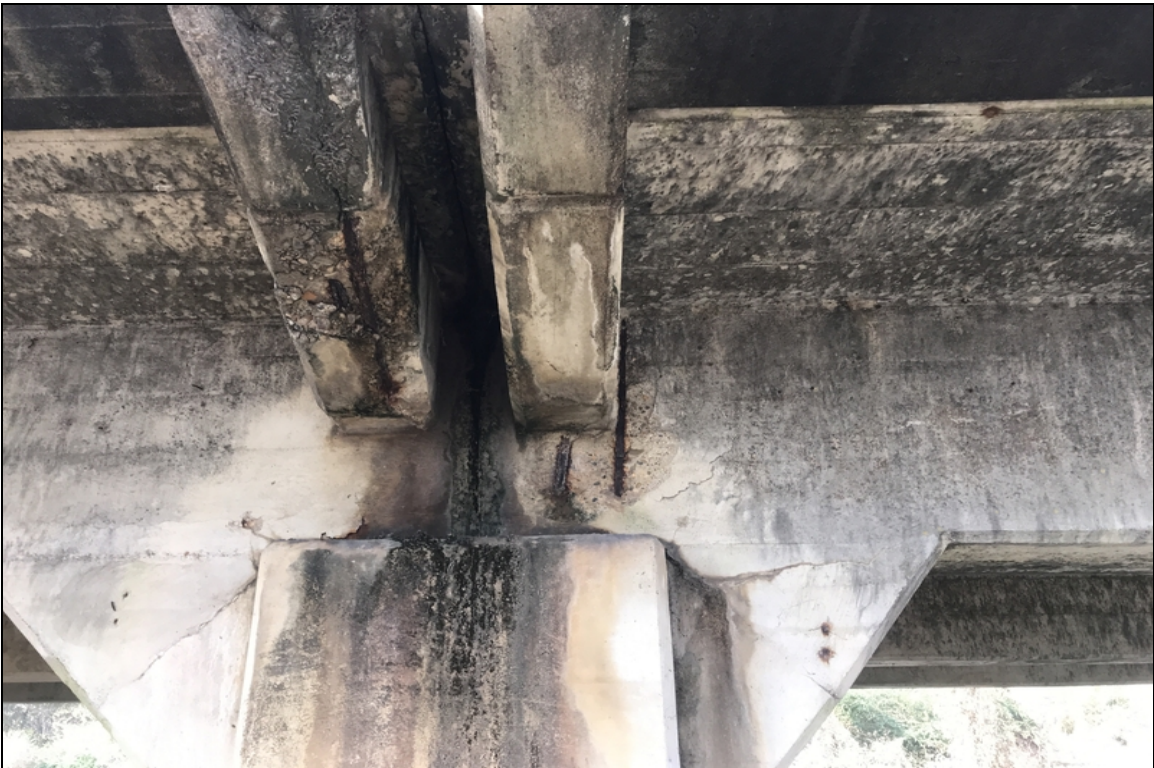
(234)							
Bent 3 cap exposed rebar.							
306	Other Joint	LF	81	0	81	0	0
2310	Leakage	LF	81	0	81	0	0
(306)							
Leaking.							
331	Reinforced Concrete Bridge Railing	LF	280	0	280	0	0
1080	Delamination/Spall/Patched Area	LF	155	0	155	0	0
1130	Cracking (RC and Other)	LF	100	0	100	0	0
7000	Damage	LF	25	0	25	0	0

Span 3 girder 3, exposed rebar at bent 3.

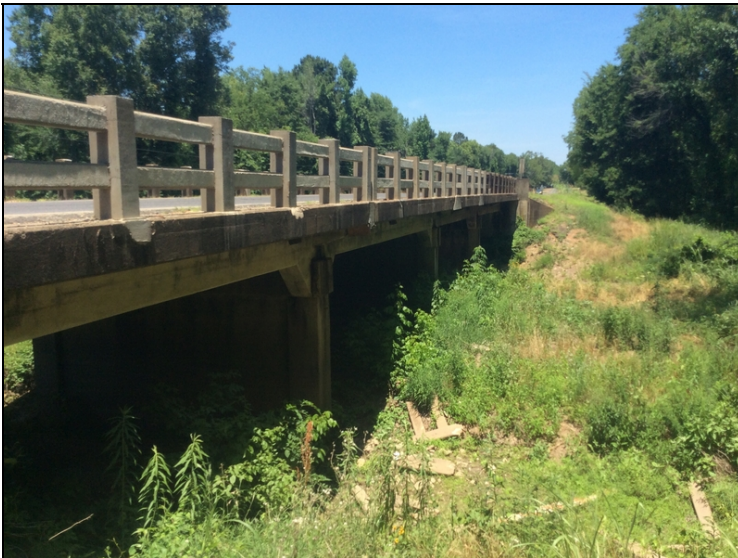
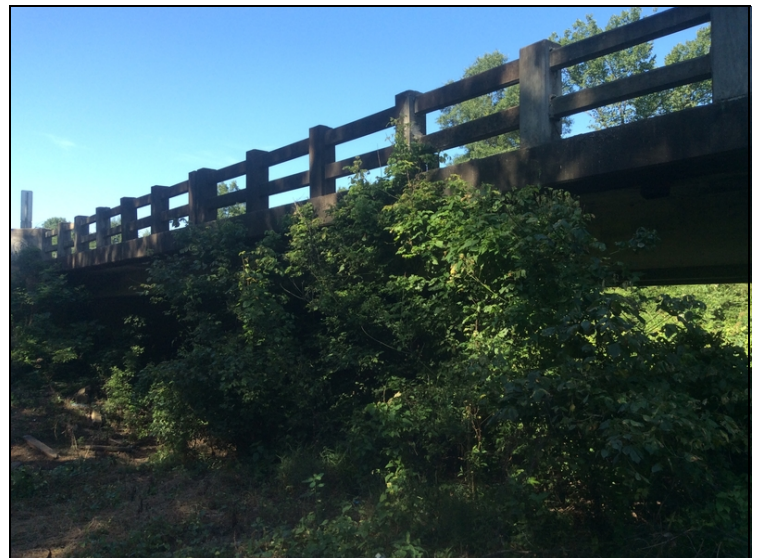
Vegetation

Heavy vegetation growing under and against the structure
