Bridge #01481(Routine)

US 67 S-5 LM 11.07 over BIG DECEIPER CREEK

Team Lead: Rickie Bratton Inspection Date: July 14, 2020

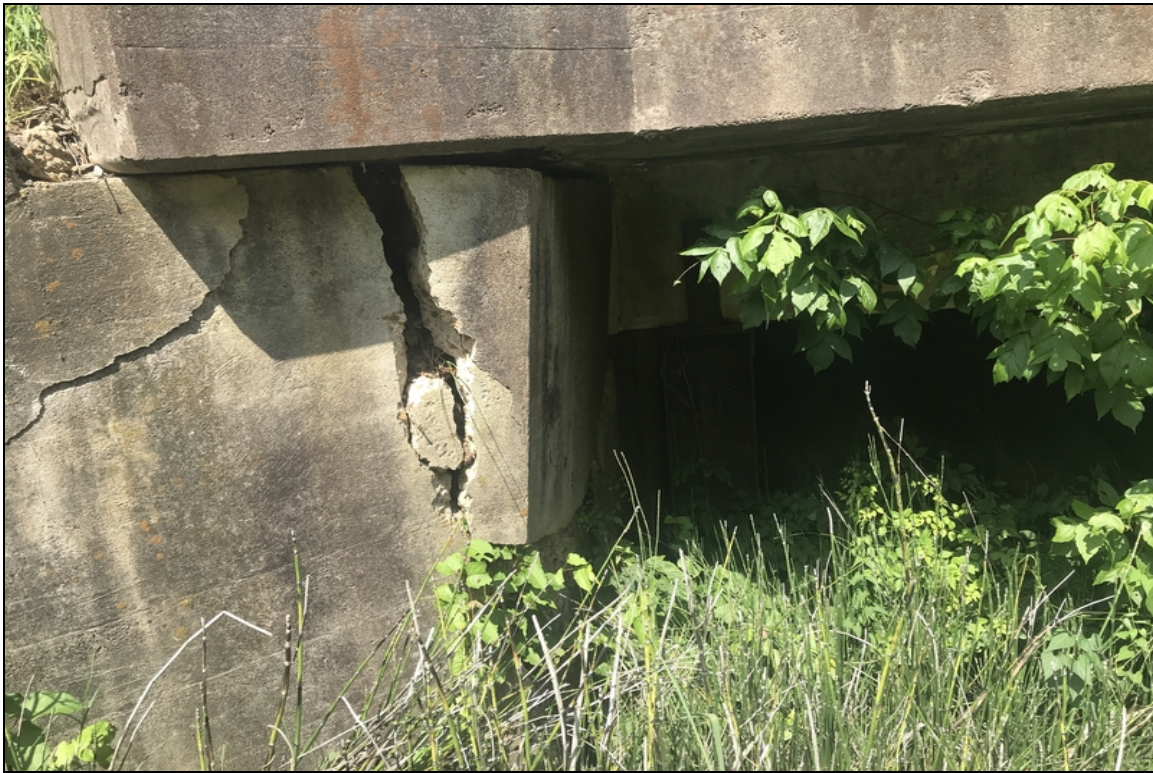
Abutment 1 right side, back wall has large delam

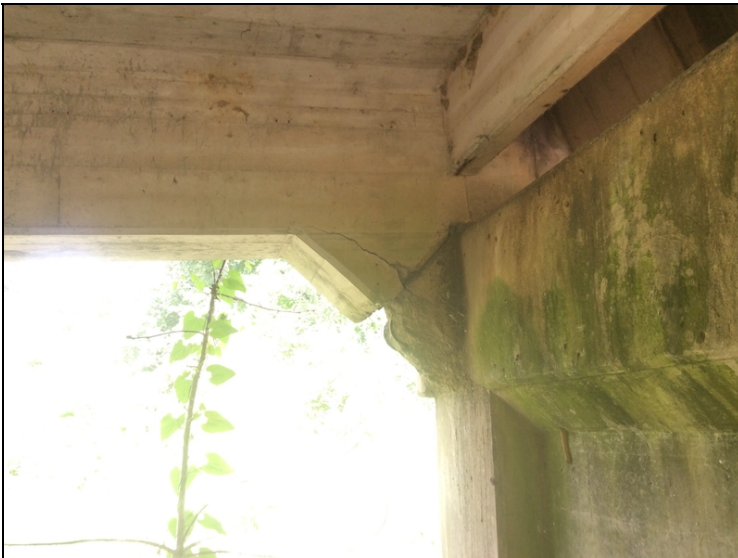
Bents 2 - 3 have shifted/rotated ahead, Girder ends are cracked and spalled @ ends and haunches.

Haunch 1 BT 2 back 01481

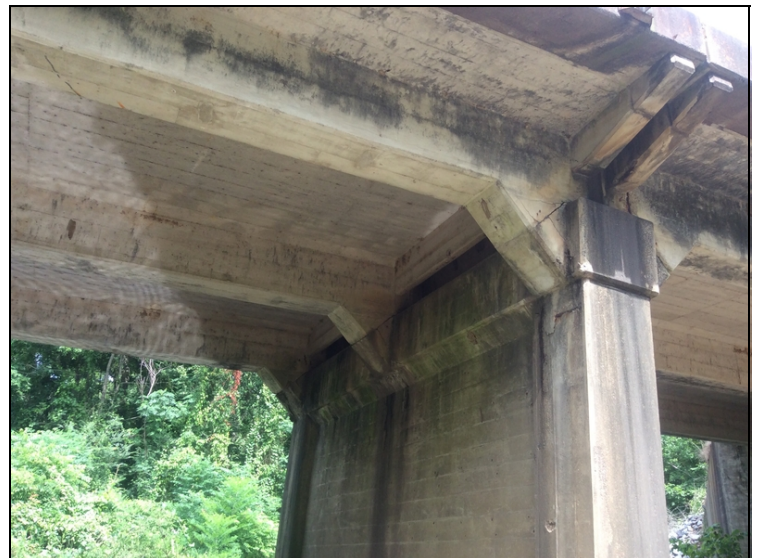
01481 BT 3 back

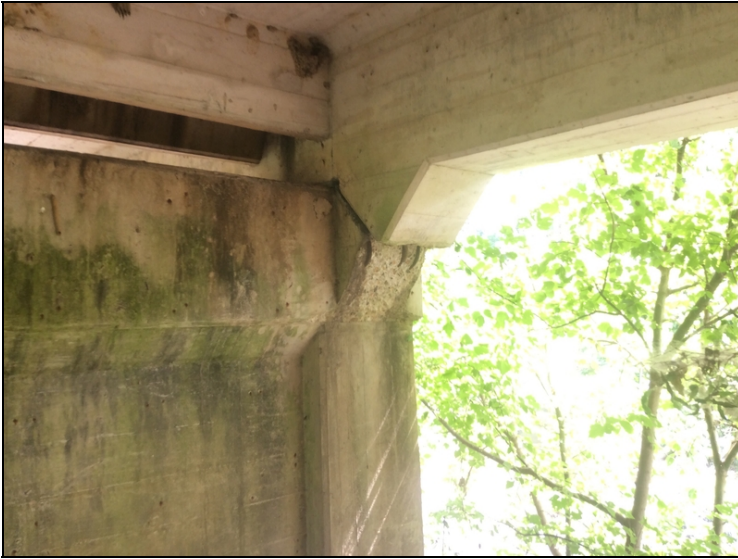
01481 haunch 3 BT 2 back

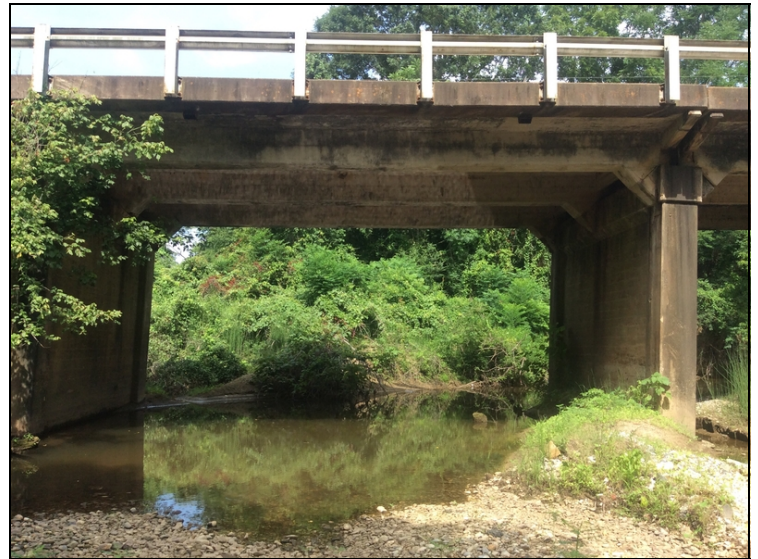
01481 main span, both bents 2 & 3 have rotated ahead.

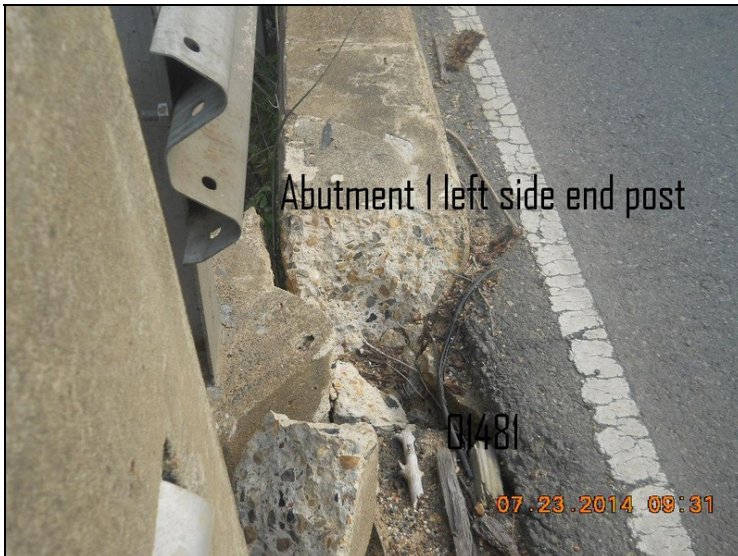
Abutment 1 Left side bridge end post and the 1st steel guardrail post and curb section @ wingwall have broke loose and post and concrete can be moved by hand, the reinforcing steel and guardrail are the only thing holding post and concrete in place.

Abutment 1 left side end post has collision damage.

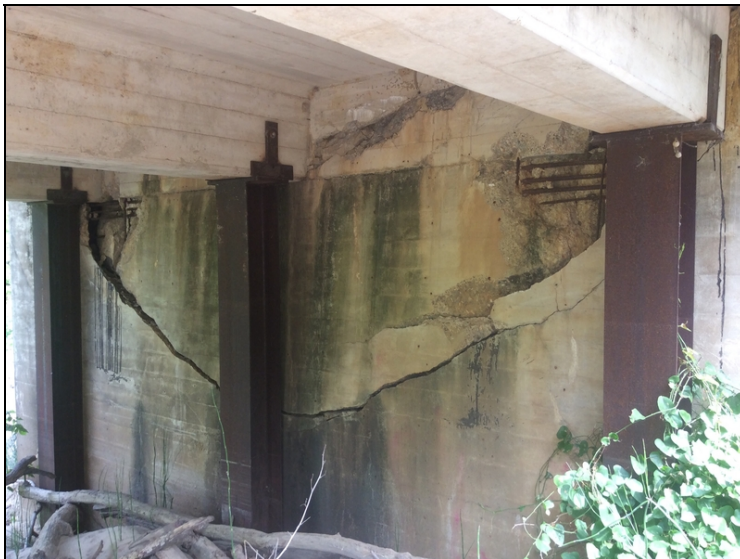
01481 abutment 2

Abutment 1 has large cracks with spalls between girders 1 & 2 and 2 & 3 in the diaphragms, abutment 2 has large cracks with large spalls and exposed steel with some section loss to steel in backwall between girders 1 & 2 and 2 & 3. Bridge superstructure and deck appears to be pushing east towards Arkadelphia. 07/23/2018 JPR -- Little or no change since last inspection.

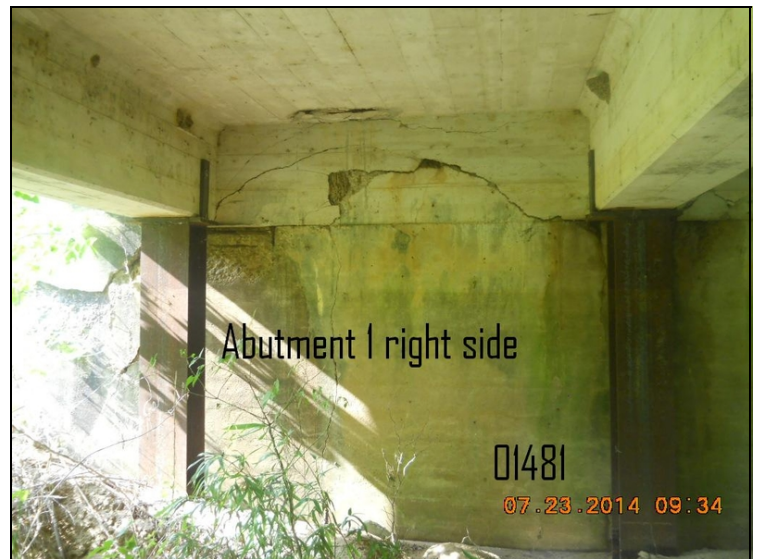
Abutment 1 Rt., cracks in diaphragm between girders 2 & 3.

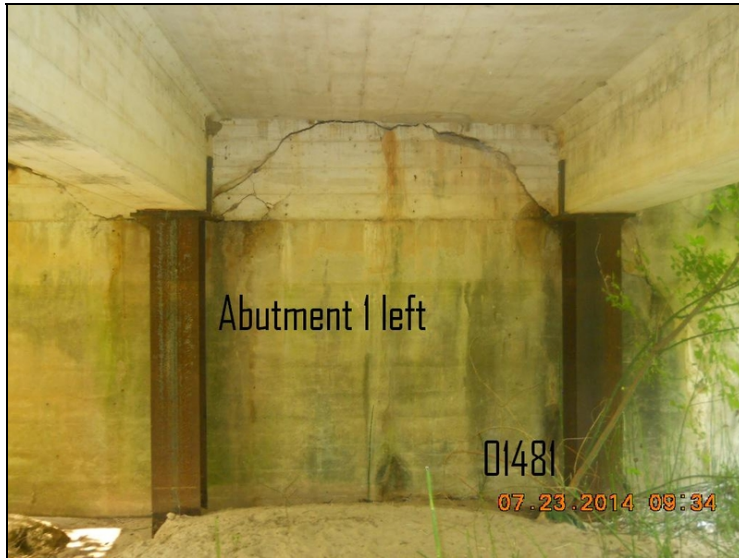
Abutment 1 Lt. cracks in diaphragm between girders 1 & 2.

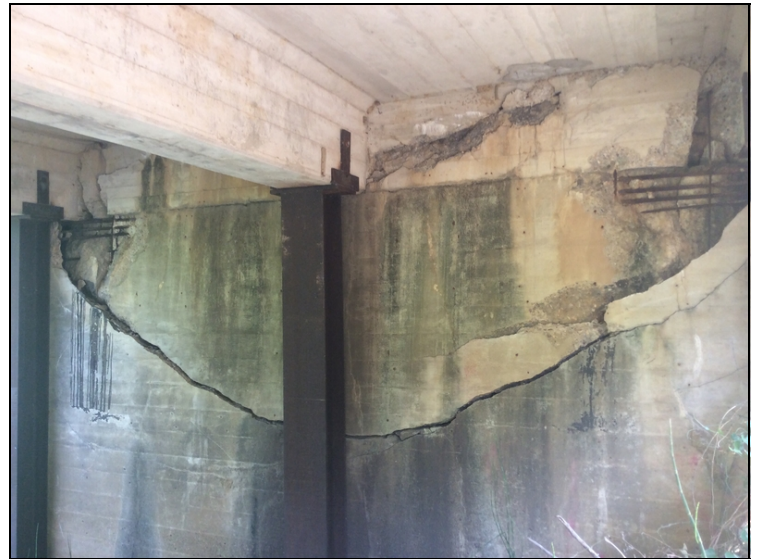
Abutment 2 pier wall has a large crack & spalls & the middle upper section between girders 1 & 3 have shifted ahead thus exposing some of the reinforcing steel.

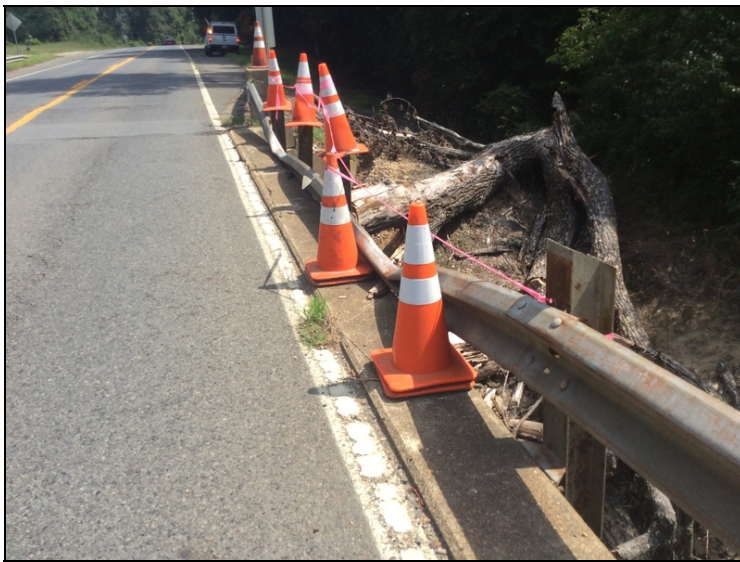
Span 3 Rt., a large tree fell and damaged 25' of guardrail on the rt. and about 2' on the Lt. across the highway from that on the Rt.

Rail damage right side

Bridge Crew has replaced new guardrail. RHB, 7-22-20.

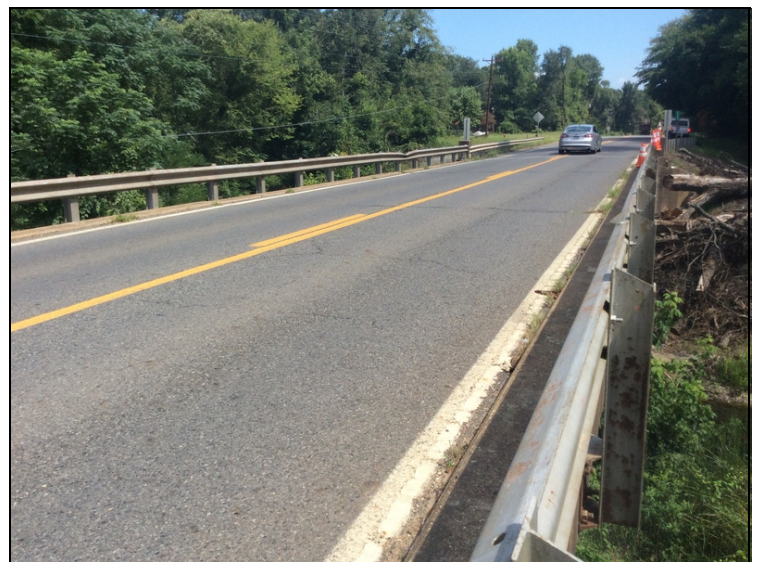
Span 3, minor damage to guardrail on the Rt. side

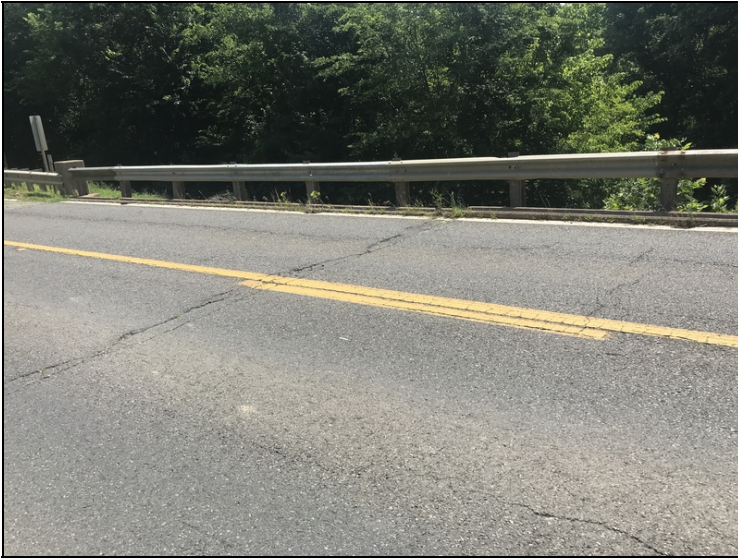
New guardrail, right side

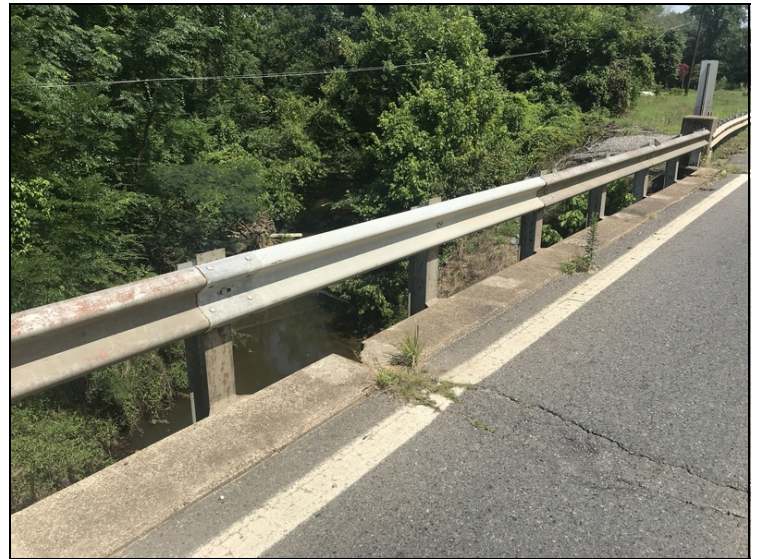
New guardrail left side
