Bridge #01482(Routine, Underwater type 2)
US 67 S-5 LM11.51 over LITTLE DECIPER CREEK

Location: 1.3 MI NORTH JCT SH 26

Team Lead: Jimmy Reynolds **Inspection Date:** March 09, 2021

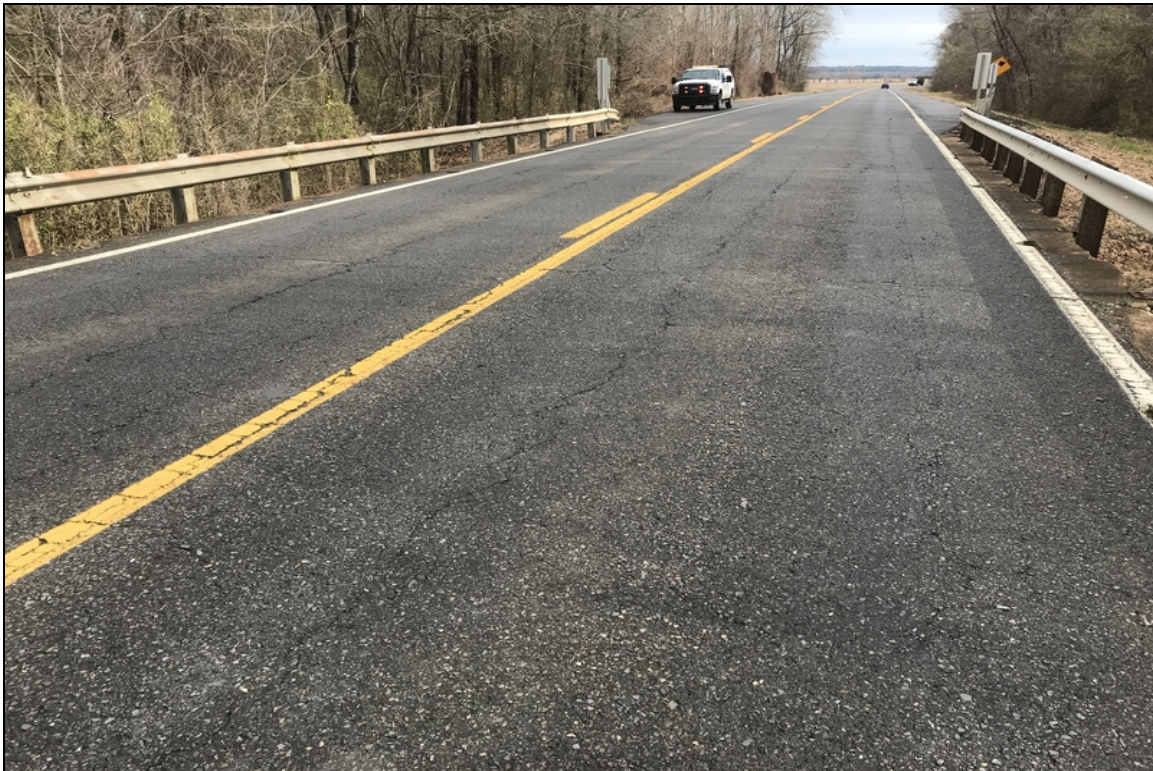
Deck overview.

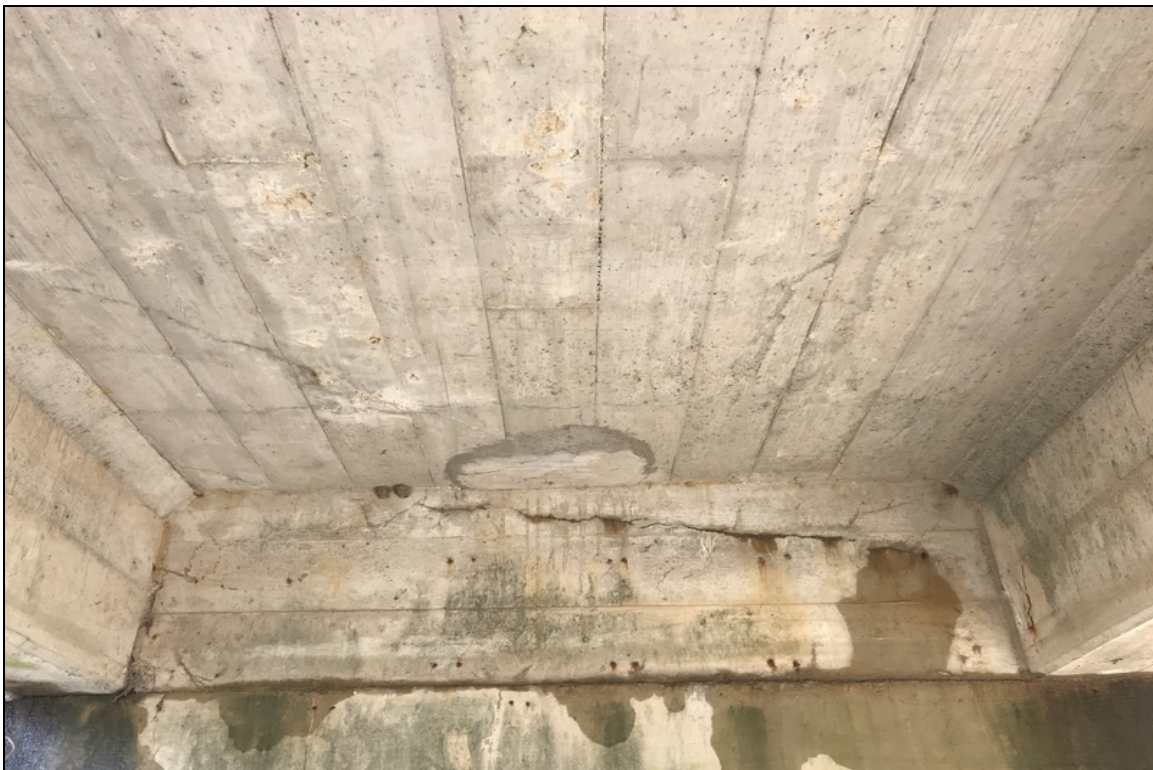
Span 3, bay 1, small cracks.

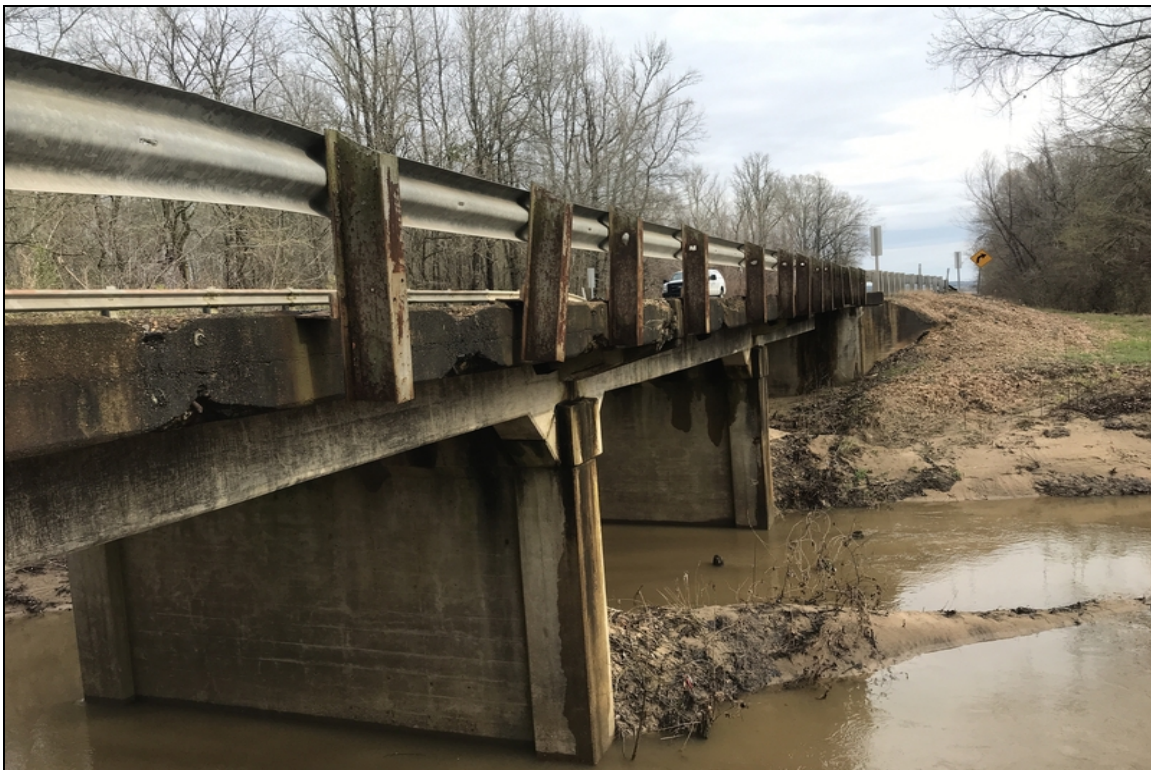
Right side curb spalls

Curbs: Curbs are spalled from impact damage from rail collision.

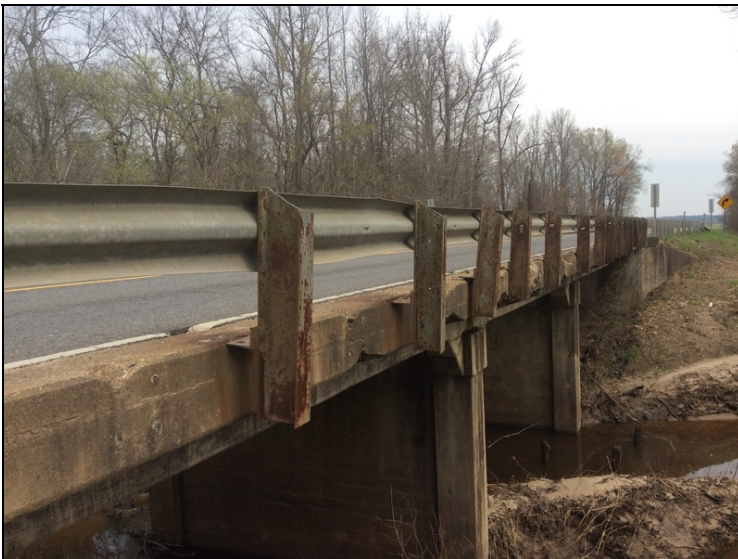
Collision damage to bridge rail and first four posts. The anchor bolts have broken from the curb and the rail is supporting these posts. Post #1 is missing, and the next 3 posts are detached from bridge with rail supporting them.

Span 1 rt. rail has collision damage, 1st 3 posts are detached from the curb.

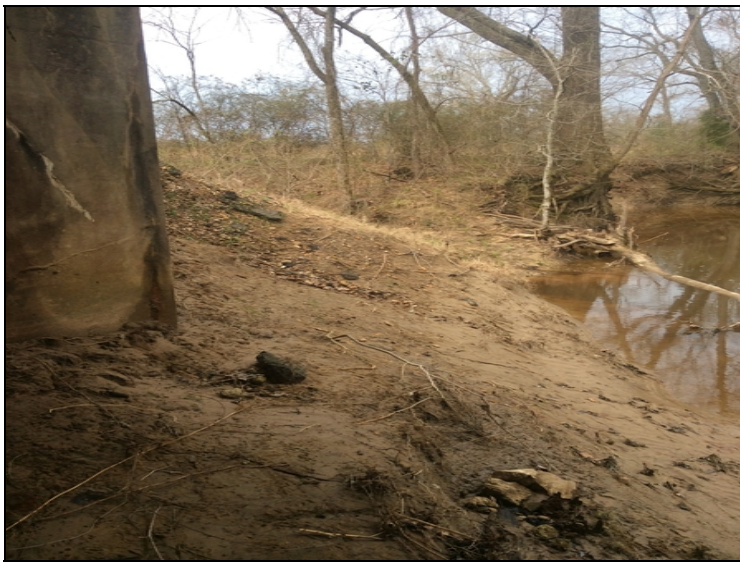
Erosion abutment 1 left side.

Slope Protection: Erosion @ base of abutment 1 left side.

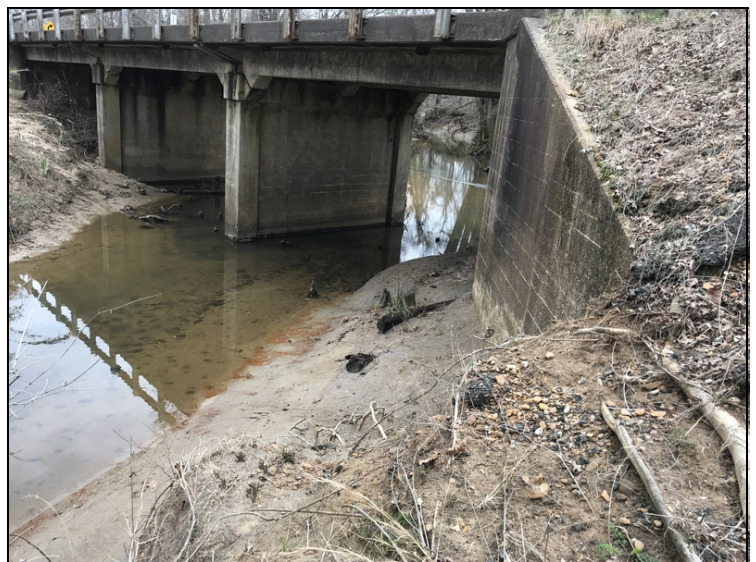
Channel
Eroding bankline downstream left.

Erosion left side
