Bridge #07329(Routine)

Us 67 S-5 LM 5.27 over North Boat Ditch

Team Lead: Rickie Bratton Inspection Date: October 27, 2020

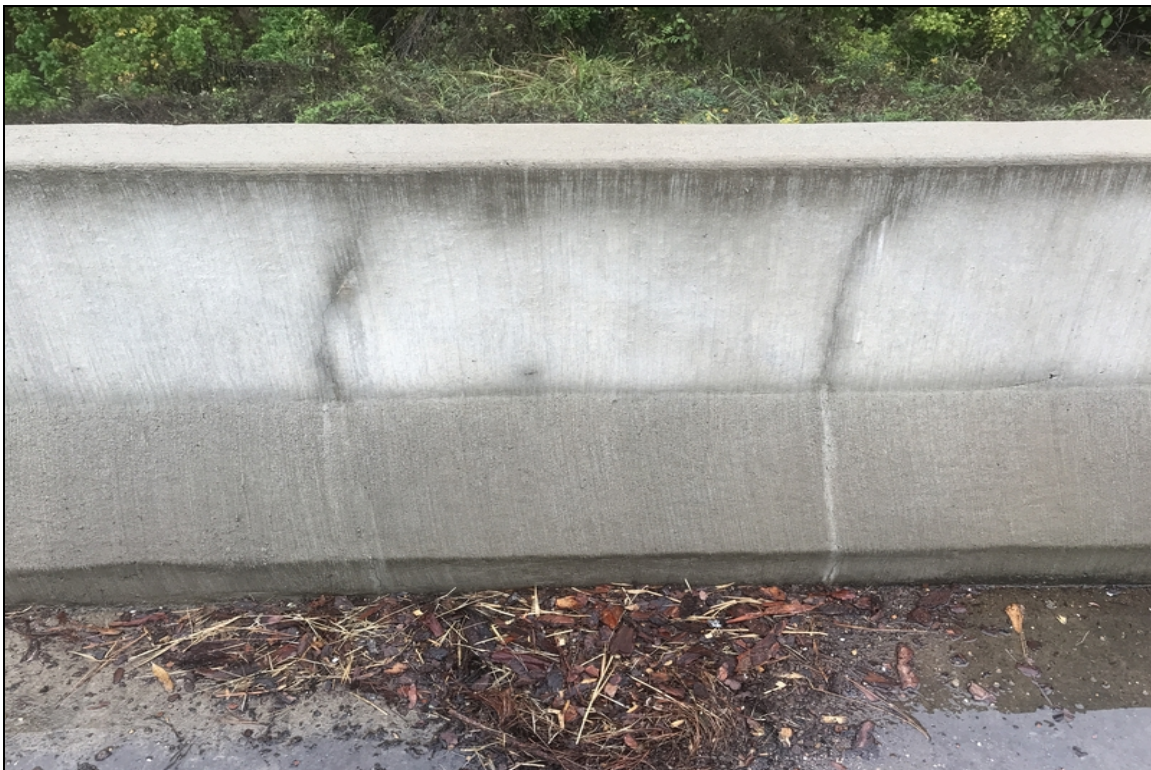
Parapet wall Vertical cracks

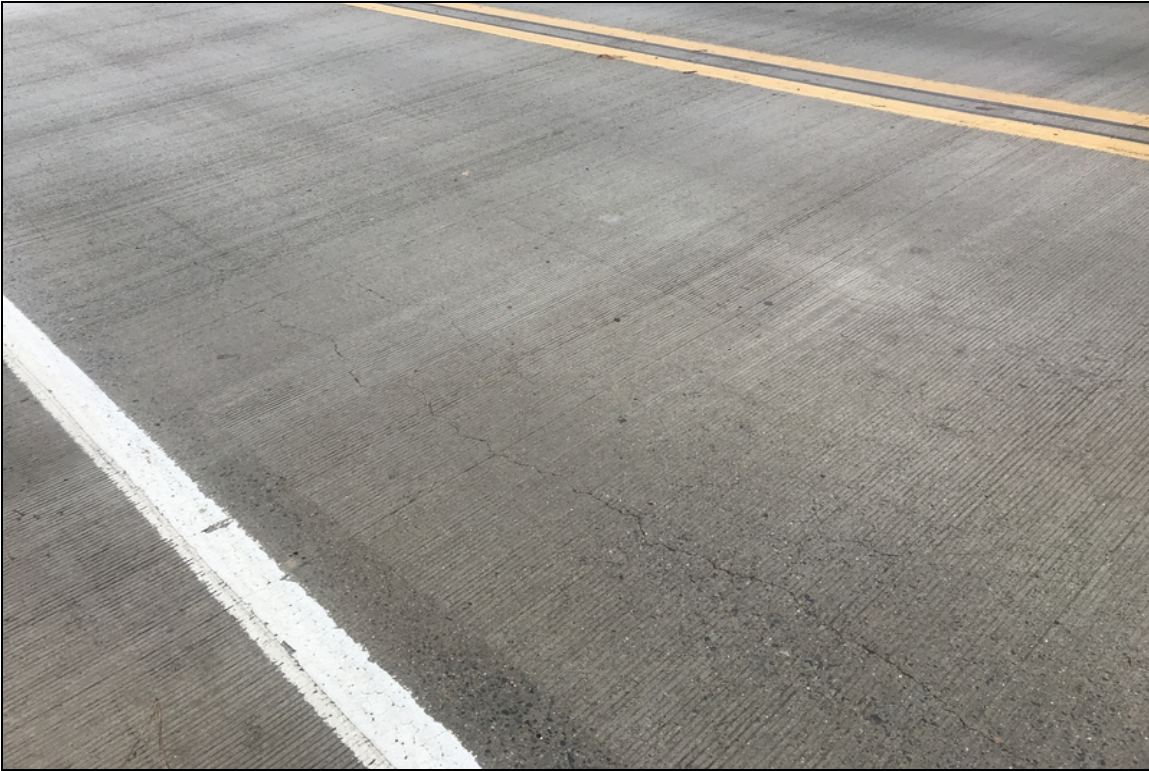
Span 1 longitudinal cracks

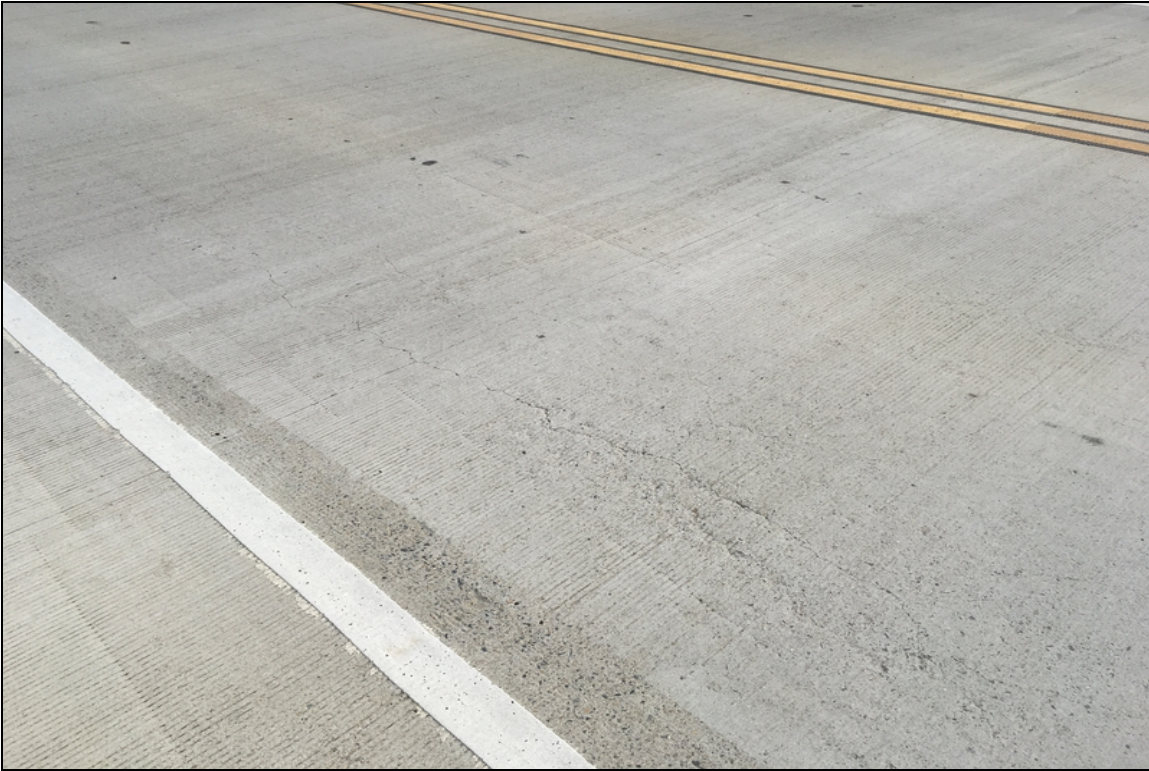
Span #1 sealable deck cracks

Sealable deck cracking throughout structure.

Date Reported: 10/31/2018  
Priority: D- Routine  
Type of Work: None  
Status: Monitor  
Component:

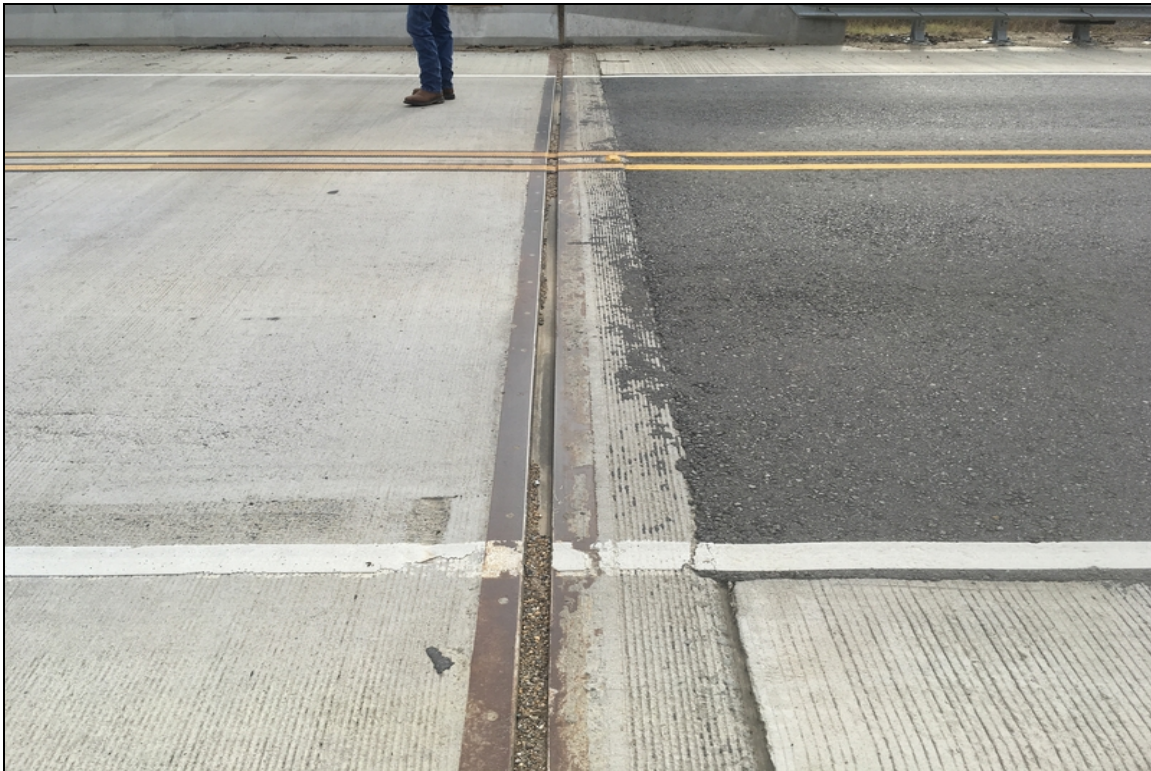
Bent #1 Joint good condition.

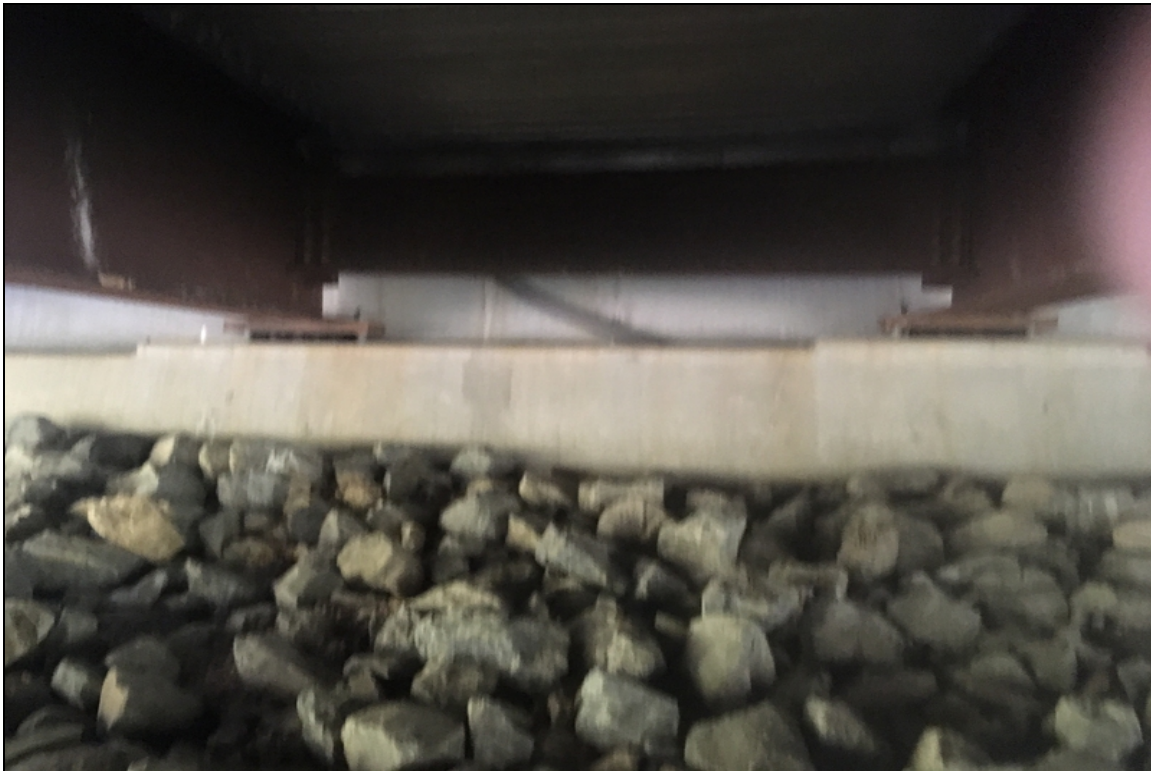
Abutments vertical Cracking with efflorescence.

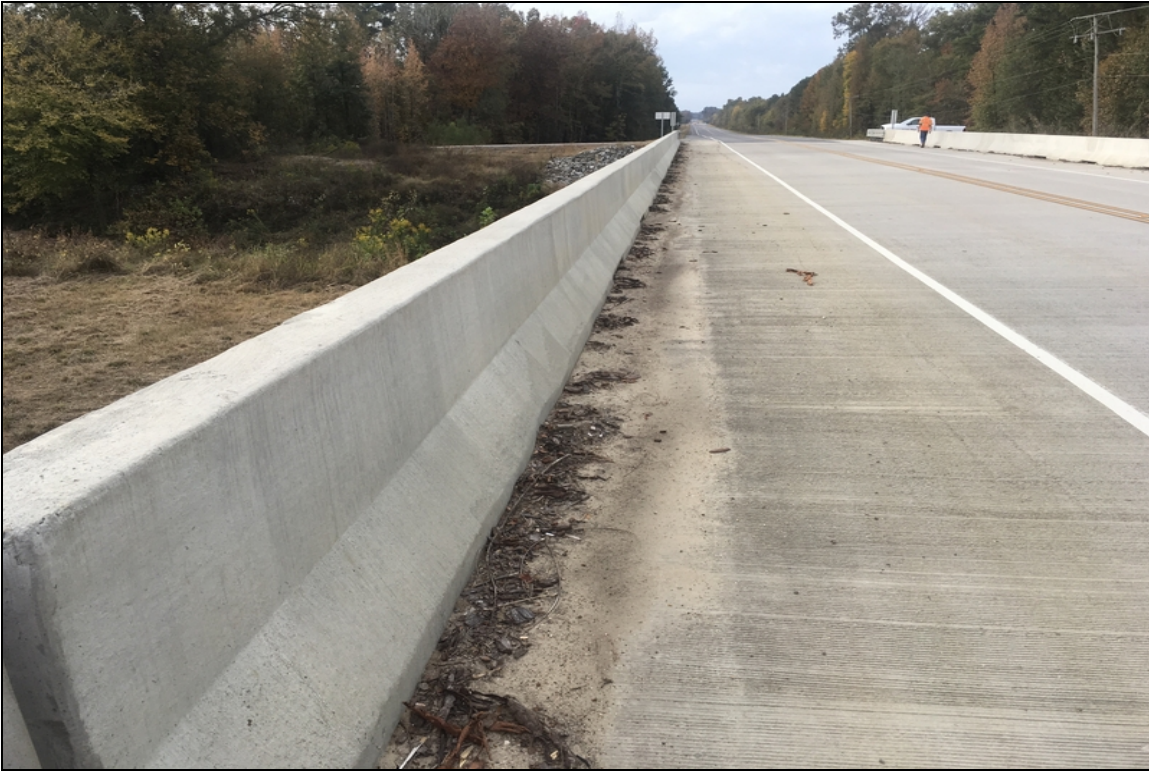
Dirt and debris in gutter.

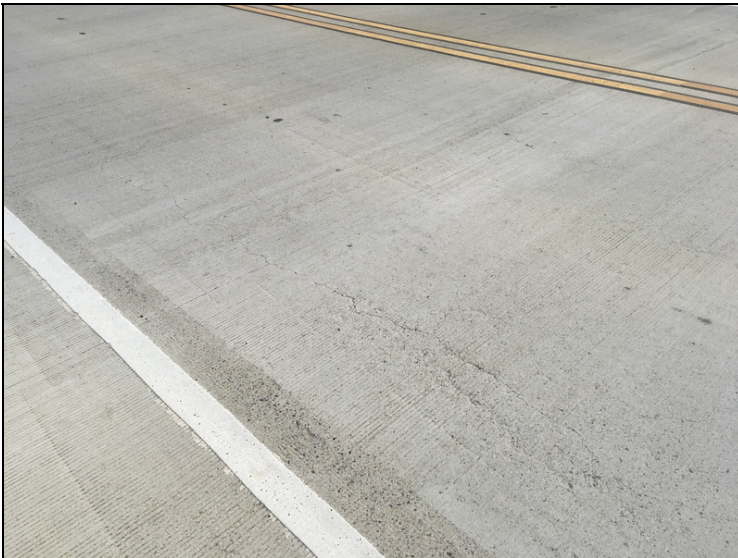
Span #1 sealable deck cracks

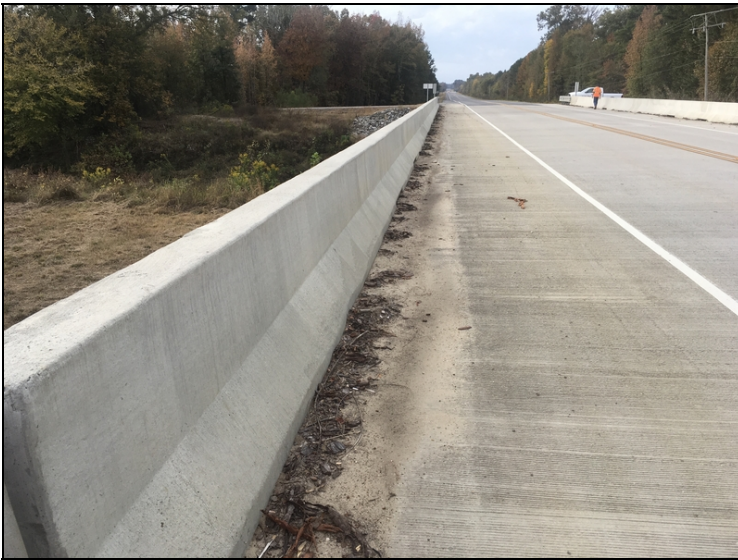
Dirt and debris in gutter.

**Priority:** D- Routine

**Type of Work:** None

**Status:** Monitor
