Asset #05560(Routine)

# US 63 S-17 LM13.61 over L'AIGLE CREEK RELIEF

Location: .75 MI SW OF HERMITAGE

Team Lead: Rickie Bratton, Inspection Date: 09/06/2022

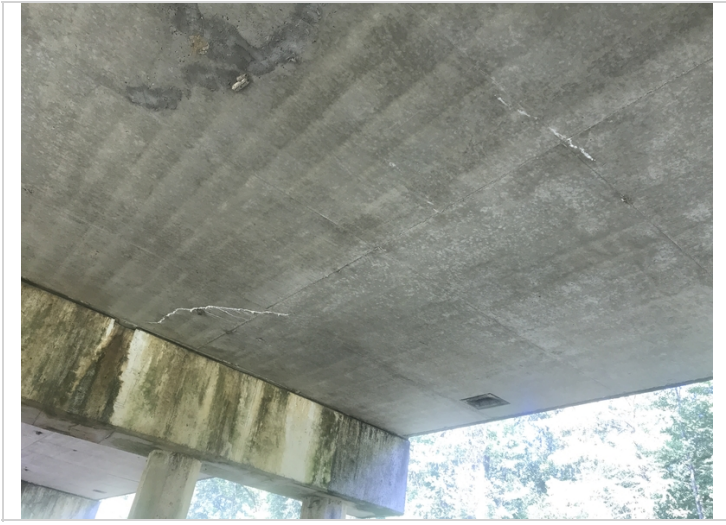
(38) Top has 133' of diagonal cracks Bottom spans 1,2,5,7 and 8 has 31' of eff. 09/24/2020 JPR -- Deck area = (280' x 32.7' = 9156 sq.ft.) per plans.							
215	Reinforced Concrete Abutment	LF	79.2	79.2	0	0	0

Soffit span 5, crack with efflorescence.

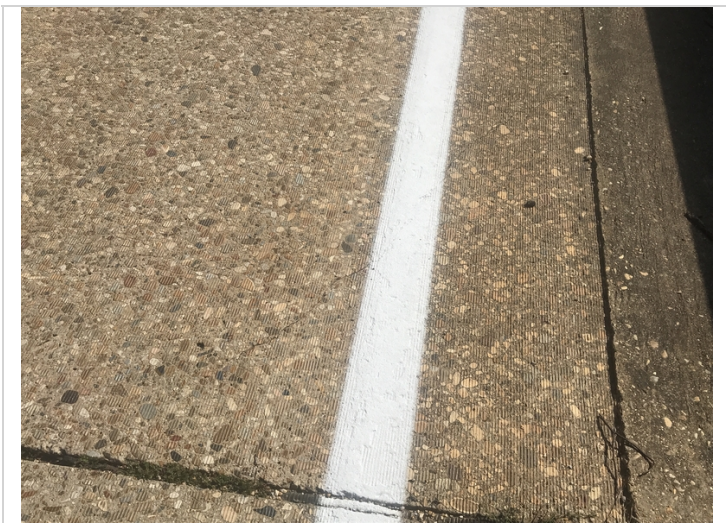
Span 5, diagonal crack.

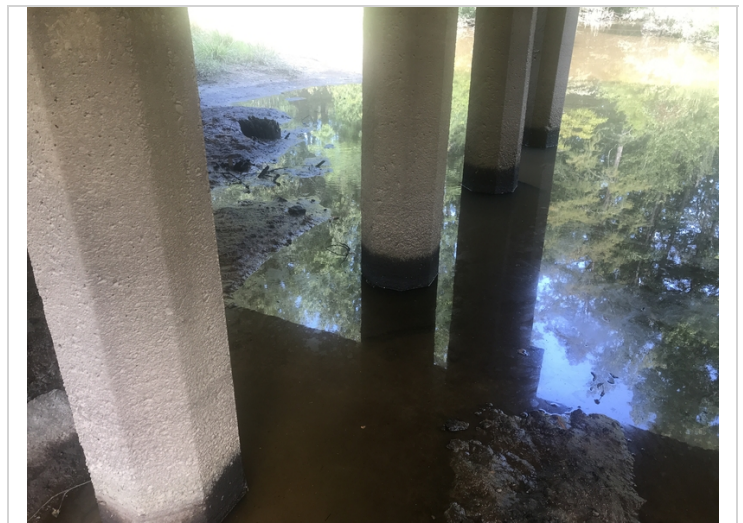
(227) Piles in bents 3-7 have light abrasion. 09/24/2020 JPR -- total number of Reinforced Concrete Piles = (6/bent x 7 bents = 42 piles) per plans.							
234	Reinforced Concrete Pier Cap	LF	231	225	2	4	0
1080	Delamination/Spall/Patched Area	LF	4	0	2	2	0
1090	Exposed Rebar	LF	2	0	0	2	0

Piles at bent 7, light abrasion.

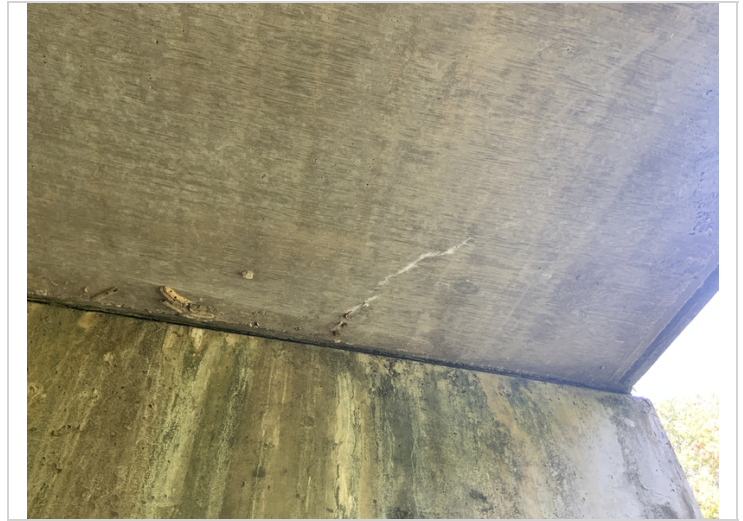
Span 1 cracks with efflorescence.

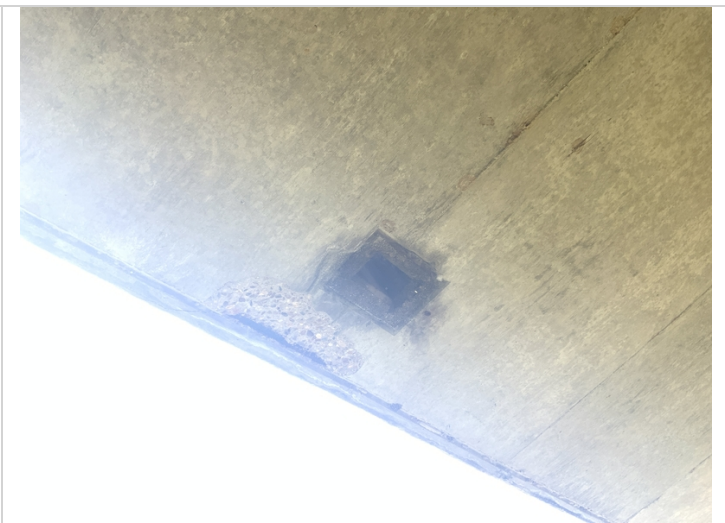
Span 1 soffit has exposed rebar.

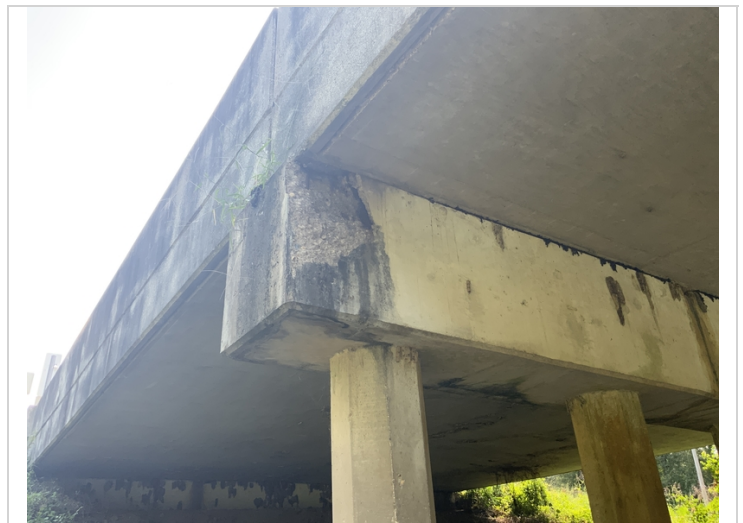
Bent 2 cap ahead spall right side.

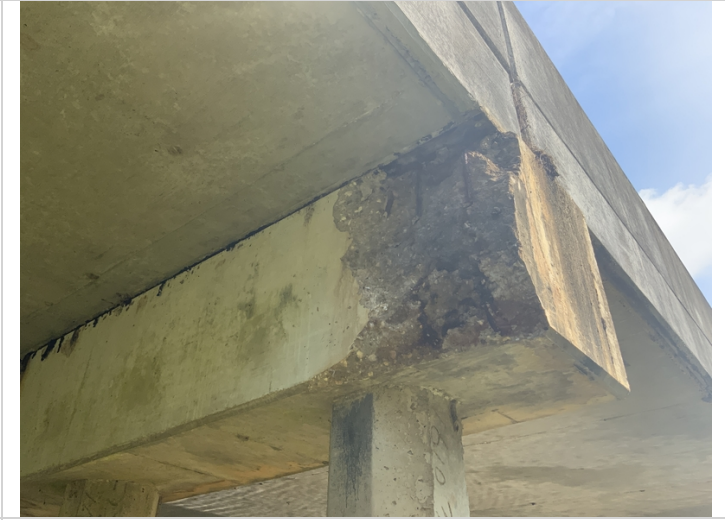
Bent 3 cap ahead left side large spall with exposed rebar.

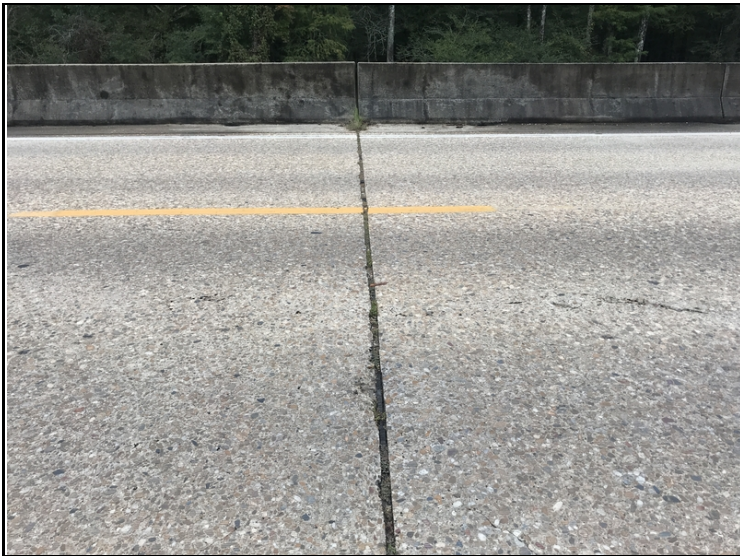
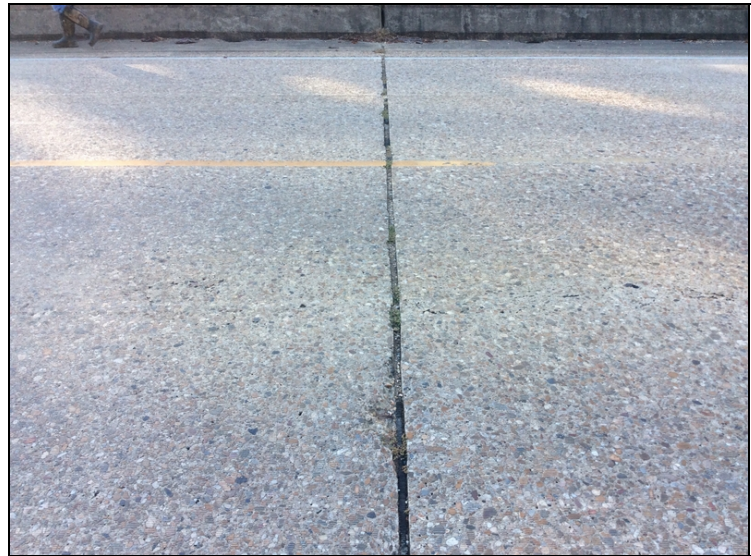
(301) All joints leaking. 09/24/2020 JPR -- Total length of Poured joint material = (32.66 x 7 = 228.62' or 229') per plans.							
331	Reinforced Concrete Bridge Railing	LF	560	560	0	0	0

Poured Joint Material, all spans has degraded and is allowing dirt and debris to fill the joints, also allowing water and debris onto caps.

Bent 5 joint material is losing bond with concrete & has some impaction & leakage.

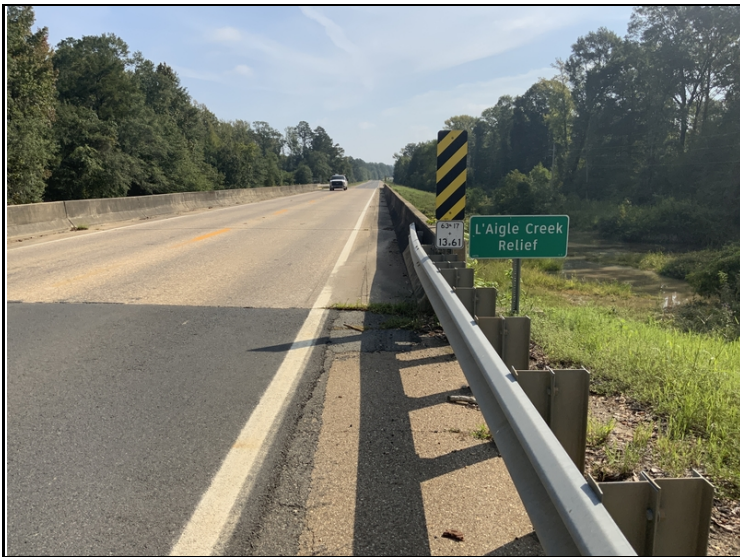
Log mile signs posted backwards.

**Date Reported:** 09/06/2022  
**Priority:** D- Routine  
**Type of Work:** Replace (General)  
**Status:** Open  
**Component:** Miscellaneous
