Asset #05561 (Routine)

US 63 S-17 LM13.26 over L'AIGLE CREEK

Location: .5 MI SW OF HERMITAGE

Team Lead: Rickie Bratton, Inspection Date: 09/06/2022

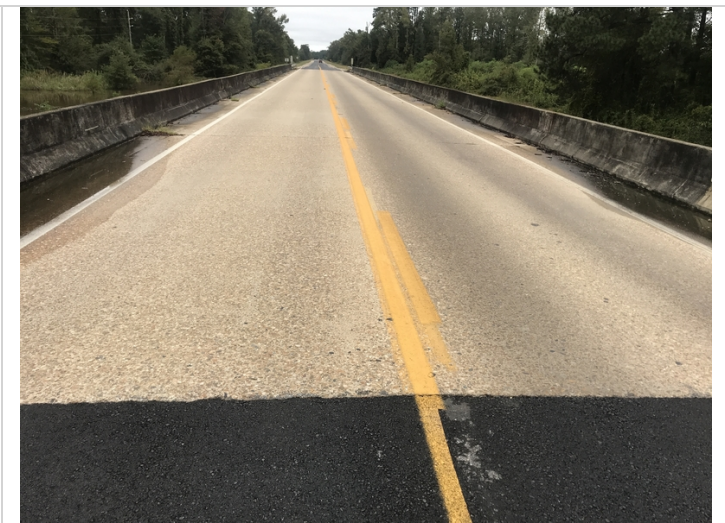
Span 1 looking ahead @ deck overview.

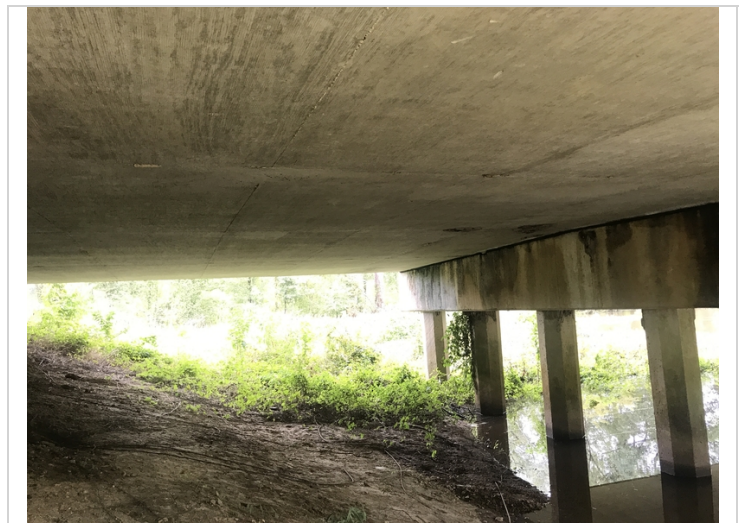
Span 1 deck soffit.

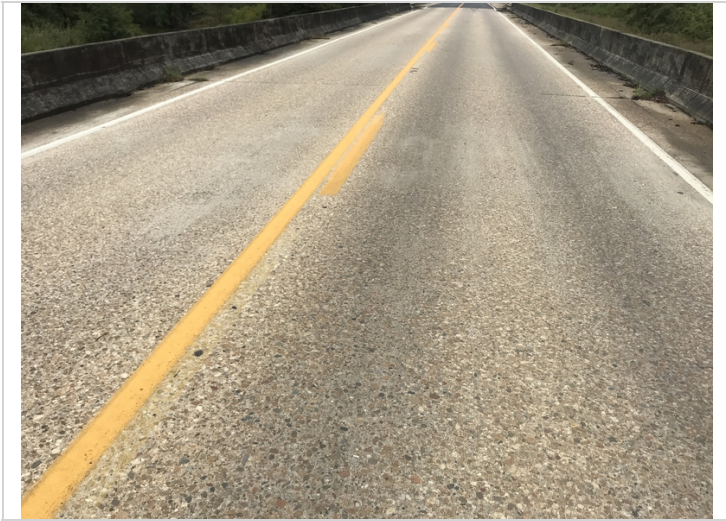
Span 4 looking ahead @ deck overview.

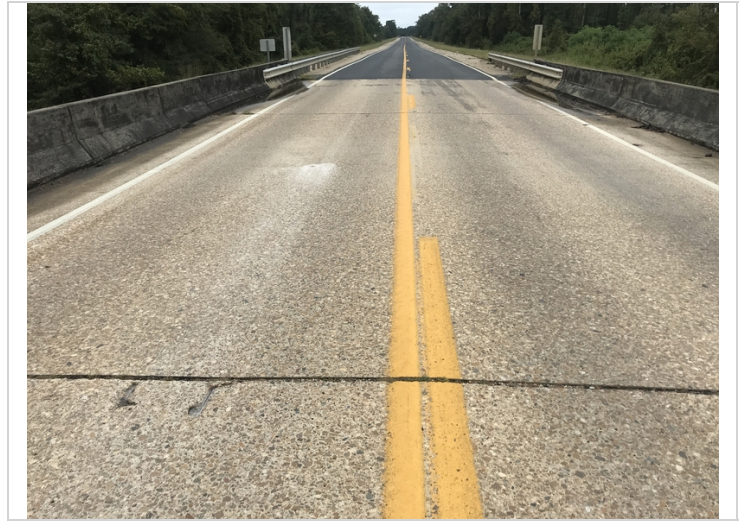
Span 8 looking ahead @ deck overview.

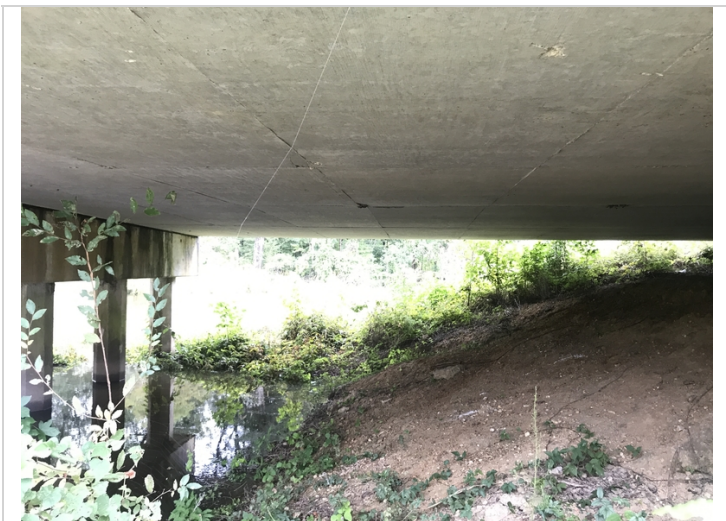
Span 9 looking from Rt. to Lt. @ deck soffit.

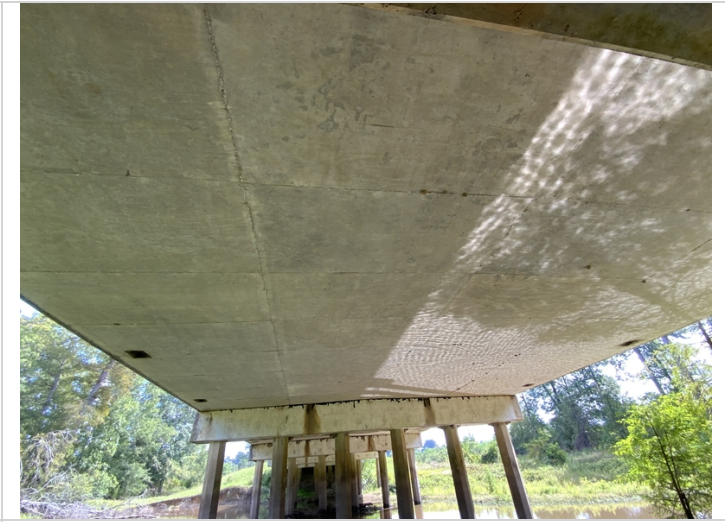
Span 5 soffit overview.

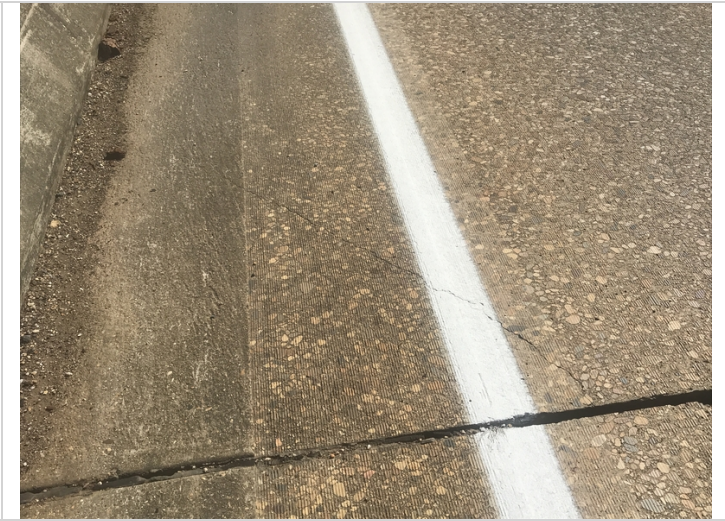
(38) Top side has 151' of cracks, diagonal at each bent, span 5 has a few transverse cracks. Bottom side spans 2, 3, 4, 5, 7, 8, and 9 has 41' of eff. 09/24/2020 JPR -- RC Slab deck area = (315' x 32.66' = 10288 sq.ft.) per plans.							
215	Reinforced Concrete Abutment	LF	79.2	79.2	0	0	0

Span 1 diagonal crack

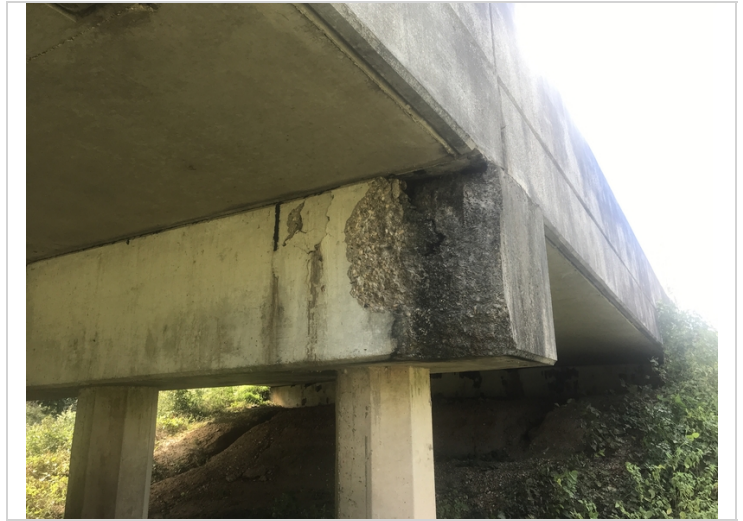
Right side bent 9 cap spall with exposed rebar.

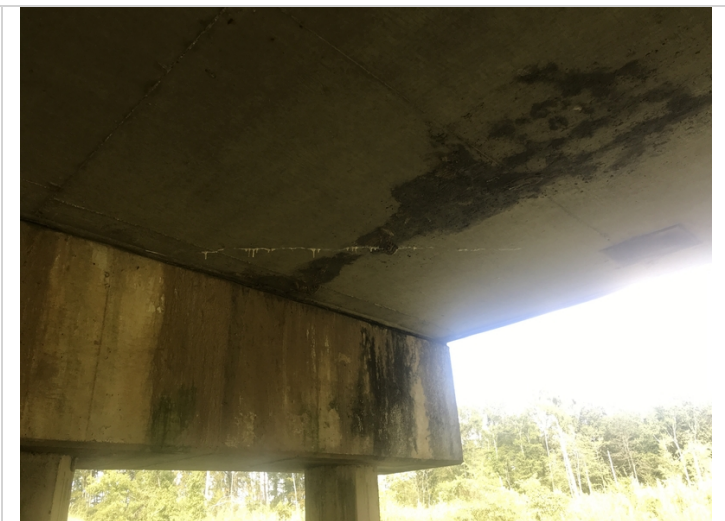
Span 7, crack with efflorescence.

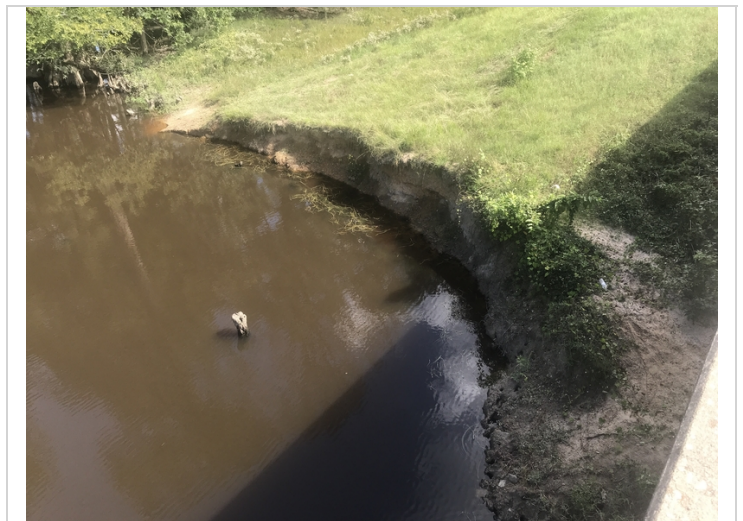
Overview of active slope erosion, 5 foot deep by 50 long.

Slope on right side of structure at spans 1 and 2 has active erosion, with in 10 feet of pile at bent 2.

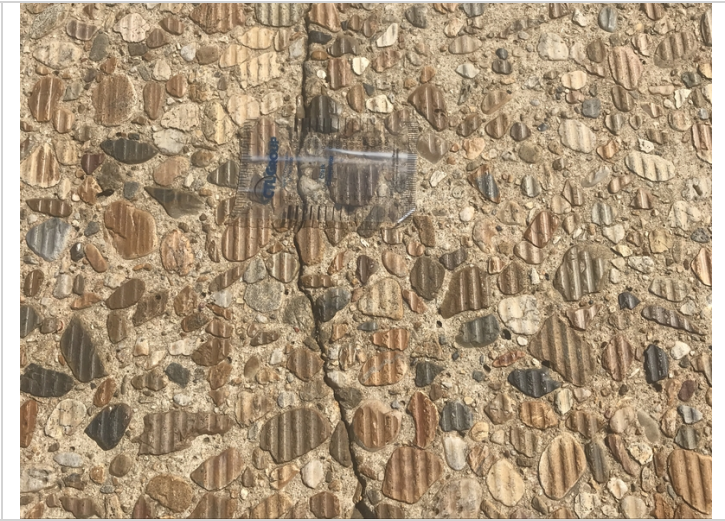
Span 9 crack

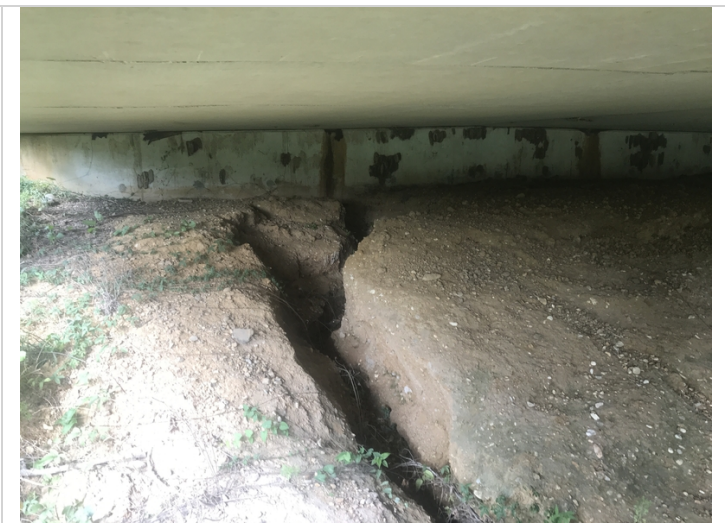
Abutment 10, minor slope erosion.

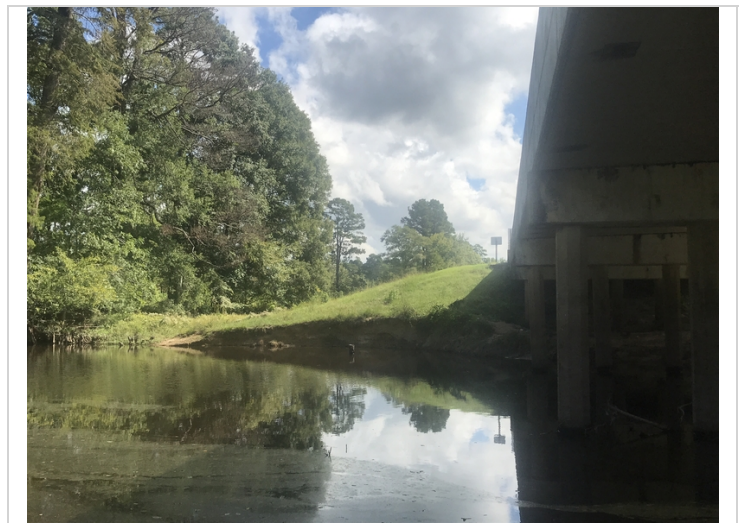
Spans 1 and 2, right of structure, slope erosion.

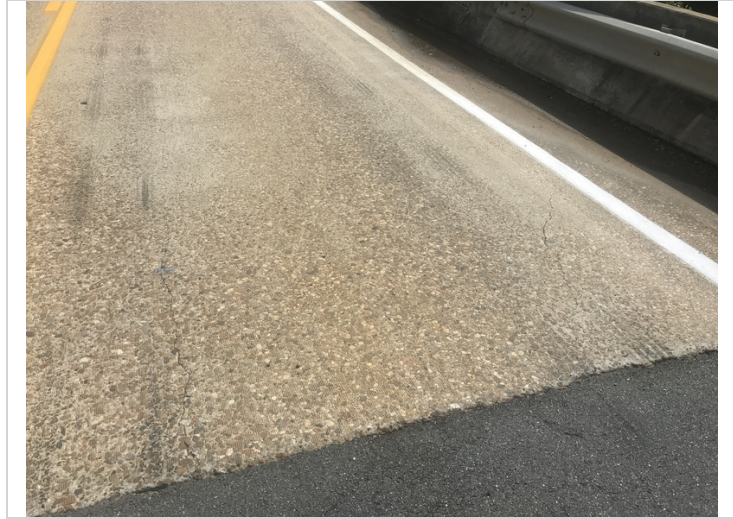
Span 9, longitudinal and diagonal cracks .

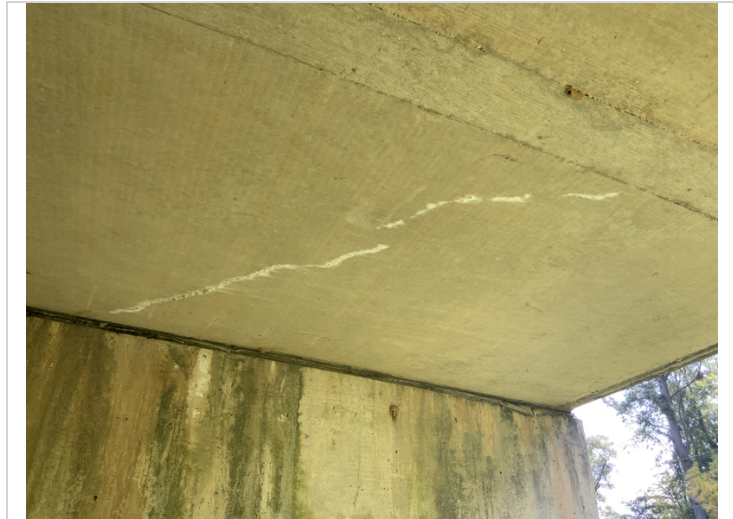
Span 9 soffit has cracks with efflorescence.

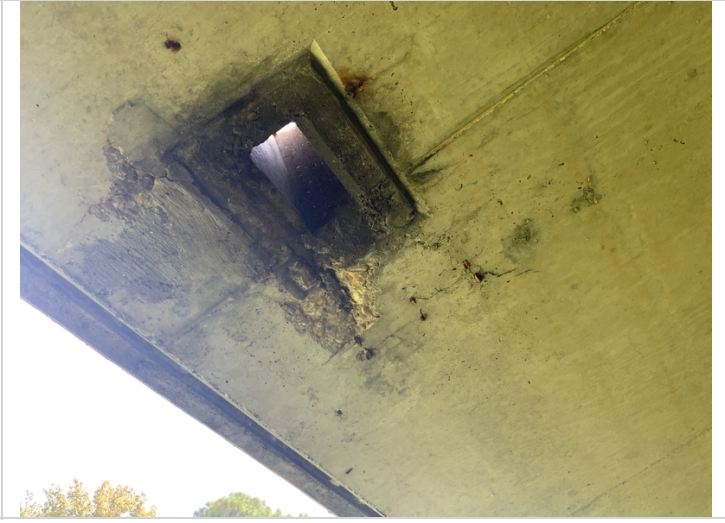
Span 7 soffit has exposed rebar.

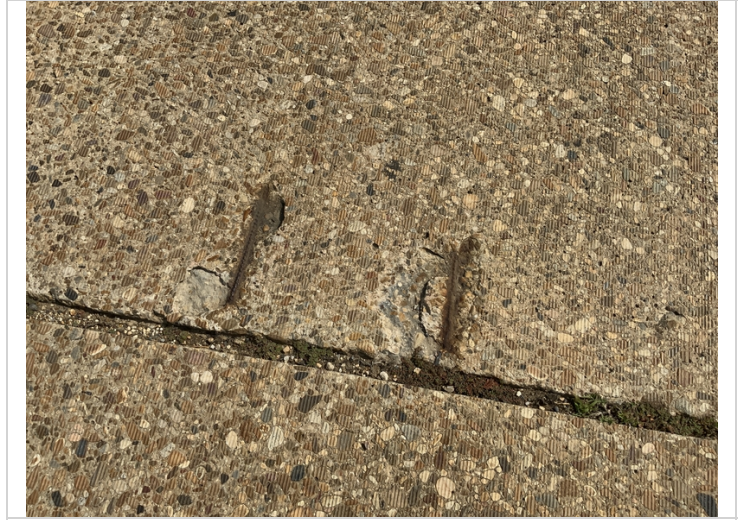
Deck span 7 at bent 8 exposed rebar in the deck.

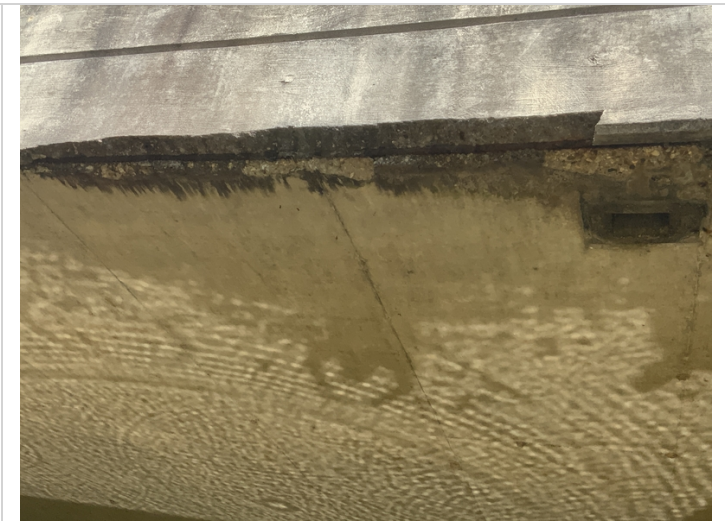
Span 4 soffit left side exposed rebar.

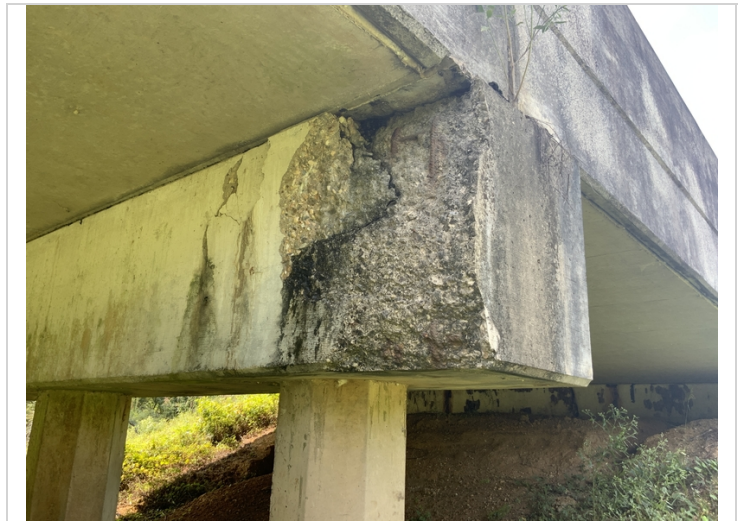
Bent 9 cap right side spall with exposed rebar.

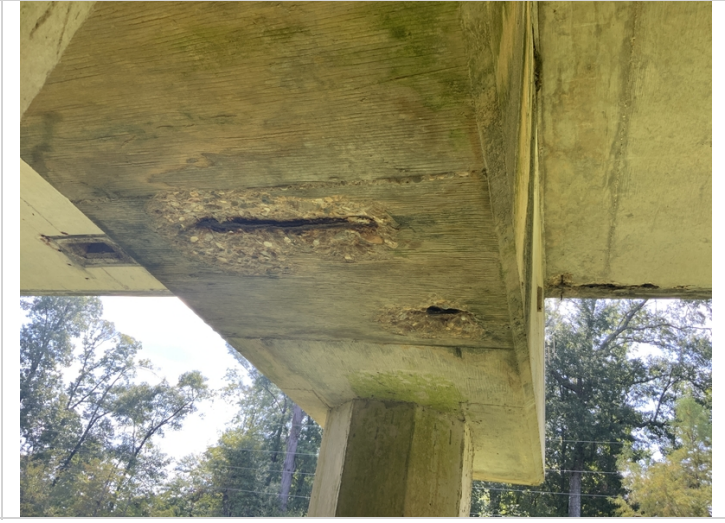
Bent 8 cap bottom has spalls with exposed rebar.

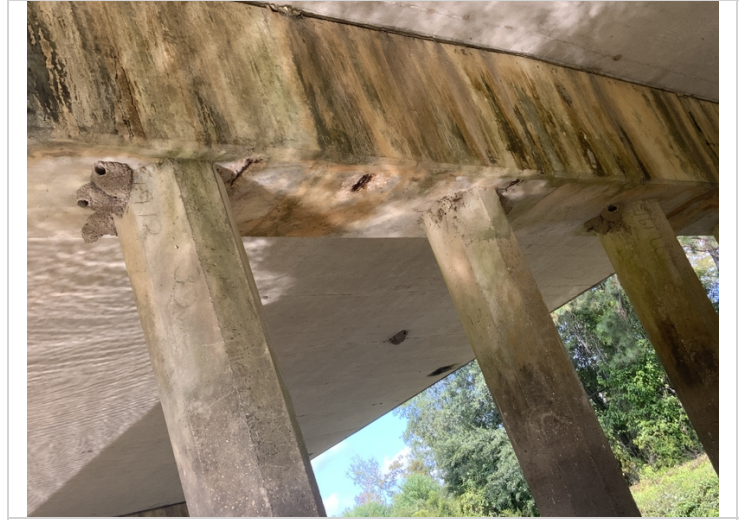
Bent 4 cap bottom has spalls with exposed rebar.

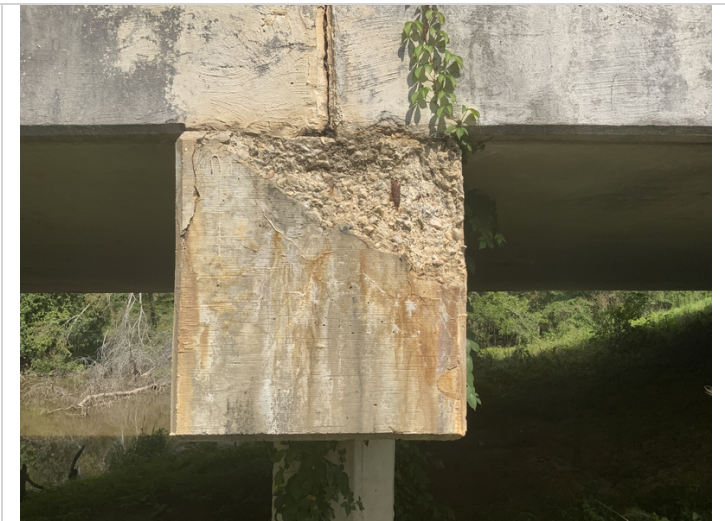
Bent 2 cap left side spall with exposed rebar.

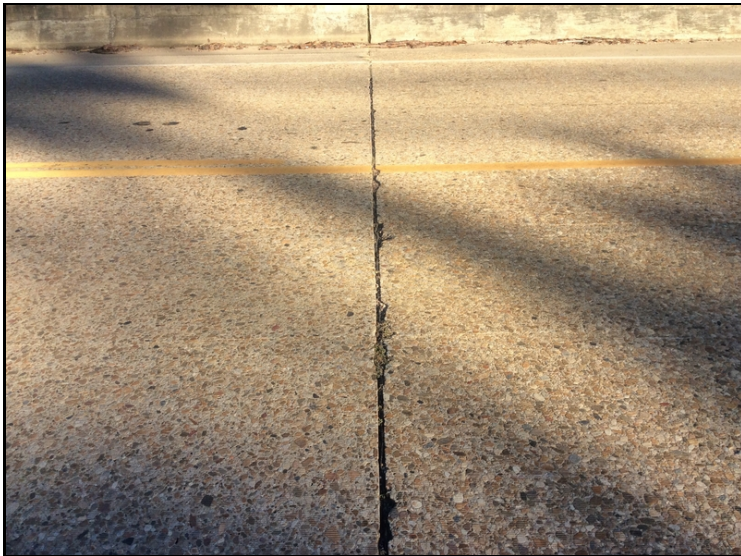
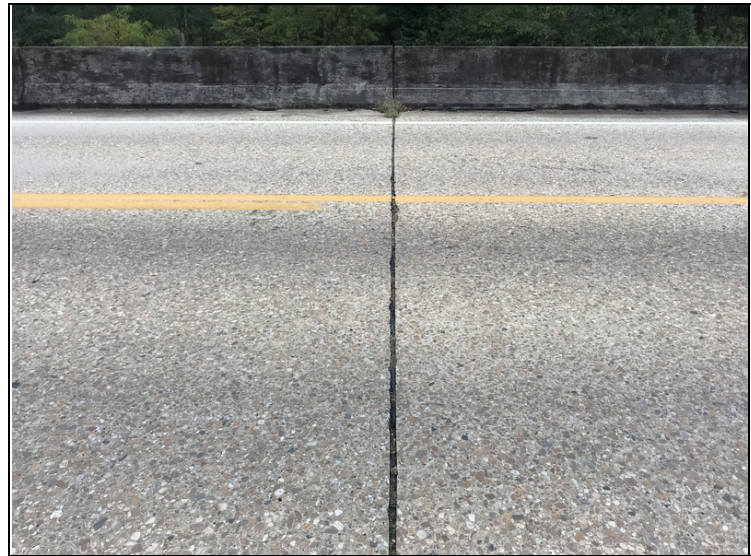
Bent 4 joint material

Poured Joint Material, all spans has degraded and is allowing dirt and debris to fill the joints, also allowing water and debris onto caps.

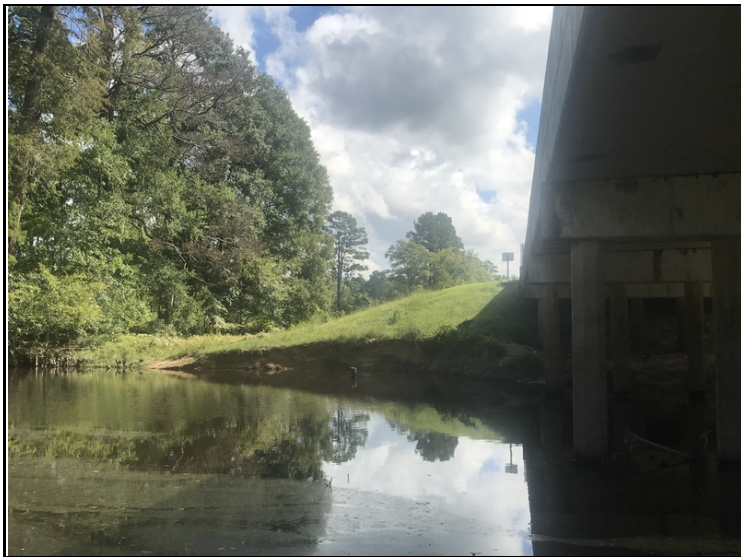
Spans 1 and 2, right of structure, slope erosion.

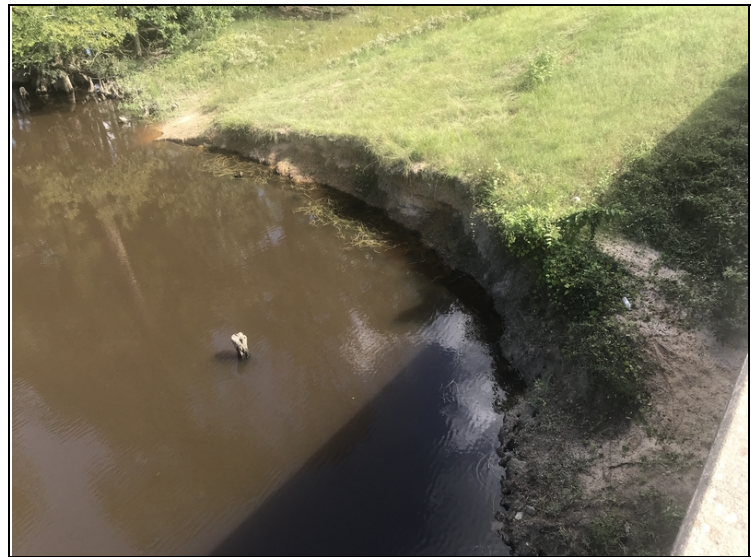
Overview of active slope erosion, 5 foot deep by 50 long.

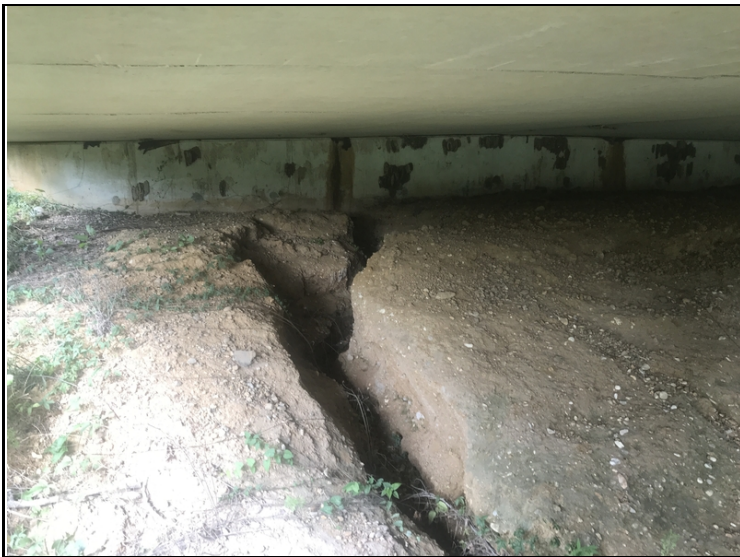
Abutment 2, minor slope erosion.

Abutment 10, minor slope erosion.

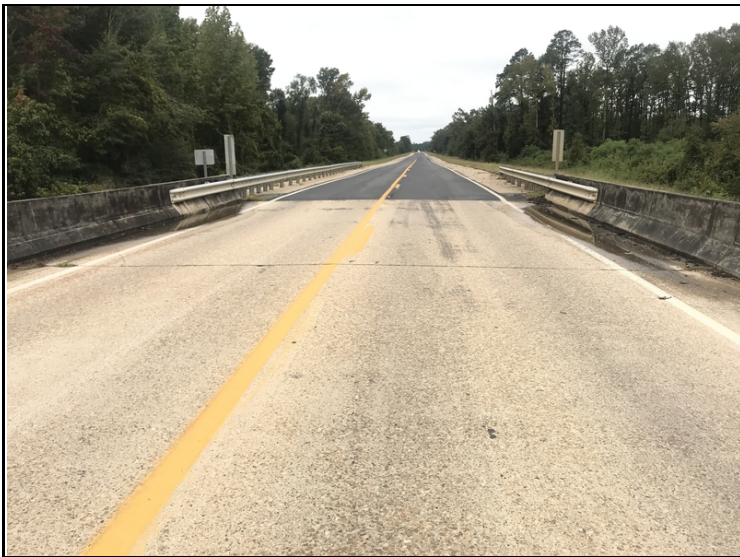
Span 9 both gutter lines have water standing in the gutter lines for almost entire span.
