Asset #06527(Routine)

US 63 S-17 LM22.88 over CHARIVARI CK RELIEF

Location: 5.8 N OF UNION CO LINE

Team Lead: Rickie Bratton, Inspection Date: 09/13/2022

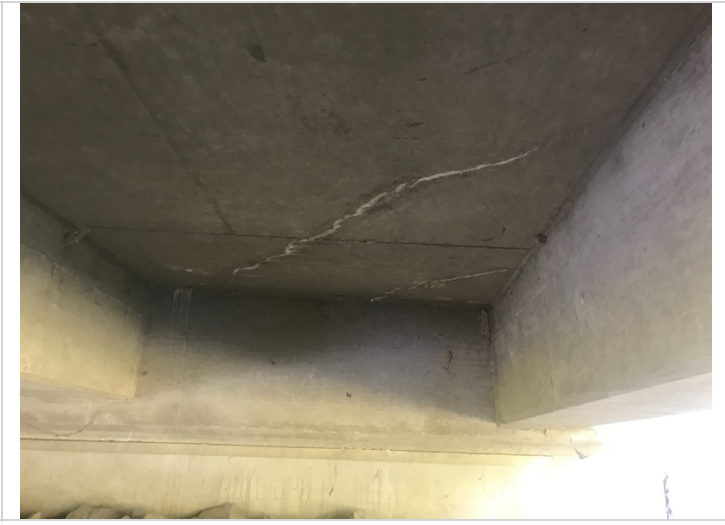
ELEMENTS	DESCRIPTION	UNITS	TOTAL	CS1	CS2	CS3	CS4
16	Reinforced Concrete Top Flange	SF	3500	3219	281	0	0
1120	Efflorescence/Rust Staining	SF	51	0	51	0	0
1130	Cracking (RC and Other)	SF	230	0	230	0	0
(16) Bottom side spans 1,2, and 3 has 20' of eff. Top side has 90' of cracks

Span 3, cracks with efflorescence.

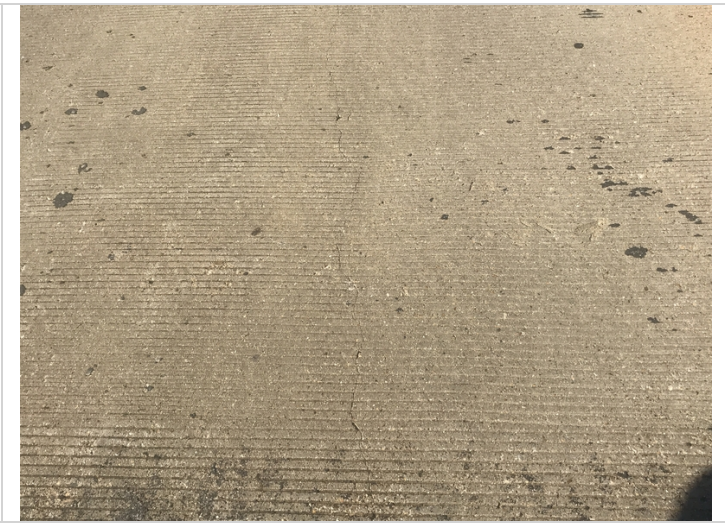
Span 1, longitudinal crack.

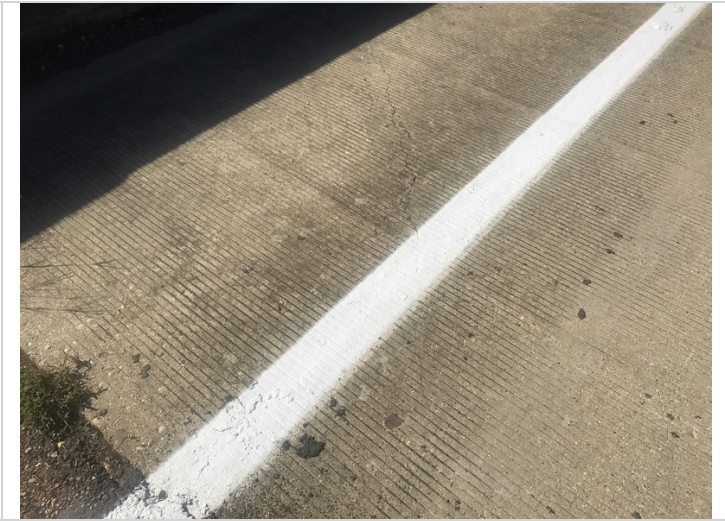
Span 1, diagonal crack.

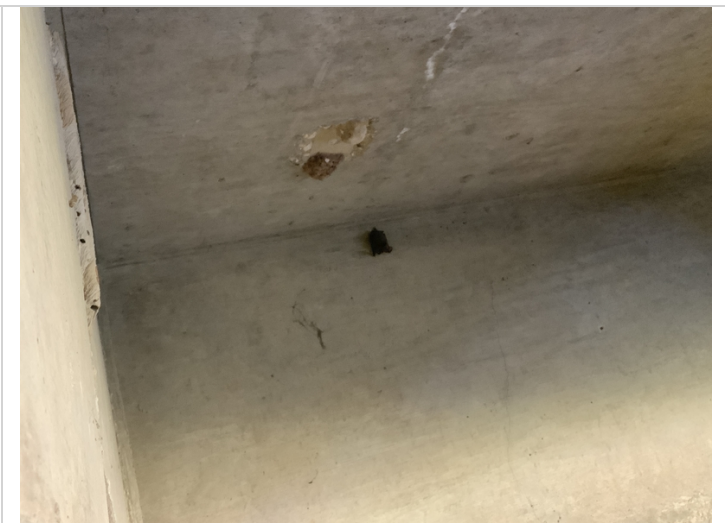
Span 3 bat present in bay 3.

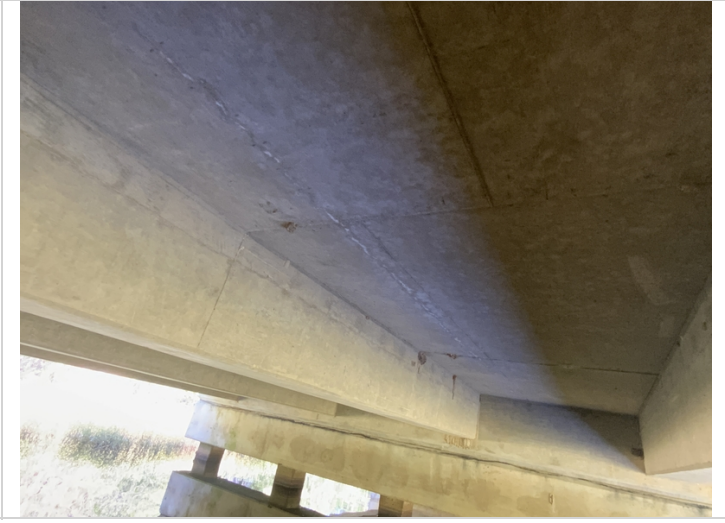
Span 3 soffit has cracks with efflorescence.

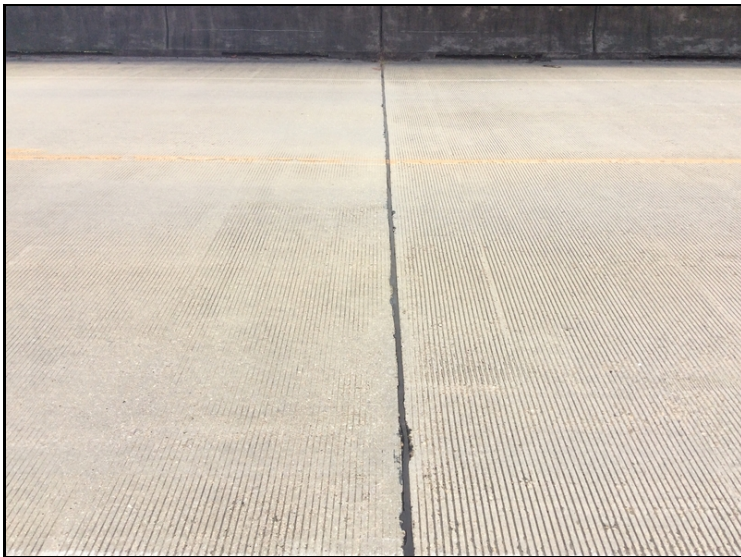
Joint material is tattered and losing bond.
