Asset #06528(Routine)

US 63 S-17 LM22.52 over CHARIVARI CRK

Team Lead: Rickie Bratton, Inspection Date: 09/13/2022

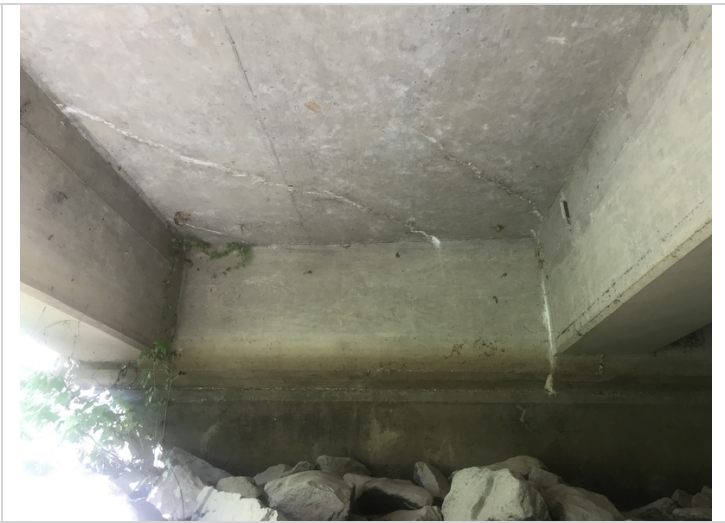
ELEMENTS	DESCRIPTION	UNITS	TOTAL	CS1	CS2	CS3	CS4
16	Reinforced Concrete Top Flange	SF	4668	4245	423	0	0
1120	Efflorescence/Rust Staining	SF	73	0	73	0	0
1130	Cracking (RC and Other)	SF	350	0	350	0	0
(16) top of deck have cracks. Bottom of deck- spans 1,2,3 and 4 has eff.							
110	Reinforced Concrete Open Girder/Beam	LF	600	600	0	0	0
227	Reinforced Concrete Pile	EA	18	18	0	0	0
234	Reinforced Concrete Pier Cap	LF	195	195	0	0	0
301	Pourable Joint Seal	LF	117	17	100	0	0
2320	Seal Adhesion	LF	100	0	100	0	0
331	Reinforced Concrete Bridge Railing	LF	240	235	0	5	0
1080	Delamination/Spall/Patched Area	LF	5	0	0	5	0

Span 4, cracks with efflorescence.

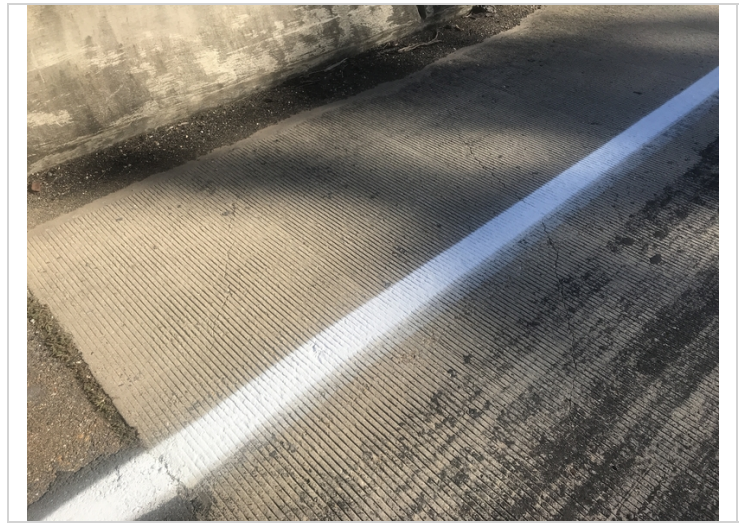
Span 4, diagonal cracks.

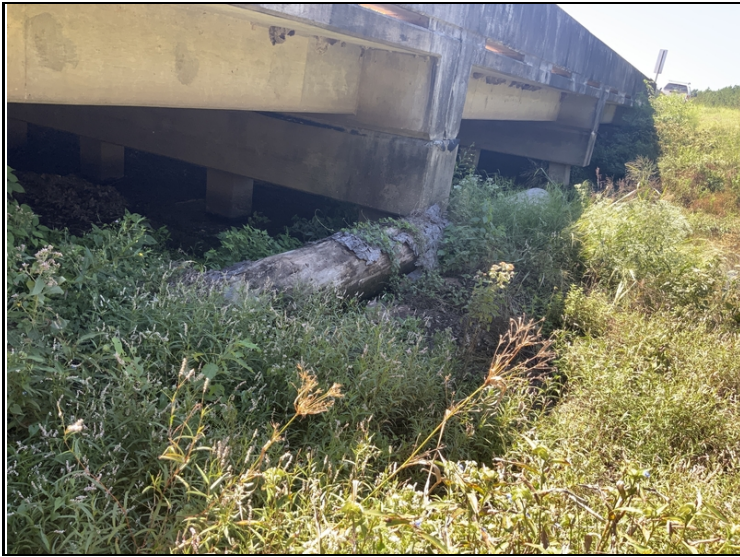
Log against bent 3 right side.
