Asset #02667 (Routine, Underwater type 2)
US 82 S-4 LM 9.43 over BIG CORNIE CREEK

Location: 2.20 MI W JCT OF SH 98

Team Lead: Rickie Bratton, Inspection Date: 02/23/2022

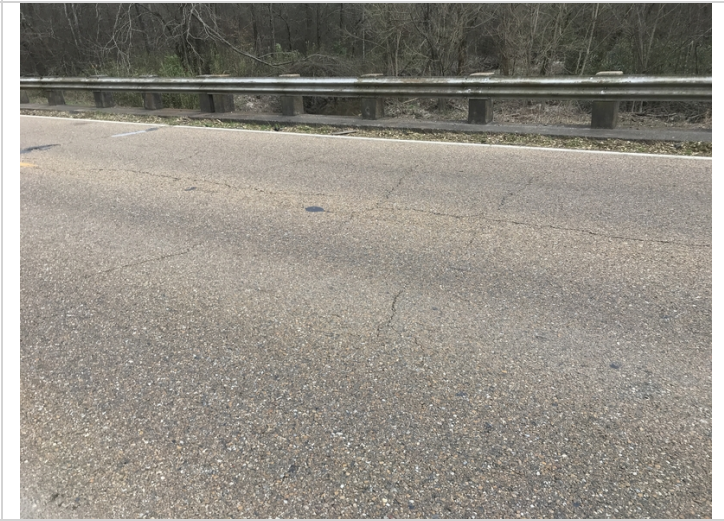
Typical cracking in wearing surface.

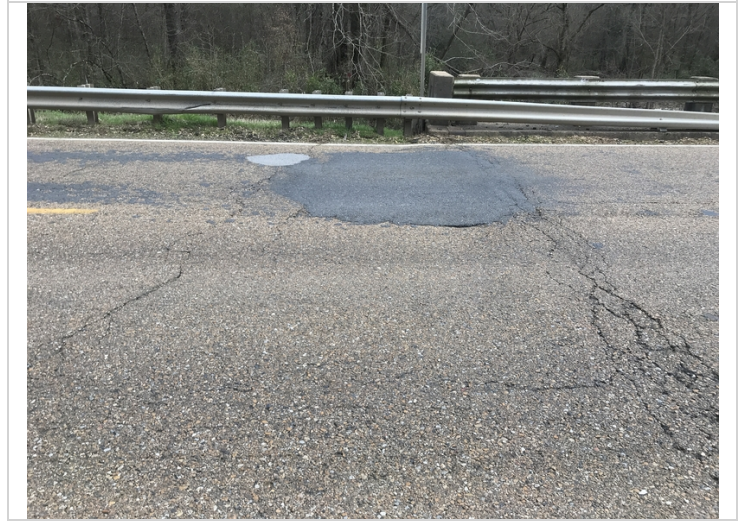
Large patched area at east approach.

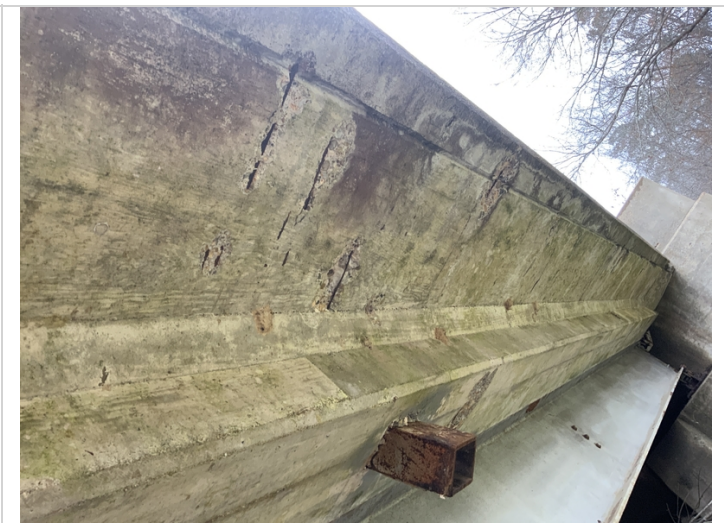
Deck soffit span 4 right side has spalls with exposed rebar.

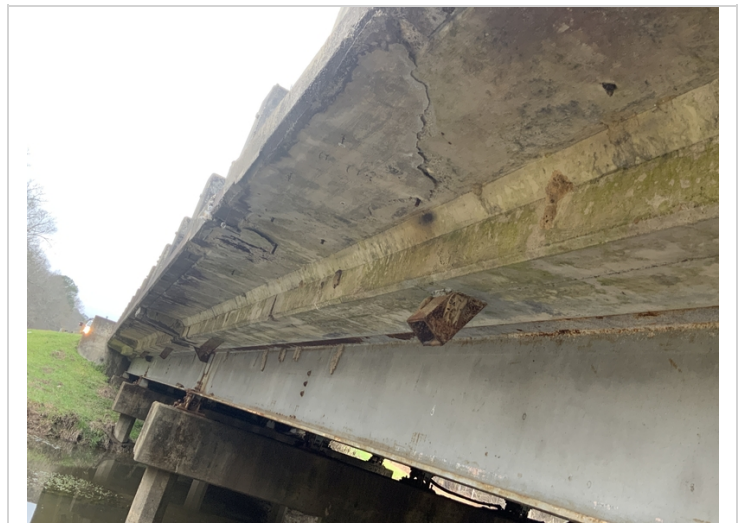
Deck span 3 right side soffit overhang has delams.

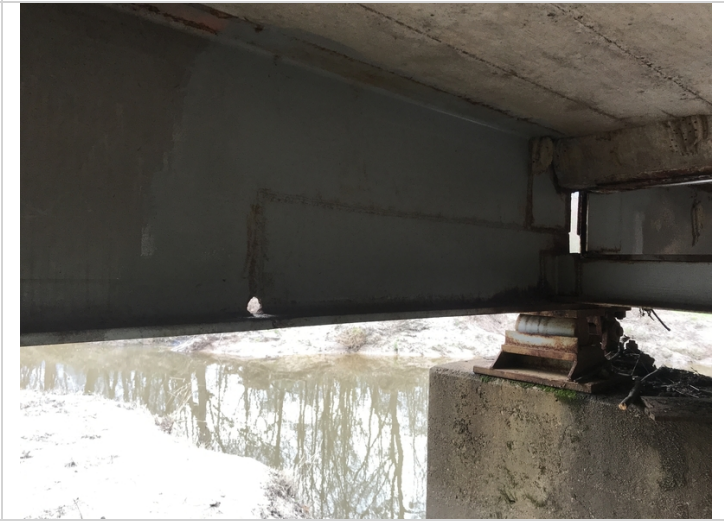
Bent girder5 has a tee splice repair.

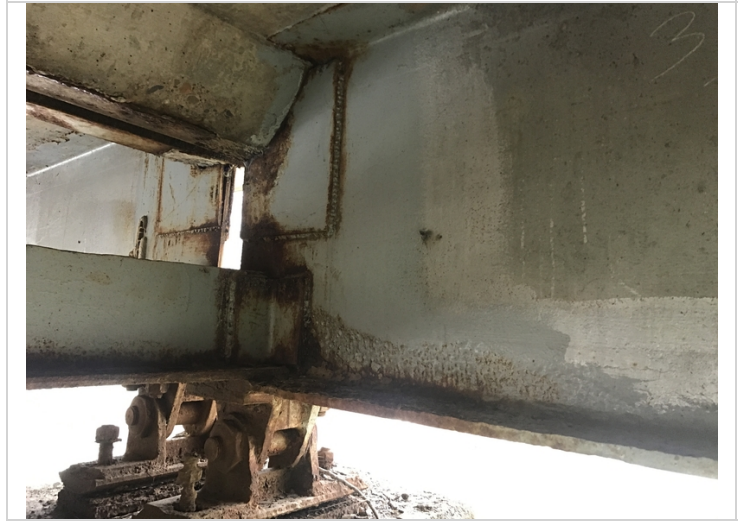
Bent 4 girder 1 has been painted in past, this area has section in lower part of web.

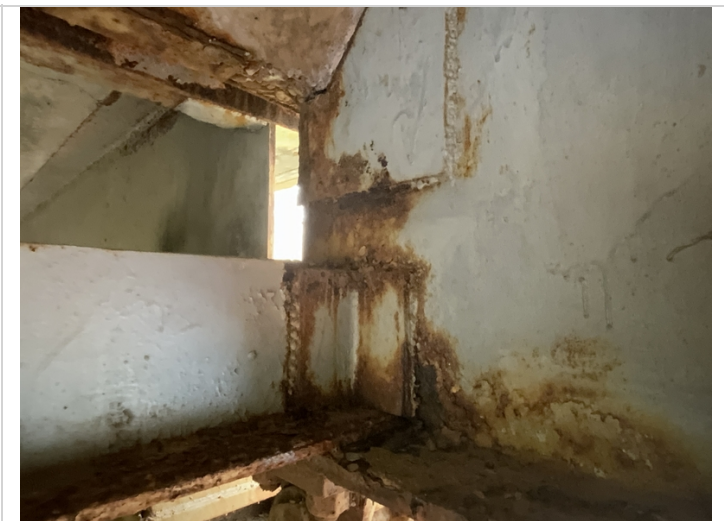
Bent 2 span 3 beam 1 beam end has corrosion.

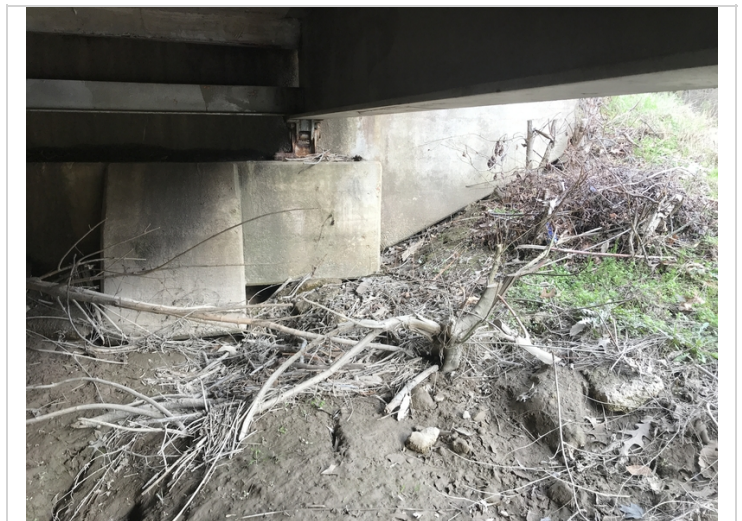
(215) KRM & ADC 2/26/2020 East abutment has erosion on right side under wing wall.							
227	Reinforced Concrete Pile	EA	12	8	4	0	0
1190	Abrasion/Wear (PSC/RC)	EA	4	0	4	0	0

East abutment has erosion under wing wall on right side approximately 10' in length

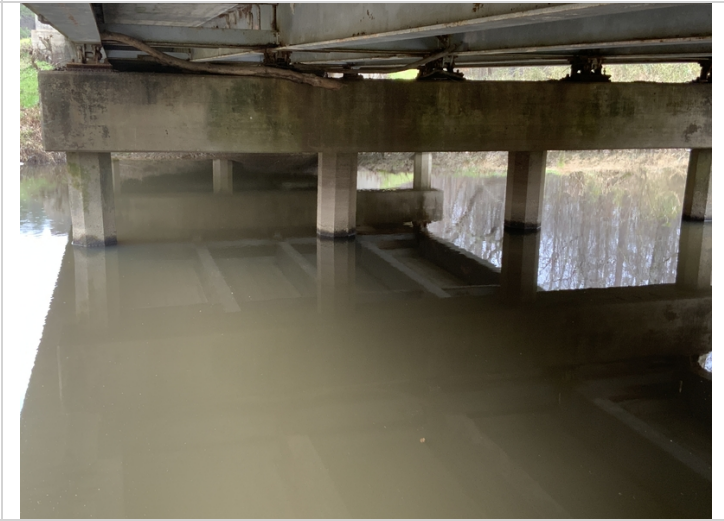
(227) KRM & ADC 2/26/2020 Bent 3, all piles have abrasion.							
234	Reinforced Concrete Pier Cap	LF	81	52	20	9	0
1080	Delamination/Spall/Patched Area	LF	6	0	6	0	0
1090	Exposed Rebar	LF	3	0	0	3	0
1120	Efflorescence/Rust Staining	LF	9	0	9	0	0
1130	Cracking (RC and Other)	LF	11	0	5	6	0

Bent 3 columns have abrasion at waterline.

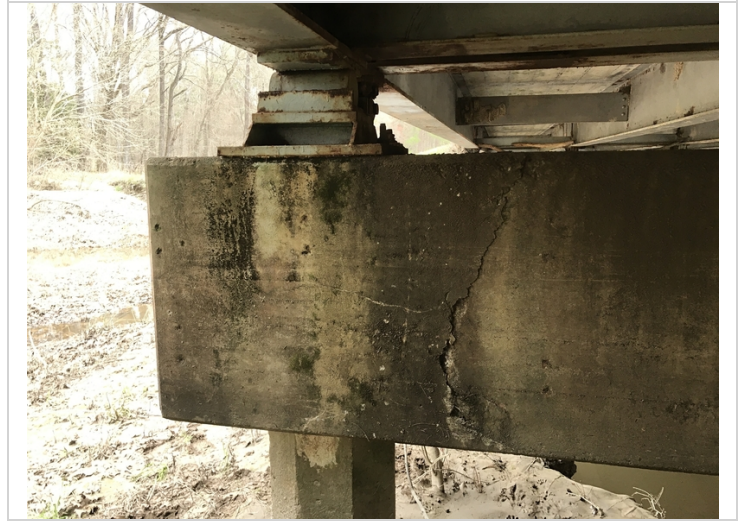
Back side bent 1 left side 2' delam this is typical on bents 3 and 4.

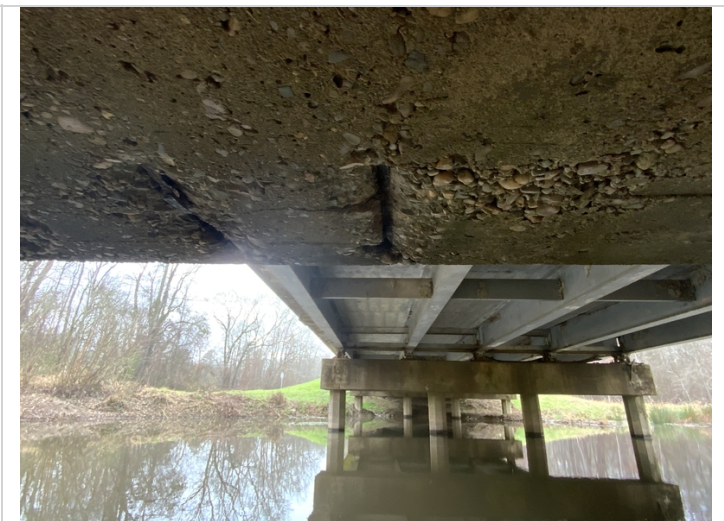
Bent 4 cap has spalls with exposed rebar on bottom of cap between columns 3&4.

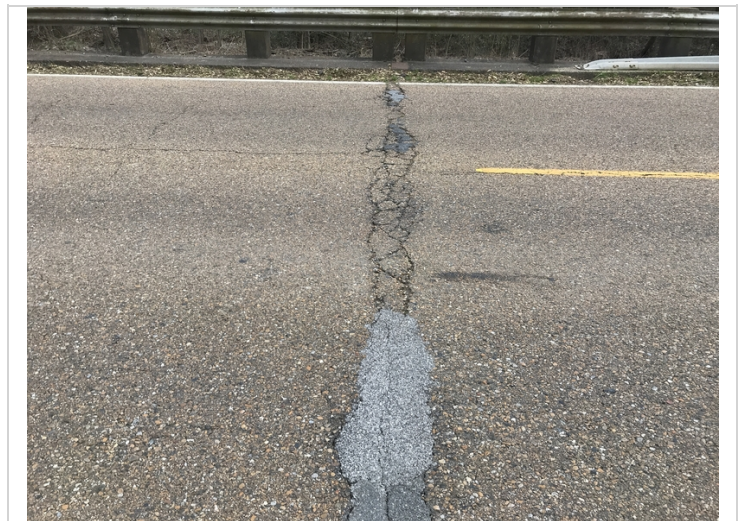
Typical condition of joints.

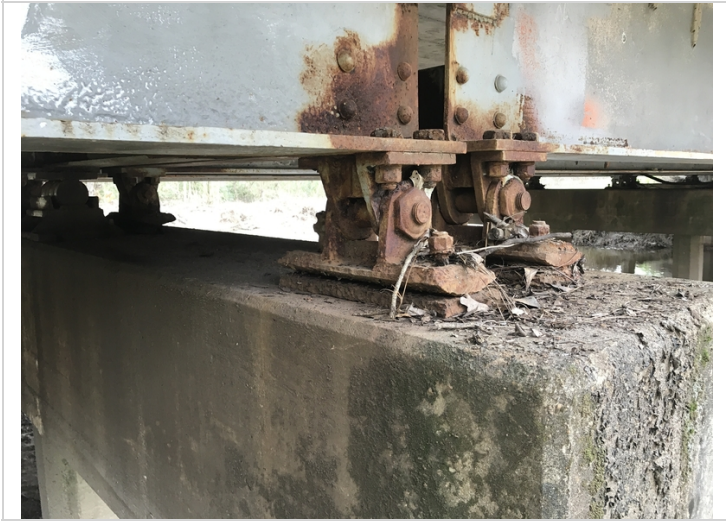
Typical condition of bearings.

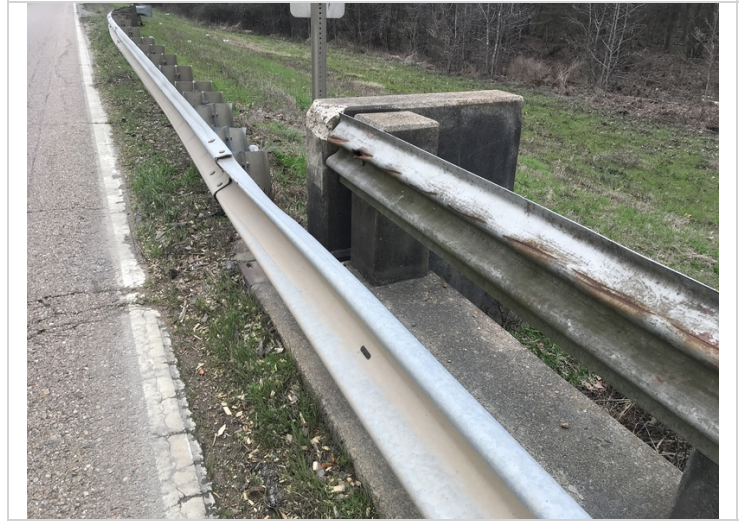
Collision damage to metal rail left side.

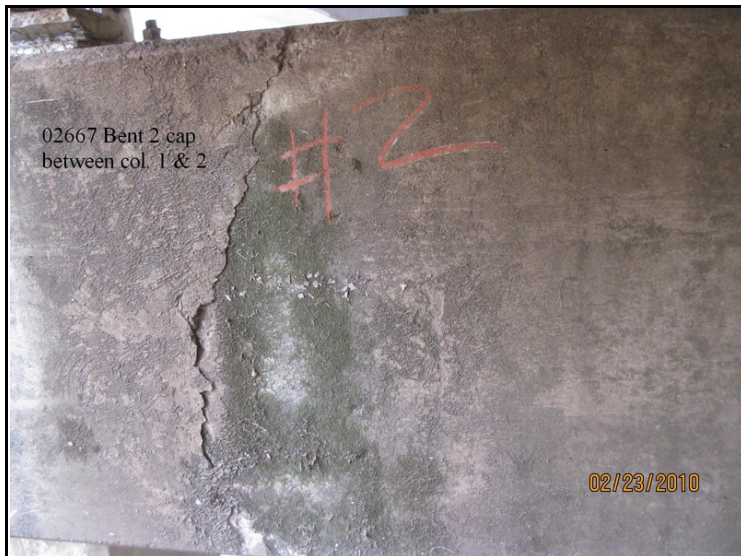
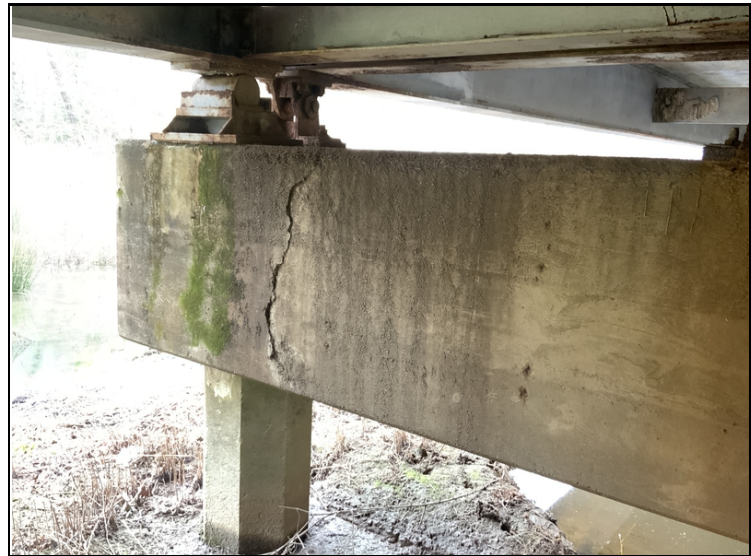
Bent 2, and bent 5, Caps.
Efflorescent cracks to caps.

Bent 2 cap is cracked.

Bent 2 cap cracked between columns 1&2.

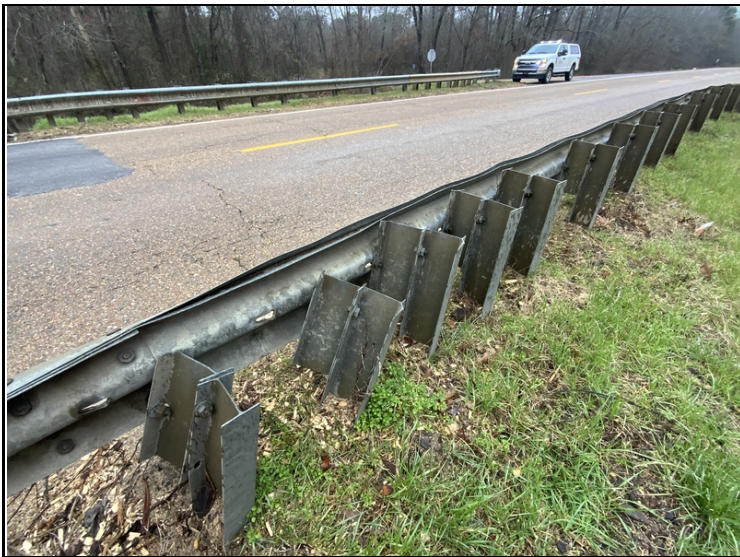
East end left guardrail posts impact damage.

Date Reported: 02/23/2022
Priority: C - Important
Type of Work: Repair (General)
Status: Open
Component: Miscellaneous
