Asset #02668(Routine, Underwater type 2)

US 82 S-4 LM 10.36 over HARPER CREEK

Location: 1.25 MI W JCT OF SH 98

Team Lead: Rickie Bratton, Inspection Date: 02/23/2022

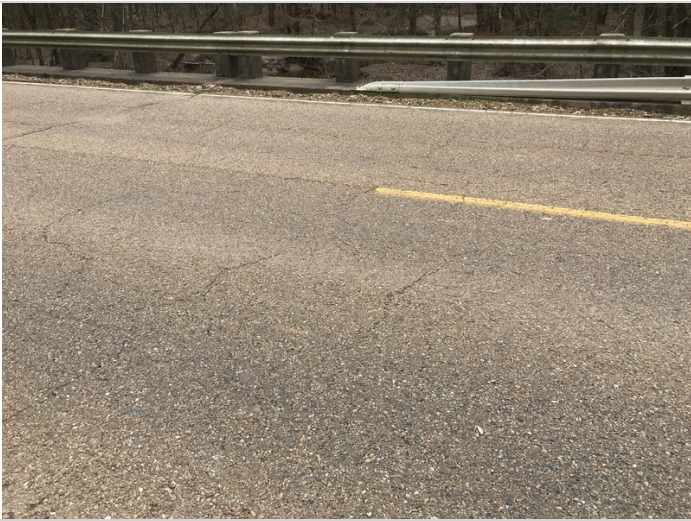
Typical cracking in wearing surface.

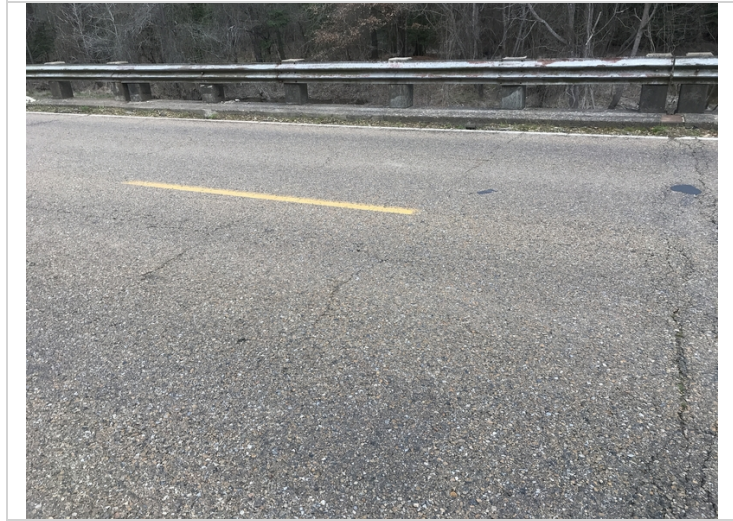
Wearing surface 481' of cracks.26xlength.

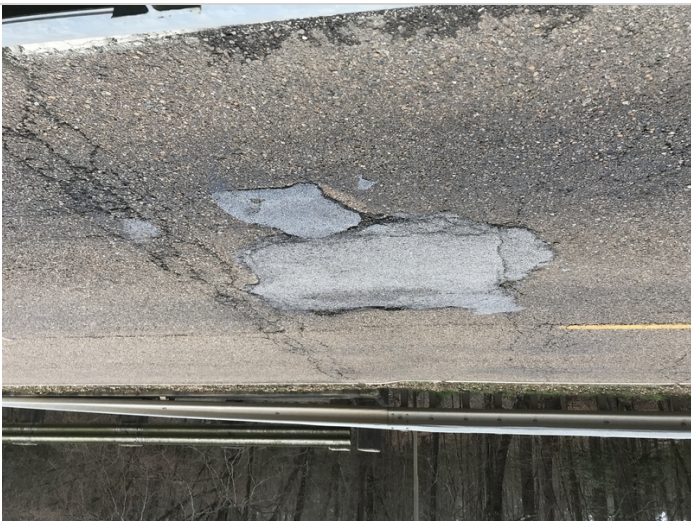
Settlement at east approach.

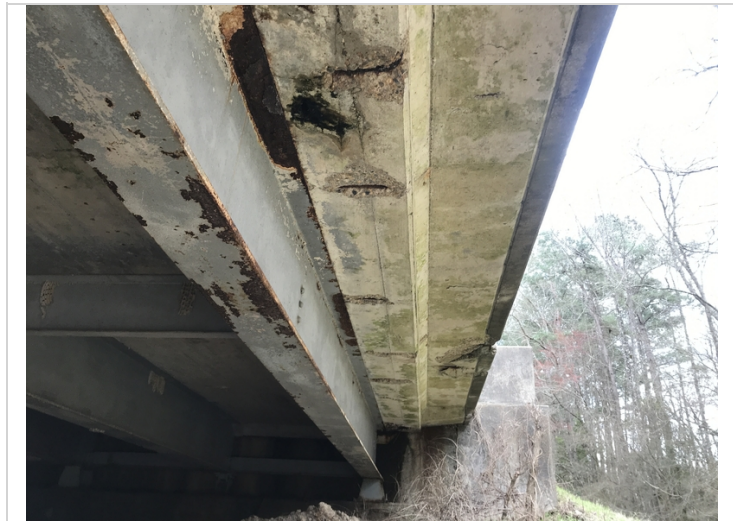
Span 5 right side spalls in the soffits with exposed reinforcing steel.

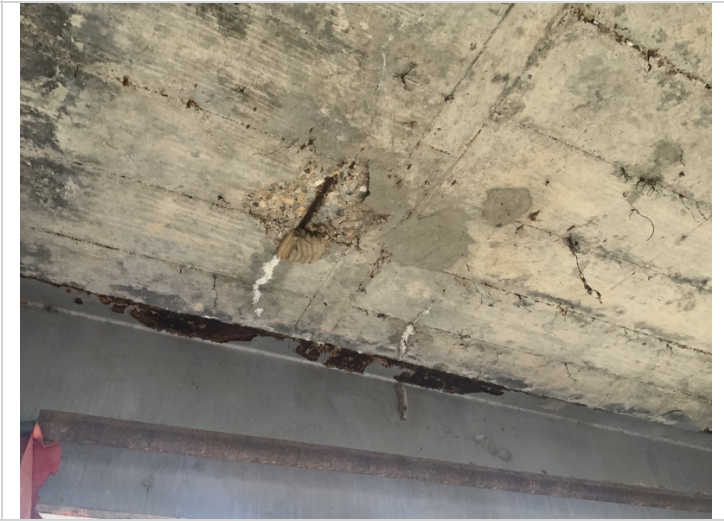
Span 1 soffit has spall with exposed rebar.

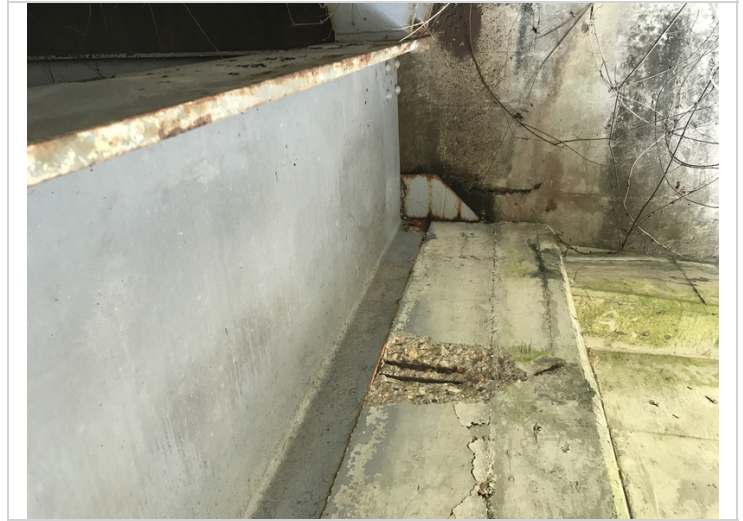
Span 1 right side spall with exposed reinforcing steel.

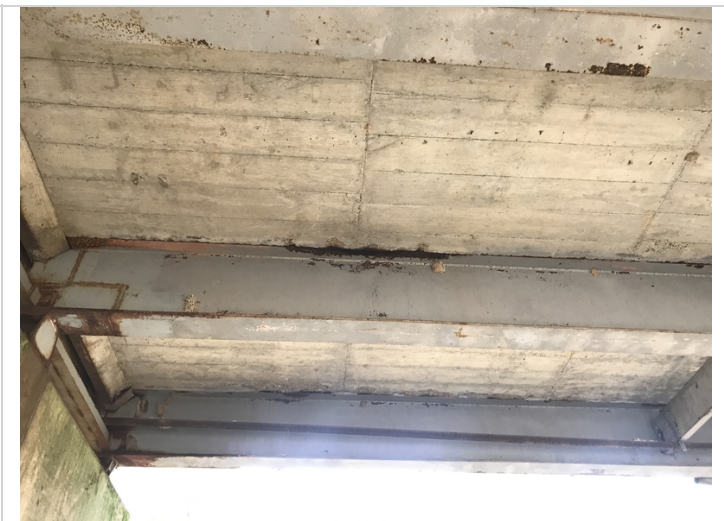
Span 3 girder 2 corrosion to top flange.corrosion

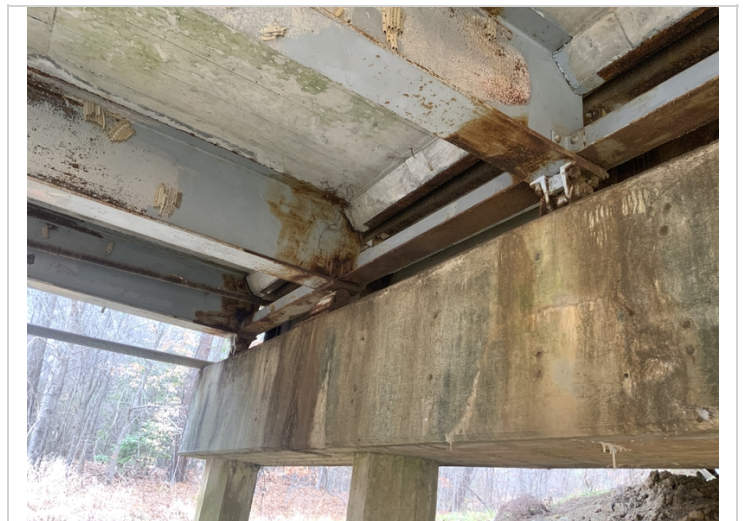
Span 4 bent 5 beam ends have corrosion.

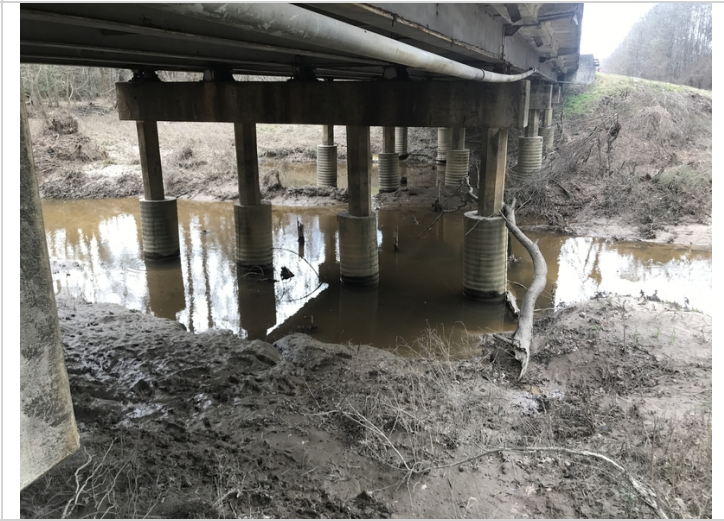
Repairs on piles at bents 2 thru 4.

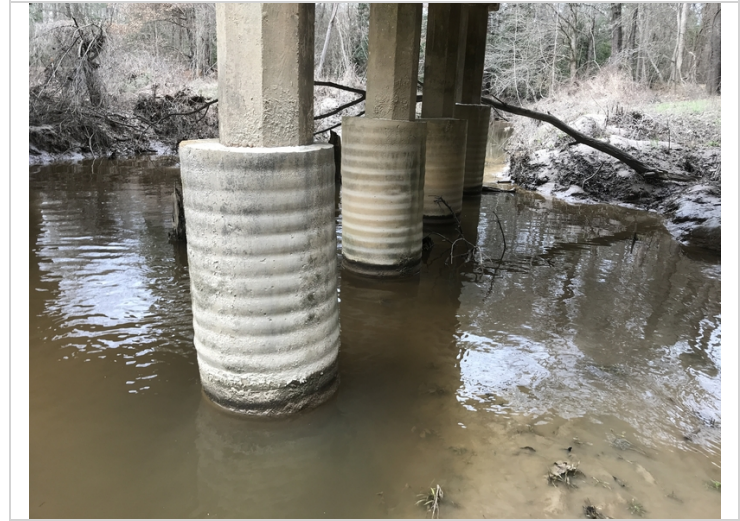
Bent 4 all 4 piles have local scour.

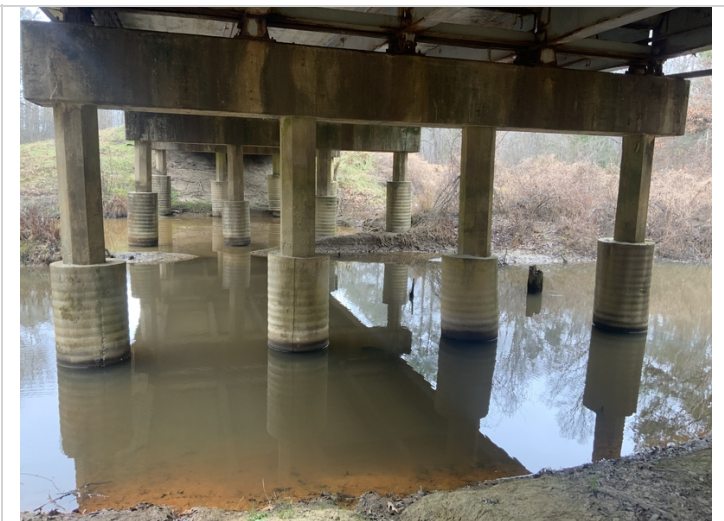
Bents 2-4 piles with cracks or spalls have been repaired with collars.

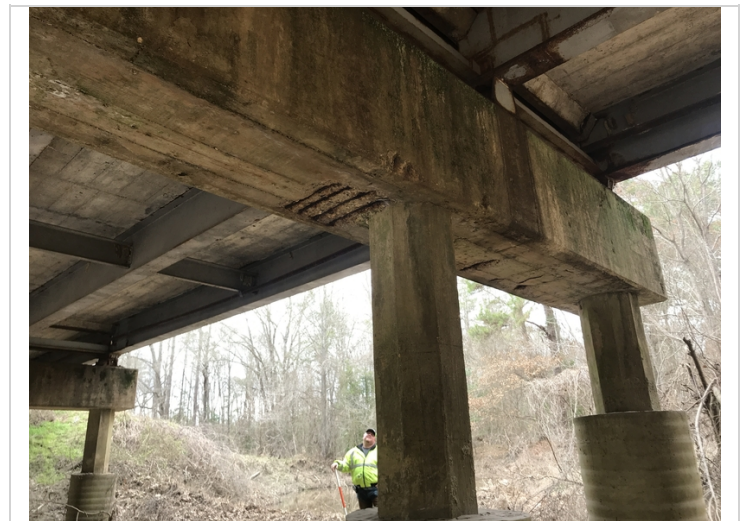
Bent 3 under side of cap has exposed reinforcing steel.

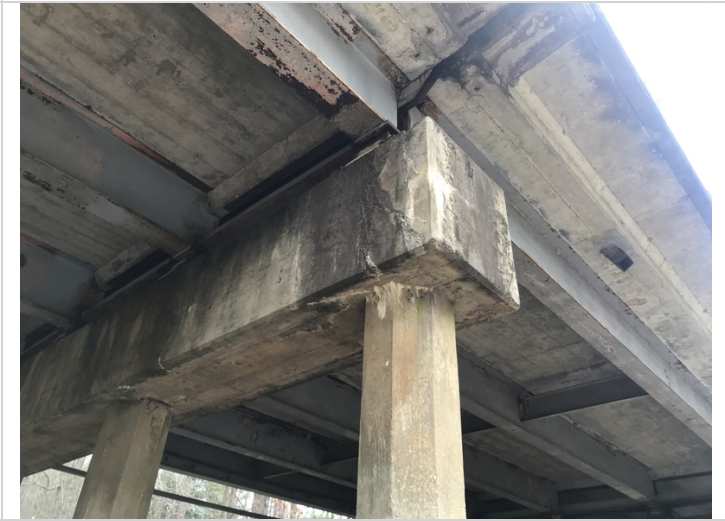
Bent 4 right side has efflorescence cracking.

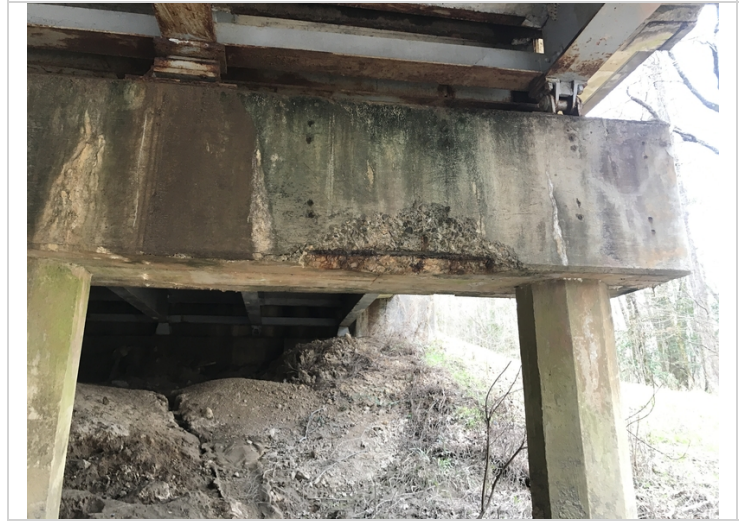
Bent 5 back side between piles 3 and 4 large spall with exposed reinforcing steel.

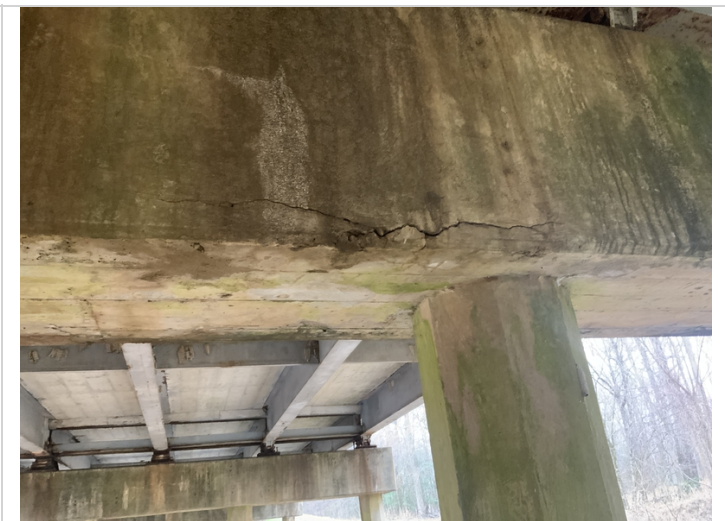
Bent 2 cap back has crack.

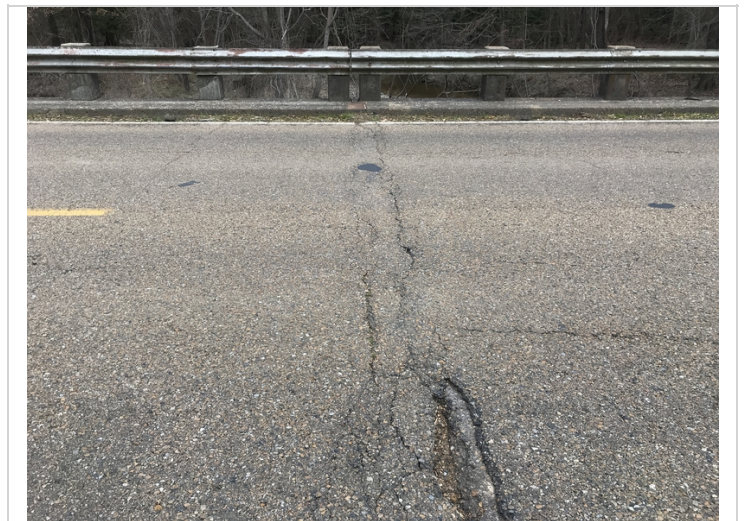
(305) KRM & ADC 2/26/2020 There is an ACHM overlay on this bridge, that goes over the joints thus restricting the free movement some.							
311	Movable Bearing	EA	25	0	18	7	0
1000	Corrosion	EA	25	0	18	7	0

Typical condition of joints.

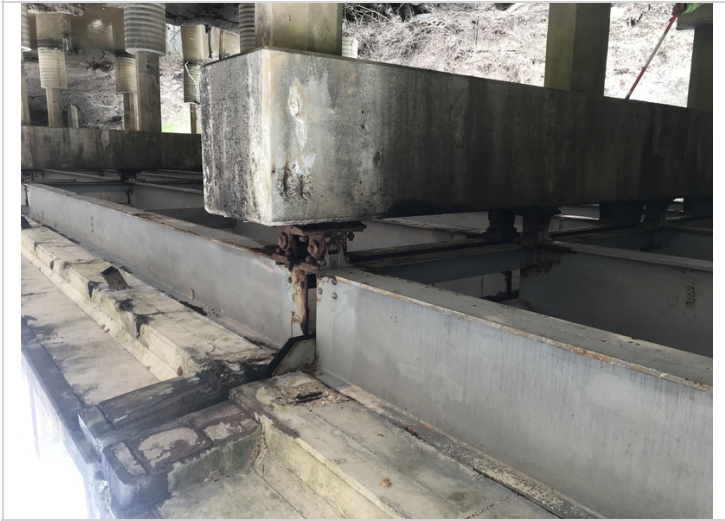
Bent 2 corrosion to moveable bearings.

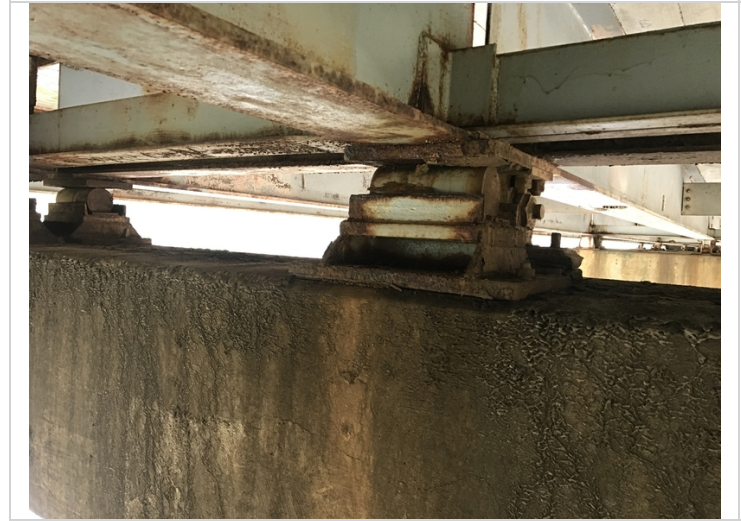
(311) KRM & ADC 2/26/2020 All bearings have corrosion.							
313	Fixed Bearing	EA	25	0	18	7	0
1000	Corrosion	EA	25	0	18	7	0
(313) KRM & ADC 2/26/2020 All bearings have corrosion.							
330	Metal Bridge Railing	LF	324	172	152	0	0
1000	Corrosion	LF	150	0	150	0	0
1020	Connection	LF	2	0	2	0	0
515	Steel Protective Coating	SF	1026	576	450	0	0
3440	Effectiveness (Steel Protective Coatings)	LF	450	0	450	0	0

Typical condition of bearings.

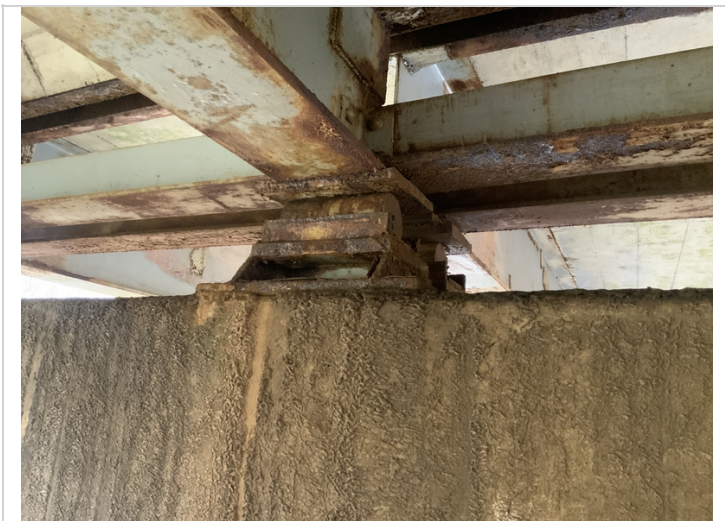
Bent 5 span 5 bearings have active corrosion.

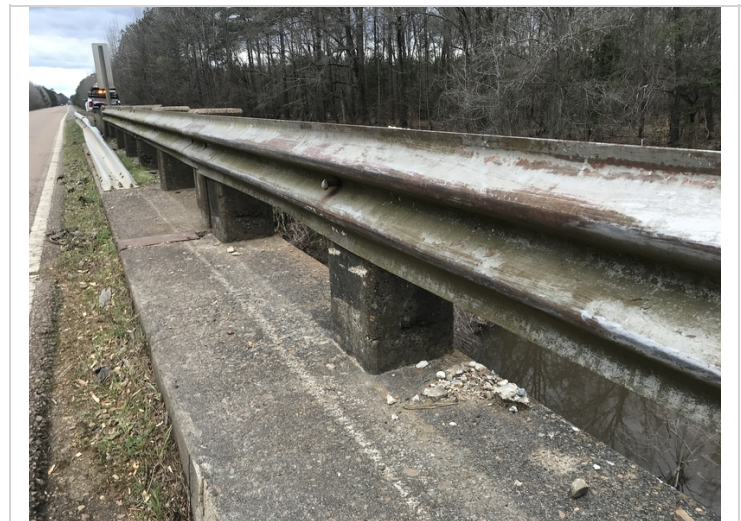
Loose connection span 2 left side.

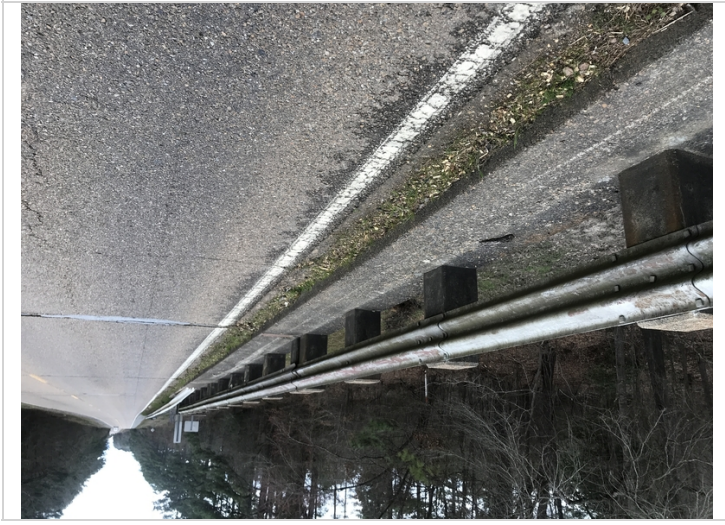
(330) KRM & ADC 2/26/2020 Metal bridge rail has 2 loose connection on left side, minor corrosion scattered throughout structure. Protective coating has lost its effectiveness.

Typical condition of metal bridge rail.

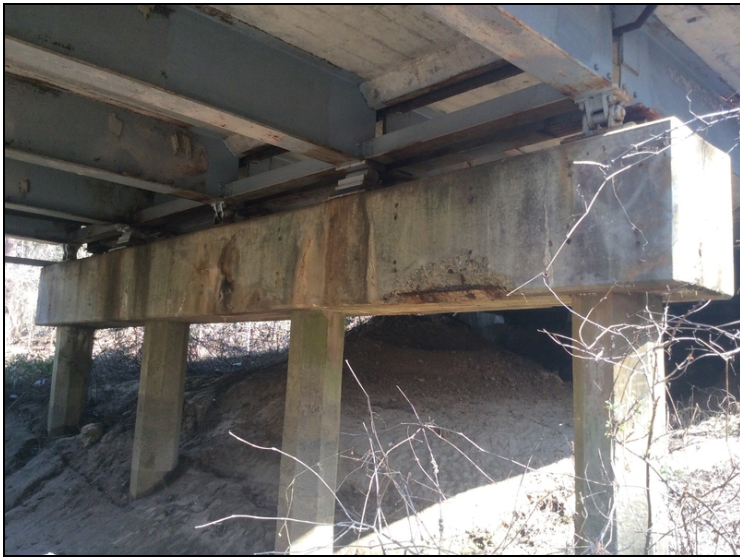
Bent 5, concrete cap.  
Cracked with efflorescence.

3' spall with exposed steel.  
02/19/2016 JPR -- Both spalls have exposed steel with section loss.

Bent 5 cap with large spall with exposed steel & section loss, between piles 3 & 4. Also cracking & delamination to bottom of cap between piles 2 & 3.

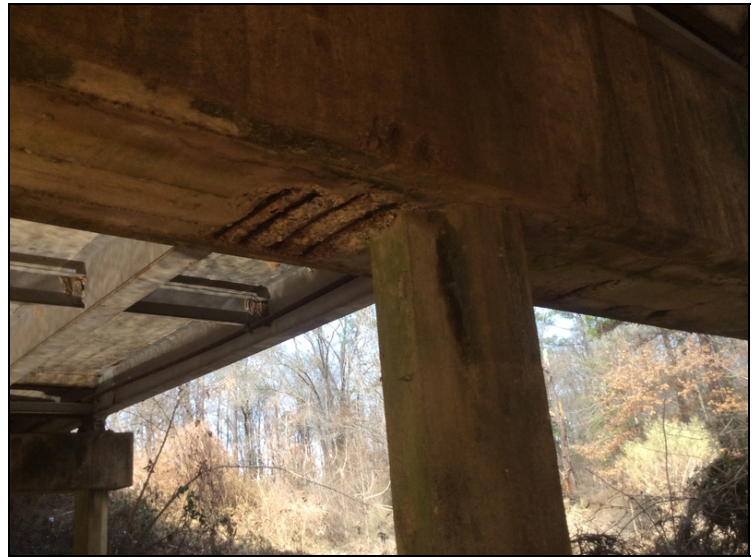
Bent 3 cap, spall between piles 2 & 3 with exposed steel & section loss.

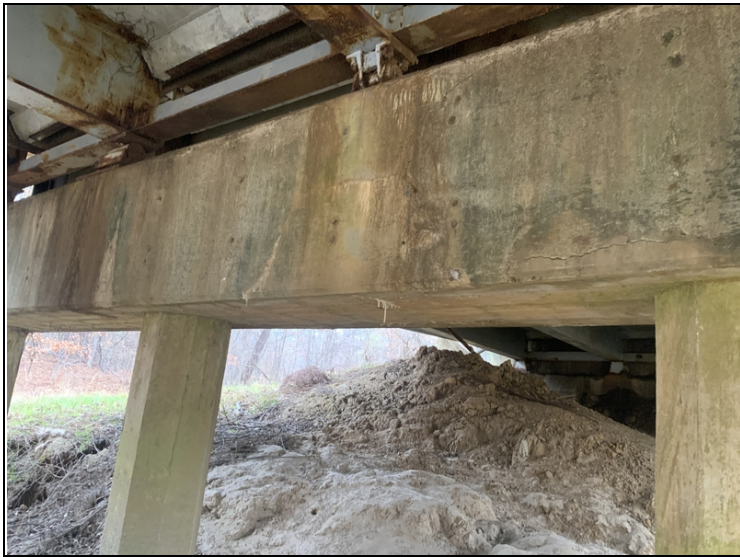
Bent 5 cap cracks with efflorescence.

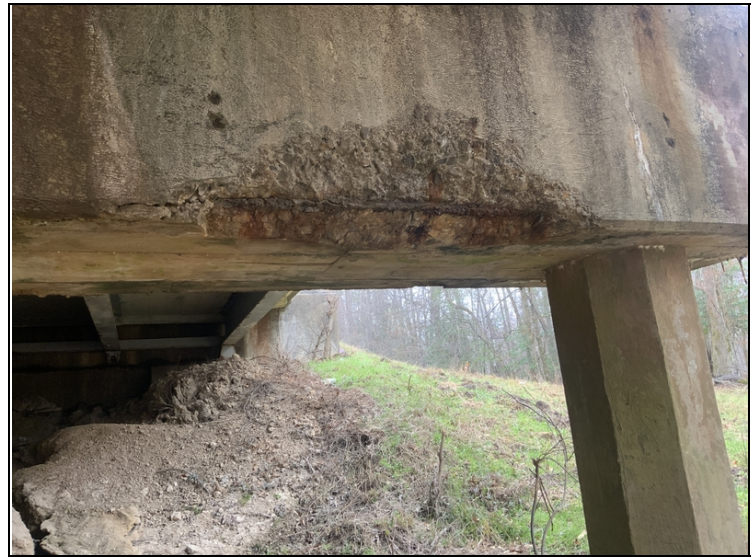
Bent 5 cap large spall with exposed rebar.

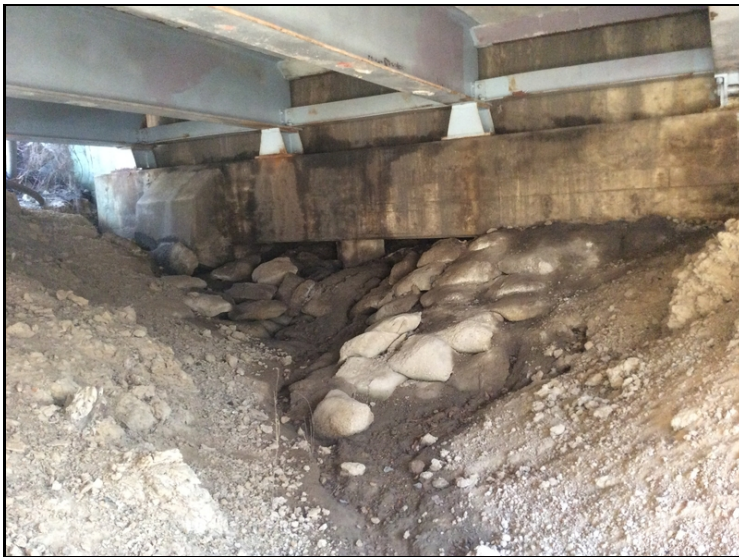
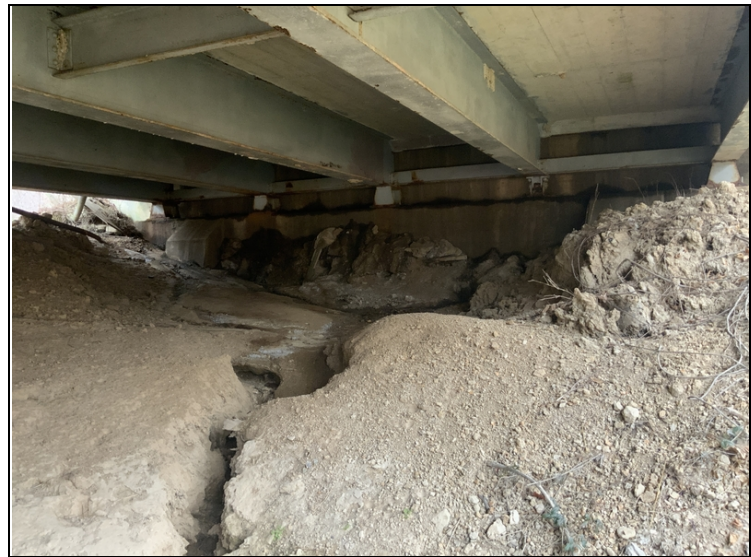
Abutment 2 scour back and under abutment cap between piling 2 & 3 with some roadway settlement.

Abutment 2 cap has scour between piles 2 & 3, with pile 3 exposed (1').
