Asset #06863(Routine, Underwater type 2)

SH 98 S:1 LM 0.52 over Beech Creek

Location: 0.9 mi E of US 82 & 98

Team Lead: Rickie Bratton, Inspection Date: 04/13/2021

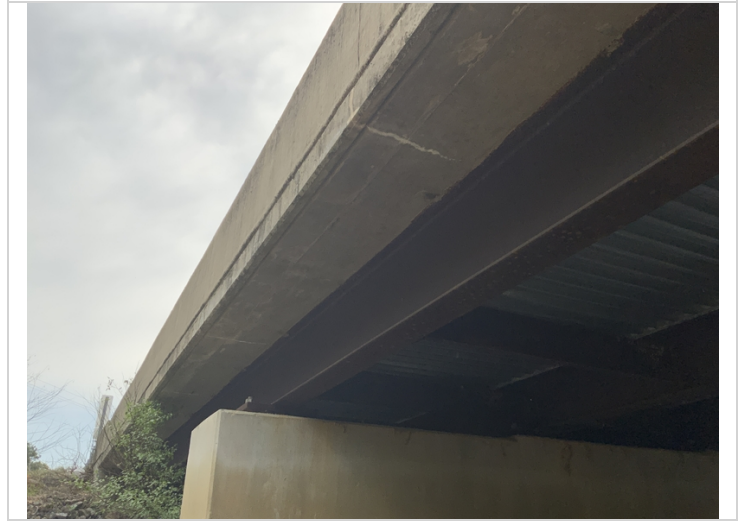
Soffit efflorescences

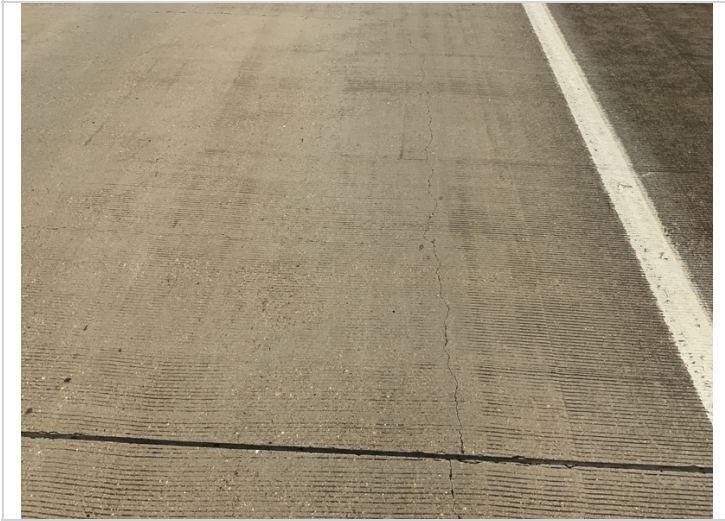
Deck has numerous longitudinal and transverse cracks all spans. Some areas of the deck adjacent to the joints have cracking.

(12) (2015 notes) Minor longitudinal & transverse cracks all spans. The longitudinal cracks are about 2' inside the white lines of both lanes. (2017 notes) Deck has numerous longitudinal and transverse cracks all spans. Some areas of the deck adjacent to the joints have cracking.							
107	Steel Open Girder/Beam	LF	700	700	0	0	0
515	Steel Protective Coating	SF	33833	33833	0	0	0
227	Reinforced Concrete Pile	EA	15	15	0	0	0
234	Reinforced Concrete Pier Cap	LF	210	210	0	0	0
302	Compression Joint Seal	LF	84	74	10	0	0
2360	Adjacent Deck or Header	LF	10	0	10	0	0

Transverse and longitudinal deck cracks 0.040 max

Deck all spans.

Numerous sealable longitudinal and transverse cracks.

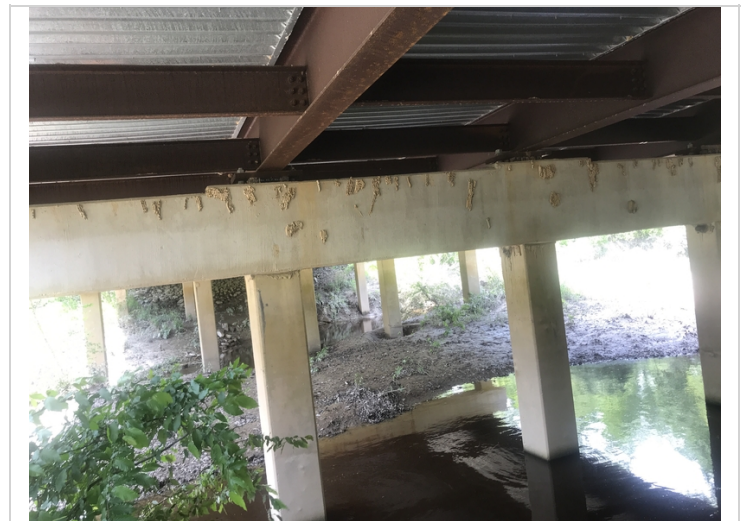
Span 4, deck soffit looking back towards bent 4.

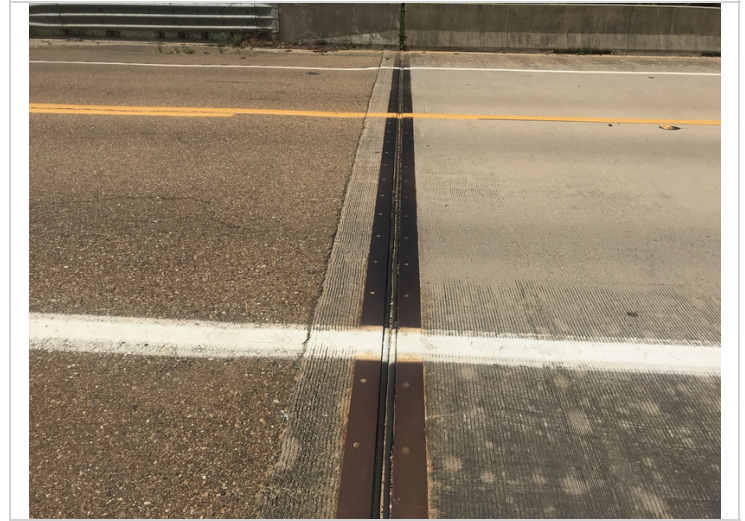
(302) Some deck cracking along the joint @ bent 2.							
310	Elastomeric Bearing	EA	25	25	0	0	0
331	Reinforced Concrete Bridge Railing	LF	284	284	0	0	0

Joint material abutment 1

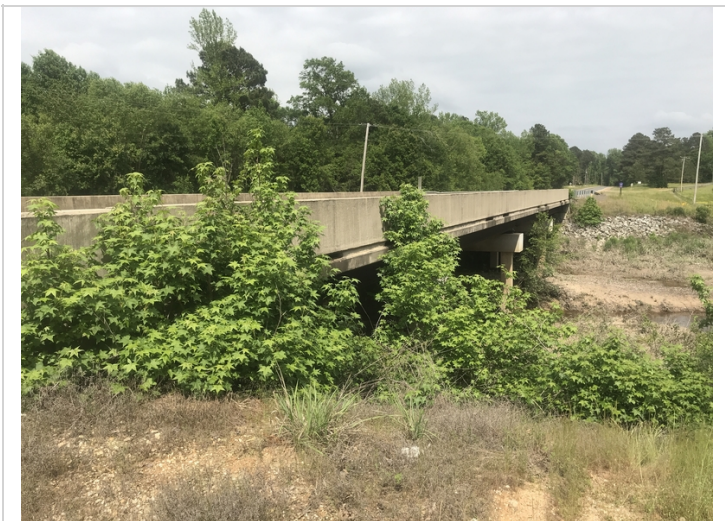
Span 1 looking ahead @ vegetation growing up beside & back under the bridge, this is typical of both sides of the bridge.

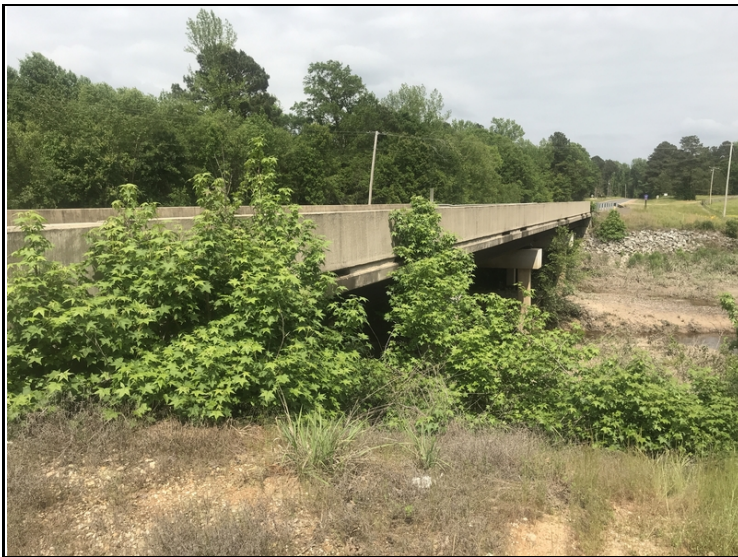
Span 1 looking ahead @ vegetation growing up beside & back under the bridge, this is typical of both sides of the bridge.
