Asset #A0539(Routine)

US 278 S-12 LM9.85 over CAMP CREEK

Team Lead: Rickie Bratton, Inspection Date: 06/07/2022

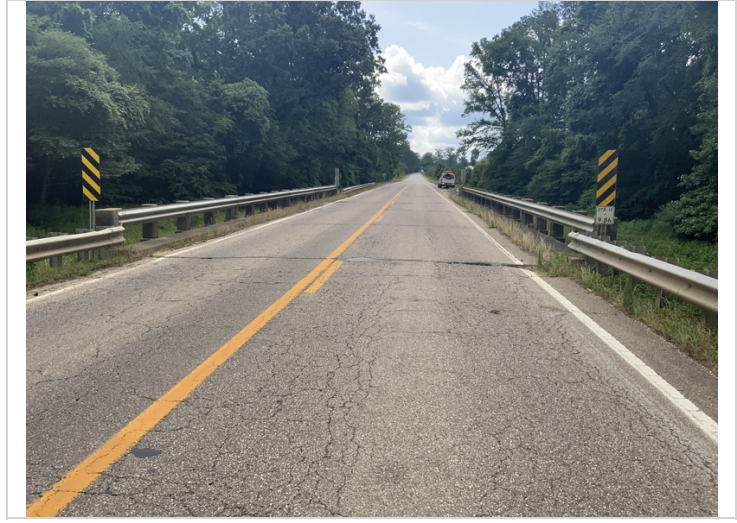
Approach roadway Eastbound.

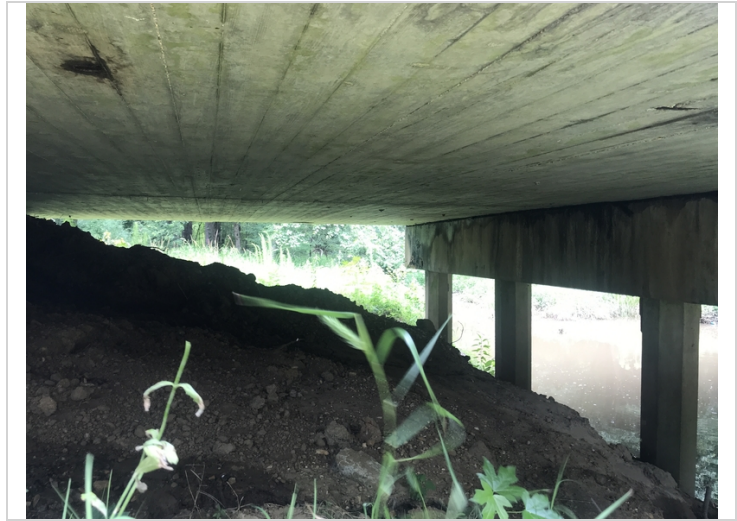
Span 1 Deck soffit.

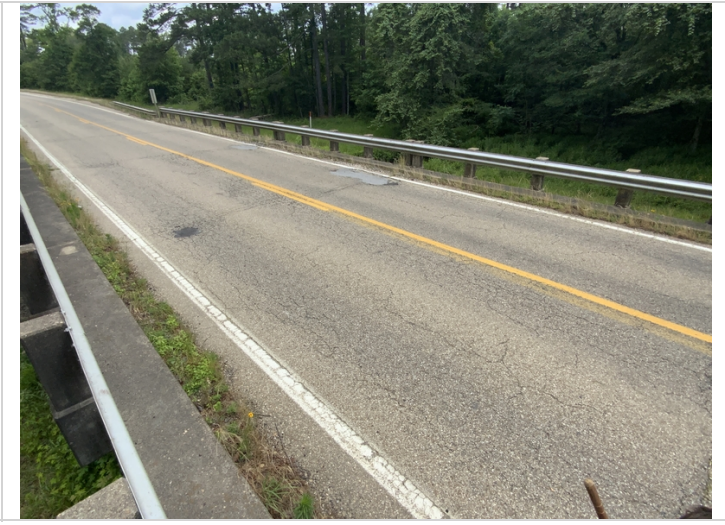
Deck overview.

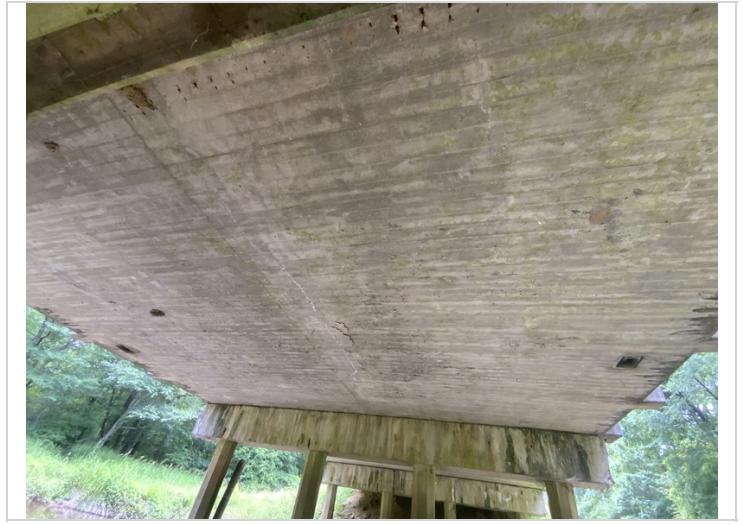
Span 2 soffit overview.

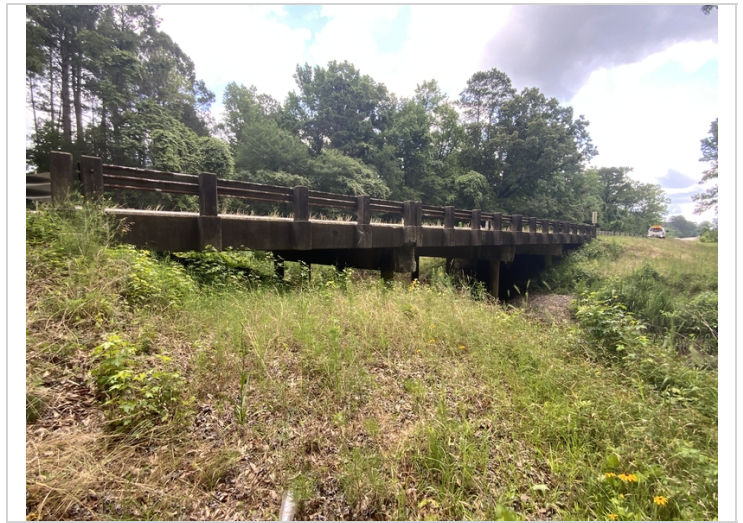
Elevation.

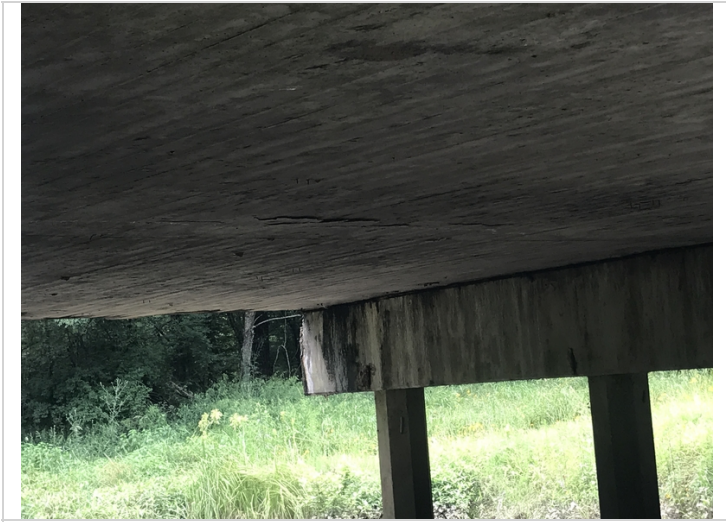
Span 2 @ C/L of bridge @ middle of span there is a 3' - 4' delamn on soffit of deck.

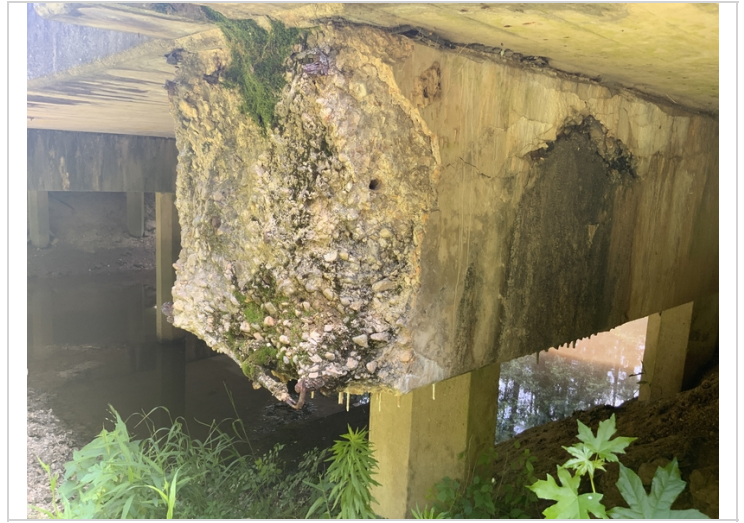
Bent 4 cap right end exposed rebar.

Bents 2,3 and 4 caps are cracked and spalled with exposed steel. With 100% section loss to the steel on bent 4 right end.

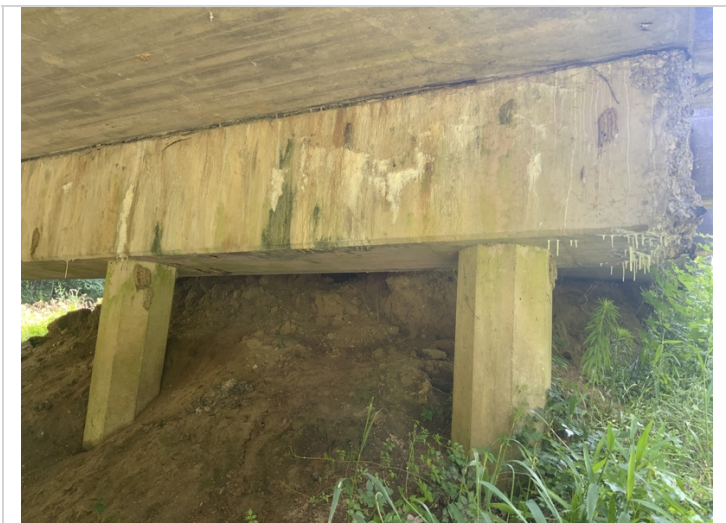
Bent 4 cap back cracks with efflorescence.

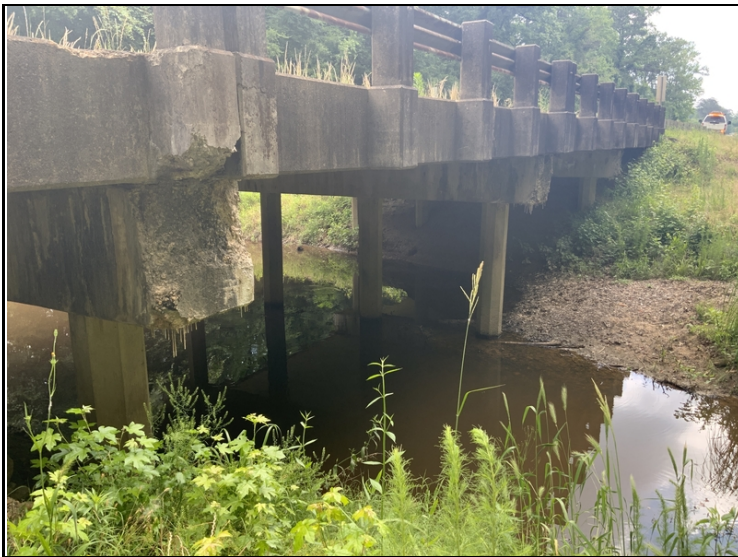
Caps 2-4 spalls with exposed rebar on right ends.

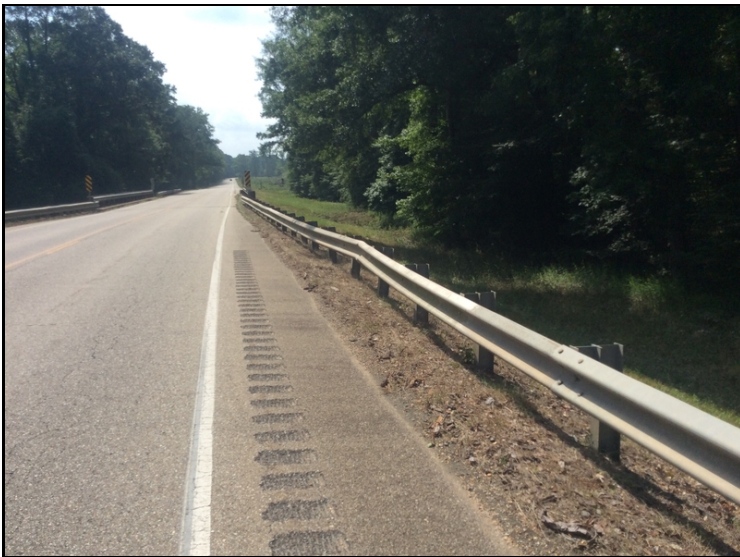
Minor rail damage right side back of abutment 1.

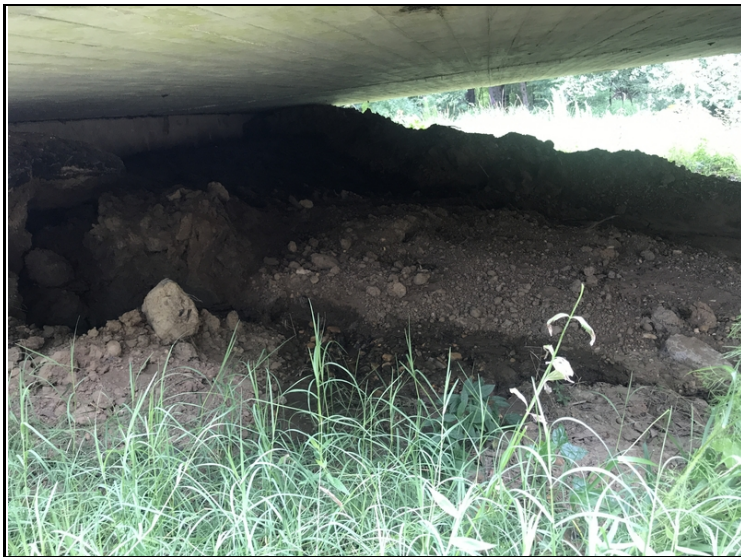
Abutment 1 erosion goes back under the abutment cap.

Abutment 1 erosion

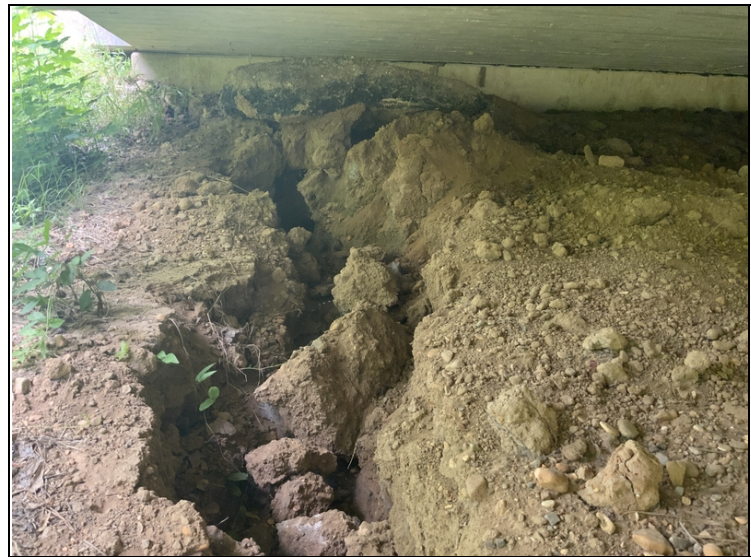
Abutment 1 erosion goes back under the abutment cap.
