**Asset #06164**(Routine, Underwater type 2)

**SH 7 S-5 LM 13.59 over BEACH BRANCH**

**Location: 3.3 MI SO JCT SH 8**

**Team Lead: John Parks, Inspection Date: 08/10/2022**

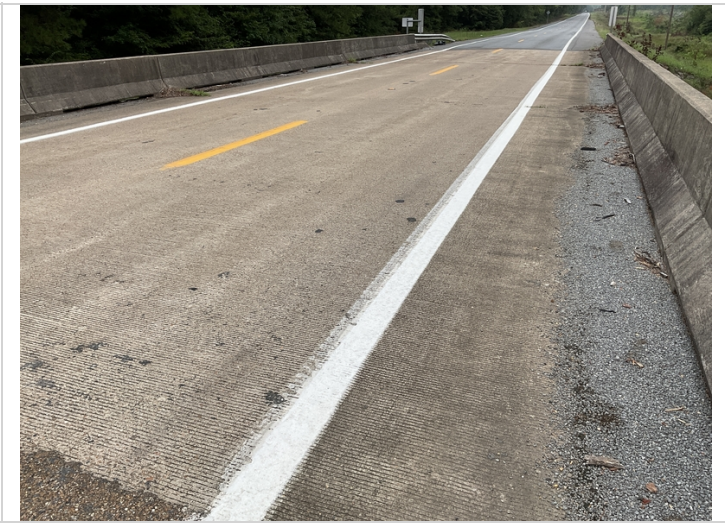
Comment: Exposed aggregates joints leaking

Deck overview

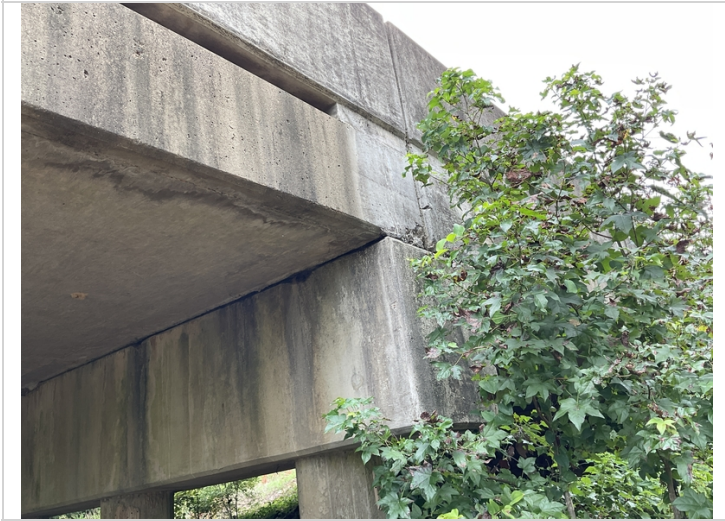
Span 2 & 3, right side at Bt. 3, spalls in the end of the slab.

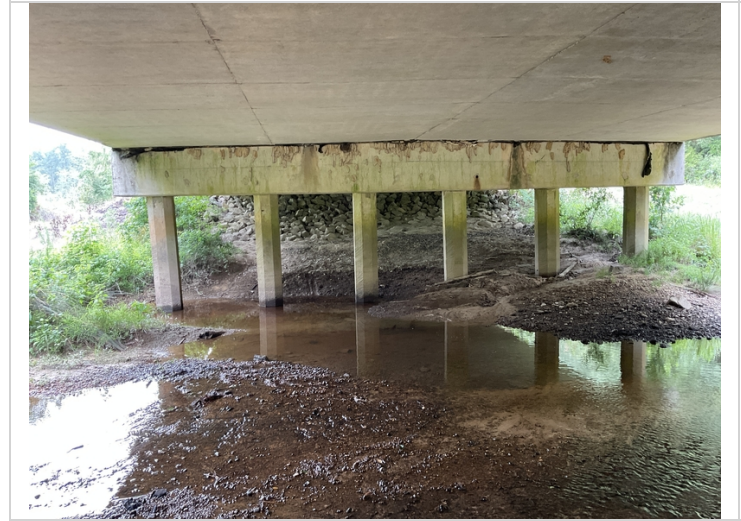
Bt. 2, typical substructure.

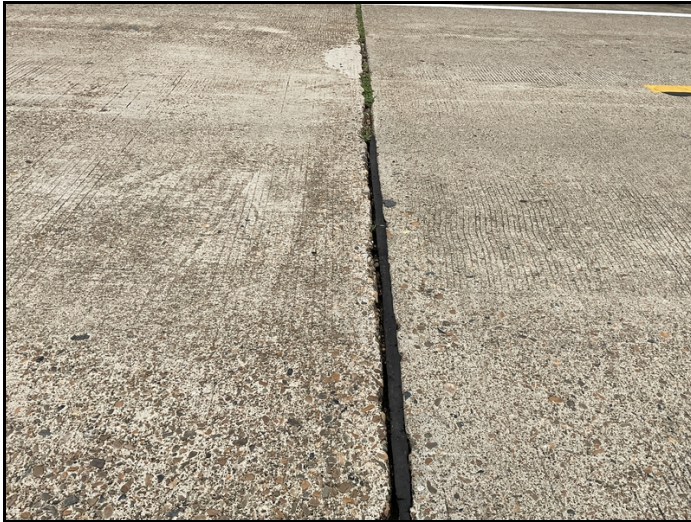
Joint seal have lost adhesion allow debris impaction & allowing leakage on to the caps.

**A-56 - Joint Cleaning/Flushing Needed**

**A-59 - Joint Repair Needed**

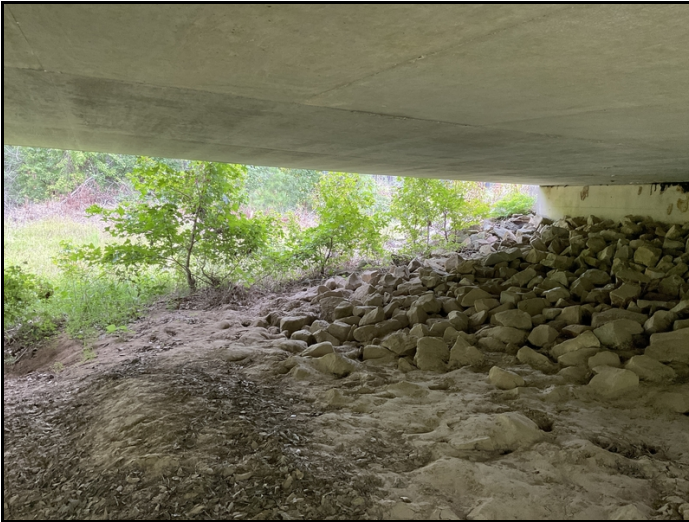
Trees growing next to the bridge.

**A-64 - Vegetation Removal Requested**
